UNITED STATES
NUCLEAR REGULATORY COMMISSION

SUBJECT: NRC INSPECTION REPORT 030-37816/2019-001 AND NOTICE OF VIOLATION

Intertek Asset Integrity Management, Inc. NRC Reactive Inspection Report 030-37816/2019-001 (Health and Safety)

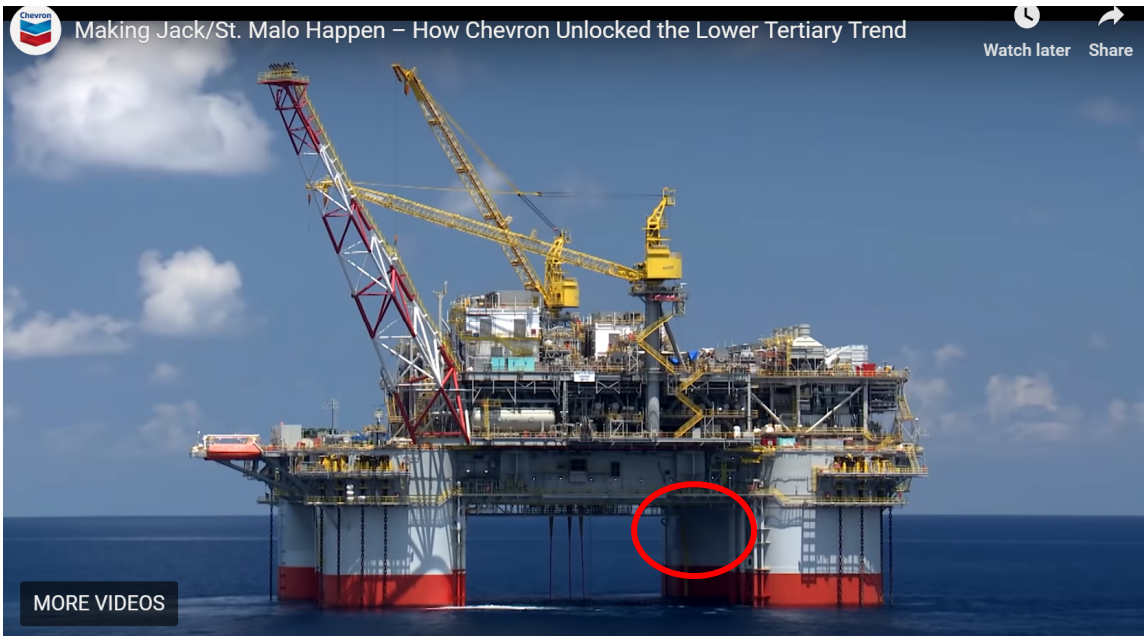
Figure 2 - Production platform the radiography was occurring on (Chevron website). Red Circle indicates the approximate location of the radiography at the time of the disconnect.

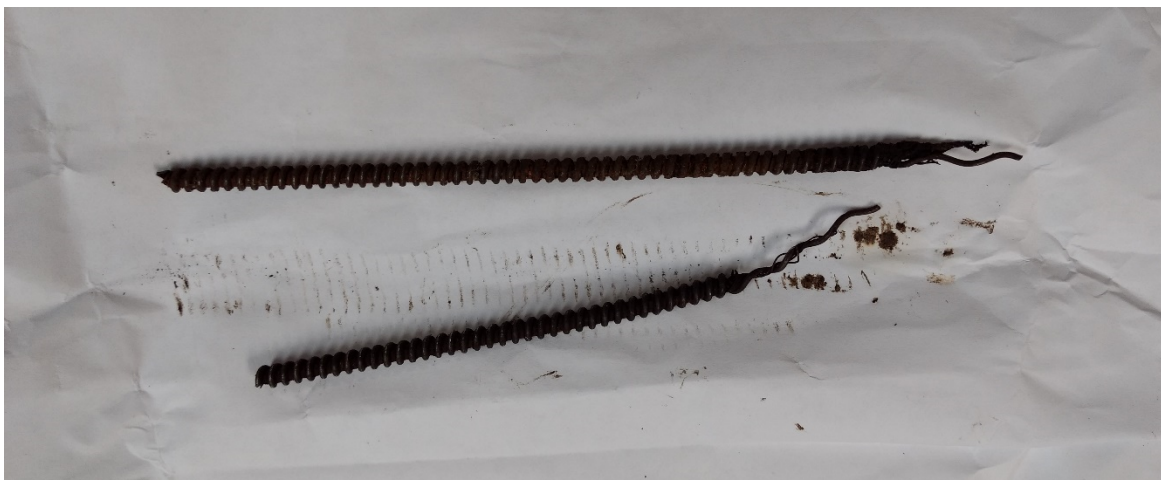
The radioactive source (iridium-192) was determined to have been disconnected by a cable break (see Figure 3). The break was caused by corrosion of the cable. The radiography source was transferred to a Source Production and Equipment Company (SPEC) C-1 source exchanger, which was stored in the licensee's mobile darkroom onboard the platform until subsequently being flown back to the onshore licensee facility for evaluation on January 28, 2019. The licensee notified the NRC of the event on January 29, 2019.

Figure 3 – Broken source cable (Note the advanced state of corrosion).

The inspector determined that the licensee's procedures were adequately developed to require the radiography crew, in the performance of daily maintenance, to identify issues, such as cable corrosion, worn, damaged, or bent cables, prior to corrosion causing an actual event. The procedures dictated that the cable is to be flexible, not crimped, and free of identifiable damage, bends, or excessive wear. The advanced state of corrosion of the cable, seen in Figure 3, had not been identified by the radiography crew. The crew did not conduct the above described tests and assessment against the full length of the cable, but rather only the first short length, which was not yet in the same state of corrosion.

During the inspection, the licensee's corporate radiation safety officer demonstrated portions of the required operability test, including bending and flexibility, using the actual cable involved in the event. Under normal circumstances, a cable should bend and return to an upright position without issue. However, the cable in question was visibly corroded and when bent remained bent at an angle, and therefore, did not pass the visual and operability check.

In the weeks that followed the NRC's January 2019 inspection the licensee had issued a "Safety Alert" company-wide to communicate the immediate issue of daily visual and operability checks at the radiography crew level and was drafting revisions to the company's Operating and Emergency procedures that would comprehensively address the deficiencies in the maintenance program. This draft revision was in the process of deploying a new maintenance program to better track, capture, and document the required maintenance of associated radiographic equipment.
