**NEI 99-02 FAQ 19-02 - Final Response  
Brunswick RCS Leakage**

Plant: Brunswick Nuclear Power Plant Unit 1

Date of Event: March 28, 2019

Performance Indicator: BI02 - Reactor Coolant System Leakage

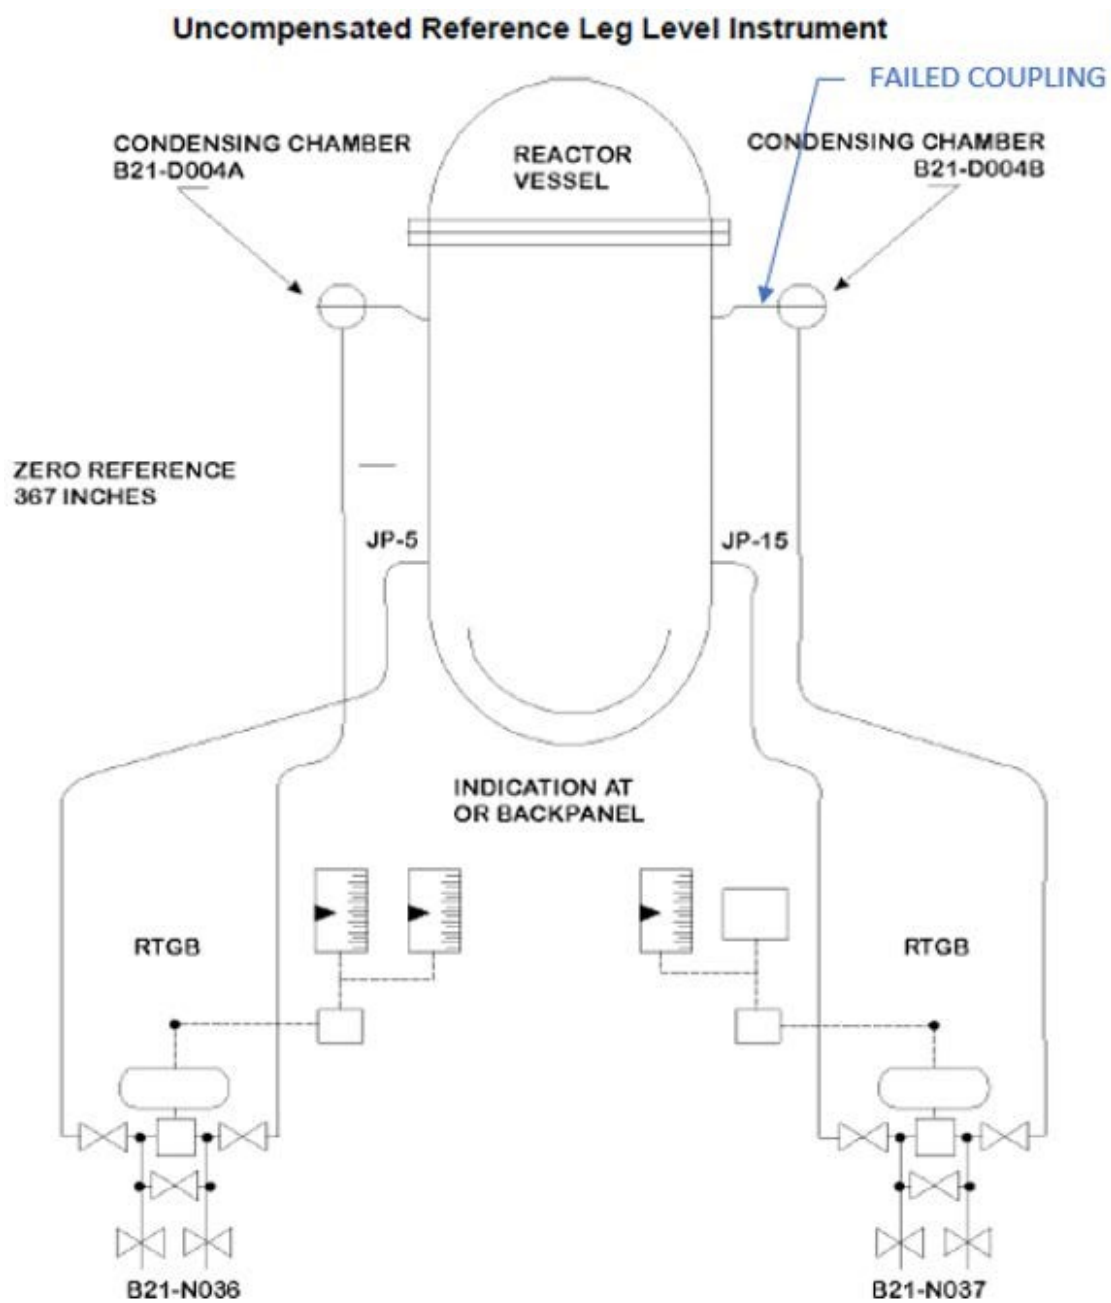
Figure 1, RCS Leak location

Contrary to this, the March 28, 2019, Brunswick event resulted from the immediate circumferential separation of a 1-inch coupling on the steam side sensing line for reactor vessel level indication, as shown in Figures 1 and 2. Based on the material of construction and environmental conditions (i.e., temperature, hydrogen), the post-event metallurgical report determined the coupling showed no evidence of localized plastic deformation. The coupling experienced hydrogen embrittlement and did not exhibit a leak-before-break failure mechanism. There were no precursors to this event and the resulting leakage from the break exceeded the Technical Specification (TS) limit. RCS leakage was stable and well below the TS limit before the event. The steam leak could not be isolated from the reactor vessel. Operations took prompt action to reduce power, commenced a plant shutdown, and depressurized the reactor to stop the leak. The leakage resulted in the declaration of an Unusual Event (UE). Operations completed an uncomplicated reactor shutdown. It was the last reading taken before entering Mode 4 (i.e., the Mode in which the SR is no longer applicable) that caused the PI to transition from Green to White. RCS leakage was stable and was being appropriately managed before the event. Based on these unique circumstances, Brunswick requests an exemption to exclude reporting the leakage from the event in the RCS Leakage PI. This would result in the PI returning to Green for March 2019.

Investigation inside containment determined that a 1-inch coupling on line 1-B21-774 located on the steam side of a reactor level condensing chamber experienced a 360° circumferential separation at the approximate center of the coupling as shown in Figures 1 and 2 below. This opened a path for steam from the reactor to leak into the drywell. Reactor water level was maintained in the established level band, below the level of the sensing line nozzle, throughout the event. The impact from the coupling failure has been analyzed by the Duke Probabilistic Risk Assessment staff and determined to be very low safety significance.

An evaluation was performed to address the couplings installed in both units. All couplings exposed to reactor steam (i.e., potentially susceptible) were removed and replaced with welded fittings prior to startup of Units 1 and 2. In addition, the installation procedure for the couplings was placed on hold pending revision, to prevent any further installation of Cryofit couplings.
