Subject: Answer to Notice of Violation and Proposed Imposition of Civil Penalty
USNRC License No.: 42-32219-01
Docket No.: 030-35252
NRC Inspection Report 030-35252/2018-003; EA-18-124

Team Industrial Services, Inc.
Answer to Notice of Violation
May 23, 2019

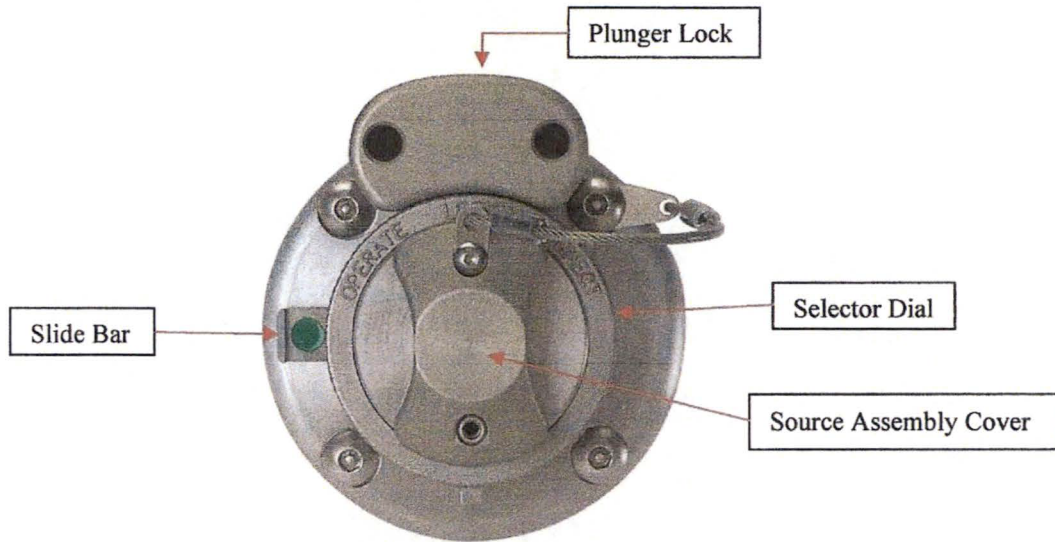
Figure 1: [REDACTED] Lock Assembly

Mitigating Factors: The exposure device being utilized was a [REDACTED] which by design incorporates three independent locking mechanisms to prevent accidental movement or exposure of the source. (See description and picture below.)

- 1) A positive locking mechanism (slide bar) which secures the source assembly in the exposure device and prevents movement of the source;
- 2) A selector dial which prevents movement of the positive locking mechanism until time to expose the source. The selector dial has three positions: lock, connect and operate. The selector dial can be rotated left from the lock position to the connect position or right to the operate position with the lock position being in the top center. Turning the selector dial to the connect position unlocks and opens the rear cover of the lock assembly for inspection of the source assembly and/or connection of the drive assembly. In the connect position, the source assembly remains secured by the slide bar as in this position there is no way to engage the slide bar. Turning the selector dial to the operate position exposes an opening in the dial whereby the slide bar can be engaged to release the source assembly when ready to make an exposure; and,

- 3) A keyed plunger lock which prevents the selector dial from being rotated.

TEAM's Operating and Emergency procedure is more restrictive than the regulation since we require the device to be fully locked prior to movement to another location. However with only the plunger lock disengaged, the source assembly is still well secured within the exposure device with no risk of movement or exposure with the selector dial still set in the locked position, the slide bar still engaged securing the source assembly and the tungsten shield still in the closed position. The fact the source was secured within the exposure device to prevent unauthorized or accidental removal of the source from its shielded position meets the intent of 10 CFR 34.23(a). Additionally, the exposure device was under continual surveillance of the radiographers at all times also meeting the requirements of 10 CFR 34.23(a).

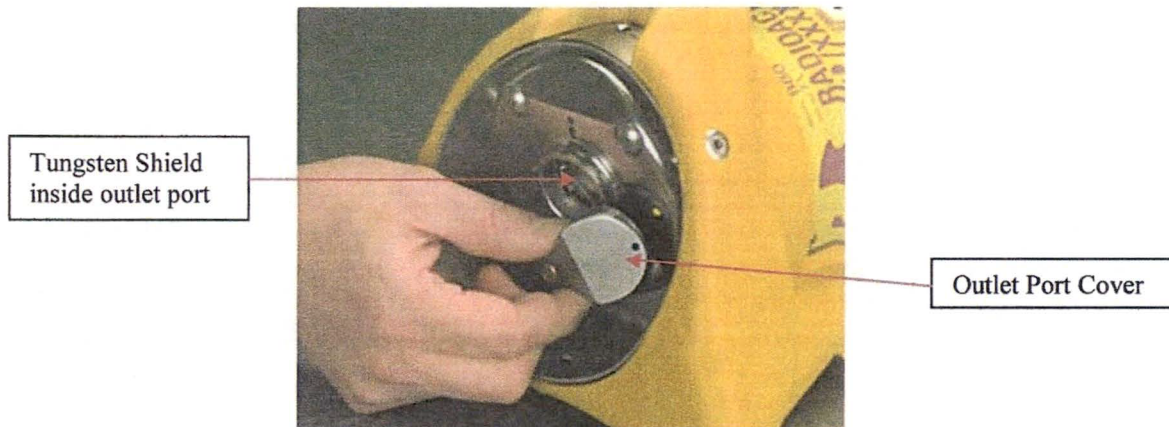
Figure 2: [REDACTED] Front Outlet Port

The device also incorporates a tungsten shield at the exit port that can only be opened once a guide tube is connected to the device. The tungsten shield provides a shielding factor to reduce exposure from the source, but also provides another level of security as it prevents the source from projecting out of the exposure device unless a guide tube is connected.
