TENNESSEE VALLEY AUTHORITY

September 6, 1979

PHIPPS BEND NUCLEAR PLANT REVERSE FAULT IN SOIL PIT

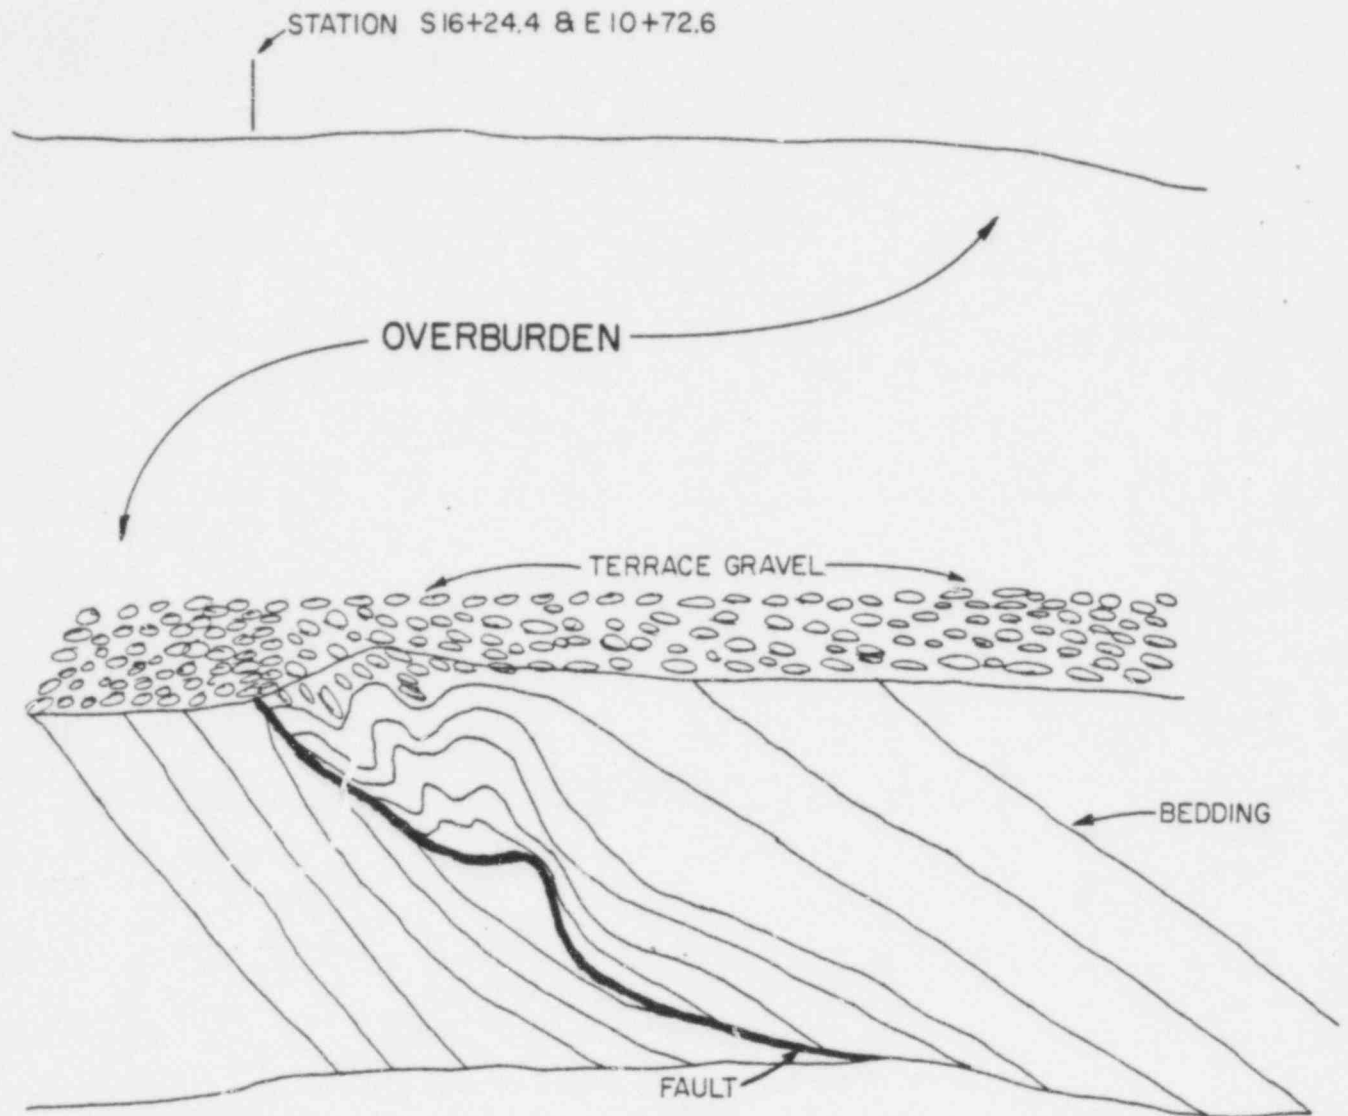
SOIL PIT EAST WALL

This is a reverse fault, defined by a tight fracture, which strikes N.50°E. and dips 55°SE. (See attached photographs and sketch.) On the north side of the fault, bedding strikes N.50°E. and dips 62°SE.; on the south side, adjacent to the fault, bedding is contorted, but farther to the south it strikes N.45°E. and dips 45°SE.
