TENNESSEE VALLEY AUTHORITY

PHIPPS BEND NUCLEAR PLANT

Thrust And Transverse Faults In The Intake Pumping Station Area

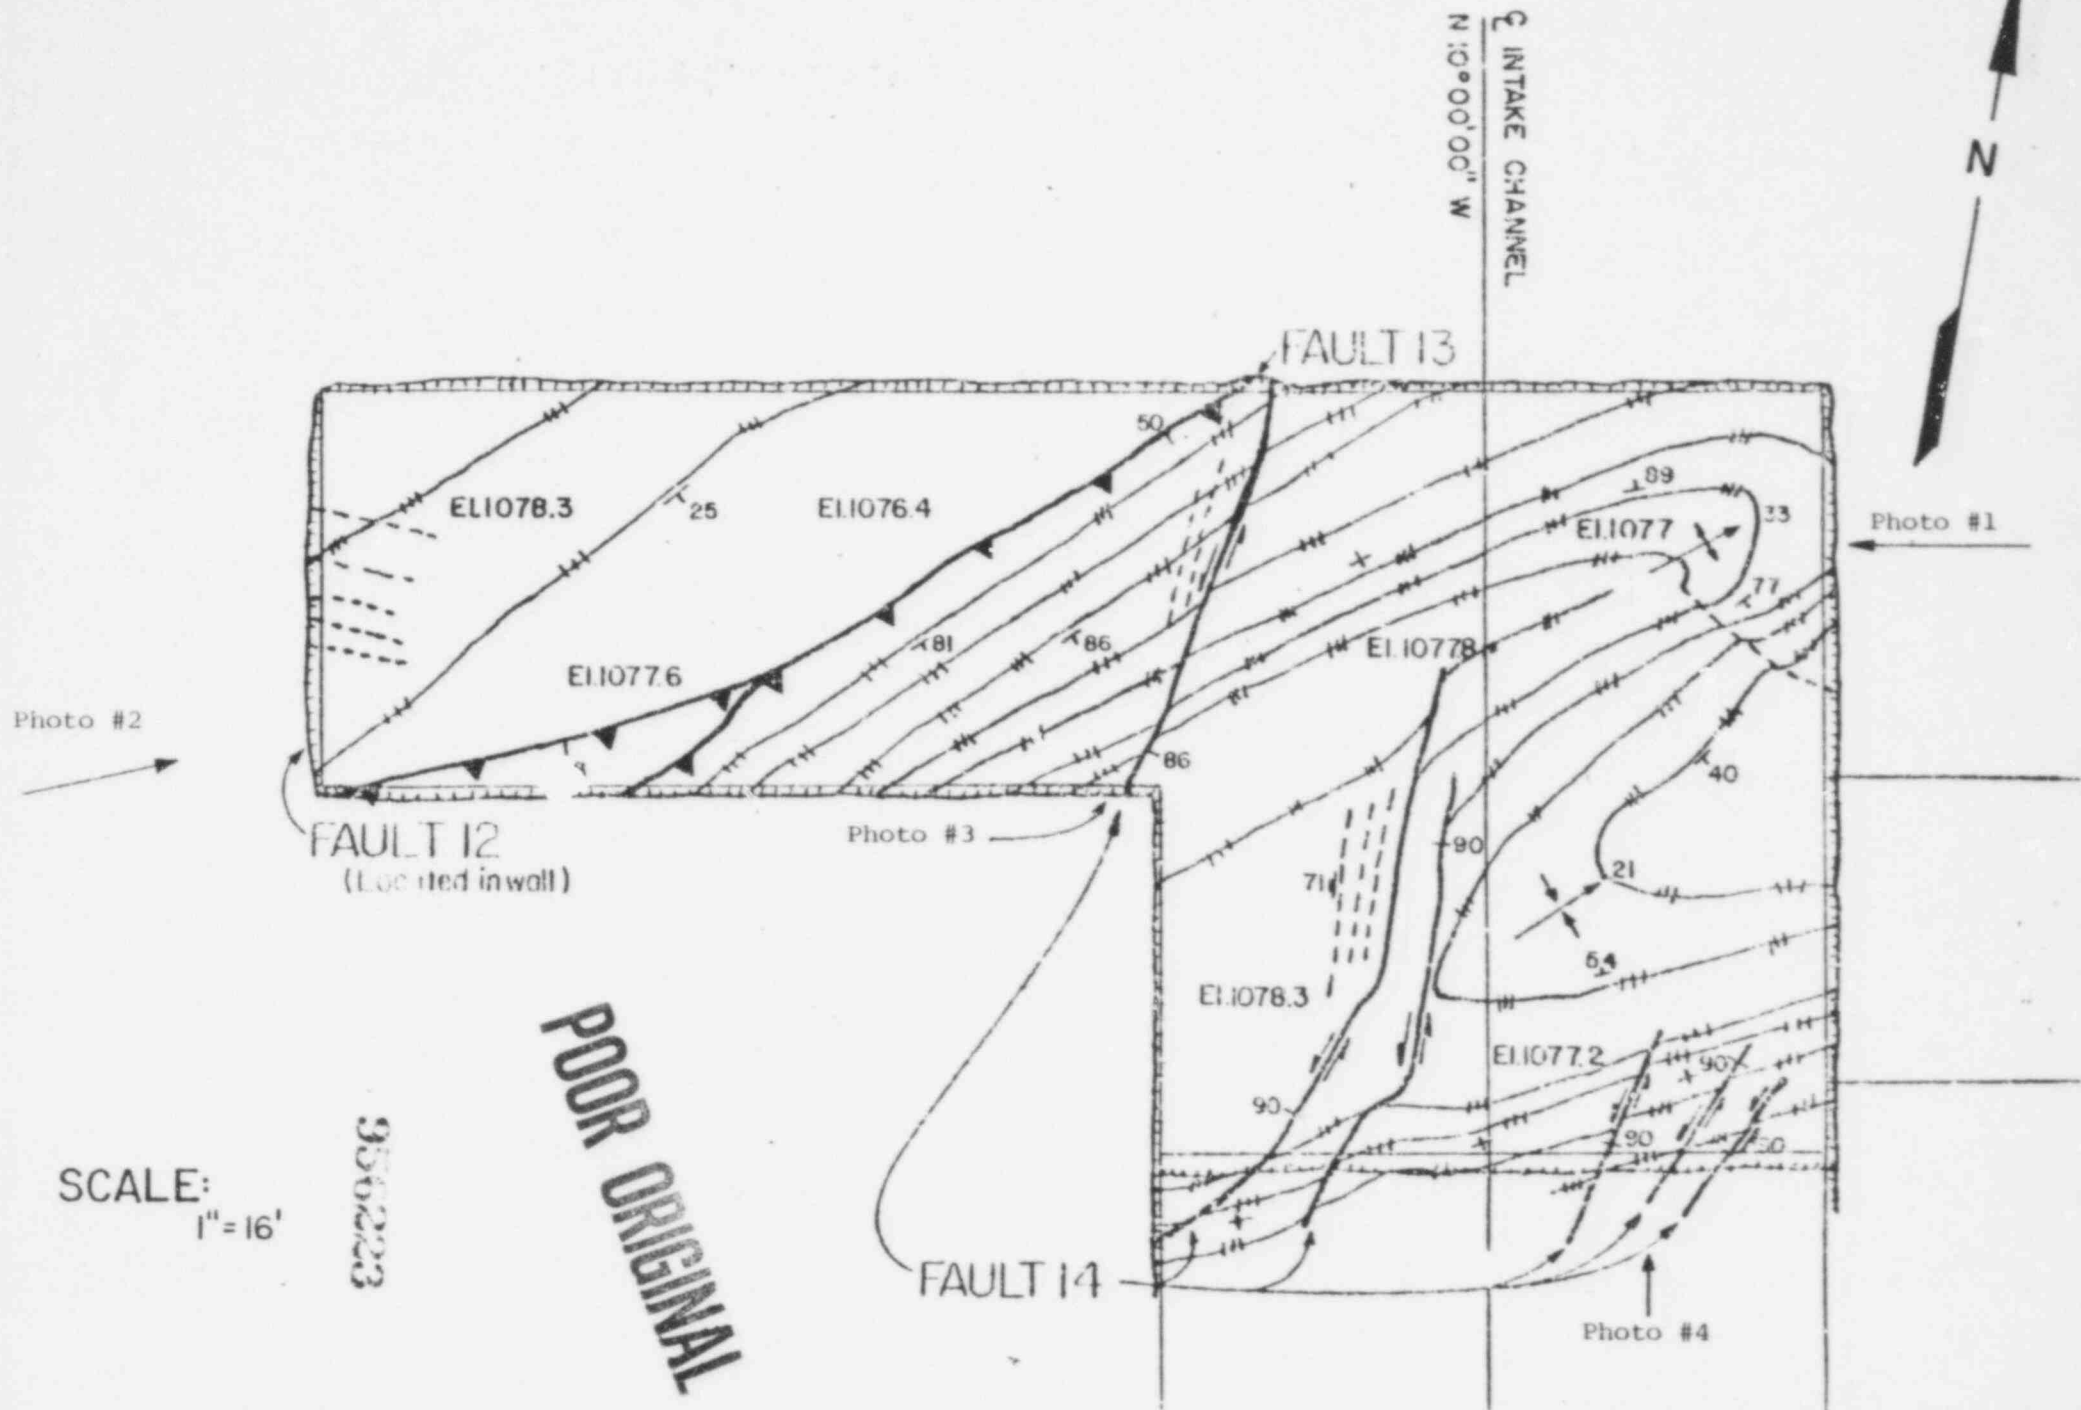
INTAKE PUMPING STATION

Final excavation of the intake pumping station has exposed two thrust faults and a series of transverse faults. (See attached map.)

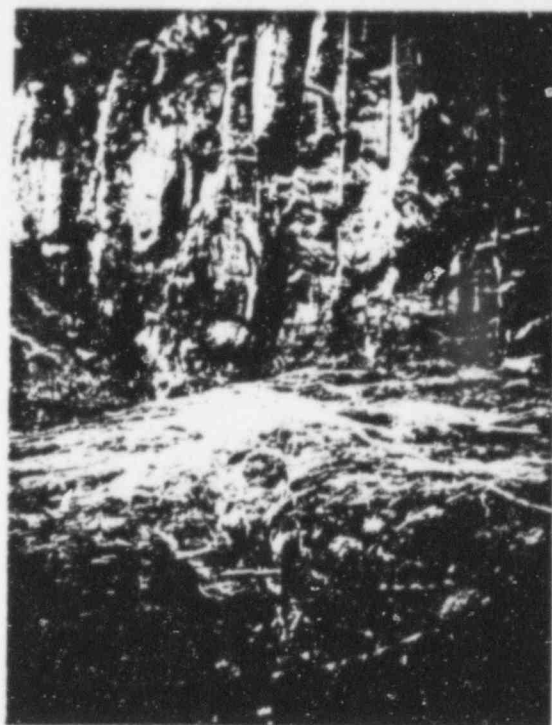
PHOTO #3 - Fault #14
View North

Fault number 14 is a series of N.0° - 10°E. trending transverse faults which dip 80° - 90° to the east and are calcite healed. The longest of these is visible for approximately 40 feet with a maximum 6 inch displacement of the beds. (See attached map and photographs #3 and #4.)

These faults are not considered to be capable of producing ground offsets or generating earthquakes. Therefore, we do not consider them as capable faults, within the meaning of Appendix A to 10 CFR Part 100.

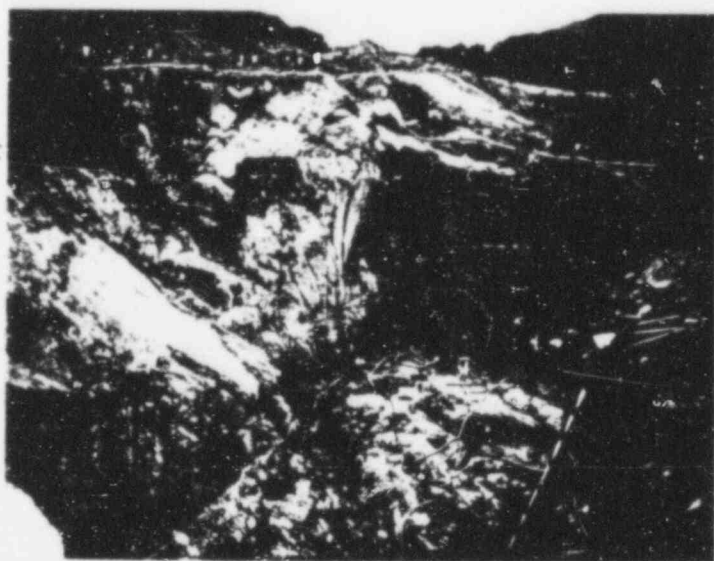
PHOTO #2 - Fault #13
View Northeast

Thrust fault number 13 (see photograph #2) strikes N.45° - 60°E. and dips 45° - 50° SE. The plane of this fault cuts the north wall of the pumping station and trends southwest across the floor of the excavation for approximately 80 feet where it is visible in the west wall.

Both of these faults are characterized by highly contorted beds in the upper plate that form tightly folded plunging anticlines and synclines. The lower plate shows little contortion of the beds which are dipping 25° - 30° SE. Both of these fault planes are calcite healed, but become weathered as they near the top of rock.
