OFFICE OF INSPECTION AND ENFORCEMENT BULLETIN 79-15 - RII:JPO
50-327, -328 - SEQUOYAH NUCLEAR PLANT

RESPONSE TO NRC-IE BULLETIN 79-15
DEEP DRAFT PUMP DEFICIENCIES

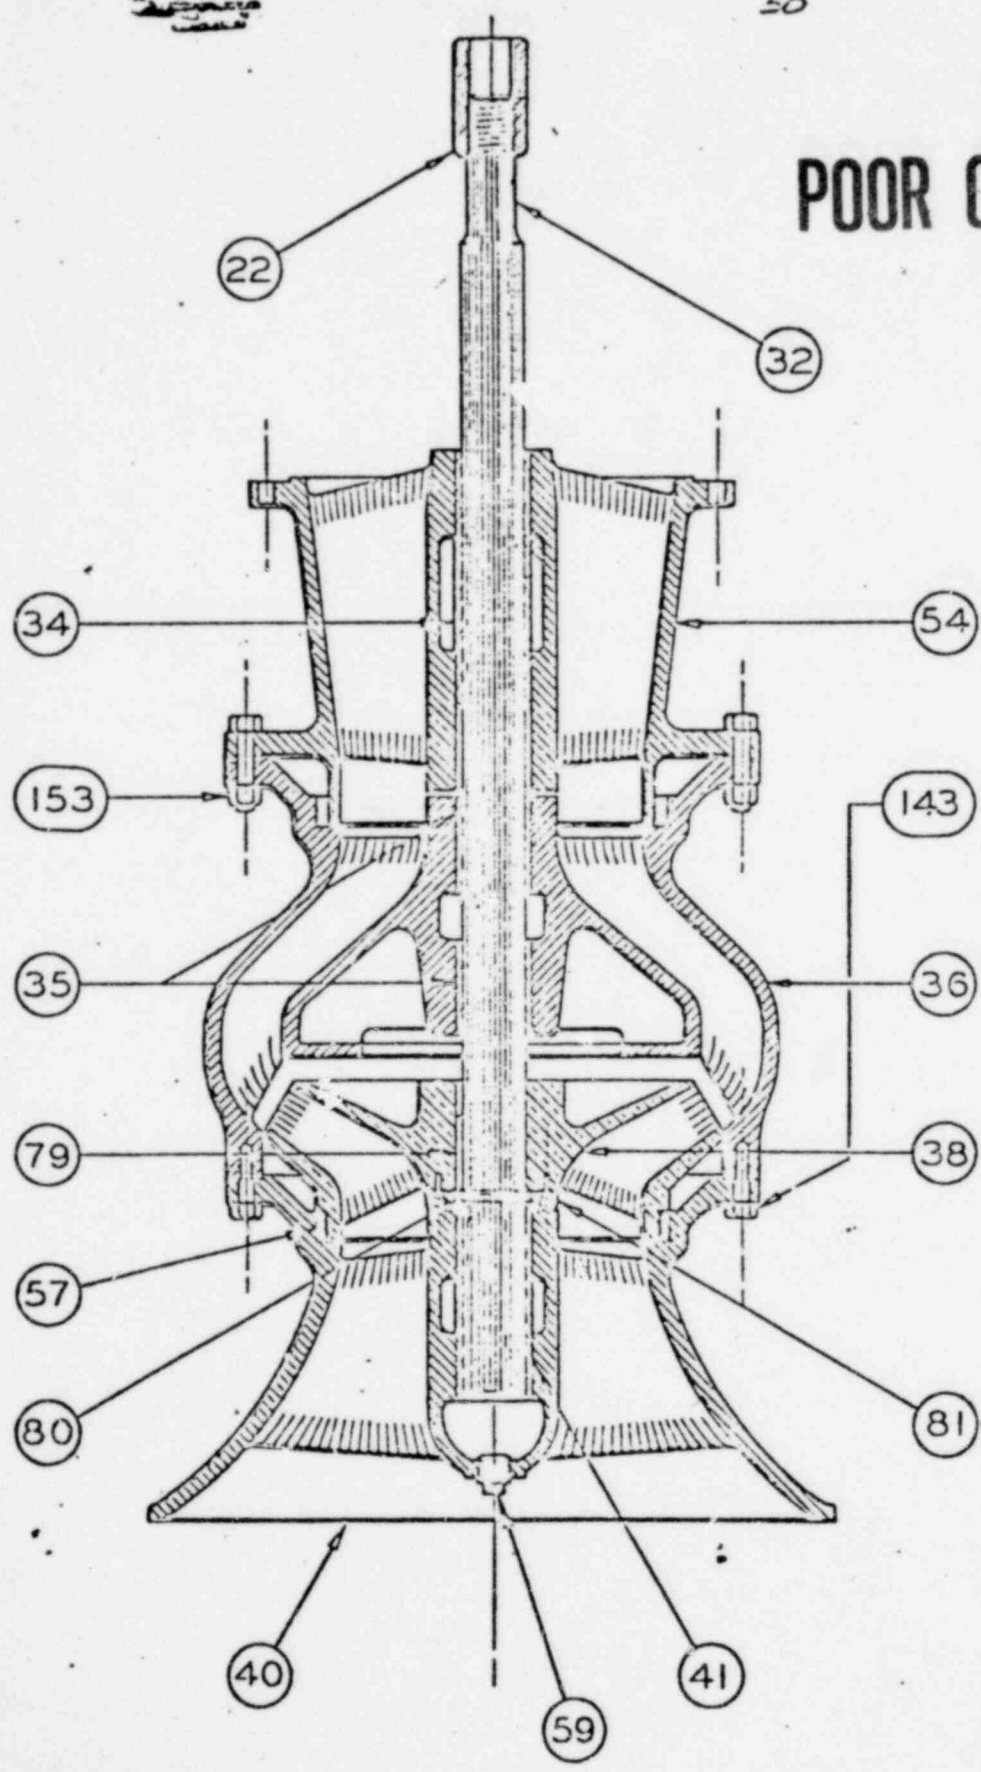
FIGURE 1

TYPICAL ASSEMBLY FOR 20" THROUGH 30" BOWES
