Consists of additional information  
pertaining to applicant's report  
entitled "Reactor Containment Building  
Ring Girder Surveillance Test Two Years  
After S.I.T.".....

Three Mile Island Nuclear Station, Unit 1 (TMI-1)  
Operating License No. DPR-50  
Docket No. 50-289

Three Mile Island Nuclear Station  
Unit 1  
Reactor Containment Building  
Ring Girder Surveillance

Ref: USNRC Letter May 3, 1977  
Request for Additional Information

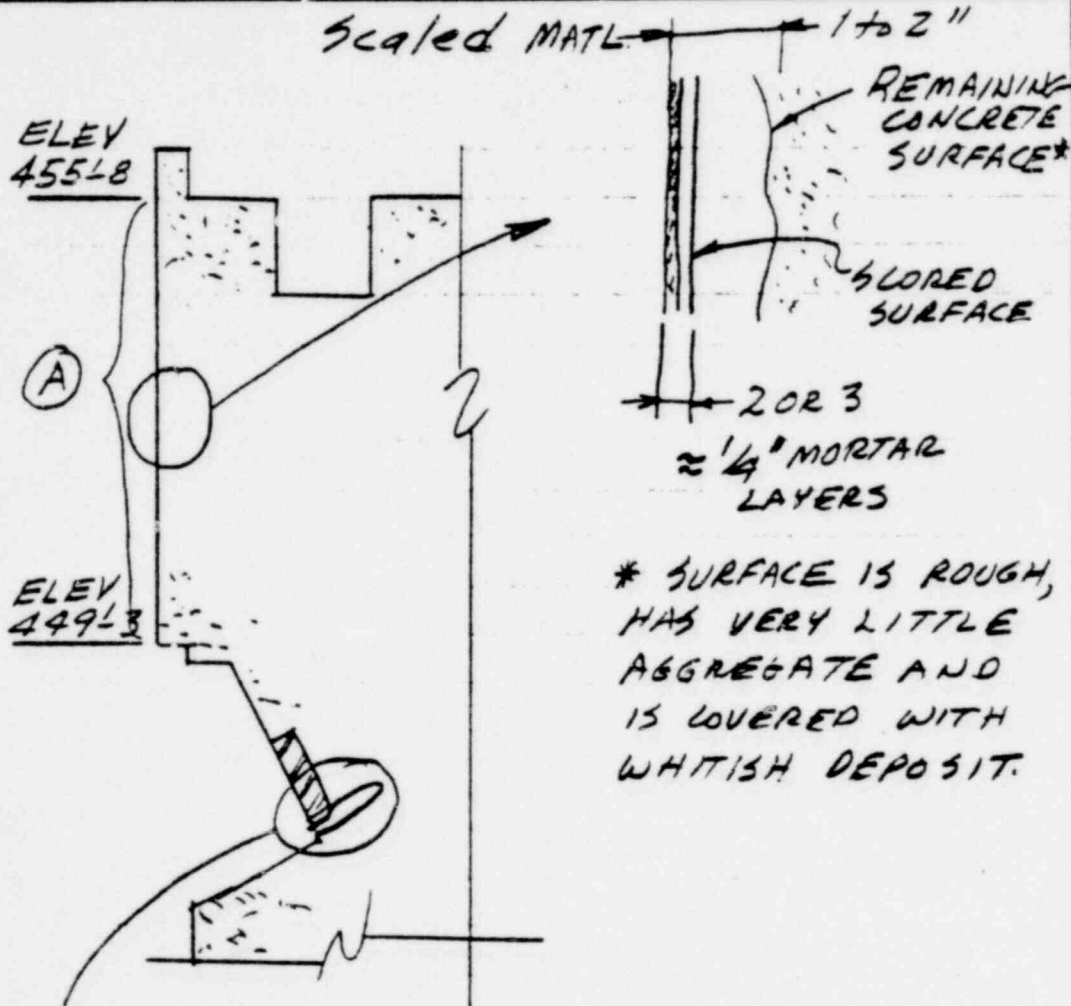
*SKETCH #1*

There is evidence of surface cracking and/or breaking away of "facing" (scaling) in the region designated as A in Sketch #1 around the entire circumference of the ring girder. The scaling is more prevalent around the North half of the structure than the South half. An examination of the scaled material indicates that two to four layers of finishing mortar has been applied in the area.

A visual inspection of a substantial region of the ring girder surface has been conducted using the nomenclature of ACI Committee 201 Report "Guide for making a Condition Survey of Concrete in Service". The surface cracking of the vertical surface can be described as pattern cracking and does not extend beyond the patching material. The condition of the surface which was exposed by breaking away of material can be described as one of severe scaling with encrustations.

With regard to the function of the "facing", the construction drawings of this area and the FSAR indicate a minimum cover of 2" for reinforcement. The scaling may have reduced the actual cover to less than specified. However, exposed reinforcing bars or rust stains which could be attributed to reinforcement corrosion in either the scaled or cracked areas has not been observed. Any significant corrosion of the reinforcement would be accompanied by increased scaling and discoloration which would be easily detectable. A review of the design calculations indicates that the vertical and circumferential reinforcing near the surface of the affected region is not required for satisfactory structural performance. It serves as minimum reinforcement for shrinkage and temperature.

In any event the surface condition around the ring girder circumference does not reduce the margin of safety for any design basis load combination. The condition is a problem of appearance rather than structural adequacy.

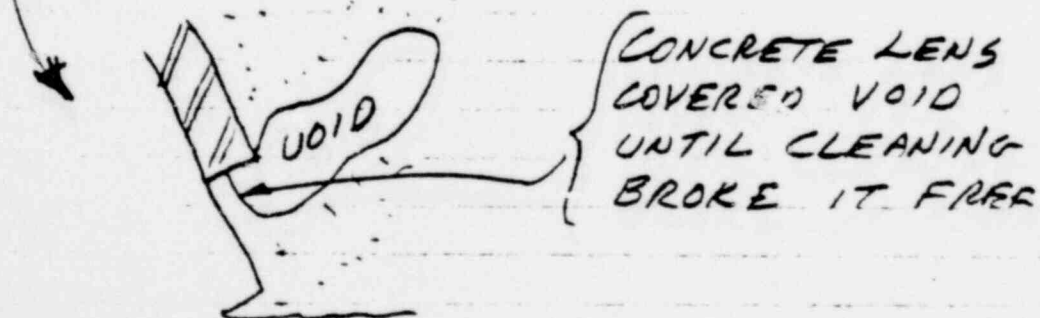
*Postulated Initial Condition*

It has been surmised that the voids were covered by lens of concrete (see Sketch #1) which resulted in their being undetected during previous inspections. The use of a reciprocating power wire brush (needle gun) to clean off the surface of bearing plates prior to painting apparently

broke the covering lens and exposed the voids. The voids were reported the next regular surveillance report.

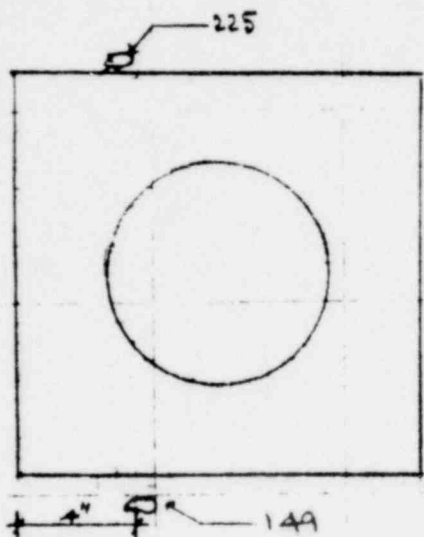
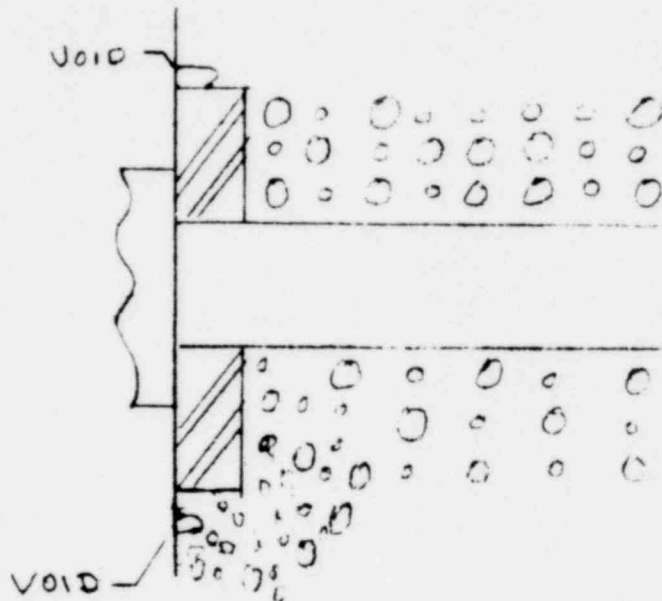
SKETCH # 2

The reported cavities are approximately 1" in diameter, 1" deep and located as illustrated in Sketch #2. They represent an acceptable as-built condition since they do not extend into the bearing area and do not degrade the structural integrity of the containment. Therefore, corrective measures are not required. However, they should be treated in the same manner as the other voids.

TENDON BEARING PLATE	149	225
SECTIONAL AREA	0.8 m <sup>2</sup>	0.8 m <sup>2</sup>
EST VOLUME	1.00 m <sup>3</sup>	1.00 m <sup>3</sup>
