To: K. E. Moore, NPGD

From: L. W. Sarver & J. S. Rovder, ARC

September 12, 1977

PRELIMINARY REPORT ON EXAMINATION
OF CR-3 DECAY HEAT PUMP SHAFT

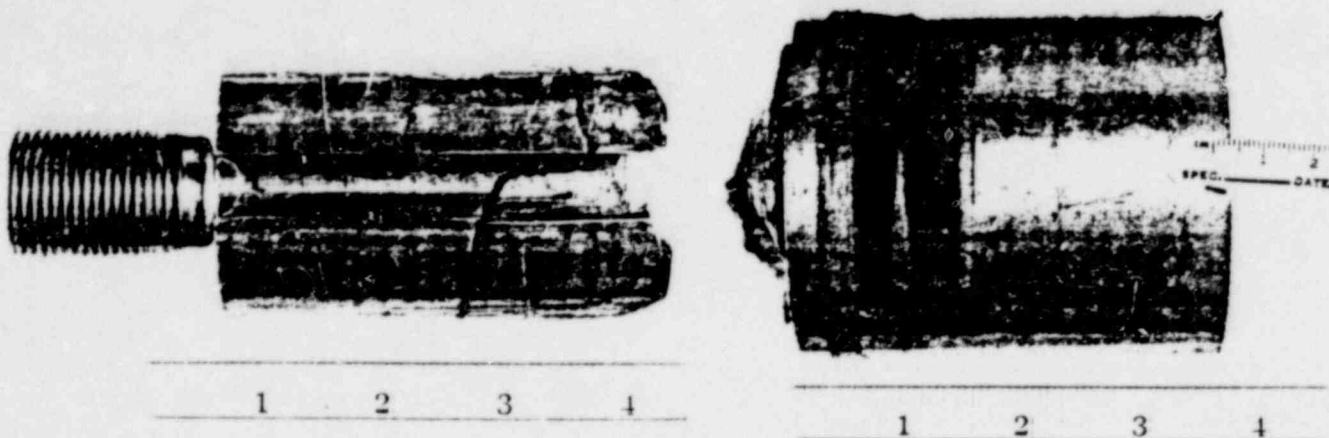
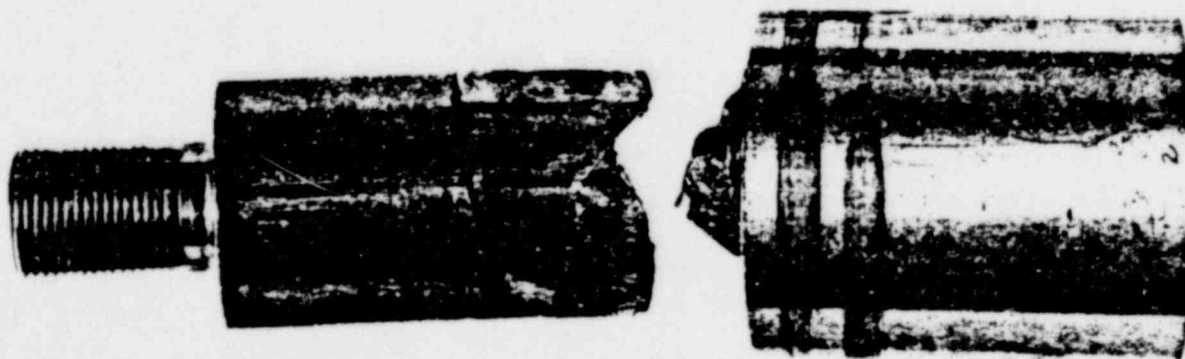
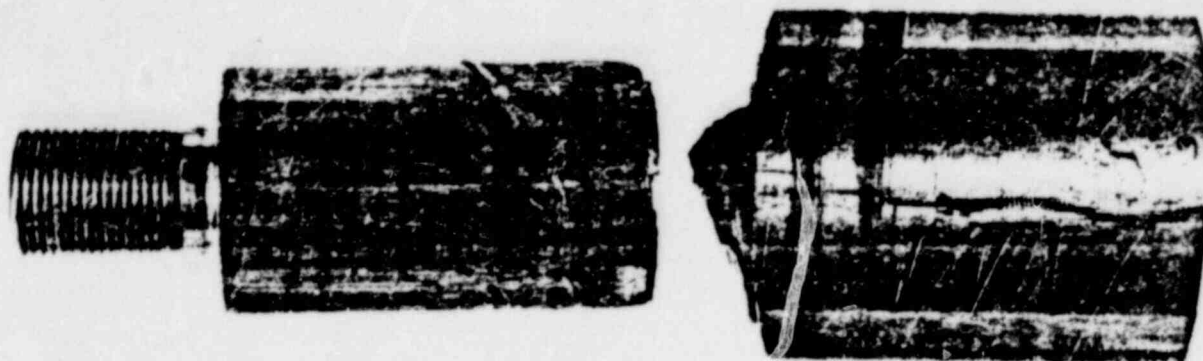
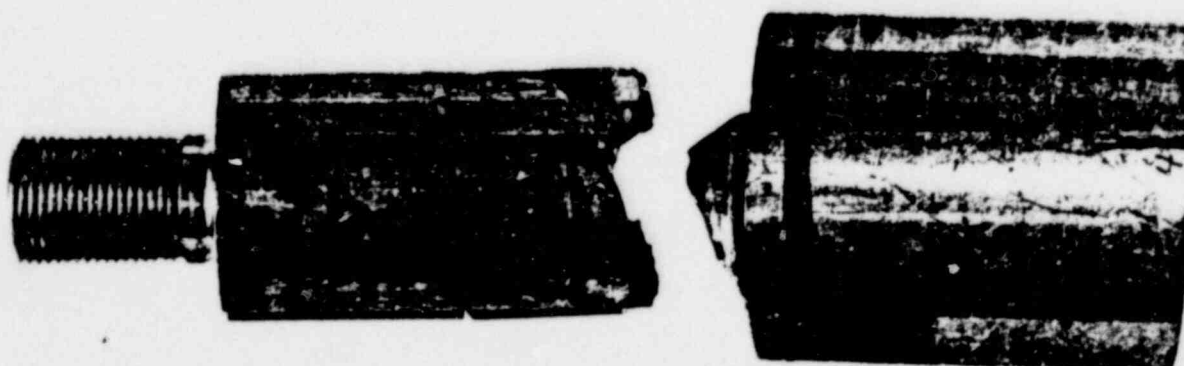
Figures 1-4 depict the broken shaft as observed at 90° rotations about its own axis.

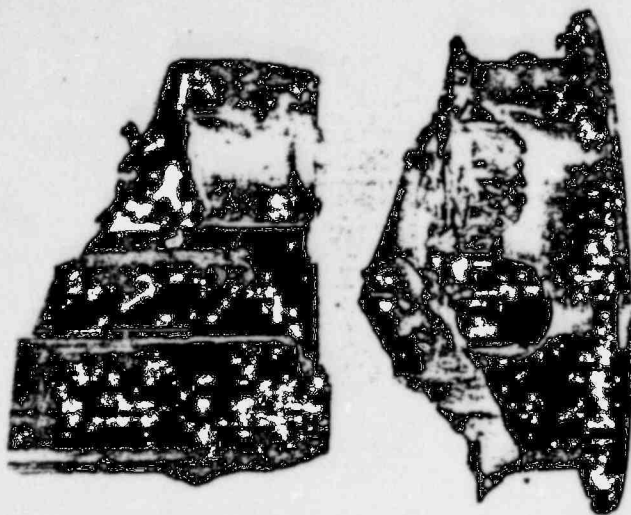
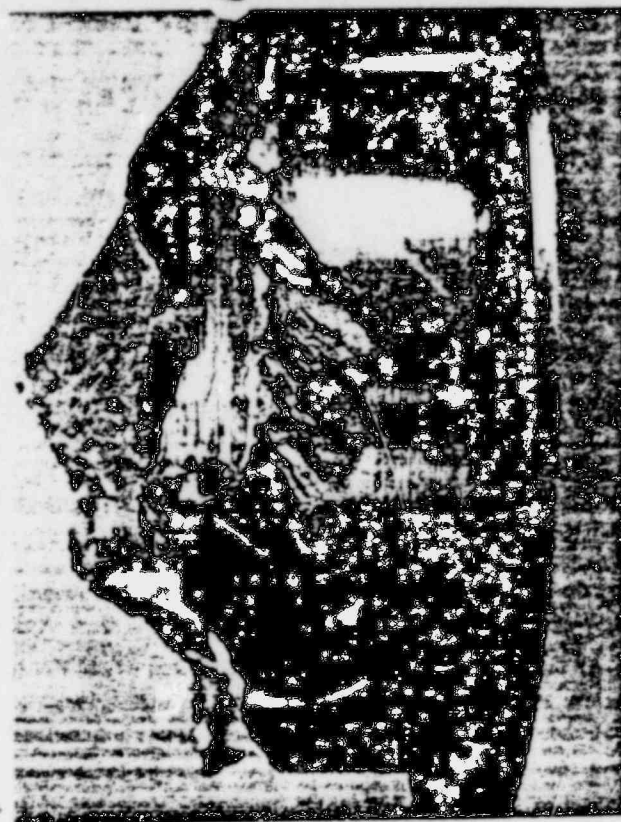
Figures 5-7 illustrate the crack origin area at the keyway root. A subsurface crack, hidden from view in figures 5 (left) is exposed in Figure 7.

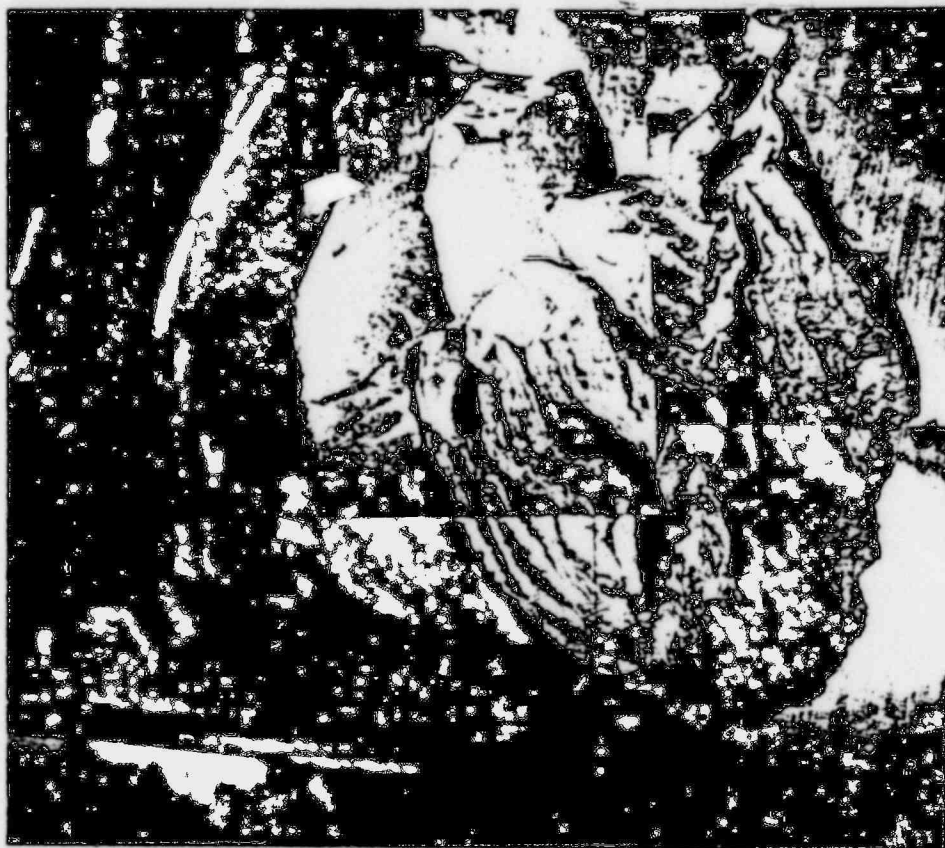
FIGURE 7 CR-3 SHAFT
CRACK ORIGIN

Figure 16 illustrates a portion of the locus of crack initiation at the root of the keyway. Figures 17 and 18 illustrate details near the origin. Figure 19 shows the crystallographic character which generally typifies the fracture surface at the origin (Refer also to Figure 7).

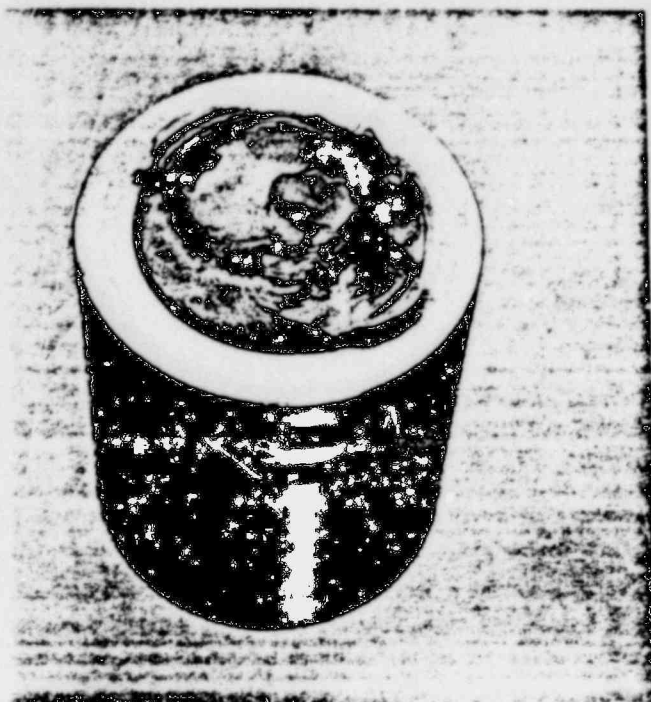
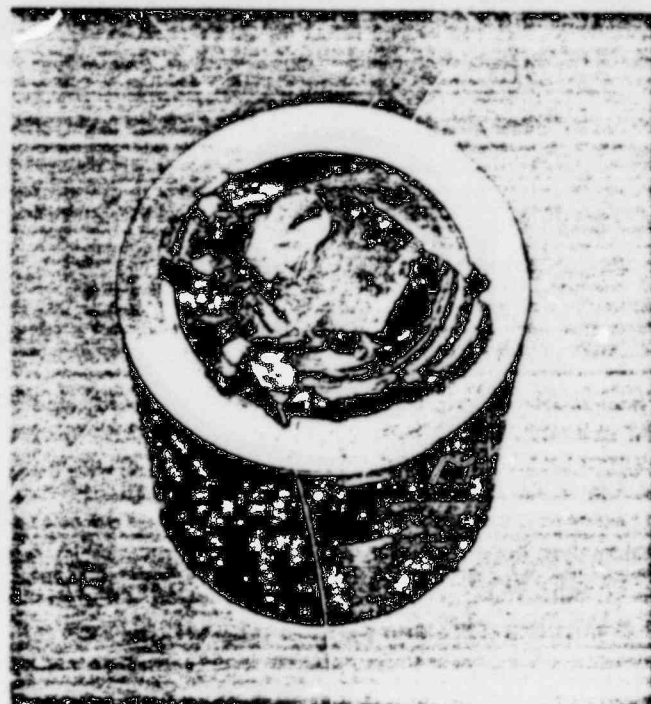
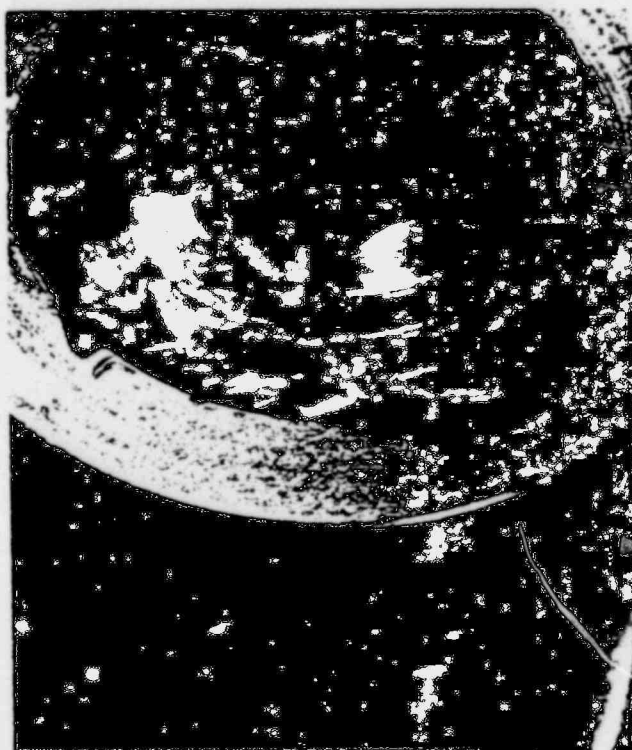
Figures 8-10 and 11-13 illustrate various aspects of both sides of the totally through-wall crack.

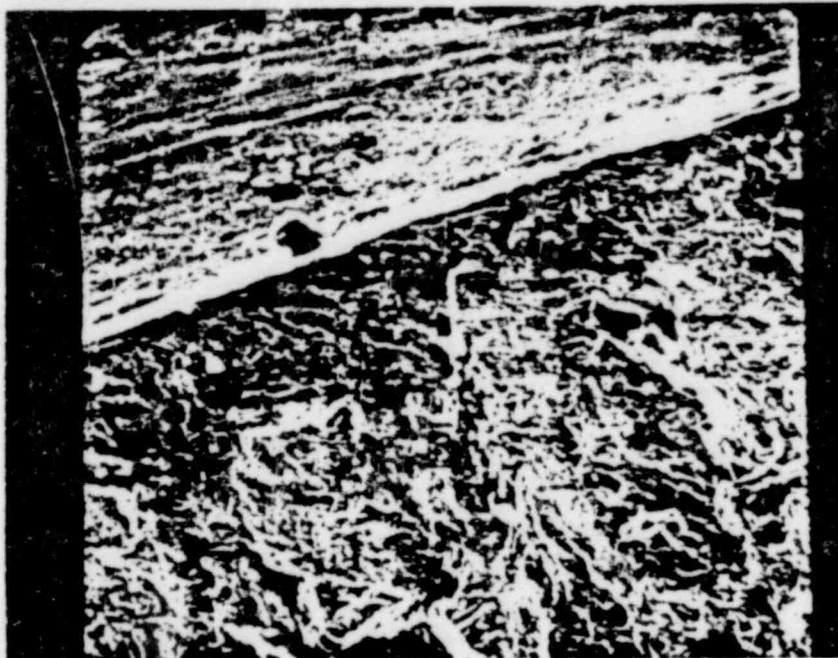
FIGURE 16

ORIGIN AREA

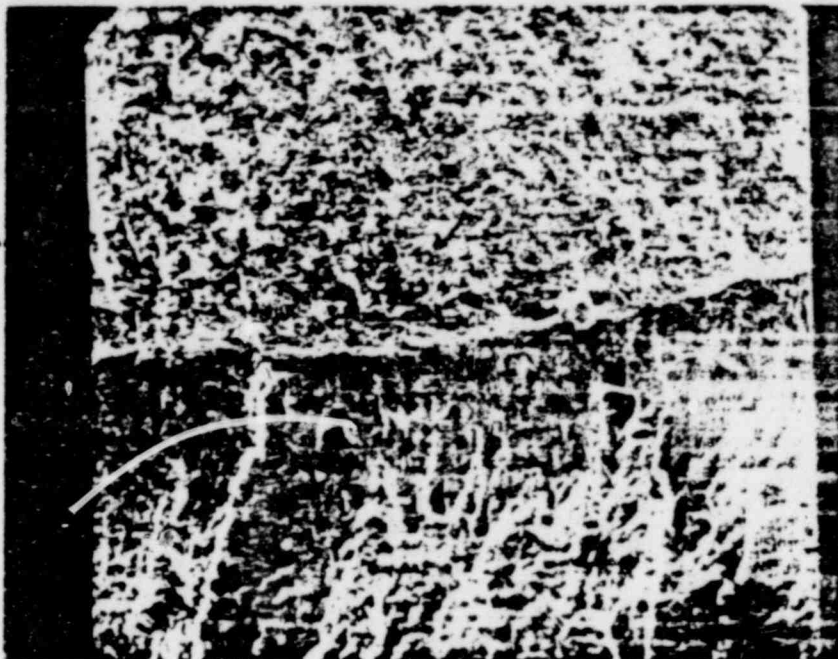
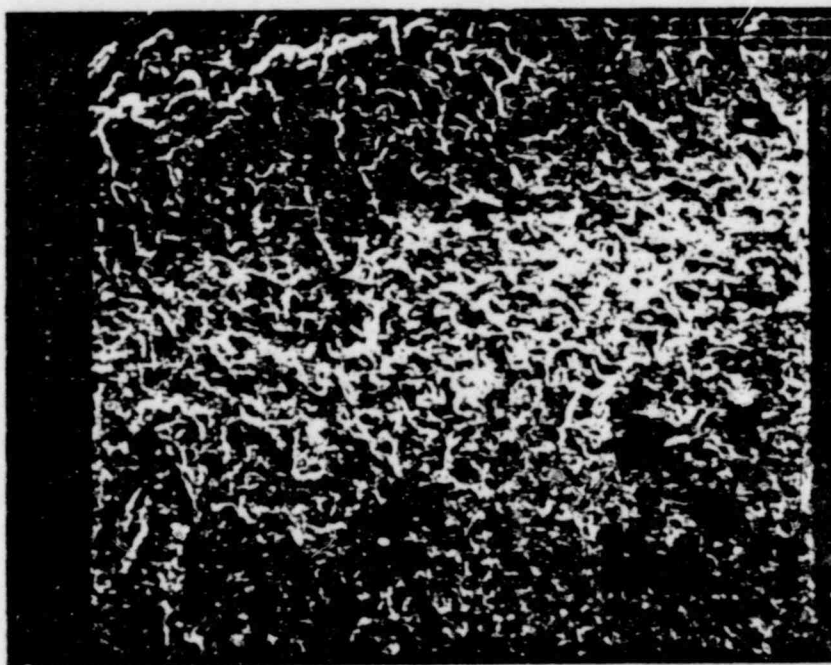
Figures 20 and 21 show two different beach-markings from a secondary propagation system, as for example indicated by arrow in Figure 9 or Figure 15. Figures 22-24 illustrate growth character proceeding the last beach mark while figure 25 illustrates growth character beyond the last beach mark (fast growth). The mixed-mode conditions shown in Figure 24 occurred near a beach mark.

MIXED MODE ↑

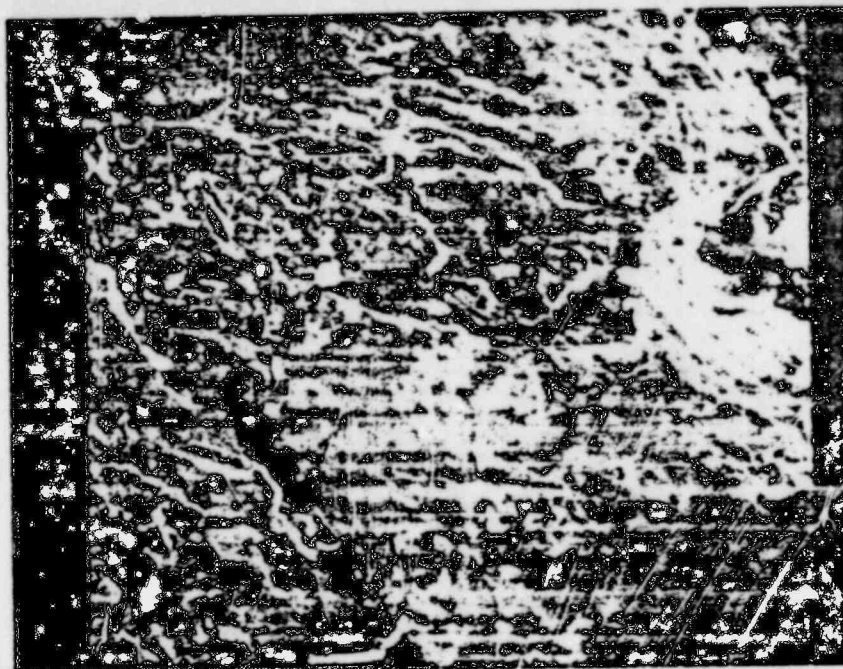
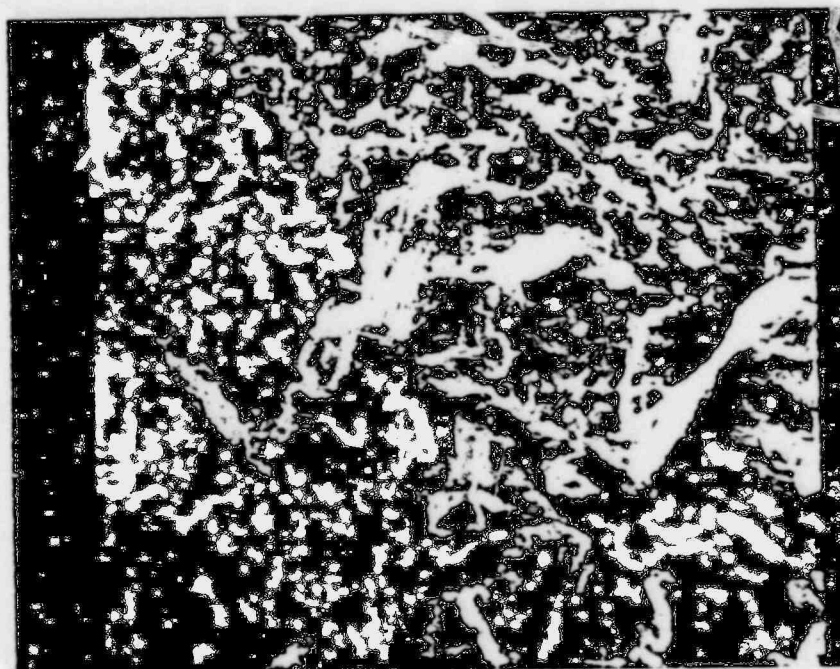
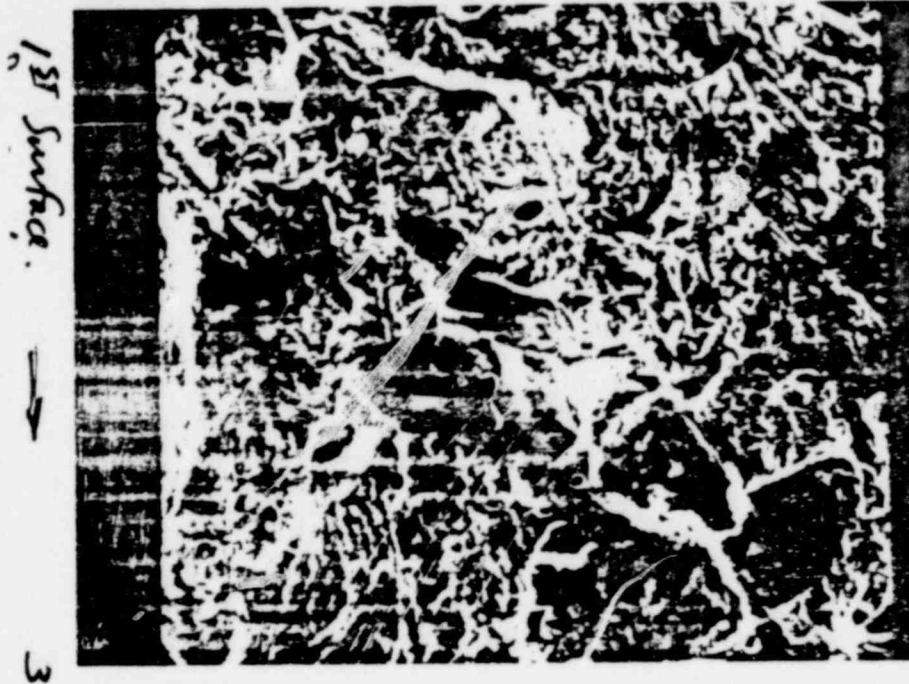
Fractographic analysis showed cracking to be predominantly transgranular in character but showed also some mixed intergranular and transgranular fractures; some of the latter mixed character was observed near beach markings. Intergranular fracture character did not appear to be associated with the origin of cracking. The significance of the intergranular fracture mode is not known.

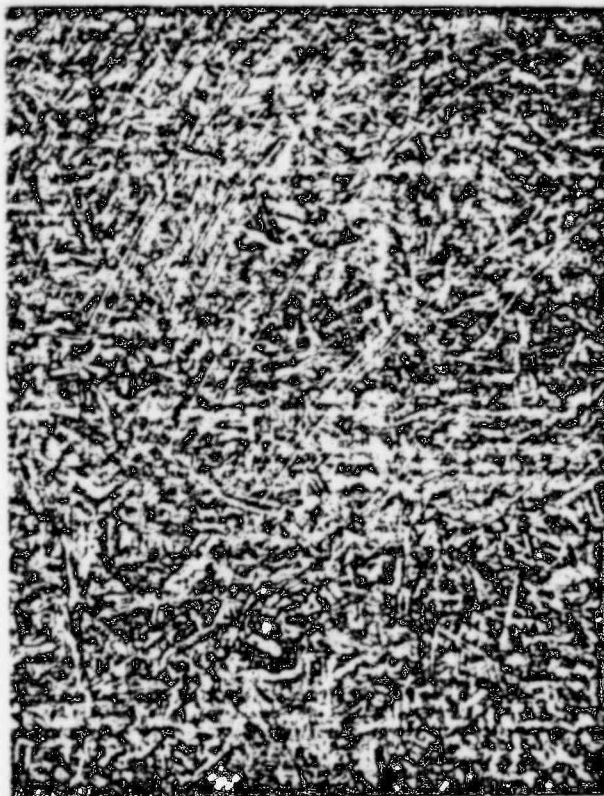
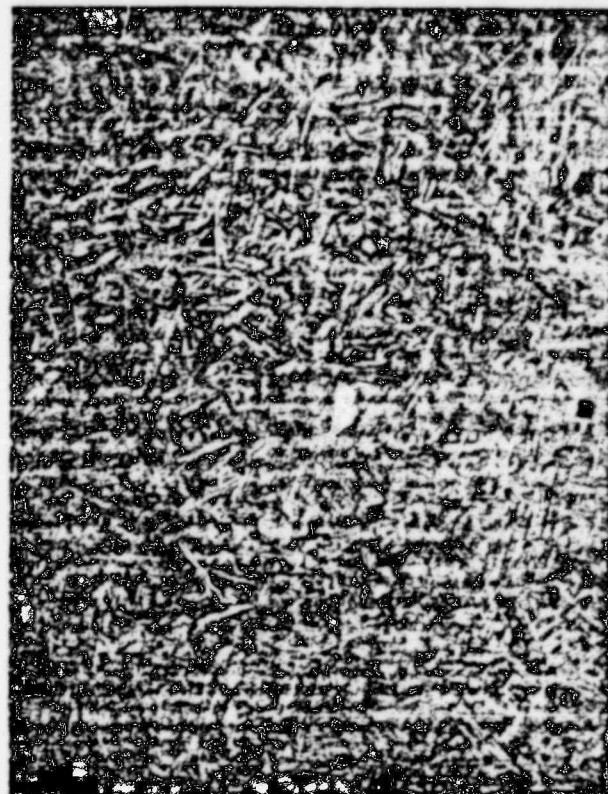
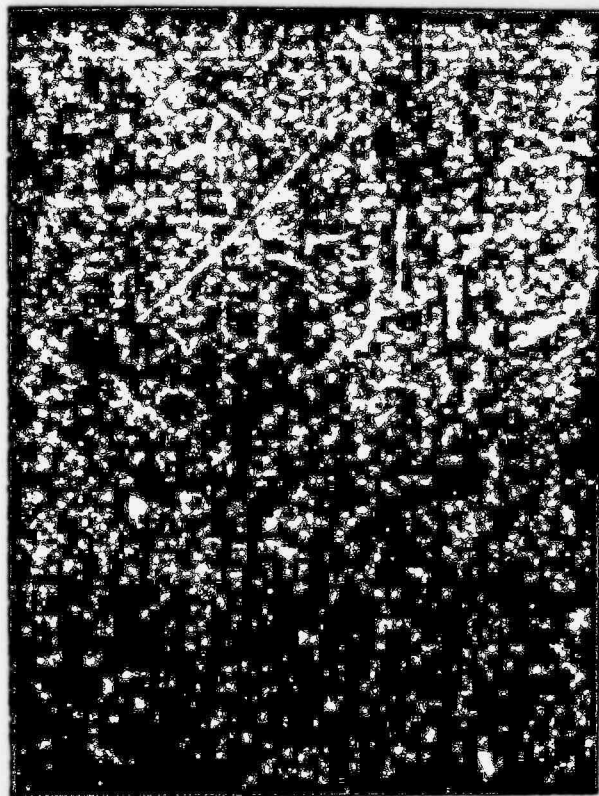
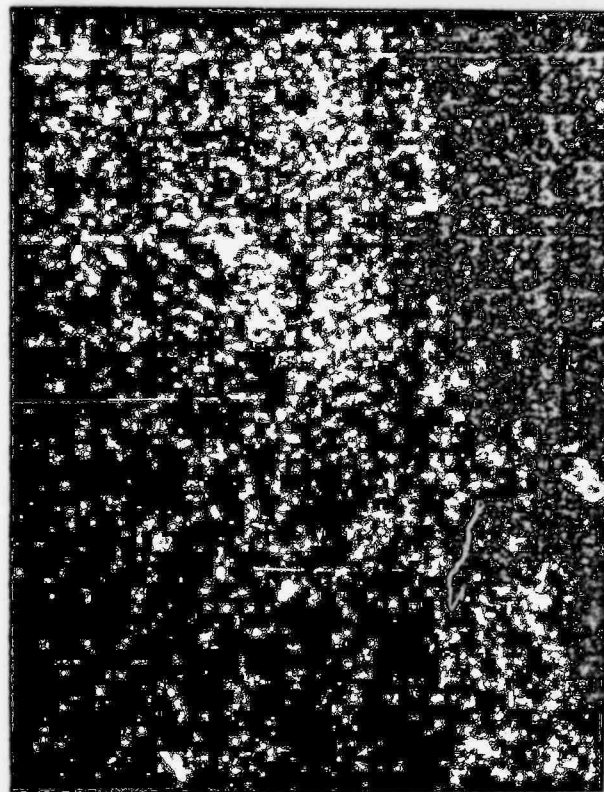
FIGURES 26-29

Metallographic analysis revealed a microstructure containing essentially tempered martensite - as expected for H 1150 heat treatment of 17-4 PH alloy (i.e., the result of the solution heat treatment, air cool, and tempering heat treatment). Longitudinal microsections revealed what appeared to be some residual elongated ferrite grains; the significance of this characteristic is not known.

Microstructure of the shaft is shown in Figures 26-29 (Transverse section) and in Figures 30-33 (longitudinal section). Microstructure close to the keyway is illustrated in Figures 34-37.
