June 17, 1977

THREE MILE ISLAND NUCLEAR STATION
UNIT 1

REACTOR CONTAINMENT BUILDING
RING GIRDER SURVEILLANCE TEST
THREE YEARS AFTER S. I. T.

METROPOLITAN EDISON COMPANY
Subsidiary of General Public Utilities, Corp.

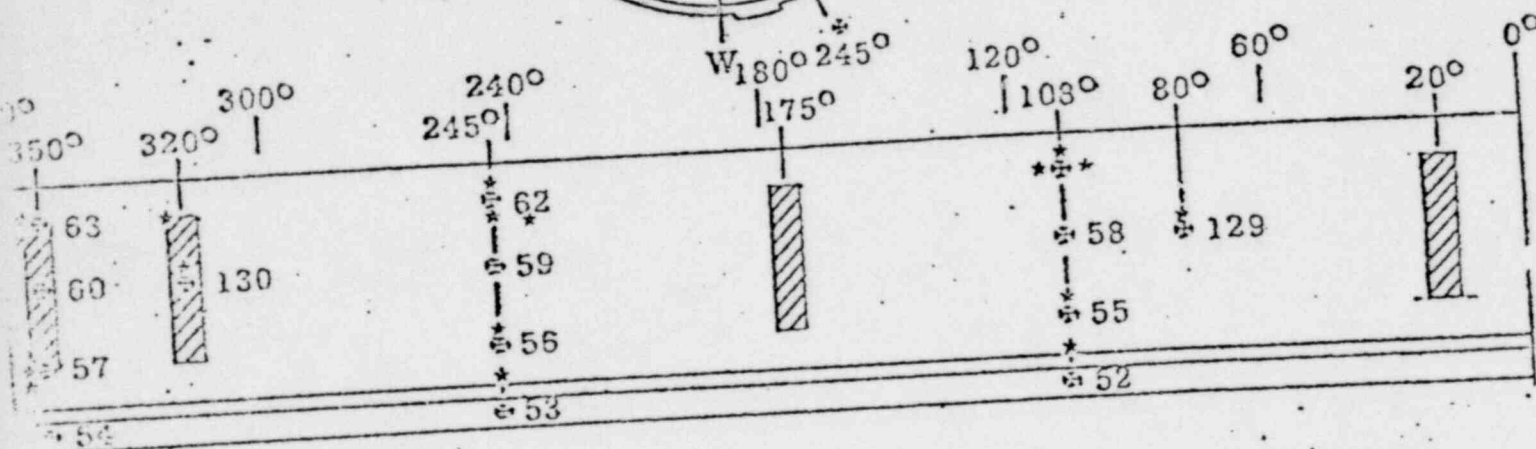
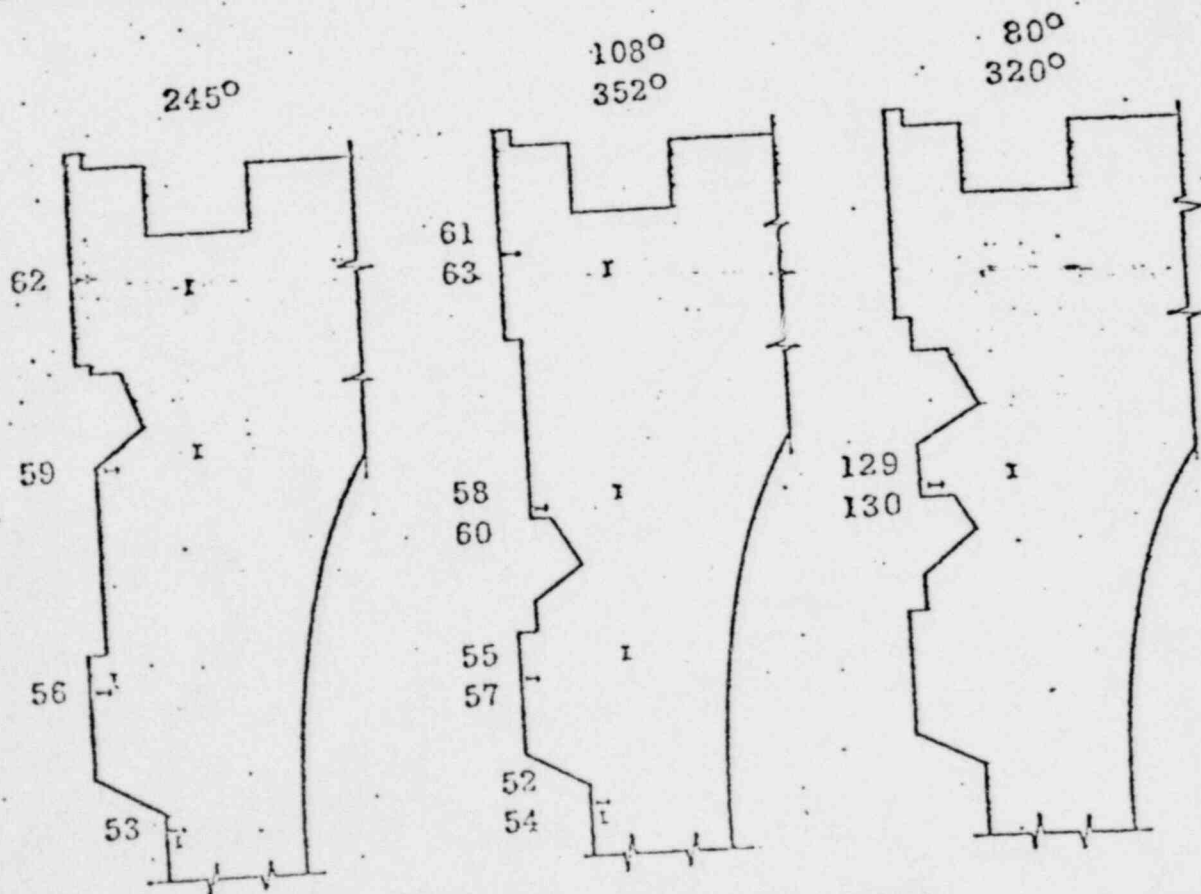
FIGURE 1.

The stresses in the reinforcing bars being monitored by strain gages do not exceed the allowable tensile stresses ± 0.004 in./in. or 11,500 psi. Strain gages at two locations indicated strain readings which resulted in the deviation of stress values (stress during fourth surveillance - stress during full initial prestress) greater than 11,500 psi, (57 VS, 22.95 KSI and 129 VS, 20.24 KSI, Ref. Table 1) but these readings are considered to be unreliable due to gage failure. During previous surveillance tests a ground reading less than 50 Mega Ohms was sufficient cause to consider the strain gage inoperative. Each of these gages had ground readings below 50 Mega Ohms in at least one previous test and low ground readings in all the other tests (Table 2). Strain gage 57 VS and 129 VS are located in the Northwest and Northeast Quadrants respectively. There are no cracks wider than 0.010" in these regions which could be attributed to exceeding stresses in the reinforcing bars.

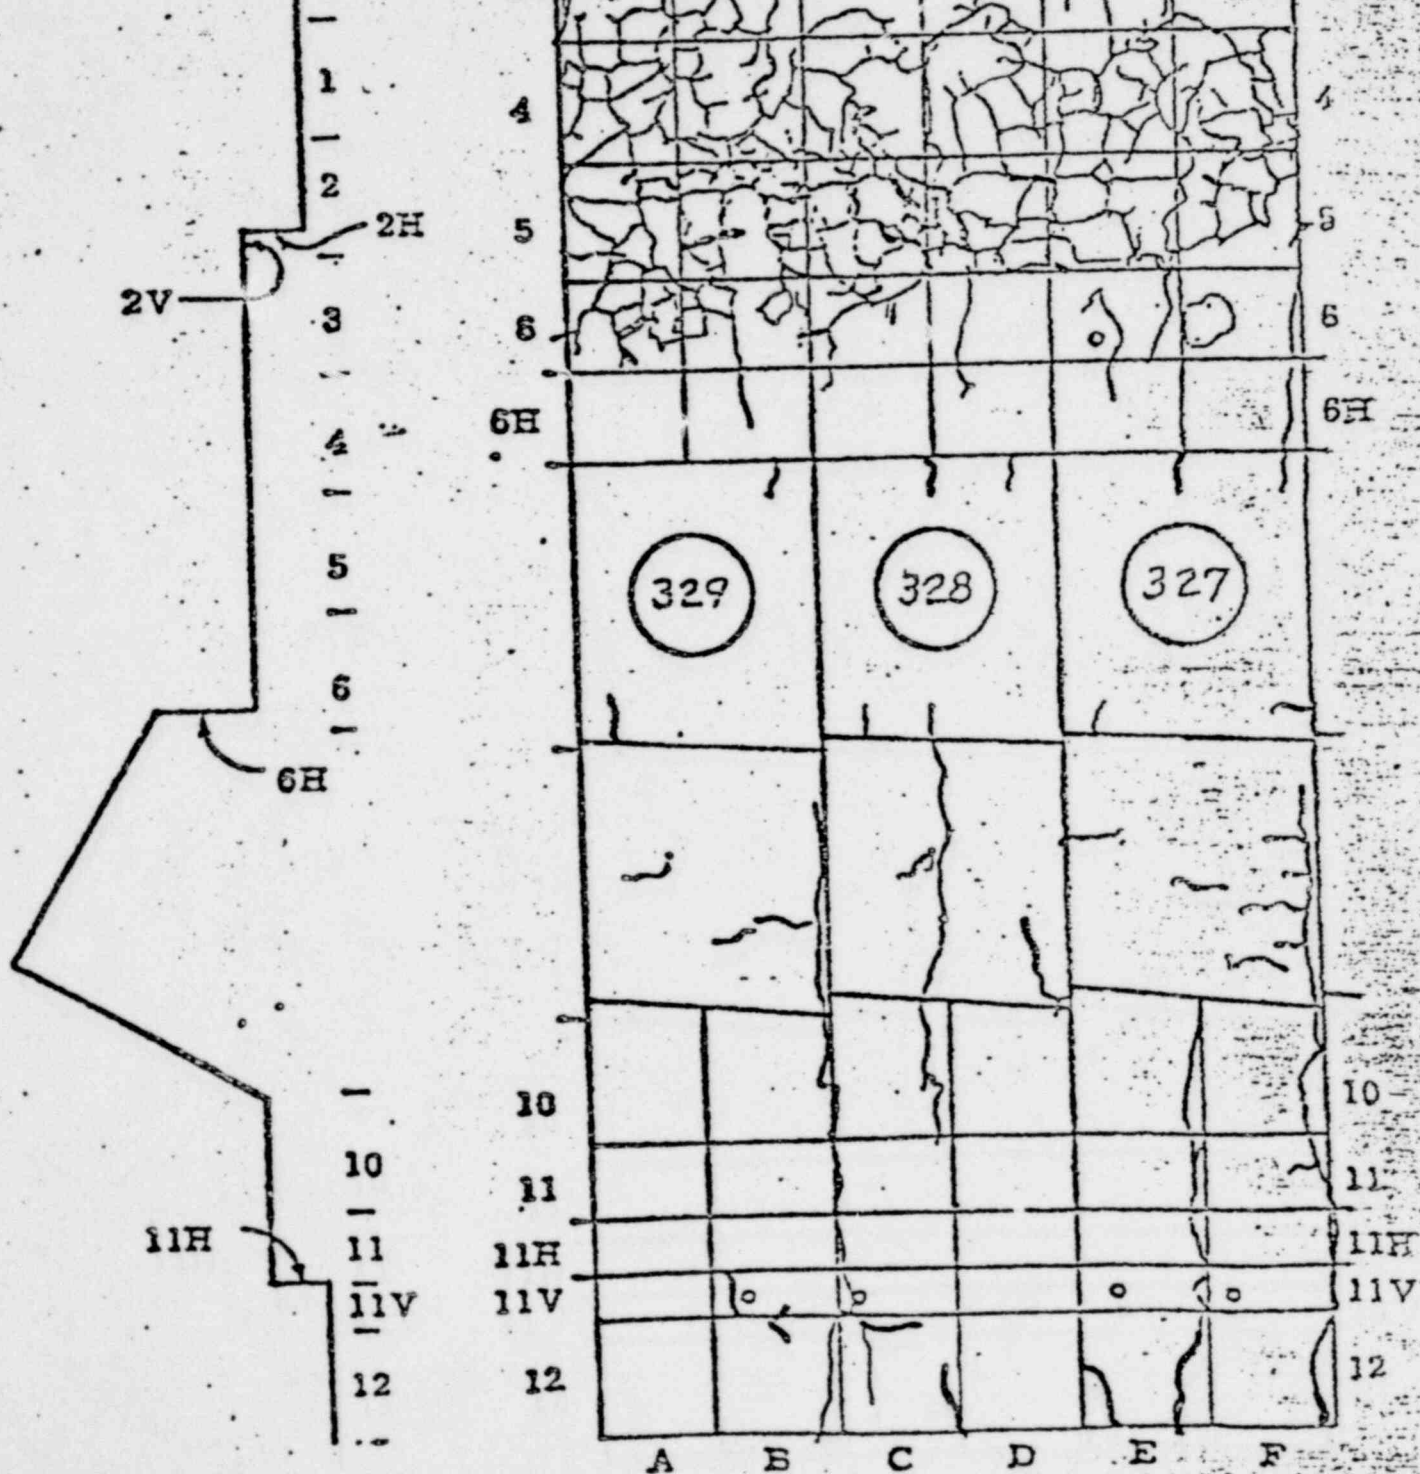
FIGURE 2

SAME AS 1976

NOTHING ADDITIONAL

ALL CRACKS LESS

THAN 0.005"

CRACK PATTERN AREA AT AZIMUTH 175°
AREA NO. 120

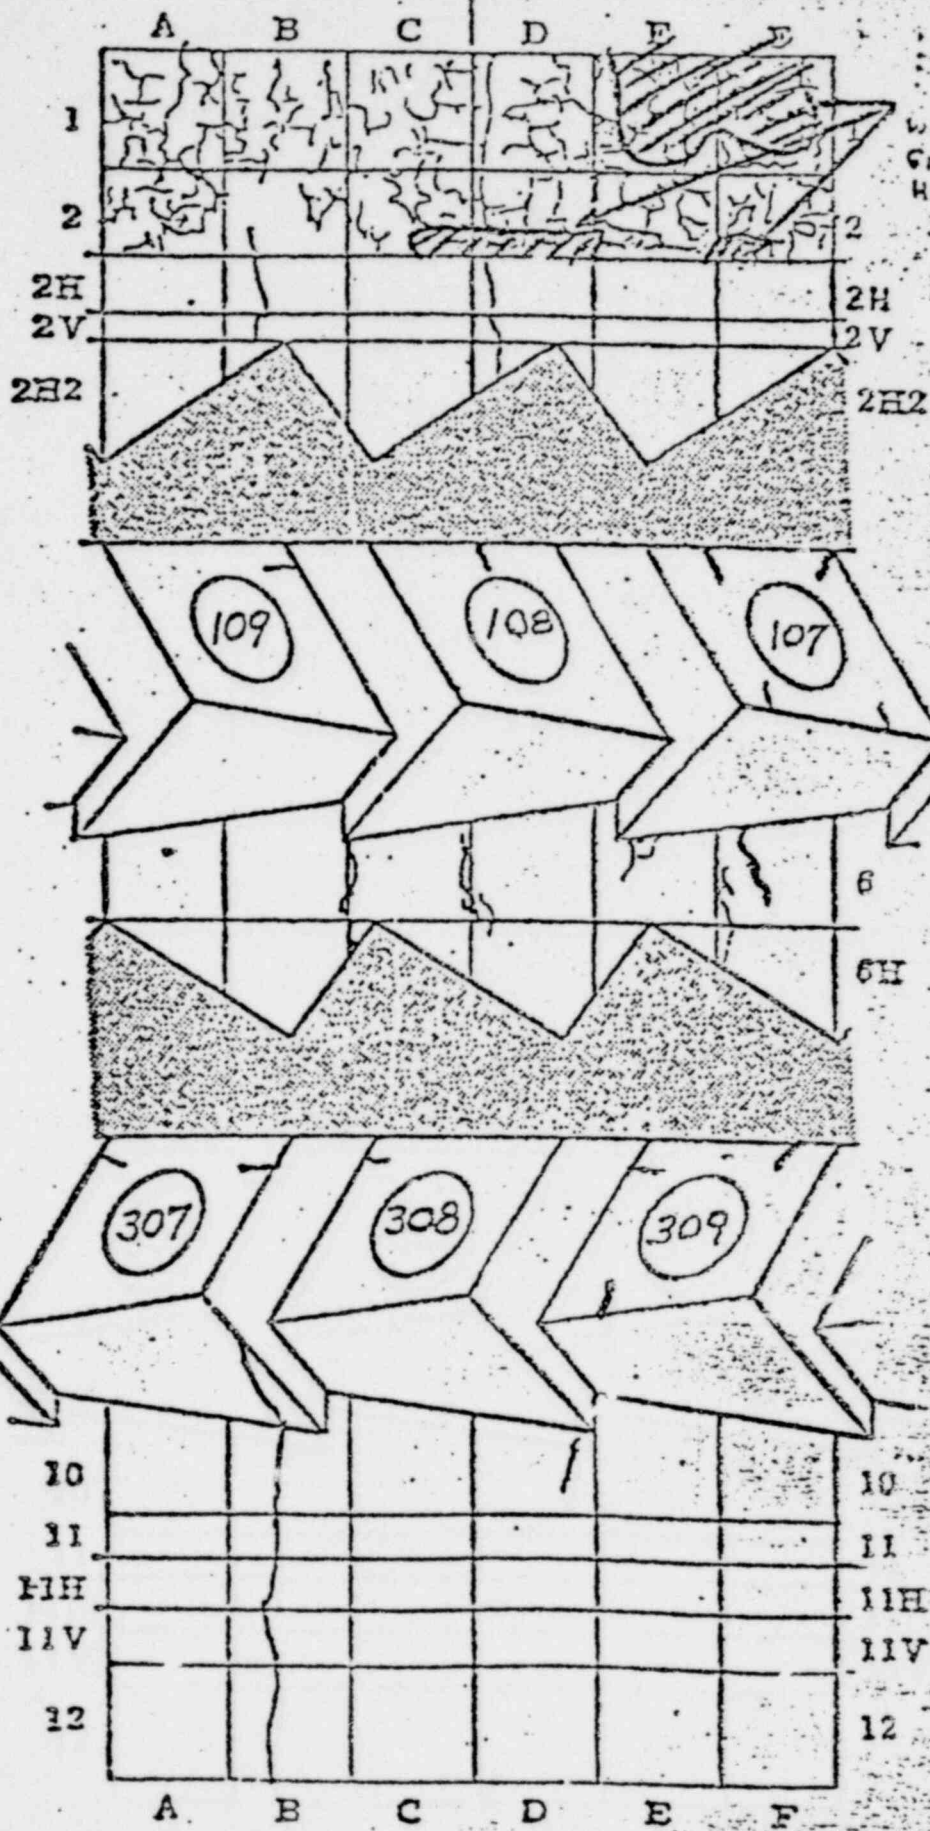
FIGURE 3

ALL CRACKS ARE LESS THAN
0.005 IN. WIDE

SAME AS IN 1976
NOTHING ADDITIONAL
ALL CRACKS LESS
THAN 0.005

CRACK PATTERN AREA AT AZIMUTH 20°

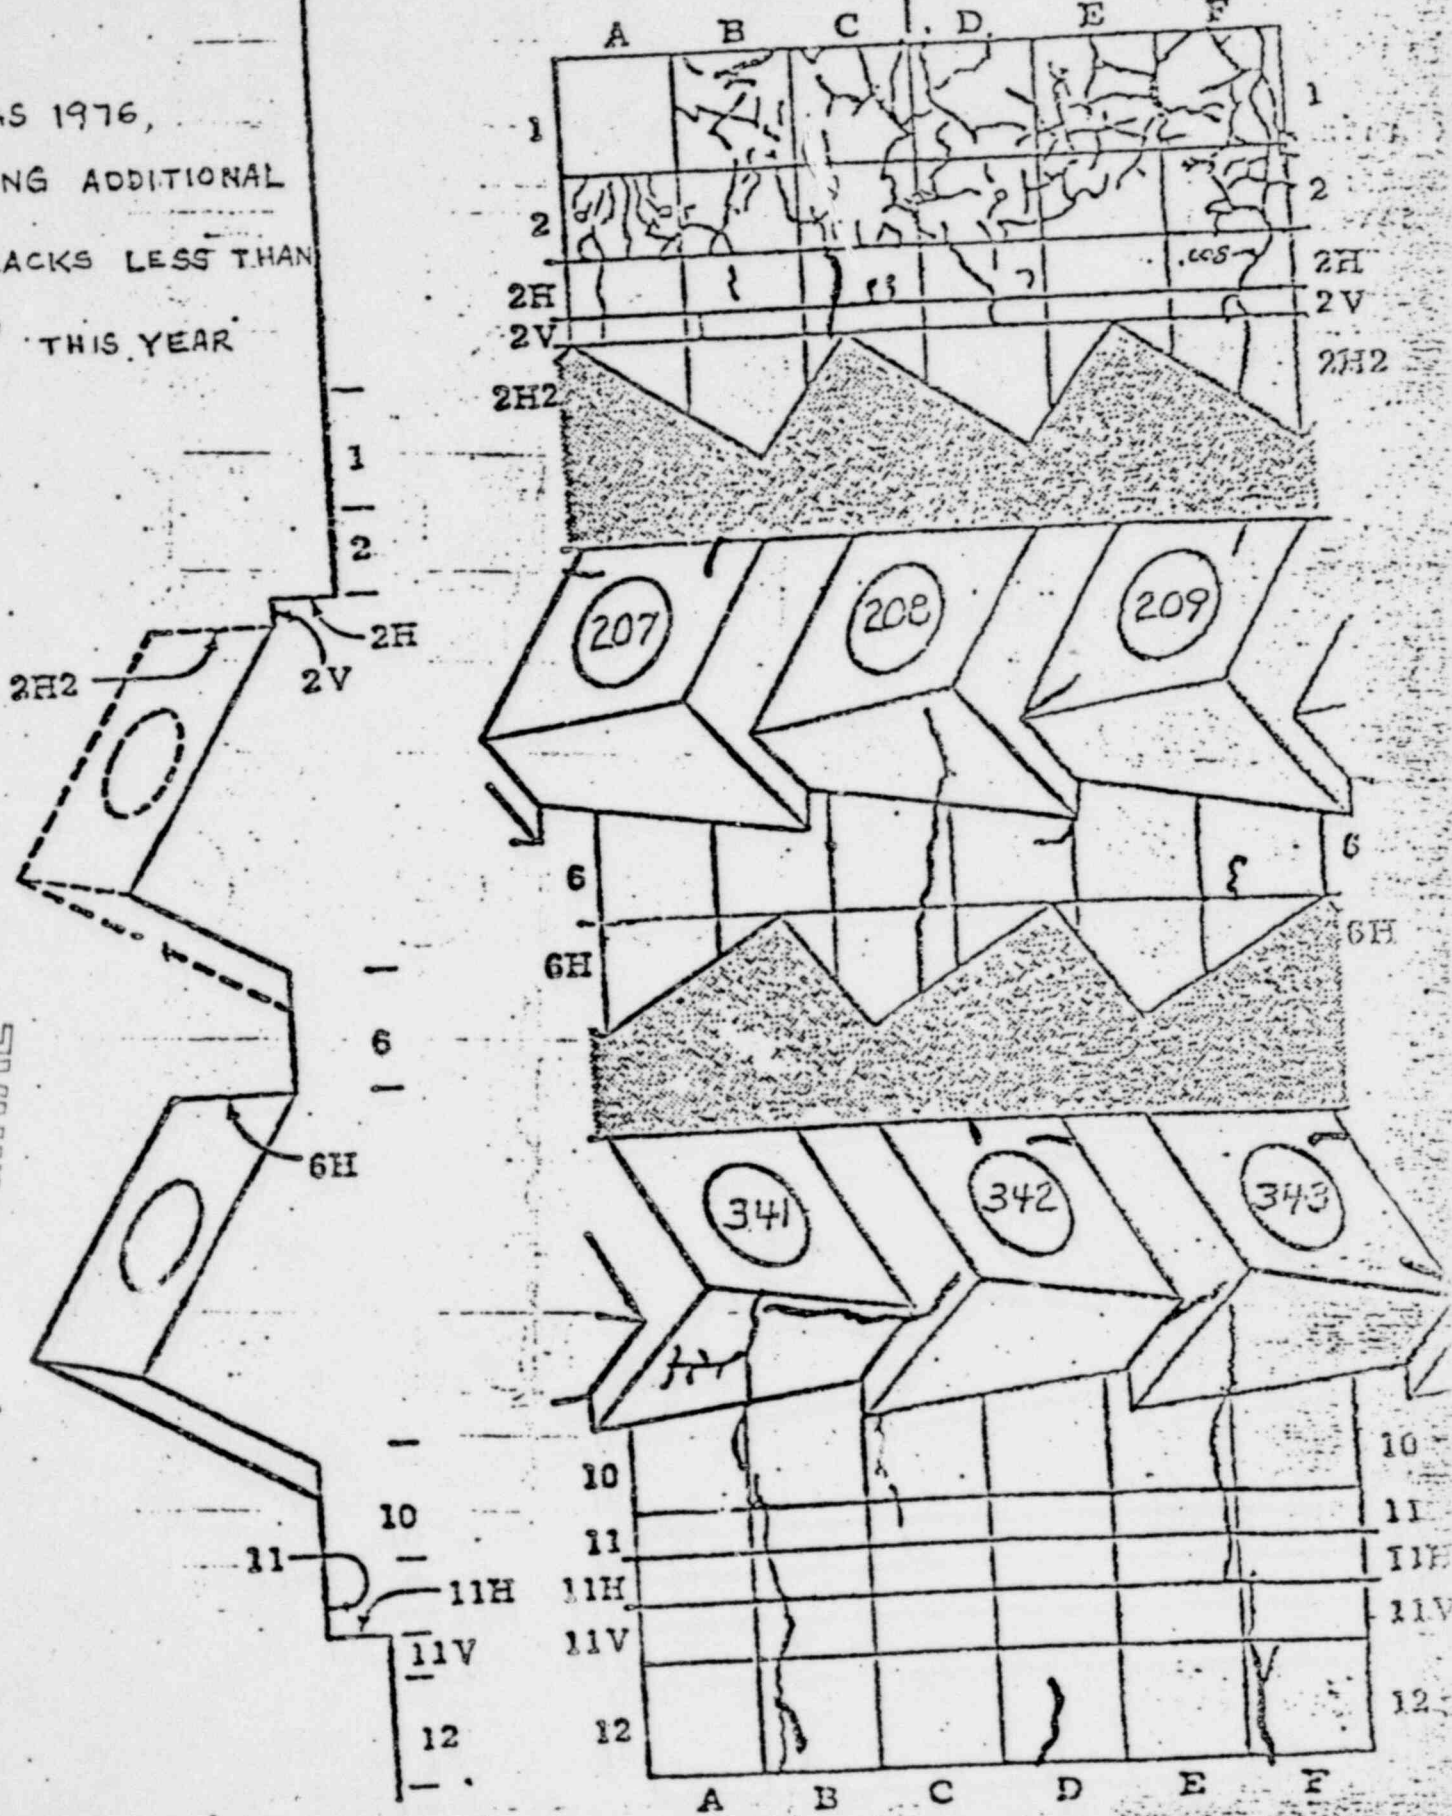
CRACK PATTERN AREA AT AZIMUTH 320° AREA 1132

ALL CRACKS ARE LESS THAN
0.005 IN. WIDE UNLESS NOTED

SAME AS 1976,
NOTHING ADDITIONAL
ALL CRACKS LESS THAN
0.005" THIS YEAR

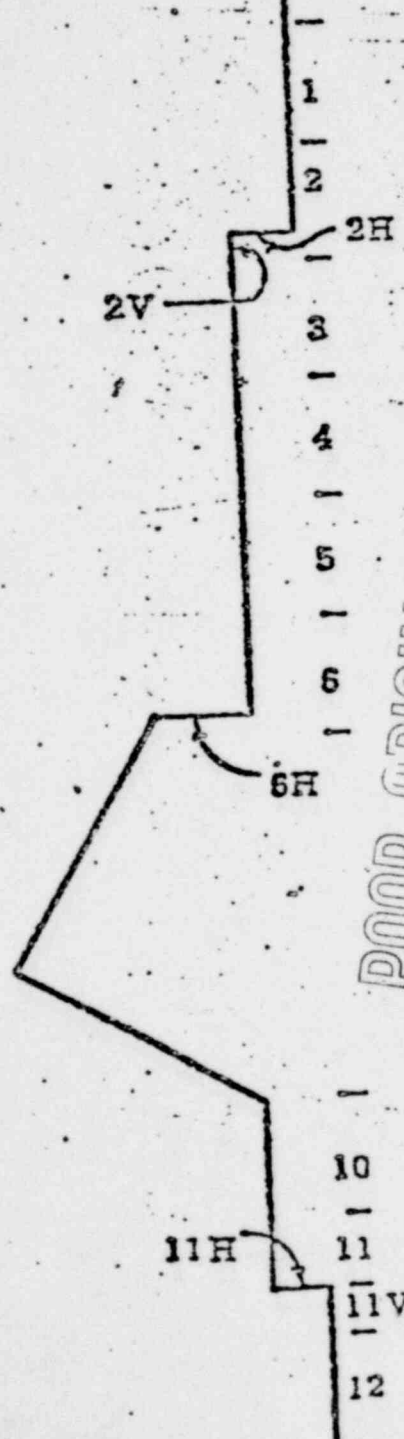
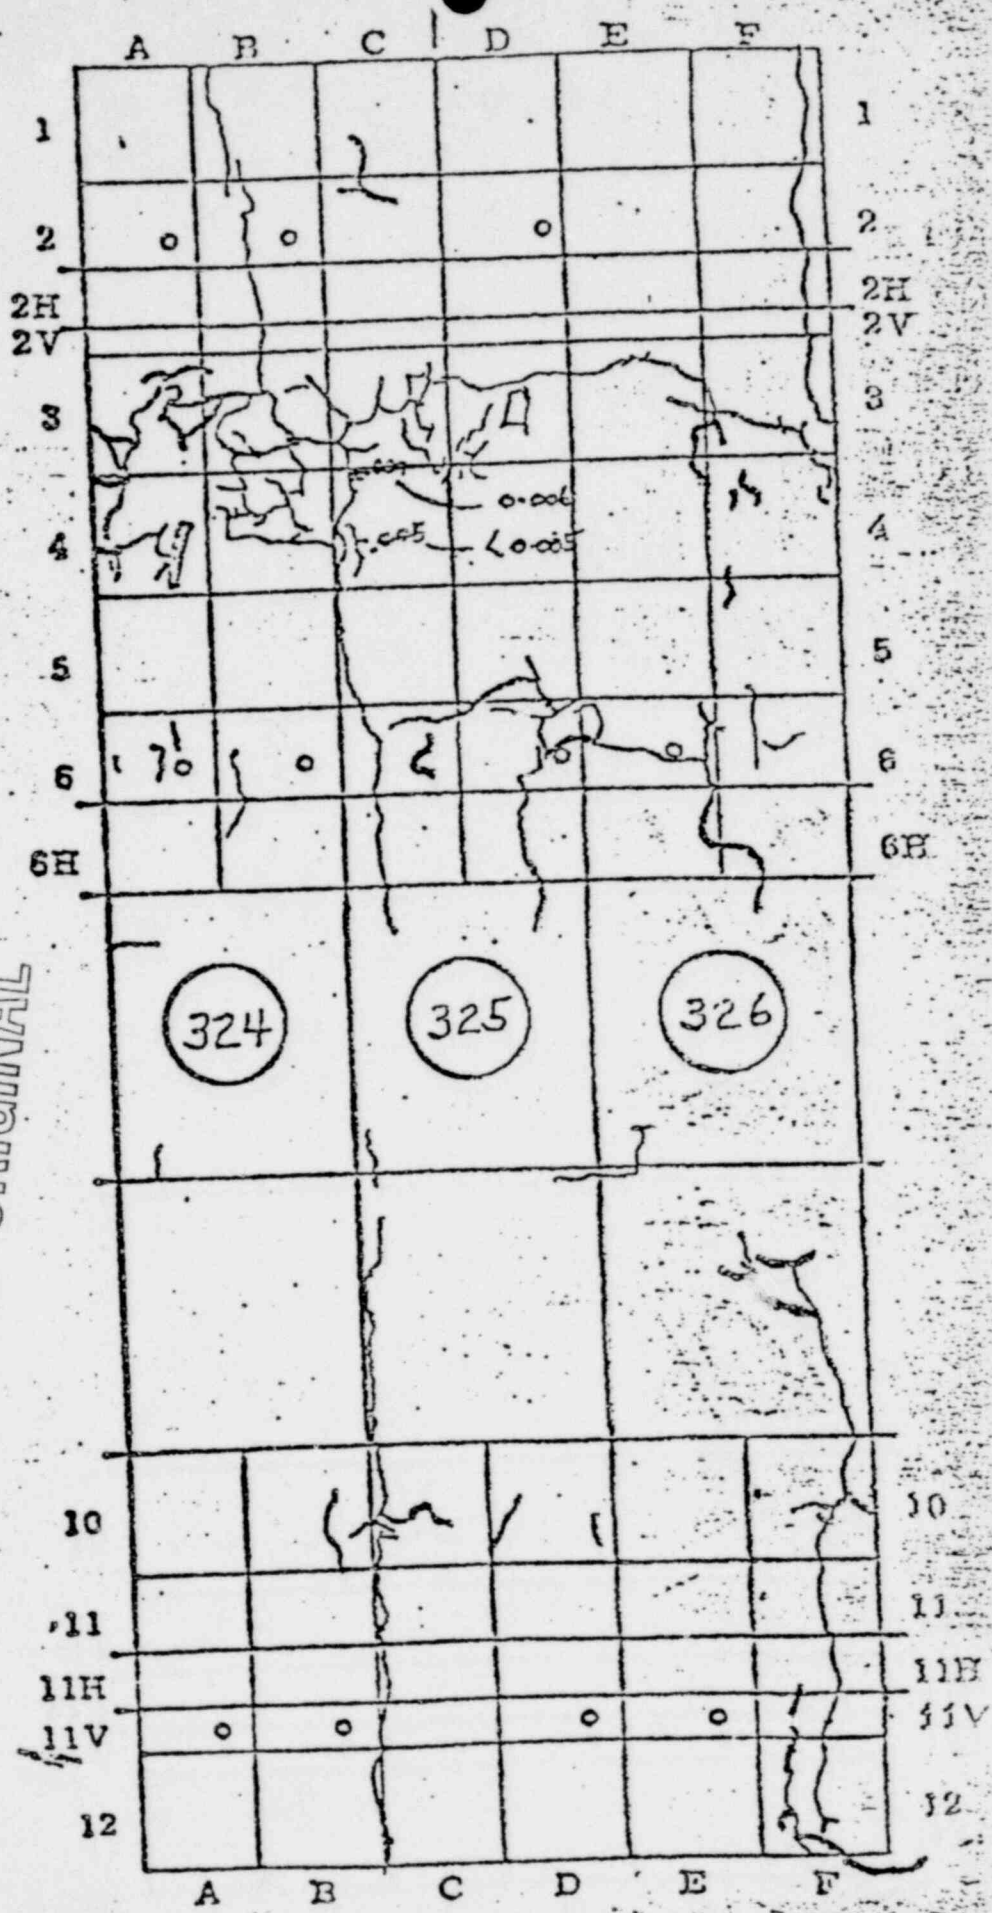
CRACK PATTERN AREA AT AZIMUTH 350°
AREA NO. 133

0.005 IN. WIDE UNLESS NOTED.

NOTHING ADDITIONAL
EXCEPT AS NOTED
I.E. DECREASE IN SIZE
OF TWO CRACKS
