To	K. E. MOORE - TECHNICAL STAFF, NPGD, LYNCHBURG	
From	L. W. SARVER/J. S. ROYDER - METALLURGY SECTION, ARC	RC-1 Form 1-77
Cust.	METROPOLITAN EDISON	File No. or Ref. LR:77:5276-01:2
Subj.	FINAL REPORT ON EXAMINATION OF CR-3 DECAY HEAT PUMP SHAFT	Date SEPTEMBER 24, 1977

INTRODUCTION

This report describes the metallurgical evaluation and failure analysis of a broken CR-3 decay heat pump shaft. This failure occurred last year at the Crystal River N.S.S. facility of the Florida Power Corporation. The decay heat pump shaft was fabricated by the Worthington Pump Corp. from 17-4 PH stainless steel.

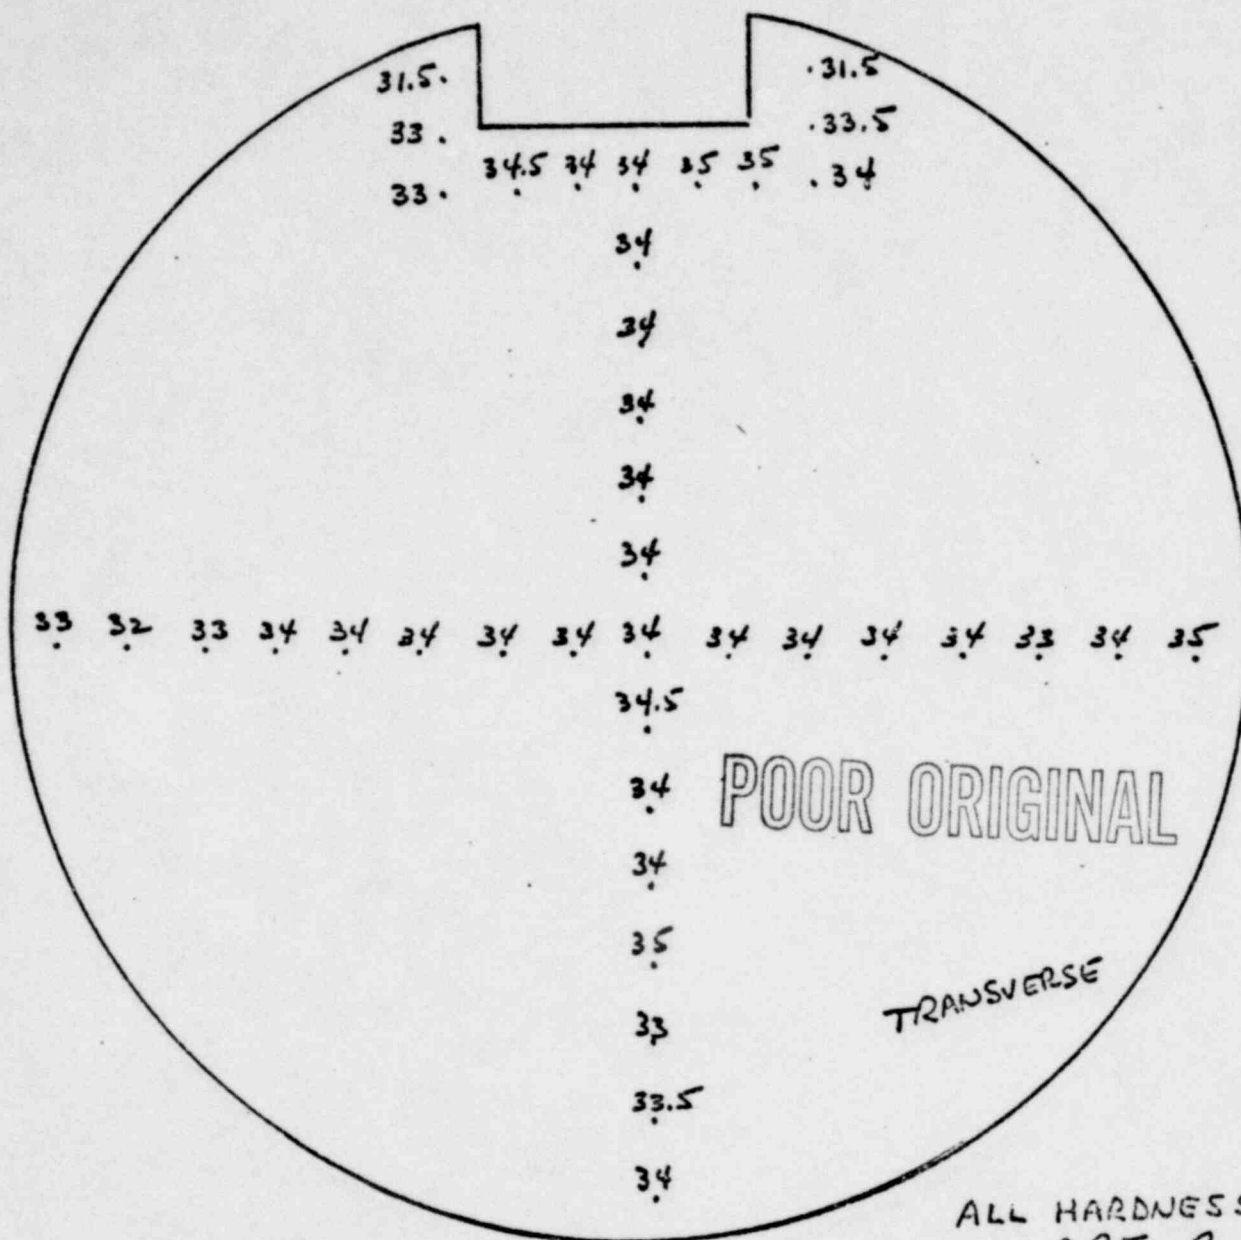
Schematics shown below illustrate the distribution of hardness values on transverse and longitudinal cross-sections of the shaft and in the corner of the keyway. The transverse cut was located about 1-1/2 to 2-1/2 inches from the separation towards the thread end of the shaft. The longitudinal cut was taken from a sleeved portion of the shaft.

LOCATED $1\frac{1}{2}$ - $2\frac{1}{2}$ " FROM THE FRACTURE.	. 35
THIS IS PART OF THE SHAFT FROM IN THE PRESS FIT AREA	. 34
	. 35
	. 35
	. 35
	. 35
	. 35
	. 35
	. 35
	. 35
	. 35
	. 35
	LONGITUDINAL

Rockwell hardness values also indicate that the shaft has somewhat higher strength properties than are typical for the H-1150 treatment for 17-4 PH steel, i.e., R_C values as high as 35 versus 33 for H-1150.

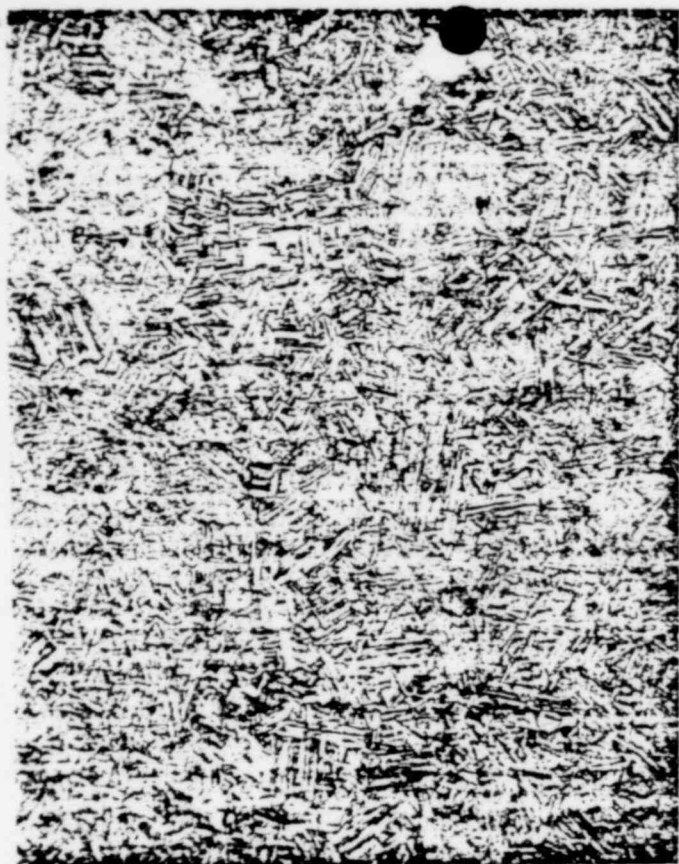
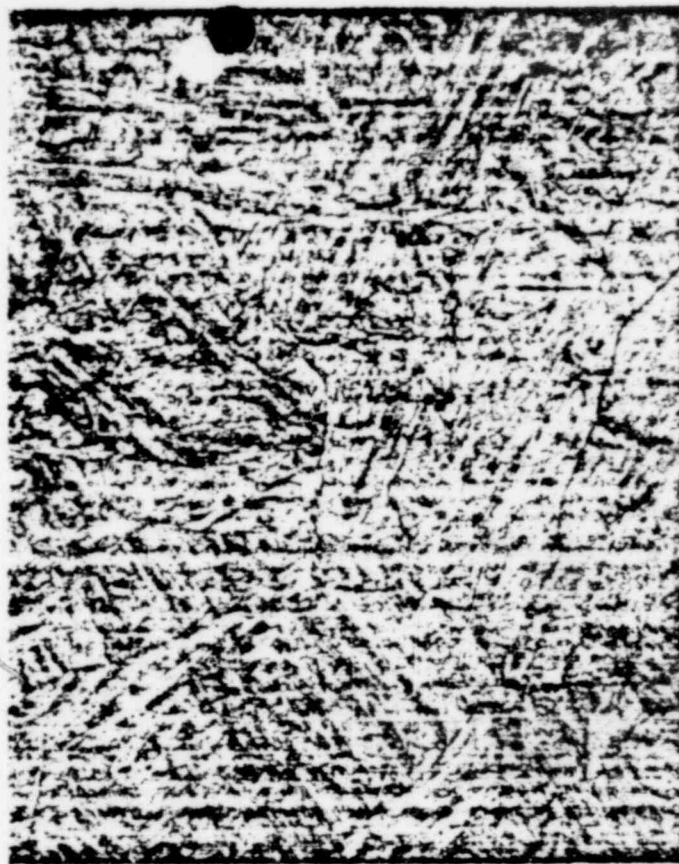
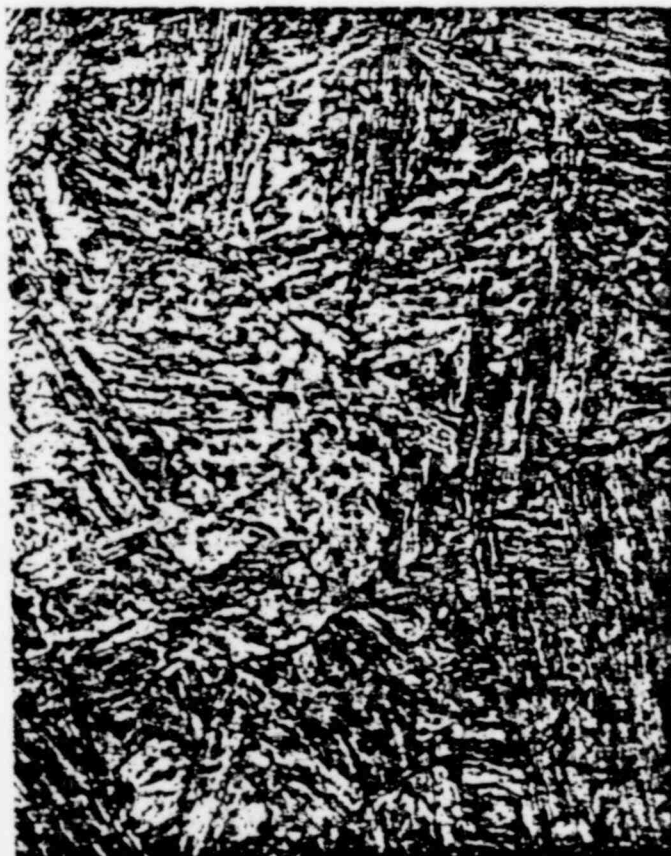
The shaft microstructure consists predominantly of tempered martensite. Minor quantities of delta-ferrite and columbium-containing inclusion stringers are also present. Fine particulates of copper are dispersed throughout the microstructure. Prior austenite grain boundaries (~ASTM 2-3 grain size) are delineated by copper particles. Microstructures are illustrated in Figures 1-4.

The shaft microstructure is not typical for the H-1150 condition. The microstructure is more typical of a lesser tempering heat treatment, i.e., it contains finer dispersed copper particles and lesser prior austenite grain boundary decoration.

Figure 1. Photomicrographs showing the microstructure in a transverse section near the shaft center.

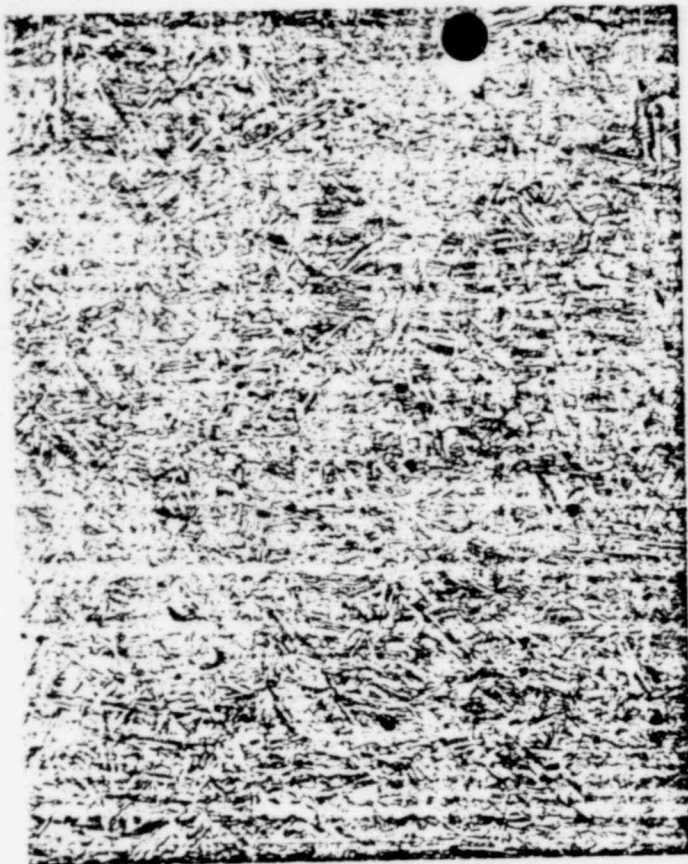
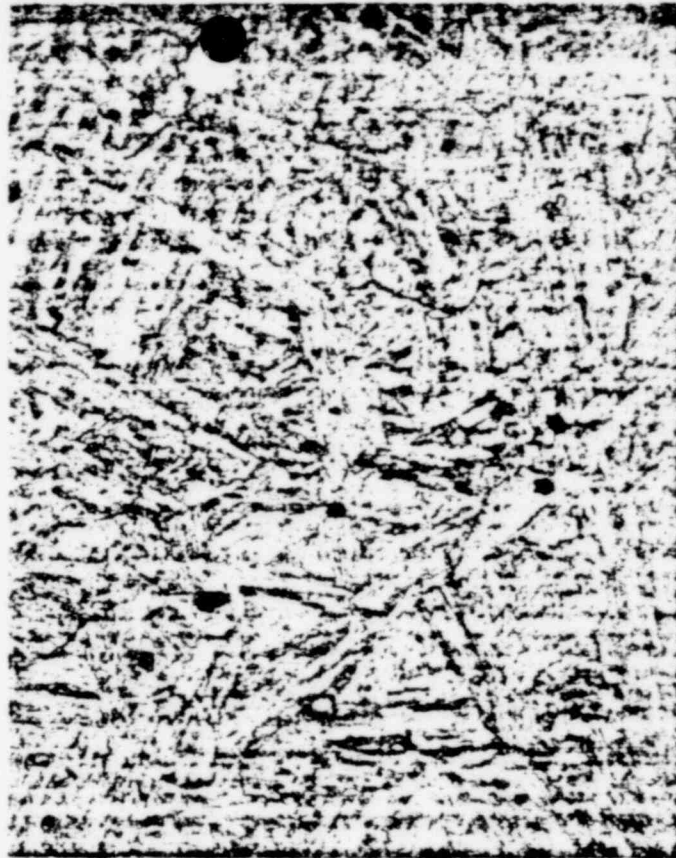
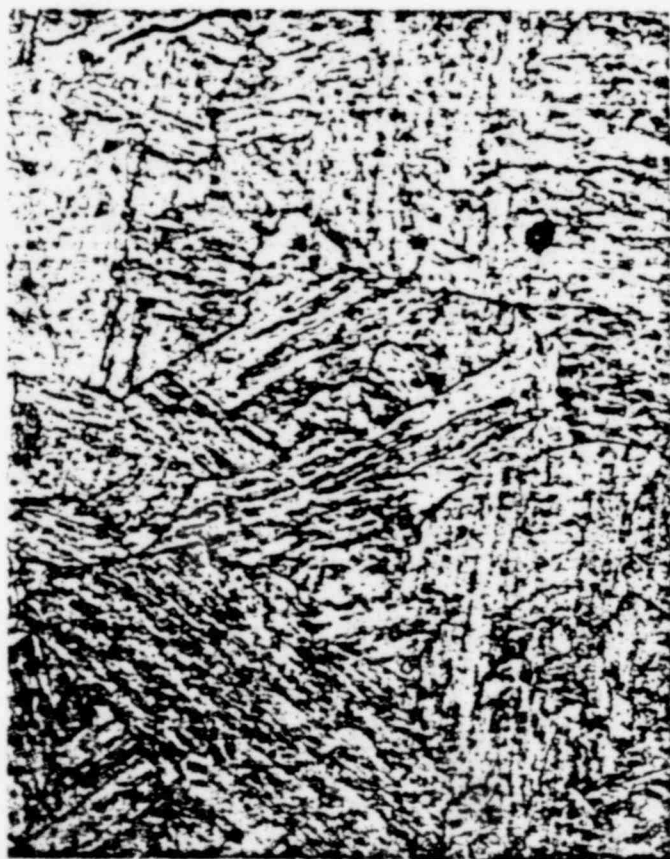
Figure 2. Photomicrographs showing the microstructure in a transverse section near the shaft OD.

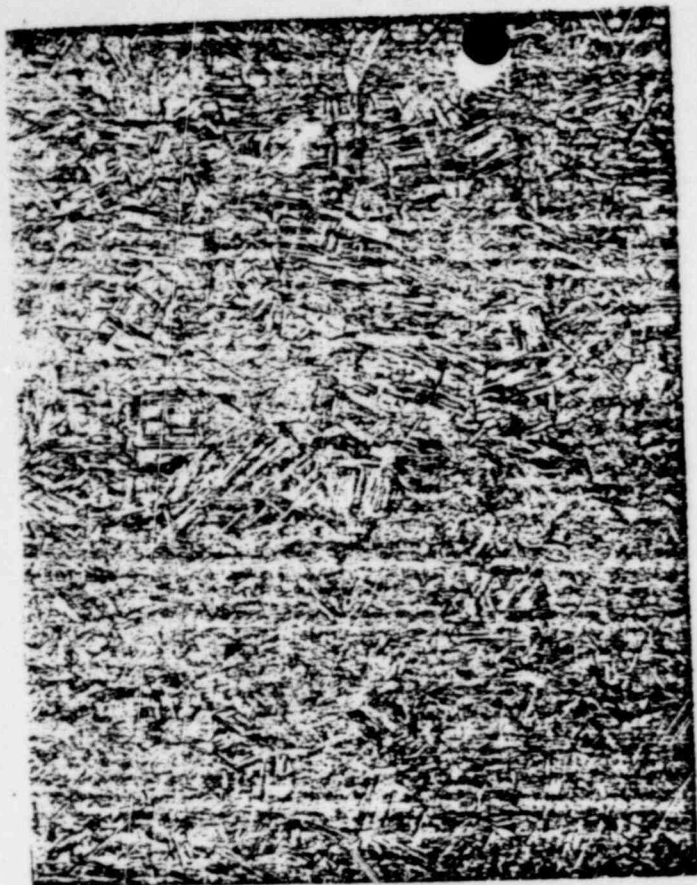
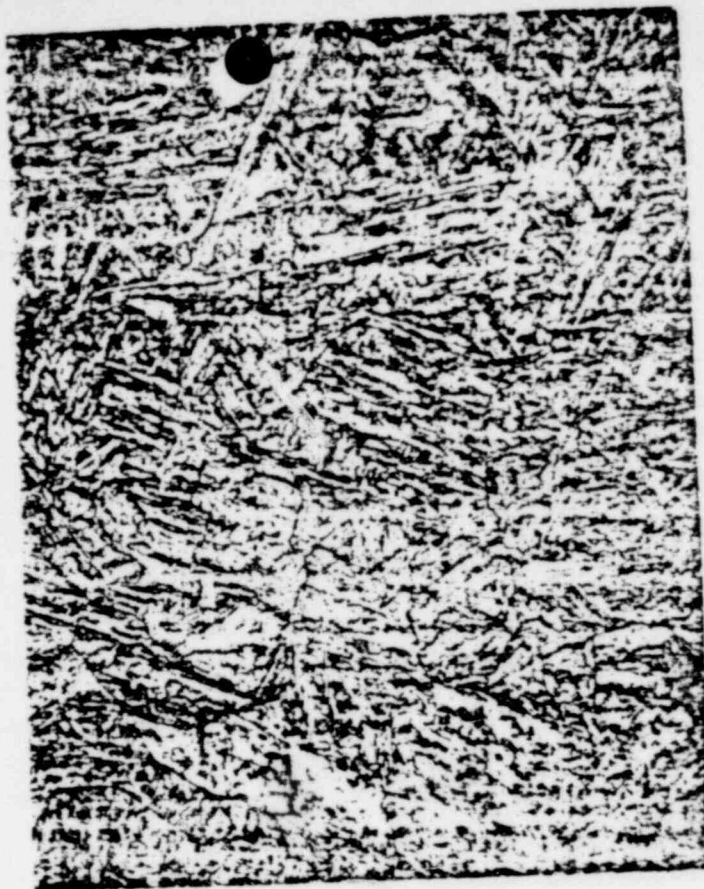
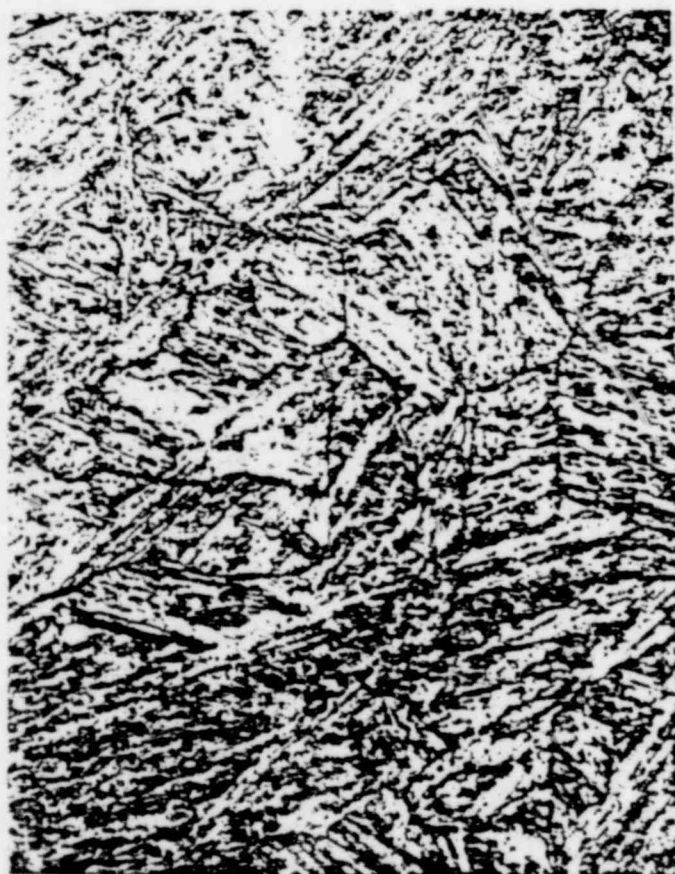
Figure 3. Photomicrographs showing the microstructure in a longitudinal section near the shaft center.

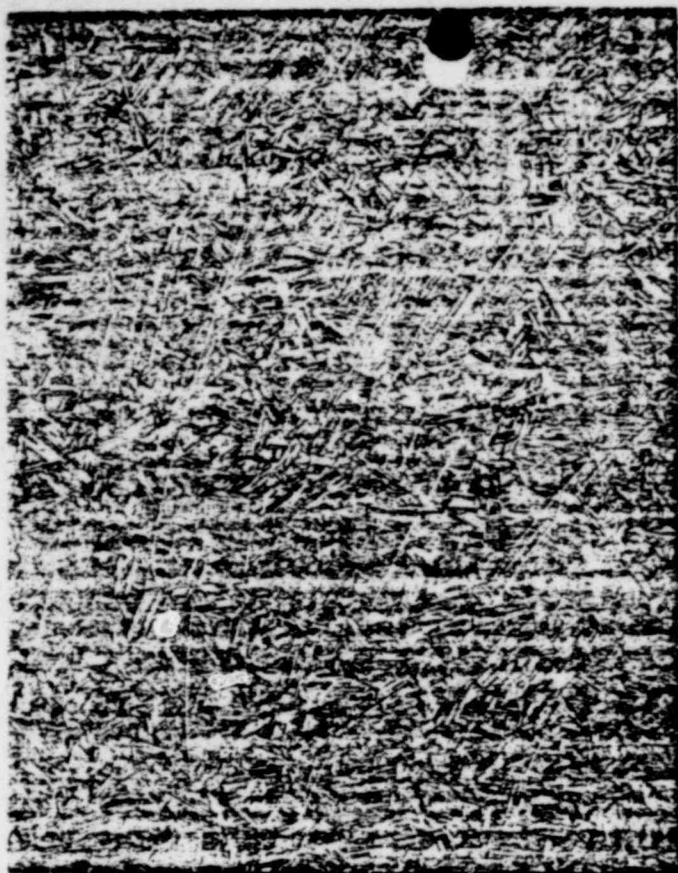
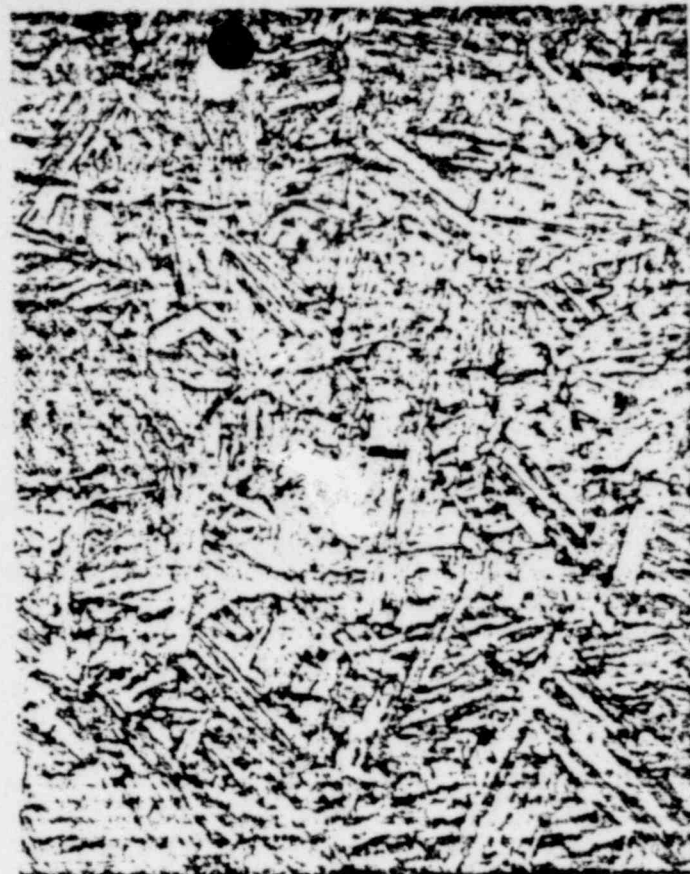
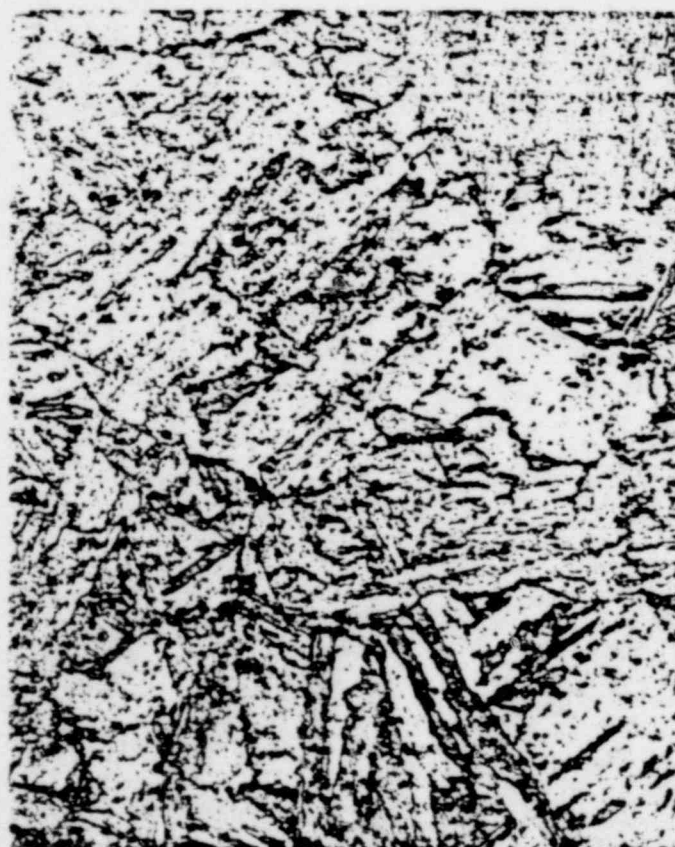
Figure 4. Photomicrographs showing the microstructure in a longitudinal section near the shaft OD.

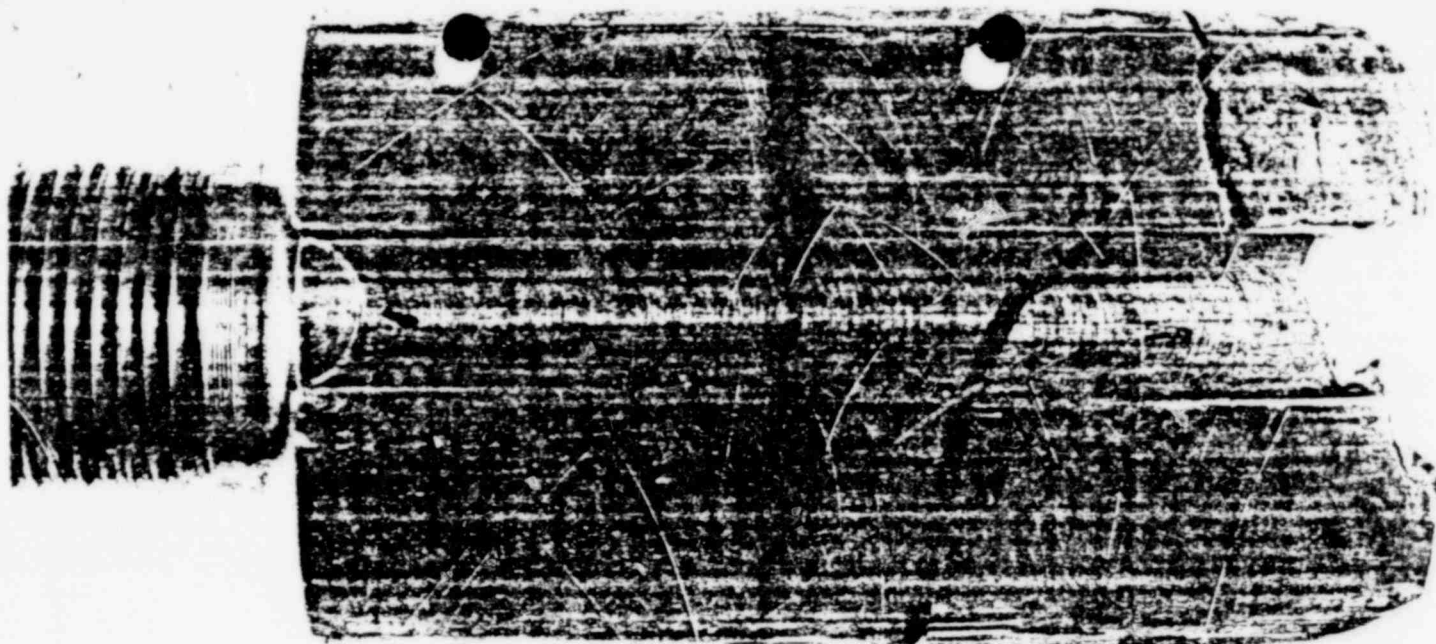
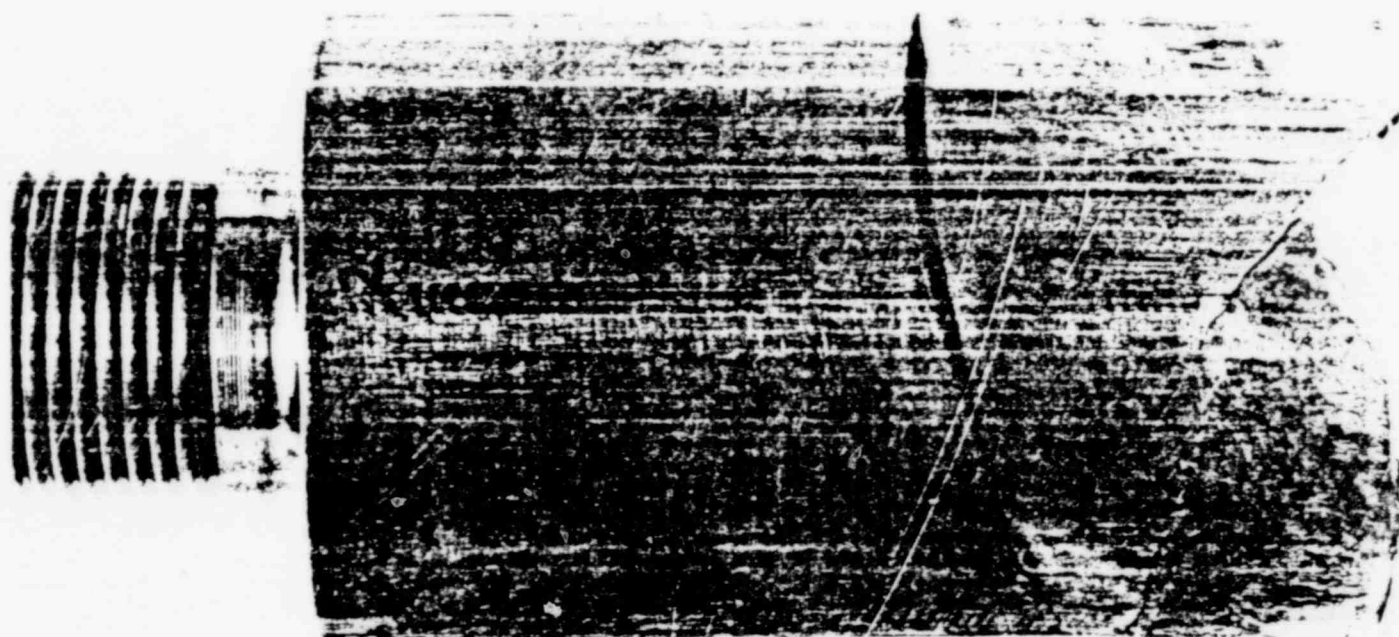
Cracking occurred at and around the location where the shaft fits into the sleeve. The ultimate separation occurred on a crack plane inclined to the shaft axis which grew from a location at the junction of shaft and sleeve. Other cracks traversed nearly the entire cross-section on inclined planes to the axis (in opposed senses) but did not completely sever. Examples are shown in Figures 5-10.

Figure 5. Photomicrograph of fractured shaft,
1. at key way and 2. rotated 90°.

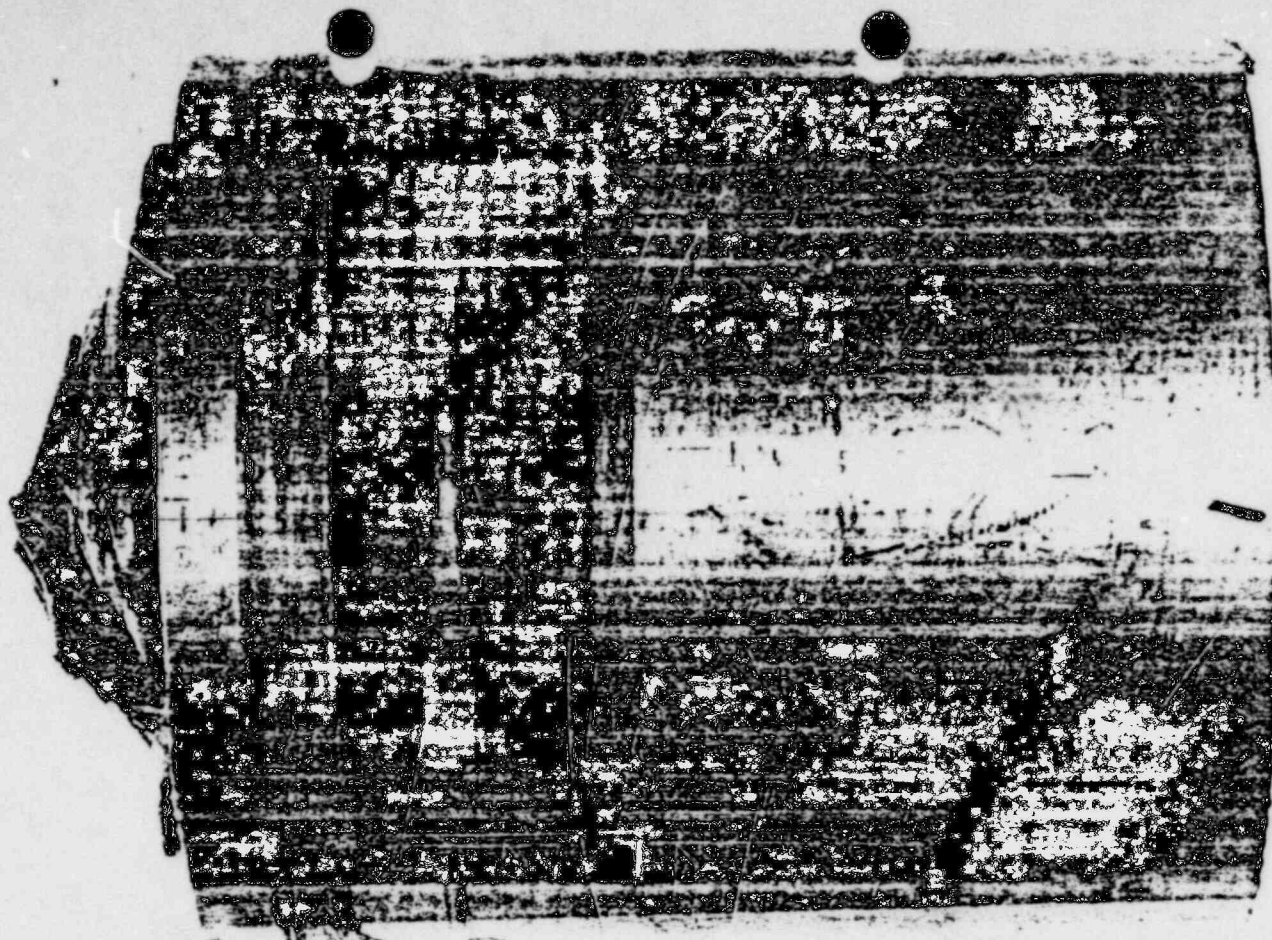
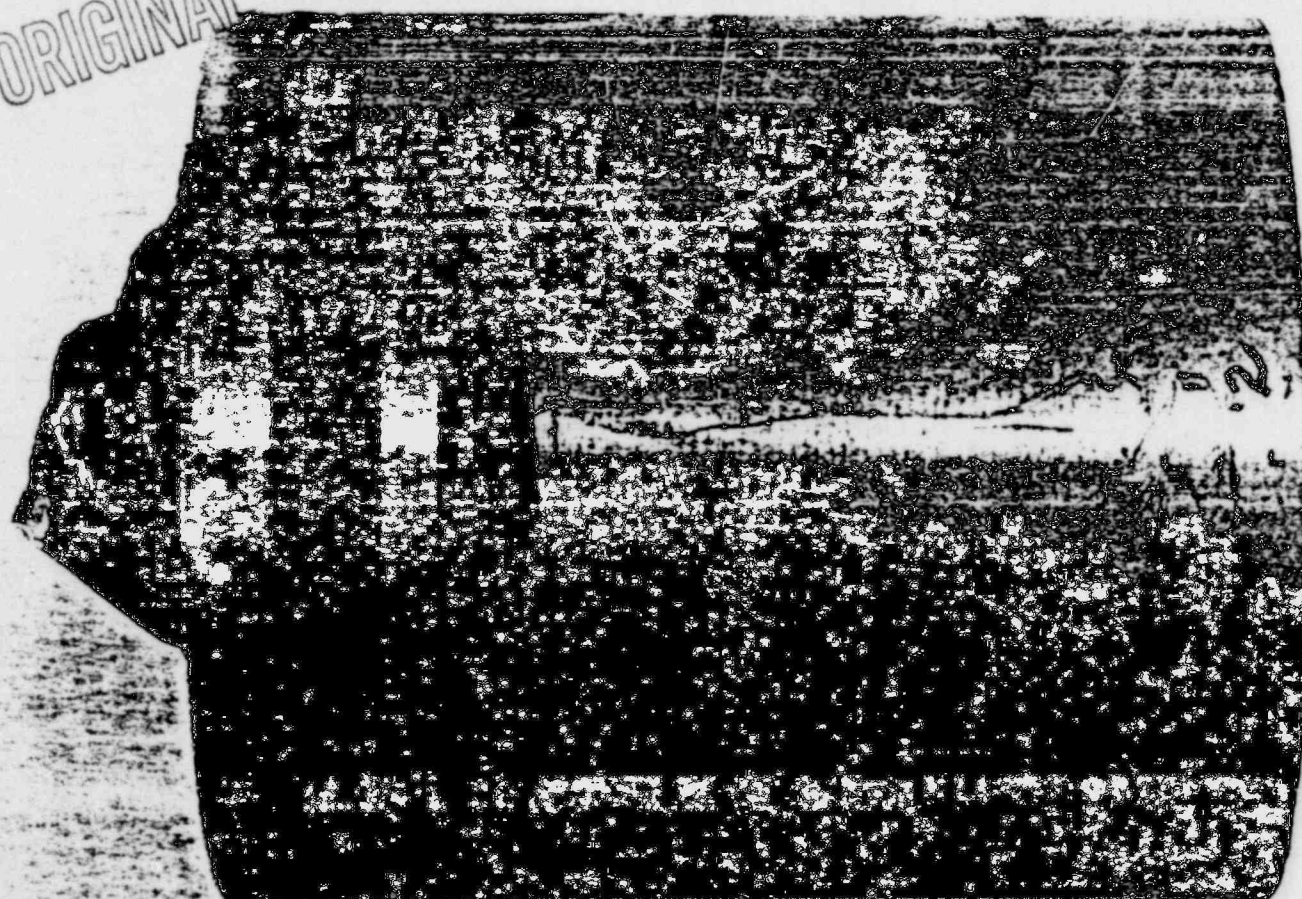
Figure 6. Photomicrograph of fractured shaft in sleeve,
1. at keyway and 2. rotated 90°.

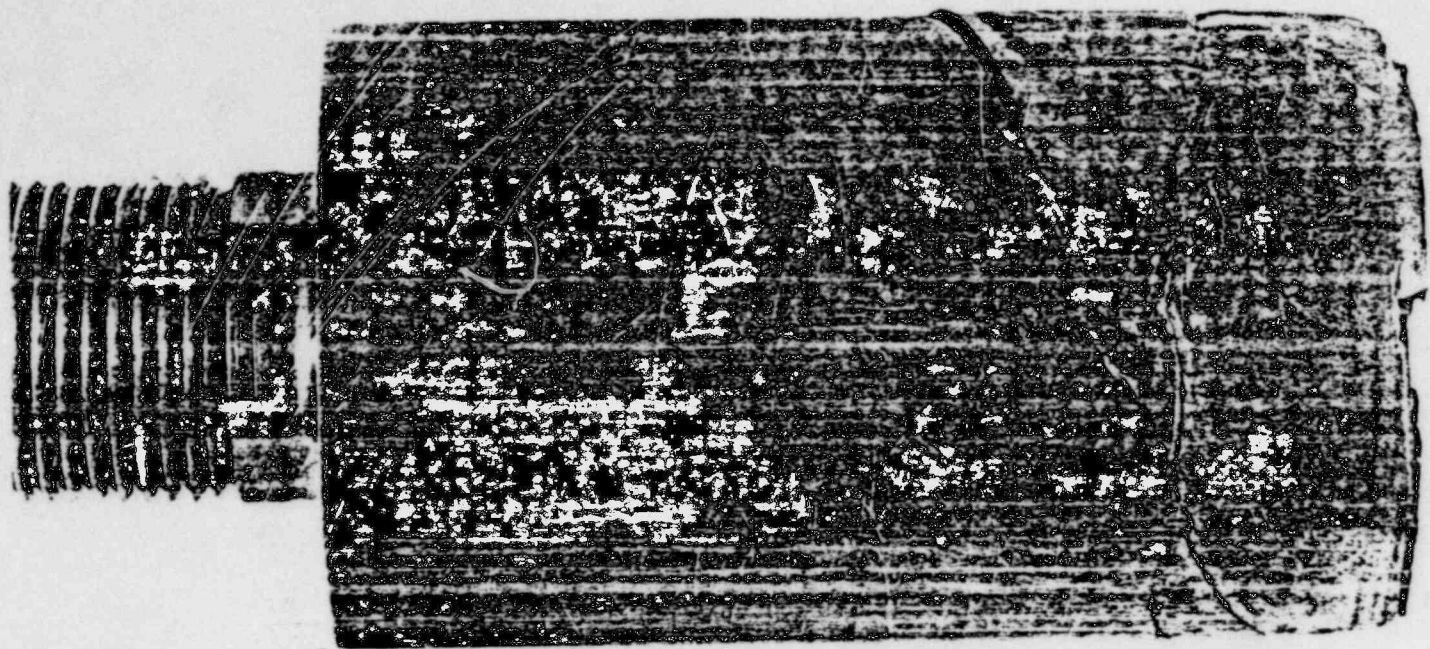
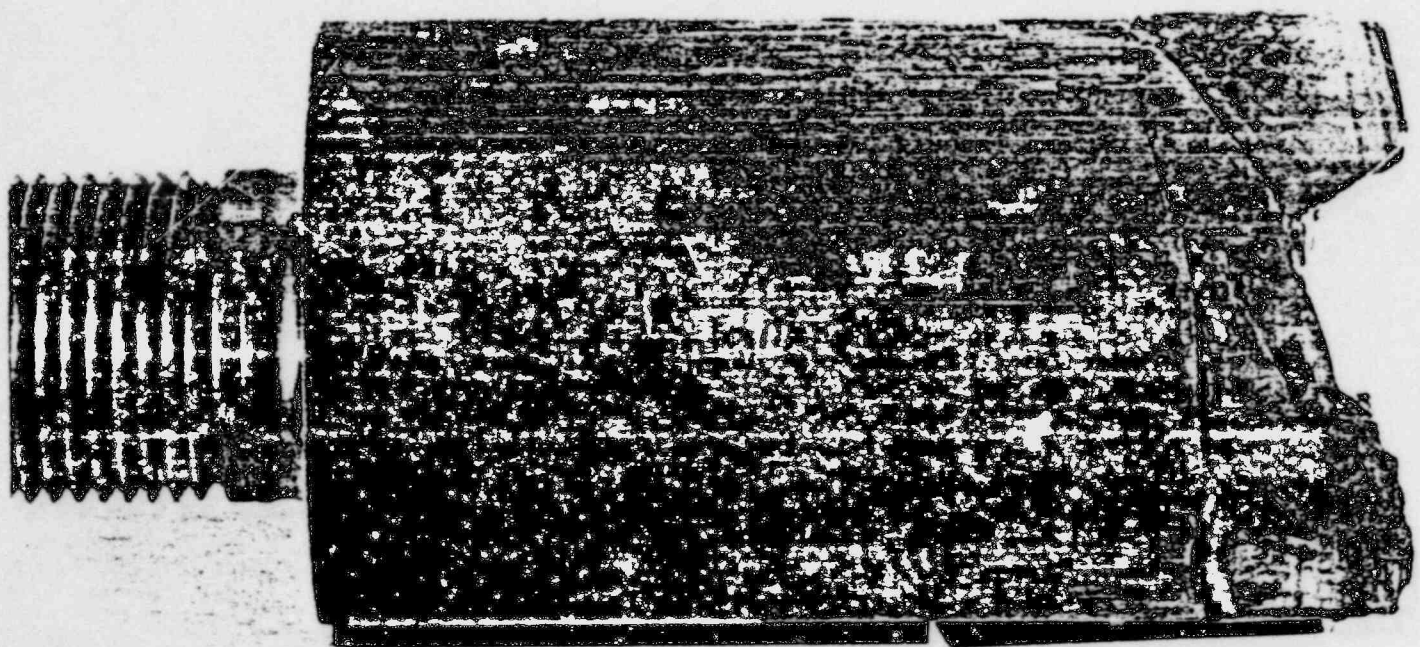
Figure 7. Photomacrographs of fractured shaft rotated
180° (3) and 270° (4) with respect to keyway.

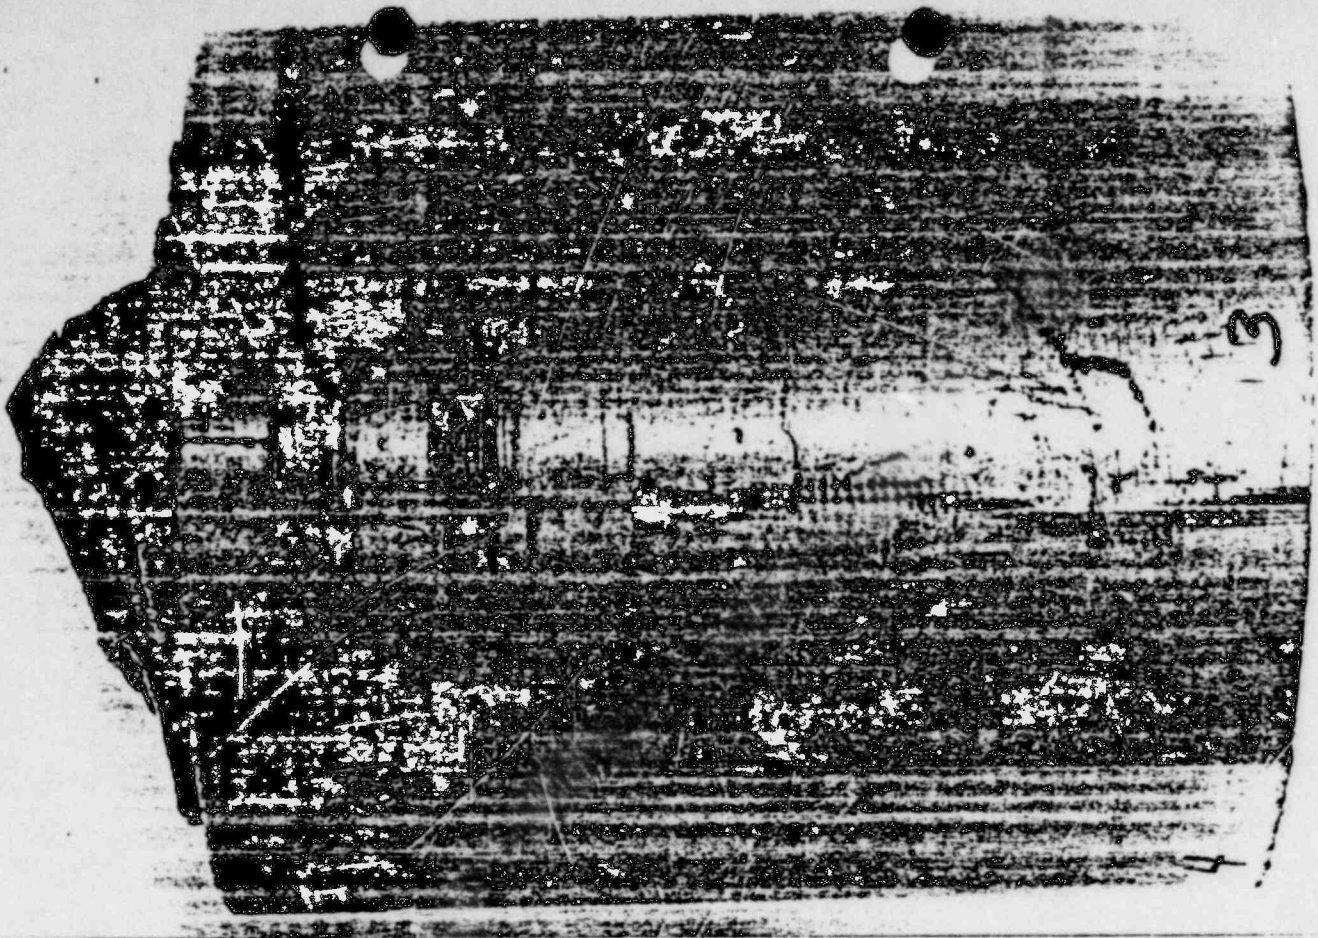
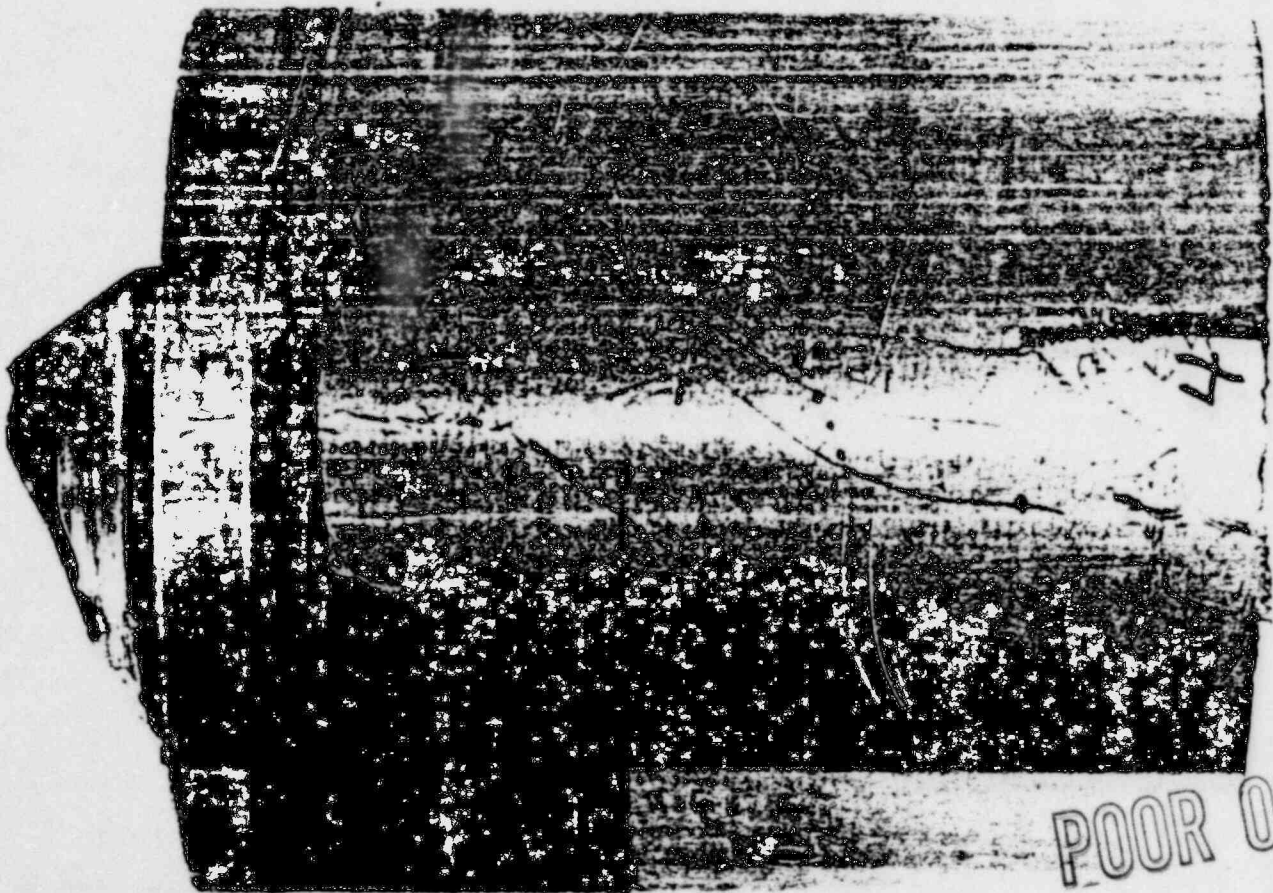
Figure 8. Photomicrograph of fractured shaft in sleeve rotated 180° (3) and 270° (4) with respect to keyway.

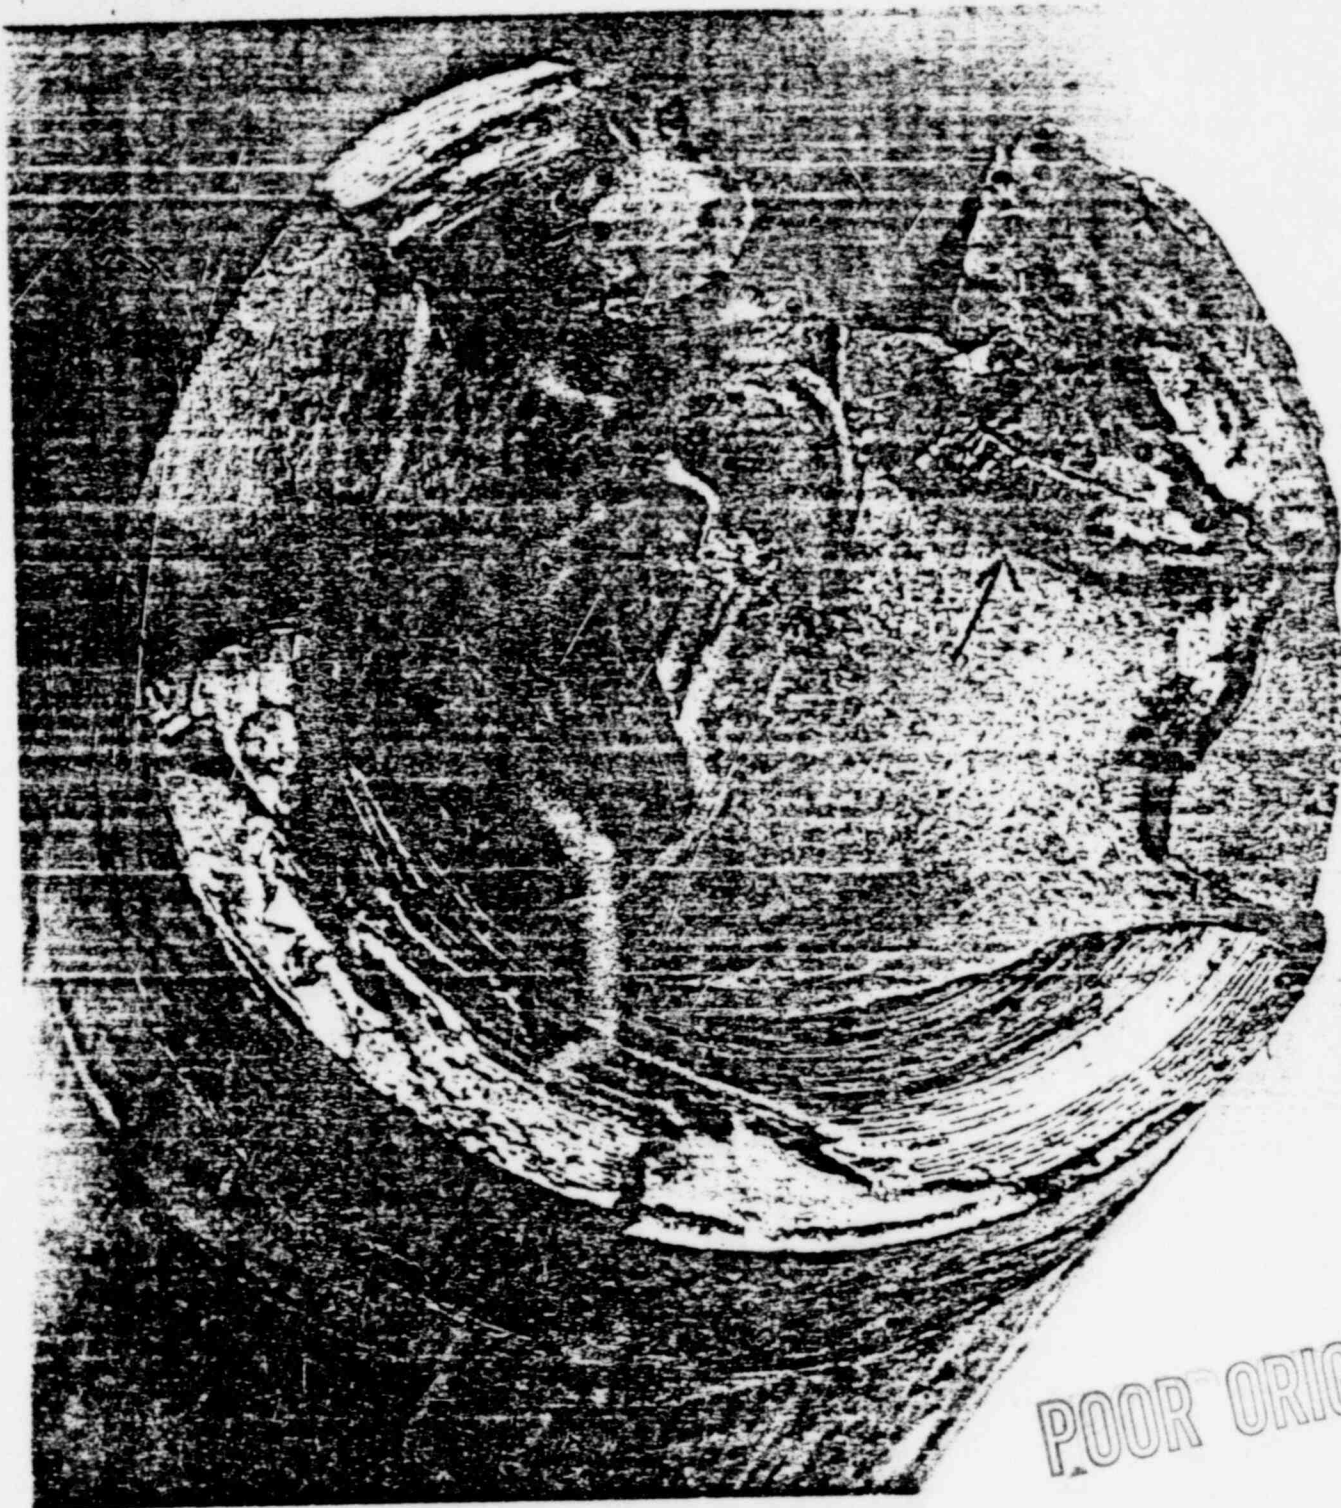
Several discrete fracture propagation systems were seen to extend from the extremities of the rough fracture area. These are all typified by smoother surfaces, by radial patterns and some "beach" markings. Arrows on Figures 9 and 15 show propagation patterns emanating from the keyway corner at the extremity of the rough fracture area on two of the major crack planes.

Figure 9. Photomacrograph of fracture plane on shaft.
Arrow indicates bench marks.

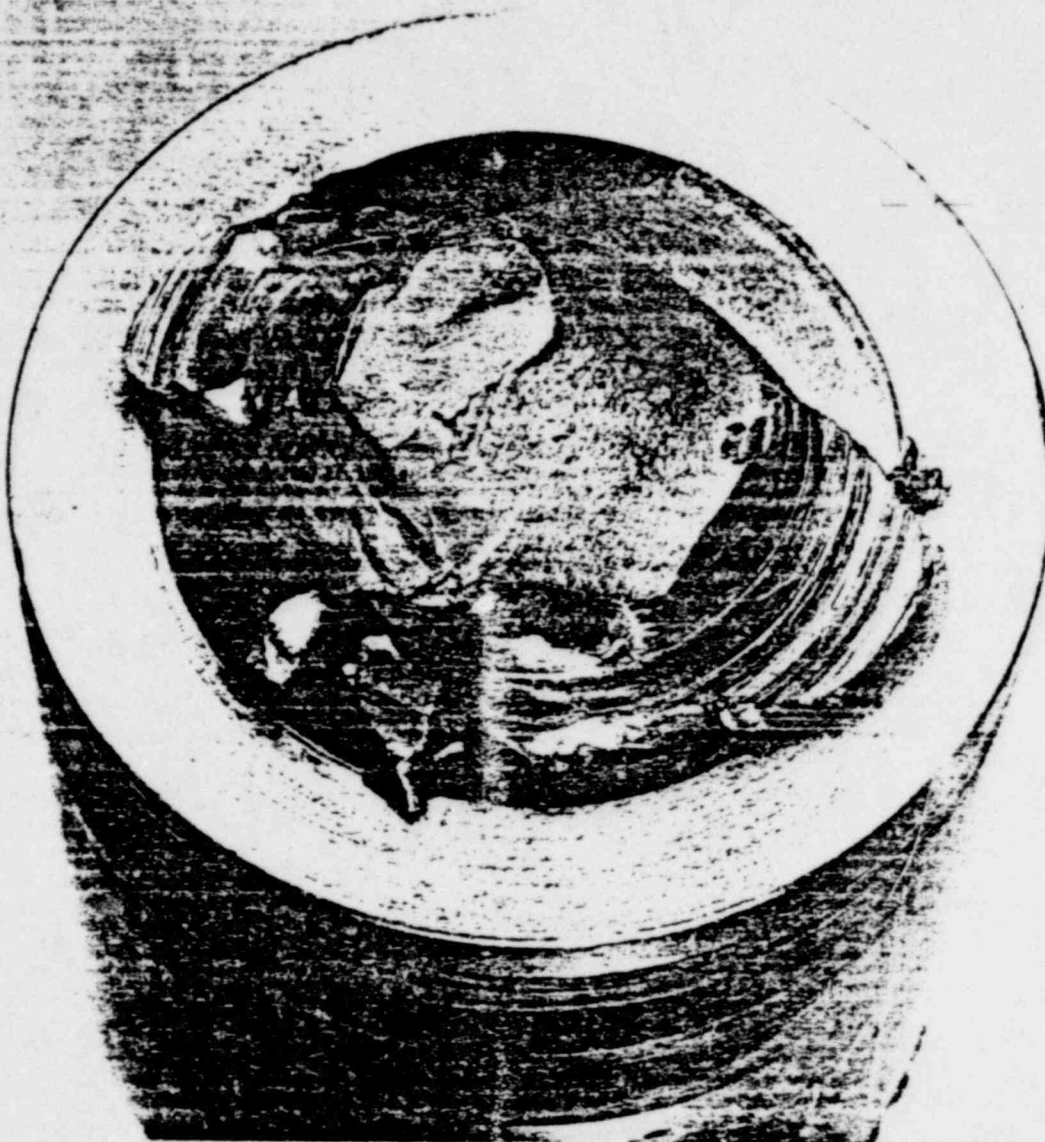
Figure 10. Photomicrograph of fracture plane on shaft. Matching surface to fracture plane shown in Figure 9.

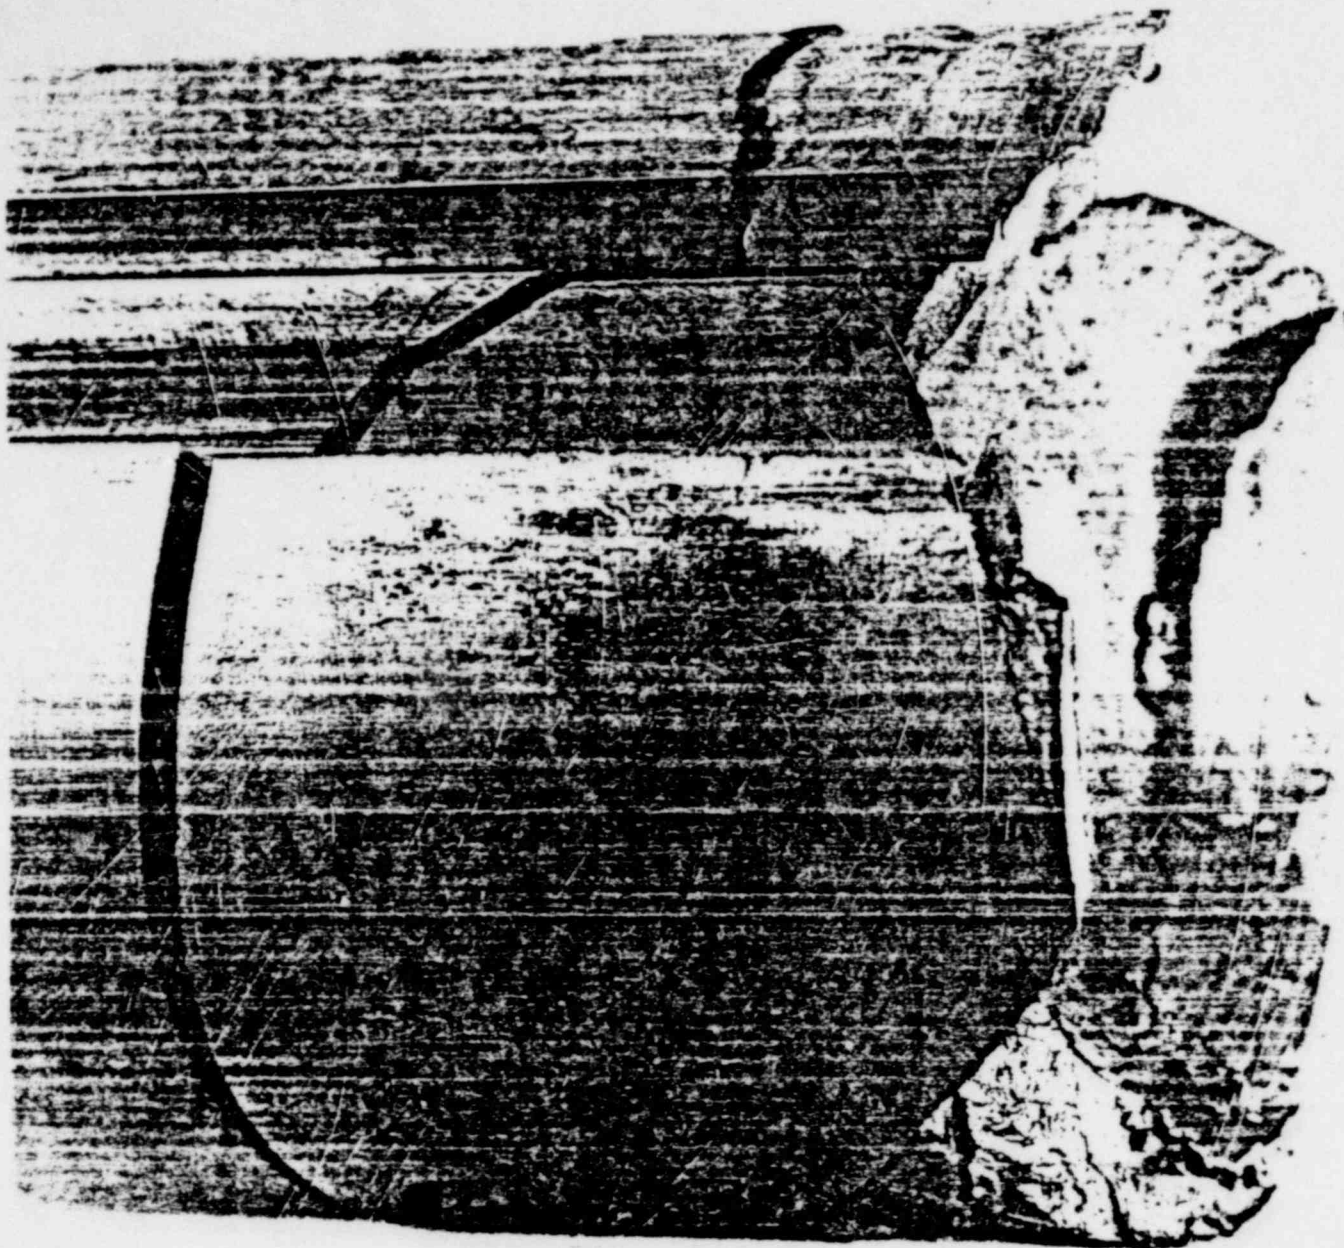
Cracks passing through the cross-section were separated by as much as 1 to 1-1/2 inch (measure of divergence) along the shaft axis. All these cracks are tied to a common feature, which is a longitudinal crack about 3/4-inch long located in one corner of the shaft keyway. This is illustrated in Figure 11.

Figure 11. Photomacrograph showing longitudinal crack in keyway corner.
