To	K. E. MOORE - TECHNICAL STAFF, NPGD, LYNCHBURG	
From	L. W. SARVER/J. S. ROYDER - METALLURGY SECTION, ARC	RC-1 Form 1-77
Cust.	METROPOLITAN EDISON	File No. or Ref. LR:77:5276-01:2
Subj.	FINAL REPORT ON EXAMINATION OF CR-3 DECAY HEAT PUMP SHAFT	Date SEPTEMBER 24, 1977

INTRODUCTION

This report describes the metallurgical evaluation and failure analysis of a broken CR-3 decay heat pump shaft. This failure occurred last year at the Crystal River N.S.S. facility of the Florida Power Corporation. The decay heat pump shaft was fabricated by the Worthington Pump Corp. from 17-4 PH stainless steel.

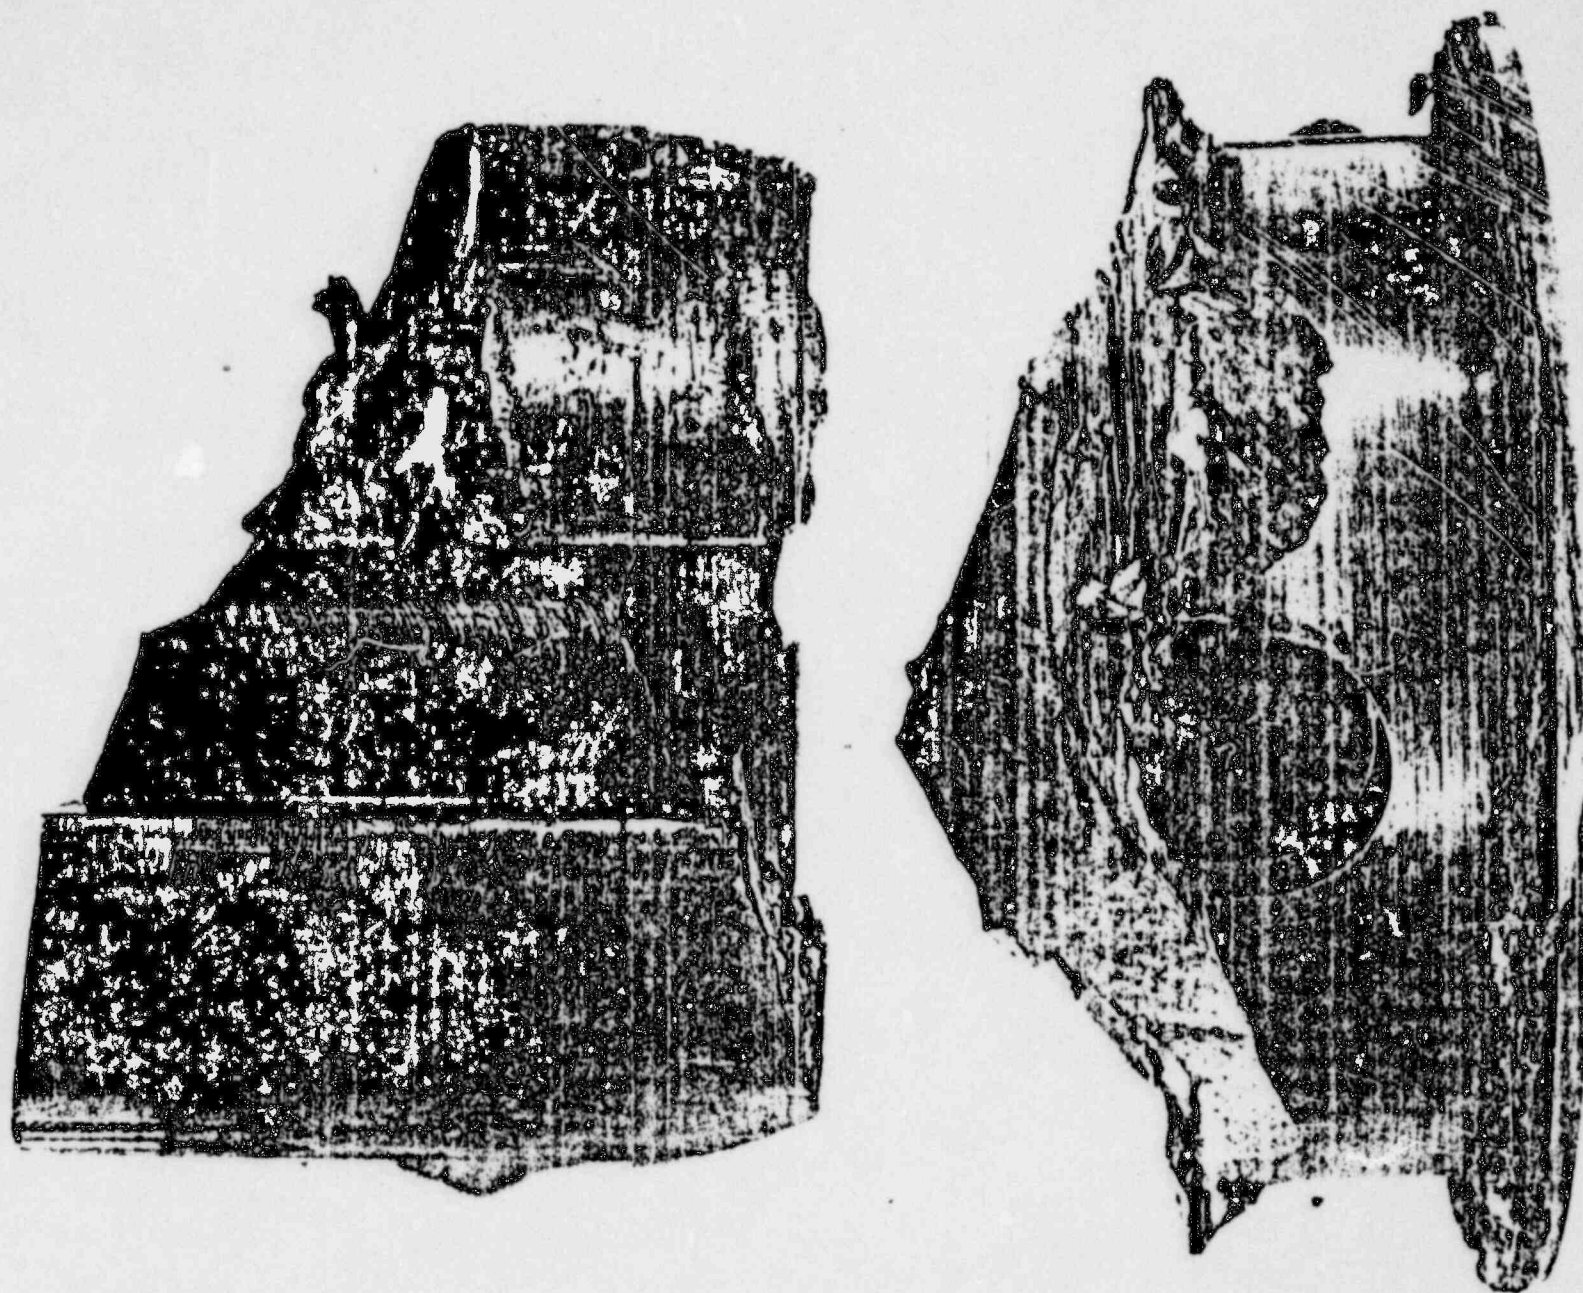
The shaft was systematically forced to fracture through the cross-section along the existing nearly-through-shaft crack planes. Thus, major cracks associated with the extremities of the longitudinal crack were exposed. Further the stub of the shaft within the sleeve was removed for examination. These pieces are illustrated in Figure 12.

A rough fracture surface area was noted beside the keyway on the shaft section removed from the sleeve (arrow on Figure 12). A continuation of this fracture area was found after forcing the adjacent cracked area to complete separation. This is illustrated in Figures 13-15.

Figure 12. Photomicrograph showing shaft removed from sleeve (section on the right) and adjacent crack forced to complete separation (section on the left).

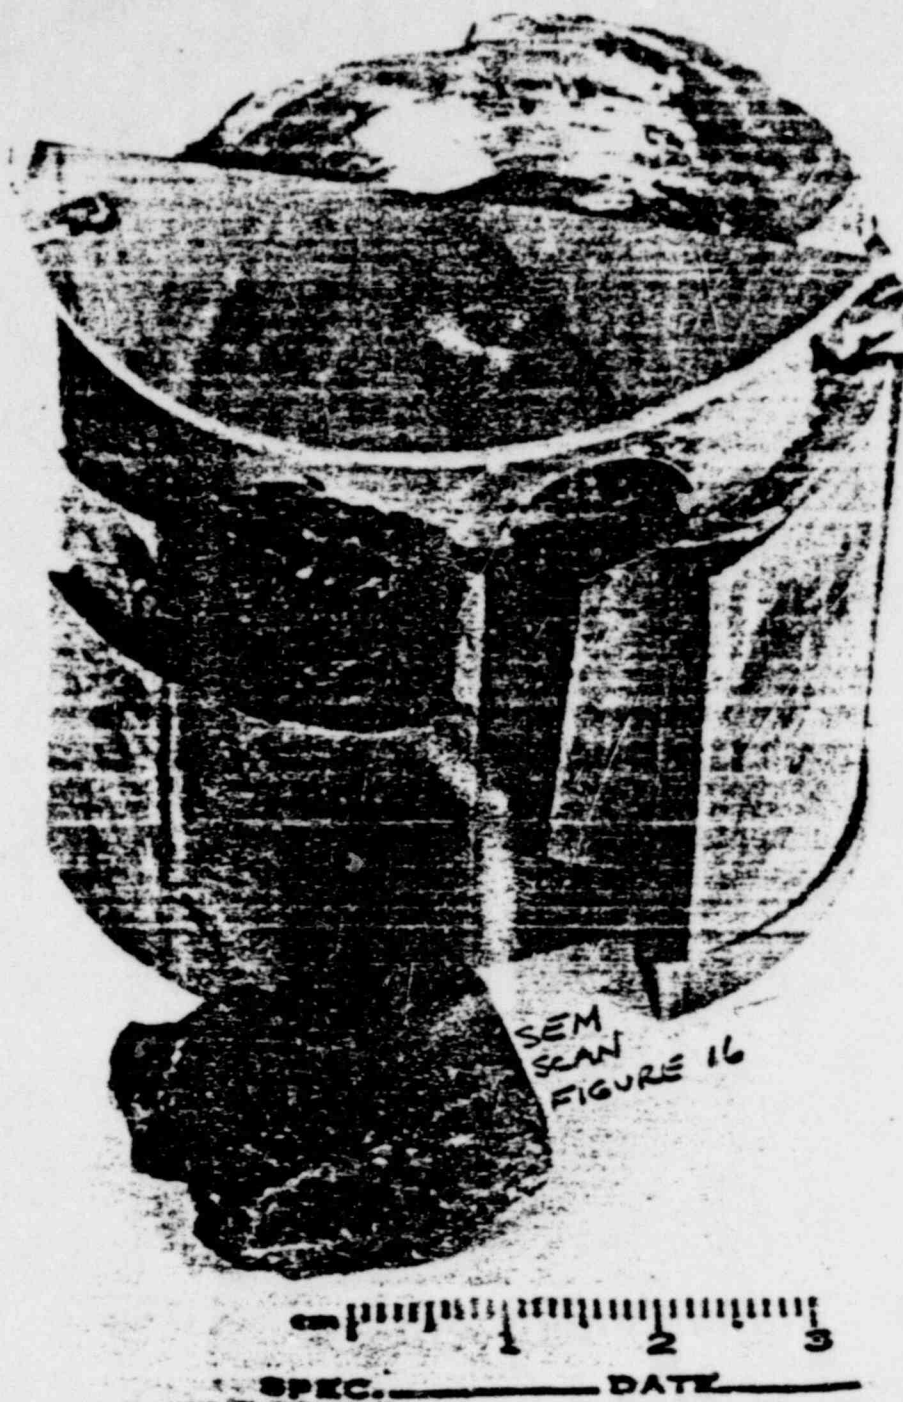
A traverse across the fracture area illustrated in Figure 16 via Scanning Electron Microscope (SEM) revealed fracture characteristics shown in Figure 14. Three discrete fracture zones are noted: (1) flat surface in a narrow band immediately adjacent to the keyway corner, (2) microscopically rough angular surface extending about 1/2 to 3/4 inch from the keyway corner and (3) smooth surface initiating abruptly at the extremity of rough surface.

Figure 14. Photomicrograph showing the reconstruction of the shaft after forcing partial separations to completion.

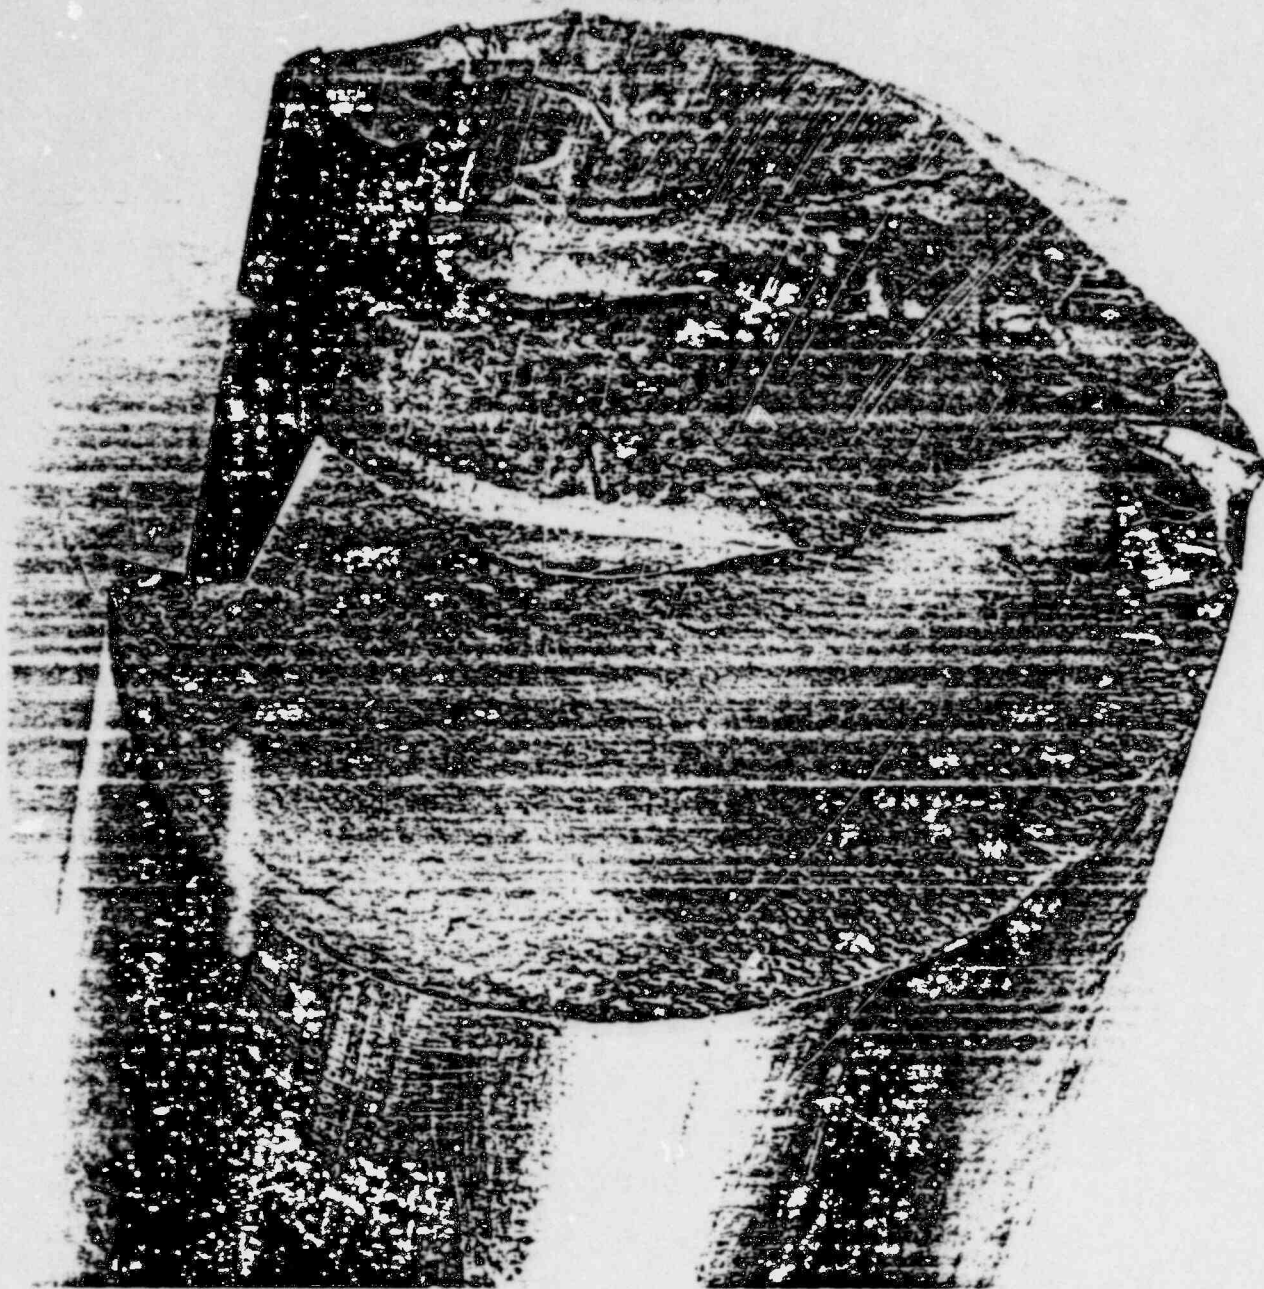
The fully exposed rough fracture surface area is seen to be derived from the longitudinal crack in the corner of the keyway. The plane of the rough fracture is parallel to and effectively an extension of the plane of the bottom of the keyway.

Several discrete fracture propagation systems were seen to extend from the extremities of the rough fracture area. These are all typified by smoother surfaces, by radial patterns and some "beach" markings. Arrows on Figures 9 and 15 show propagation patterns emanating from the keyway corner at the extremity of the rough fracture area on two of the major crack planes.

Figure 15. Photomicrograph showing the fracture plane forced to complete separation. Location of plane shown on Figure 12.

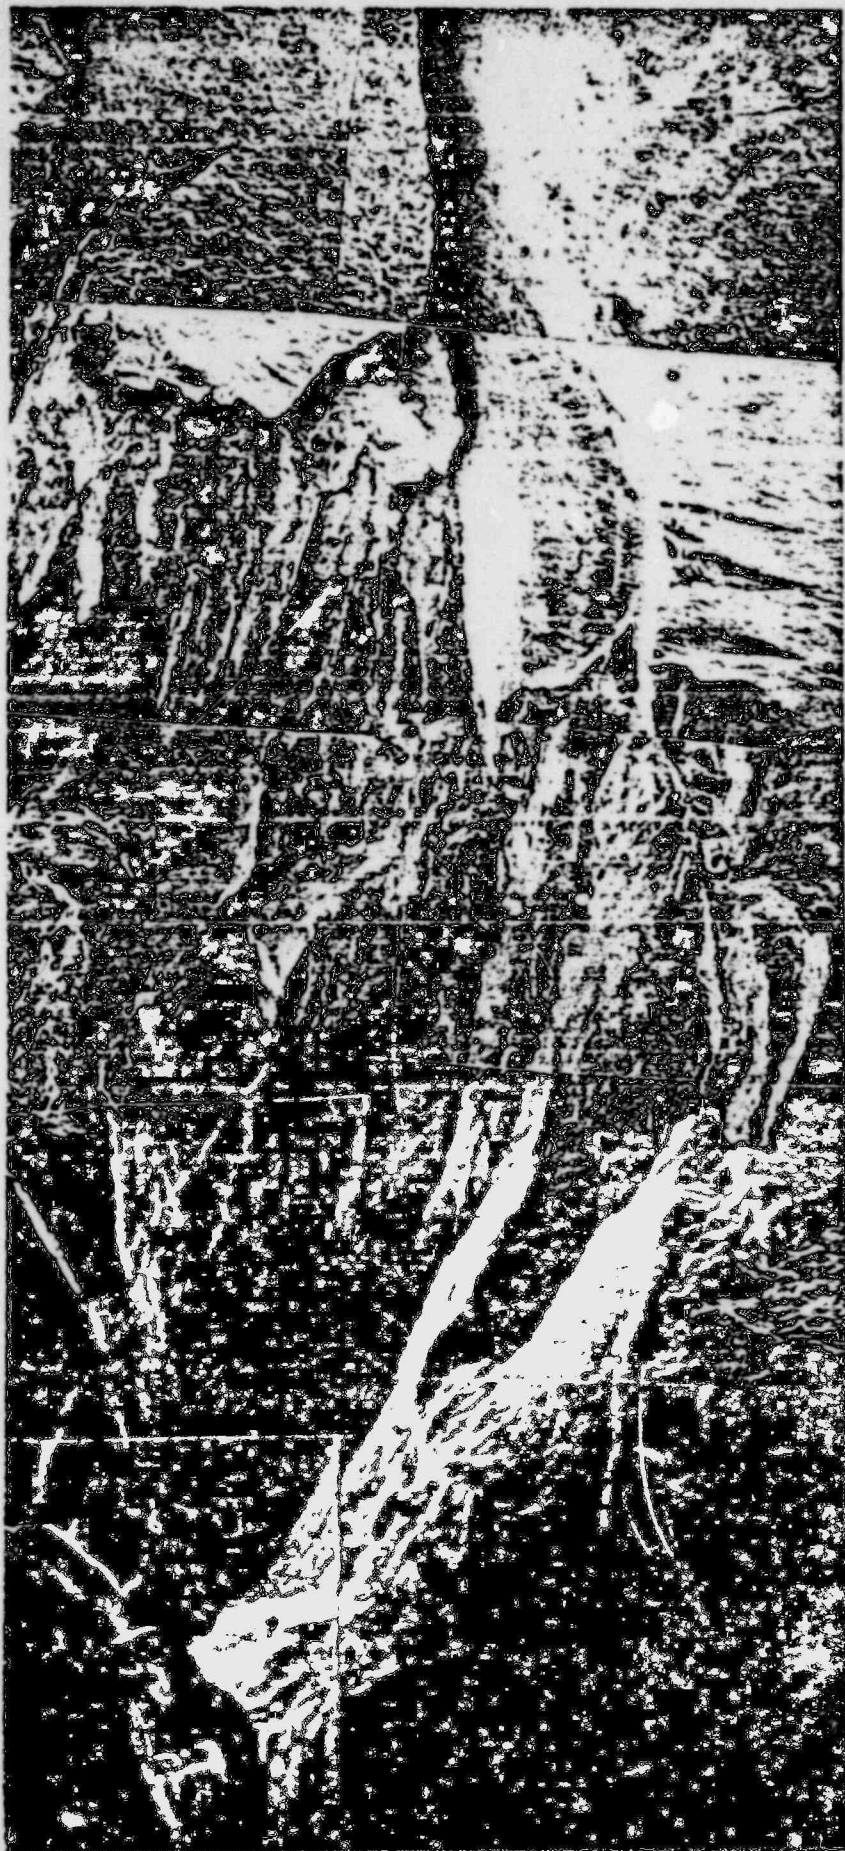
Figure 16. A series of scanning electron microscope photomicrographs traversing piece A in Figure 14.

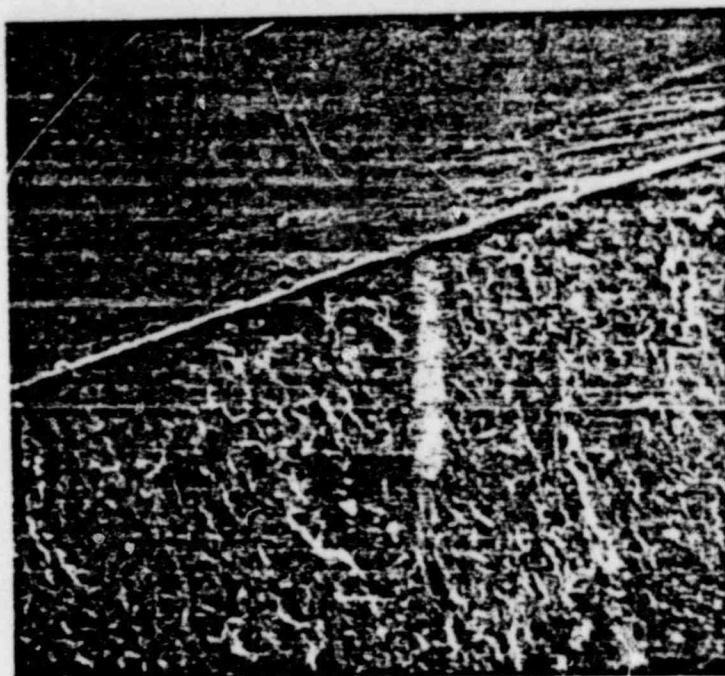
Figure 17 illustrates a portion of the locus of crack initiation at the corner of the keyway. Figures 18 and 19 illustrate details near the origin. Figure 20 shows the crystallographic character (looks "cleaved") which generally typifies the fracture surface at the origin.

It appears that cracking initiated at the corner of the keyway on a lineal locus along the shaft axis. The initial crack extension proceeded by a transgranular mechanism. There were slight tear ridges oriented perpendicular to the corner of the keyway which suggested that a planar crack front moved away from the corner.

Figure 17. Fractograph showing portion of locus of crack initiation (corner of keyway).

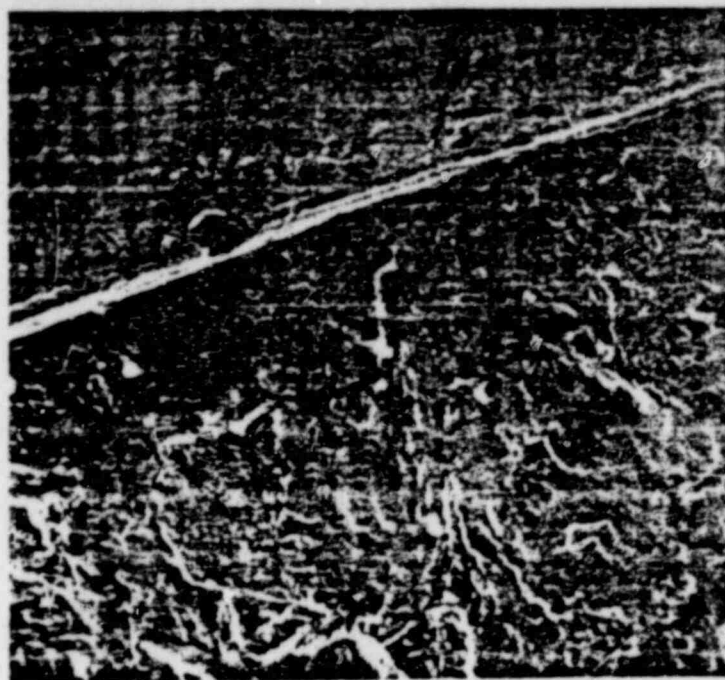
Figure 18. Fractograph of crack origin in corner of keyway.

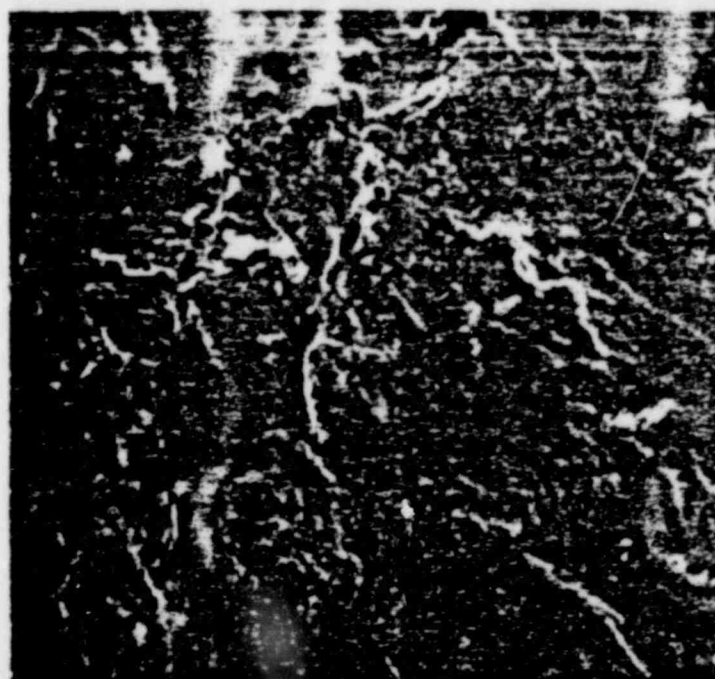
Figure 19. Fractograph of detail in crack origin area.

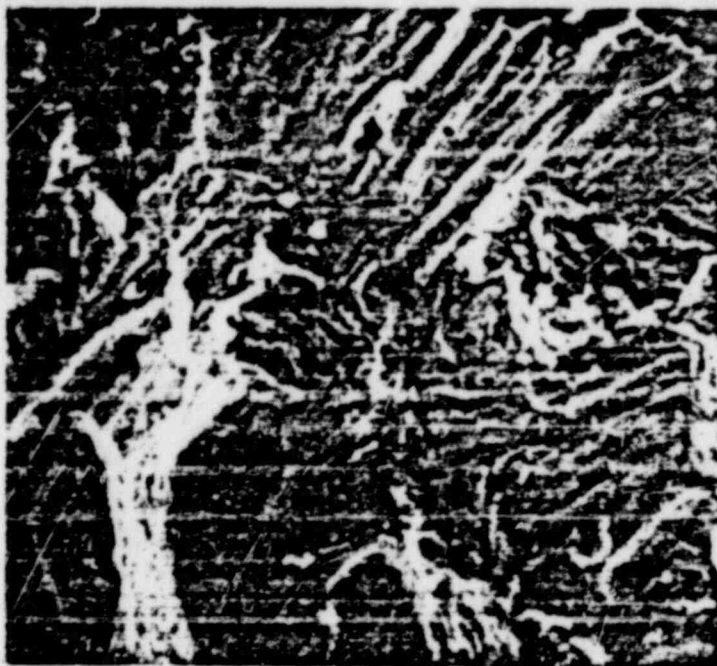
Crack extension beyond the initial region proceeded by a structure-sensitive ("cleaved") micro-topology which is characteristic of fatigue propagation for many materials in the realm of low stress intensity range associated with crack propagation rates less than 10^{-6} inches per cycle.

Figure 20. Fractograph showing detail in crystallographic ("rough") fracture surface area.

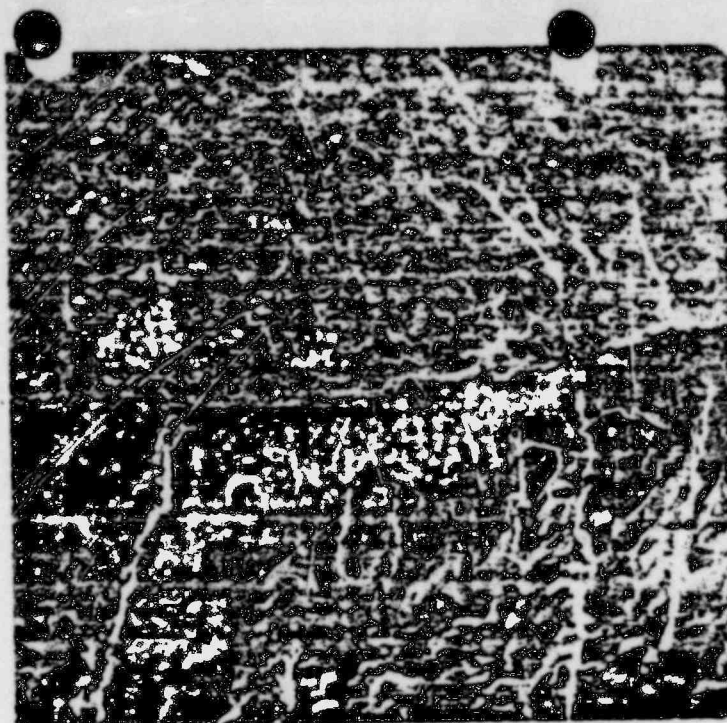
Figures 21 and 22 show two different "beach" markings from a secondary propagation system. Figure 23 illustrates growth character preceding the last beach mark while Figure 24 illustrates growth character beyond the last beach mark (fast growth). Mixed mode conditions such as illustrated in Figure 25 were sometimes found near beach marks.

Figure 21. Fractograph of beach mark in secondary crack propagation system.

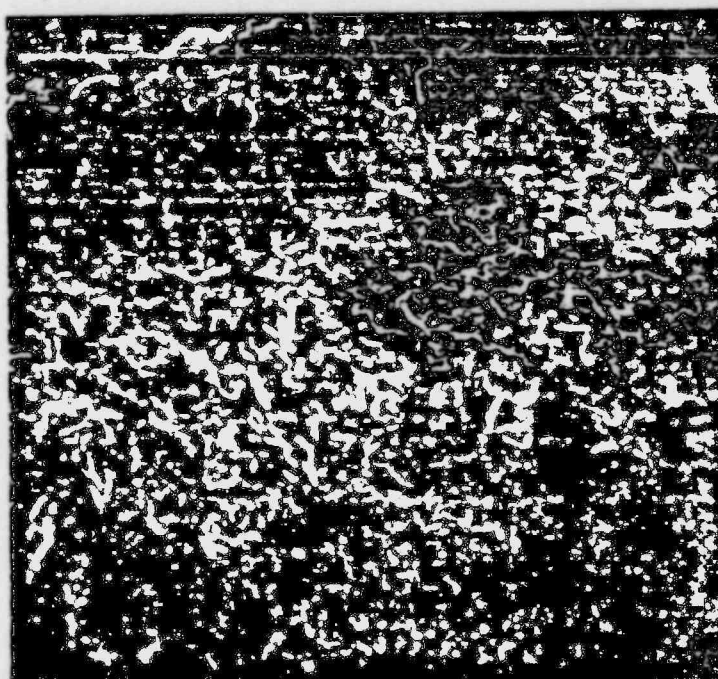
Figure 22. Fractograph of beach mark in secondary crack propagation system. Mixed mode fracture is present in the mid-region of the photo.

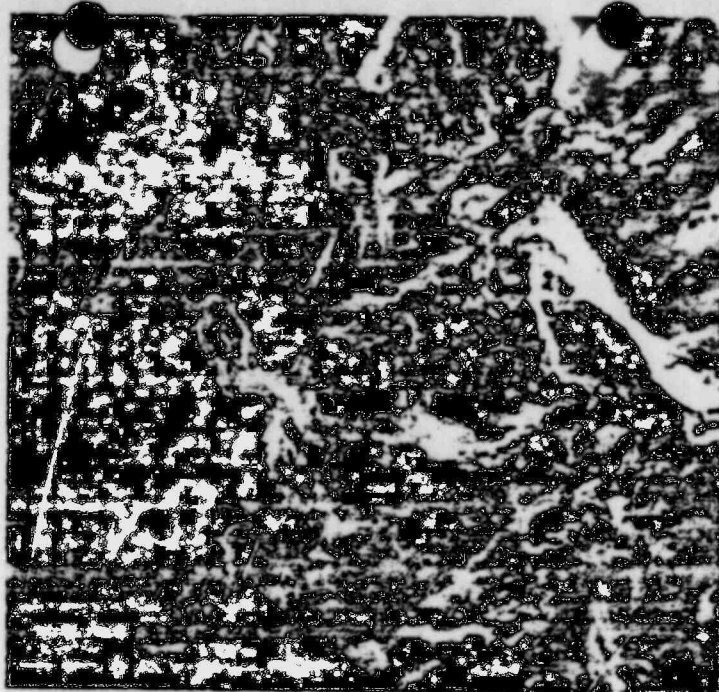
Figure 23. Fractograph showing crack growth character preceding beach mark in secondary propagation system.

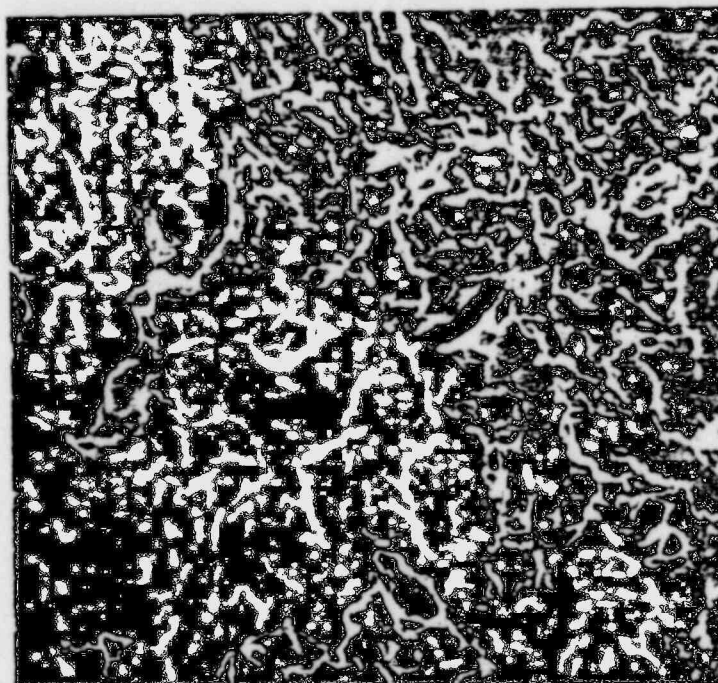
Figure 24. Fractograph showing crack growth character beyond last beach mark in a secondary propagation system.

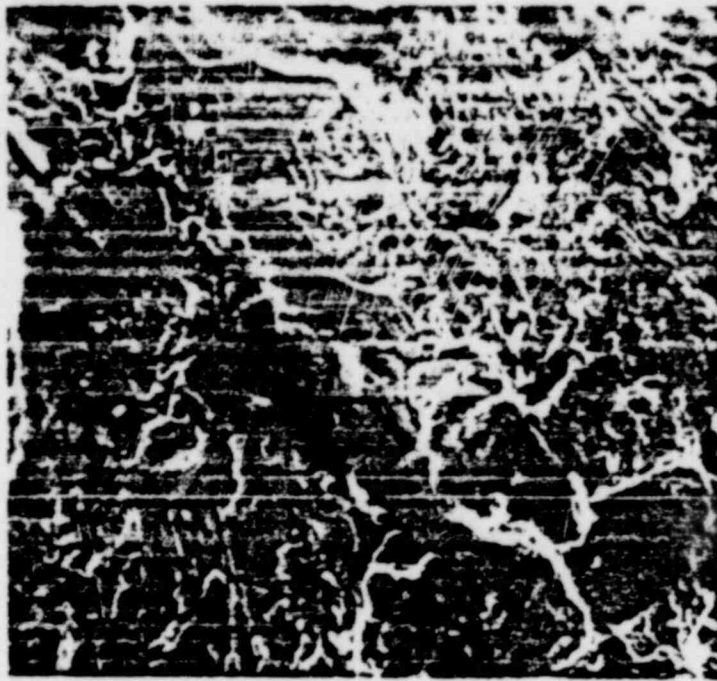
Some bands of intergranular fracture mixed with transgranular fracture were observed. This suggests possible grain boundary weakness in the material or some environmental effect on propagation. Either phenomenon would seem to be incidental and not significant to the failure process.

Figure 25. Fractograph showing detail of mixed mode fracture character near beach marks.

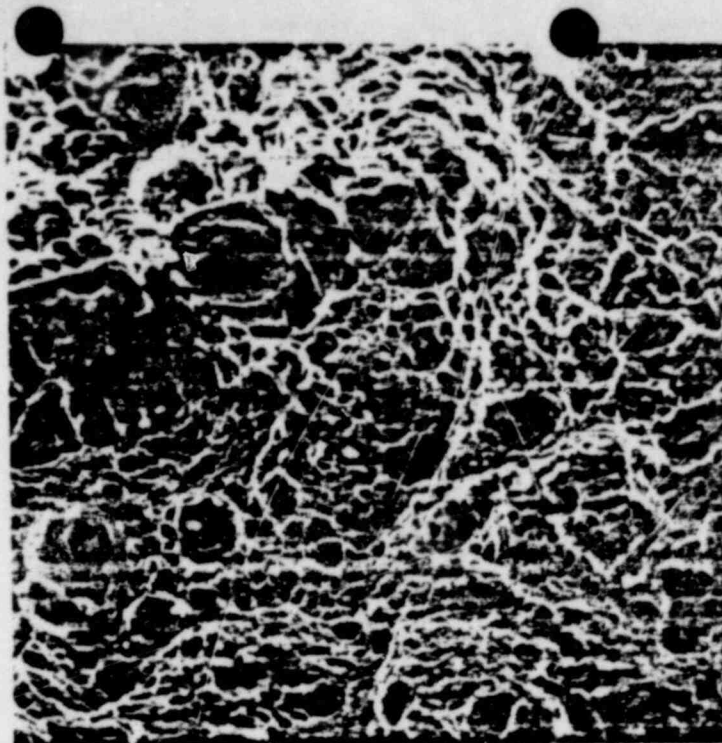
Sample bars were notched and hammer impacted at ambient temperatures to produce examples of high strain rate overload fractures. Fractographic examination showed that the surfaces generated were micro-dimpled (illustrated in

Figures 26 and 27); thus the material appeared relatively tough.

Figure 26. Crack Surface Perpendicular to Shaft Axis 550X

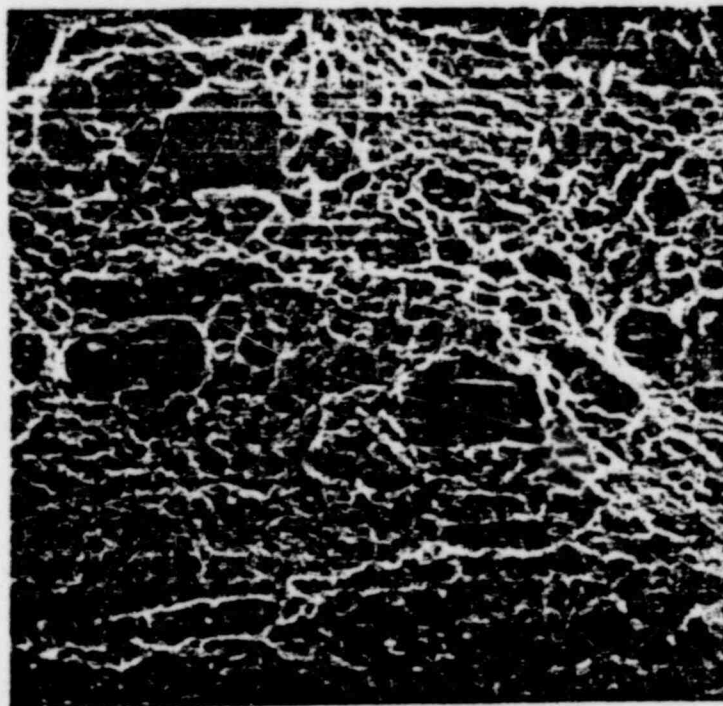
Figure 27. Crack Surface Parellel to Shaft Axis. 550X

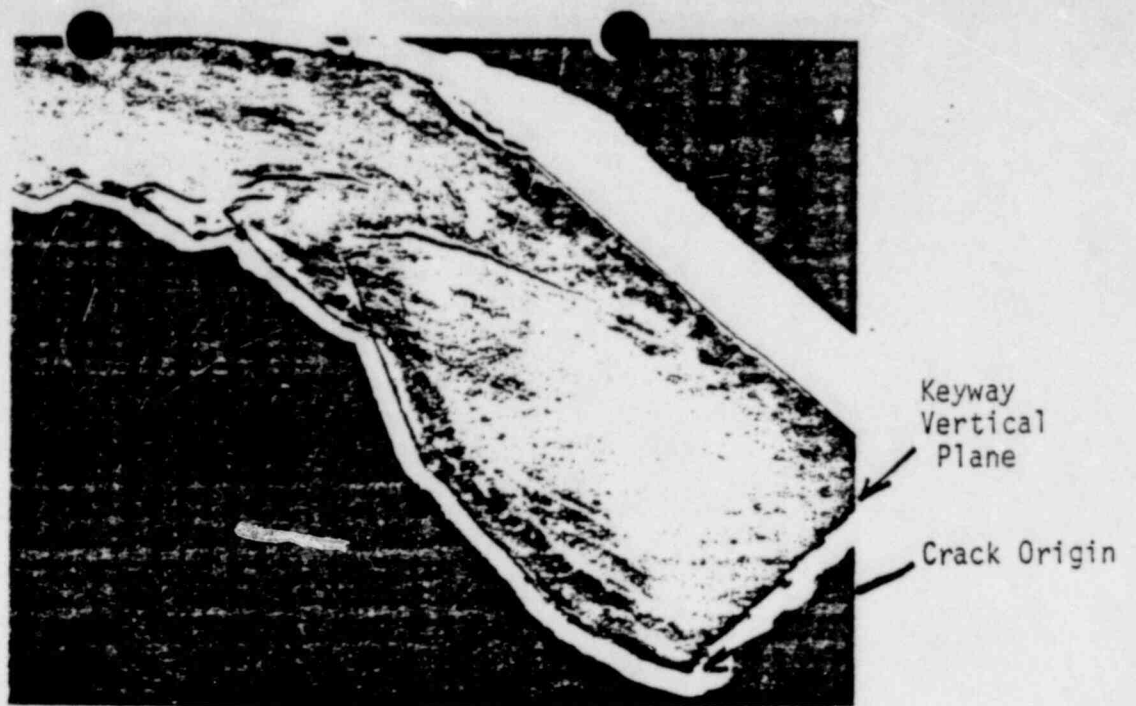
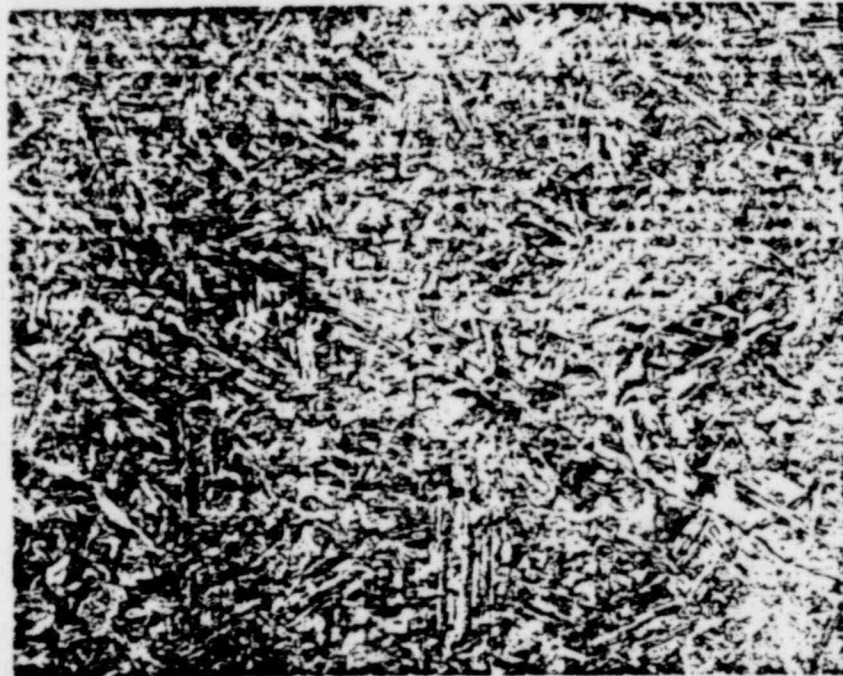
Metallographic analysis showed that crack propagation was essentially transgranular with respect to both prior austenite and martensite grains. The pattern of propagation was observed to be typical of fatigue cracks. These points are illustrated in Figure 28.

Figure 28. Optical Photomicrographs Illustrating Microstructural Crack Profiles
