ADDENDUM 3  
REPORT ON CONTAINMENT BUILDING RING GIRDER  
CONSTRUCTION AND REPAIR

THREE MILE ISLAND NUCLEAR STATION  
UNIT NO. 1

METROPOLITAN EDISON COMPANY

August 23, 1972

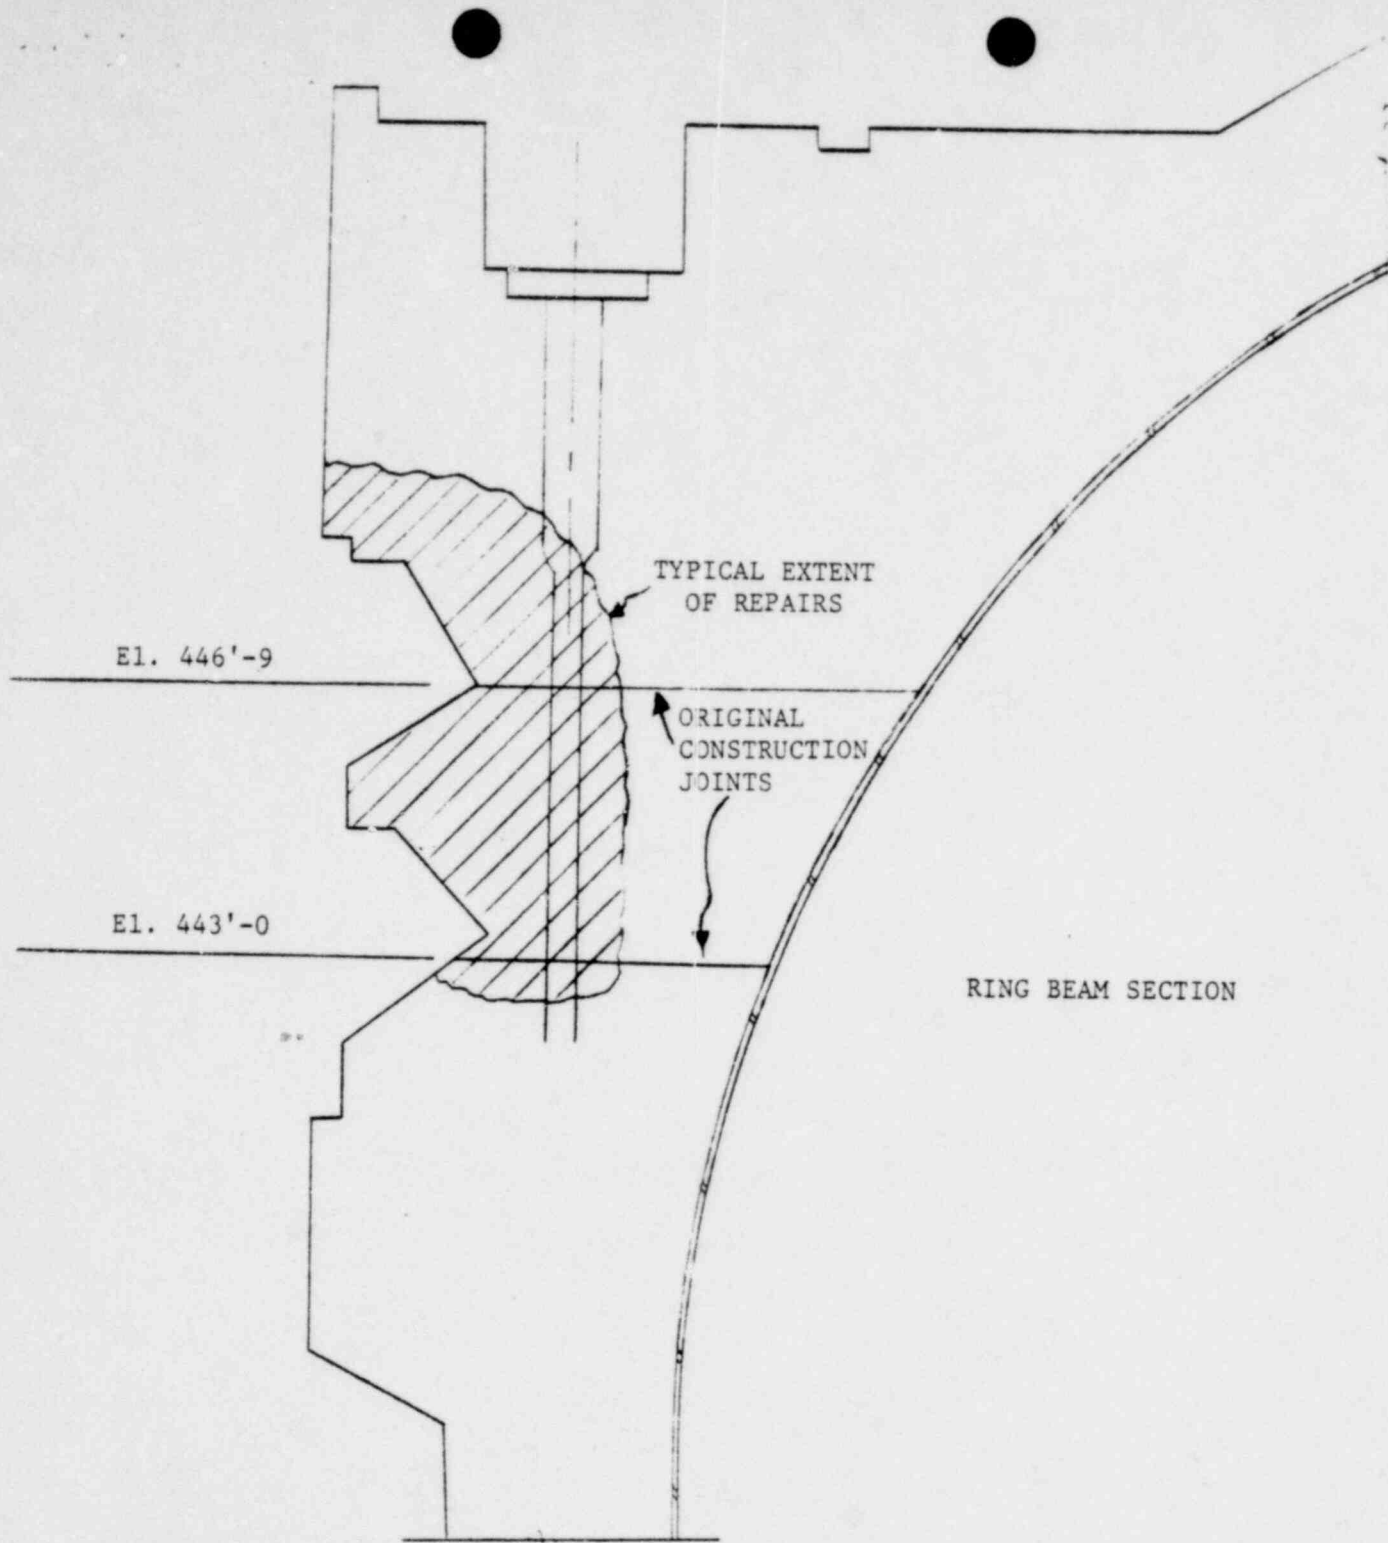
FIGURE 1  
TYPICAL EXTENT OF REPAIRS

The horizontal ring girder construction joint condition at elevations 443 ft-0 in. and 446 ft-9 in. has changed substantially from that investigated in Addendum 2 to the Ring Girder Report. Concrete excavation into the ring girder has extended up to and behind the vertical tendon conduits for more than fifty percent of the South 180°. Figure 1 indicates the extent of concrete removal for the South 180°. Construction joints for the replacement concrete will be located at different elevations than the original joints. In addition all joints will be carefully prepared ensuring complete aggregate interlock at the joints. The shear study on the construction joints presented in Addendum 2 was based on assumptions that are no longer valid; namely, the construction joints at elevation 443 ft-0 in. and 446 ft-9 in., extending horizontally across the full thickness of the ring girder, utilize only friction for transferring shear. The repair will provide complete aggregate interlock at the new construction joints, located at different elevations than the original construction joints.
