ADDENDUM 4

REPORT ON CONTAINMENT BUILDING RING GIRDER  
CONSTRUCTION AND REPAIR

THREE MILE ISLAND NUCLEAR STATION

METROPOLITAN EDISON COMPANY

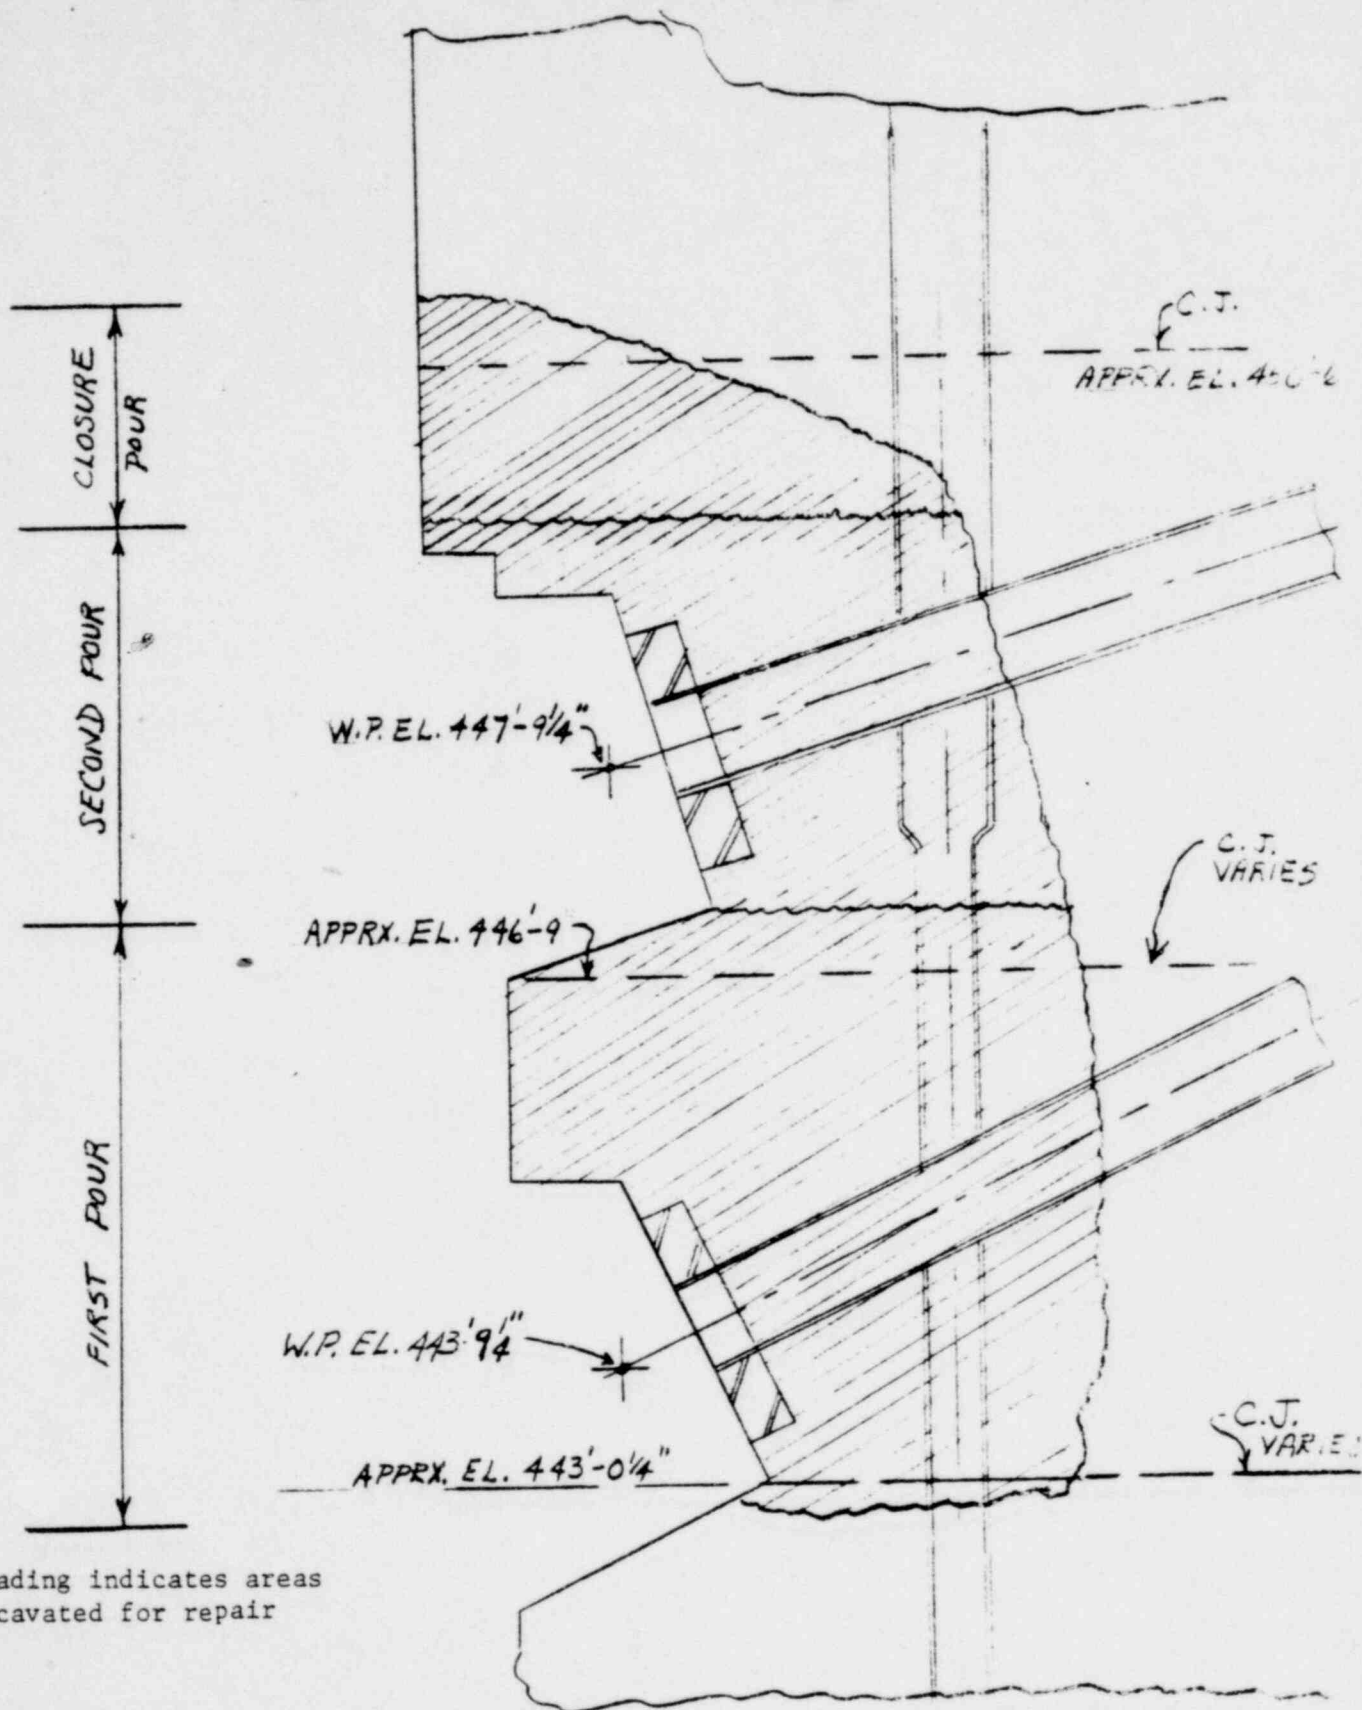
The horizontal ring girder construction joints at elevations 443 ft-0 in. and 446 ft-9 in. have been investigated for transfer of shear under load combinations including normal operation, initial prestress, accident, pressure test, seismic, wind, and aircraft impact. As originally constructed, the joints at these elevations extended horizontally across the entire ring girder section. Visual examination and core-borings as documented in Addendum 2 indicated that part of the joint extending in from the outside face of the ring beam was questionable for load transfer. The questionable areas of the joint have been completely excavated as shown in Figures 1, 2, and 3.

FIGURE 1 Part Section through ring beam showing sequence of repair pours for double dome tendon area

Note: Shading indicates areas excavated for repair

Visual and core-bore examinations confirm that the remainder of these horizontal joints left as originally placed is sound. The construction joints required for the replacement of concrete in the excavated areas (see Figures 1, 2, and 3), will be carefully prepared by green-cutting and other suitable methods to ensure that a sound construction exists prior to concrete placement. The repaired ring beam will perform its structural function as part of the reactor containment building as intended in the original design.

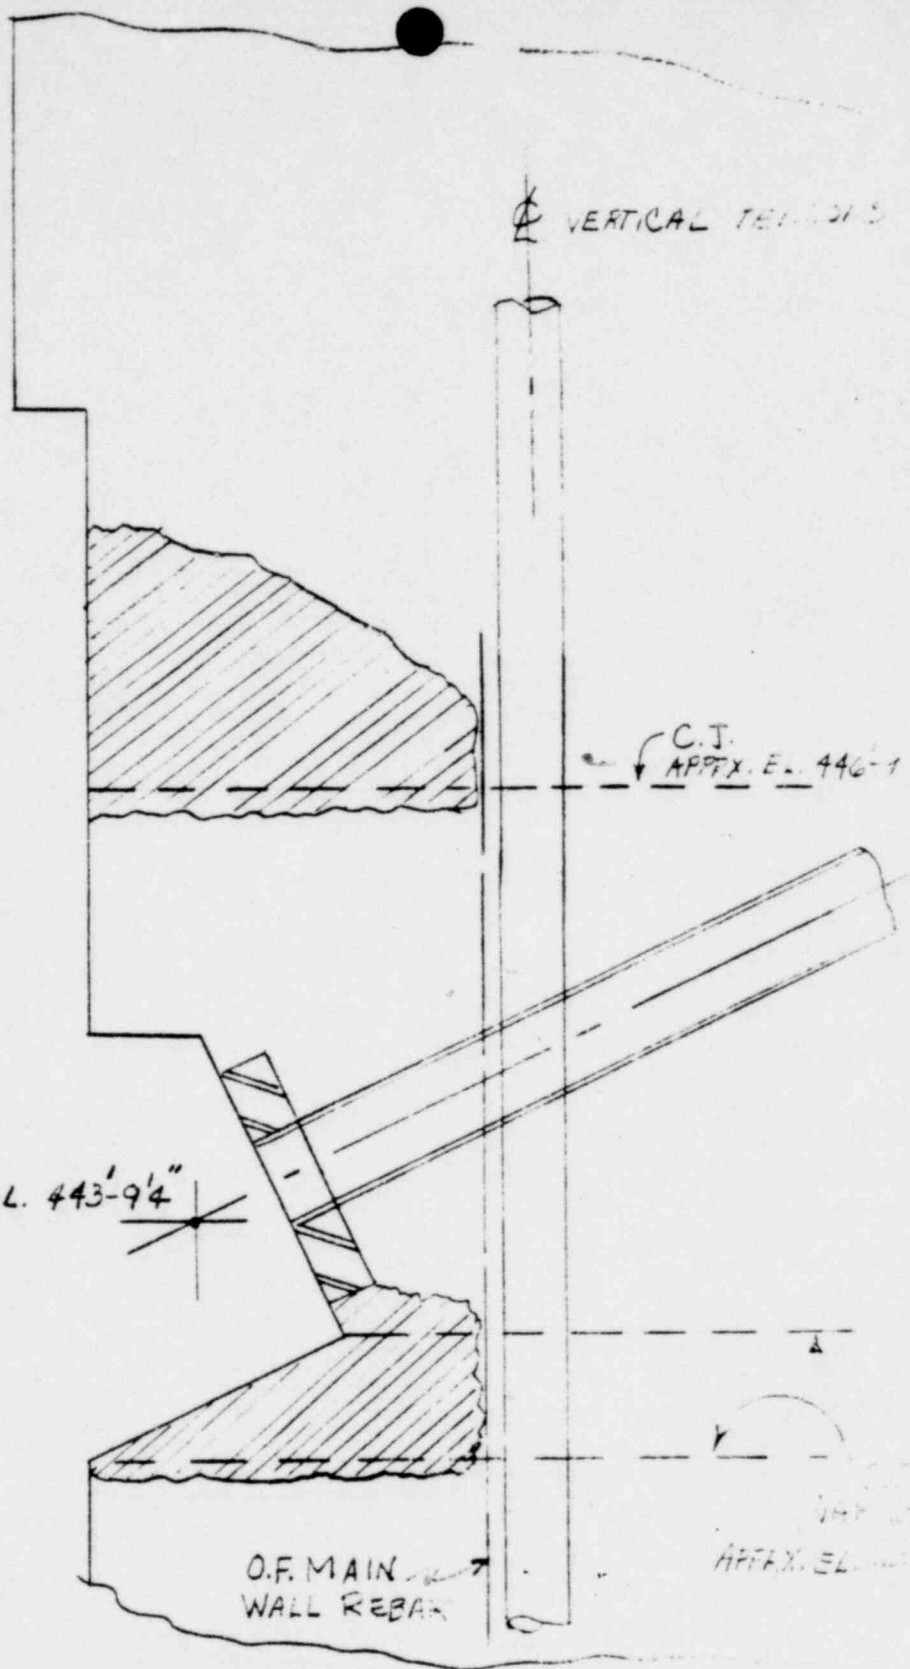
FIGURE 2 Part Section through ring beam showing typical repair pours for single lower dome tendon areas

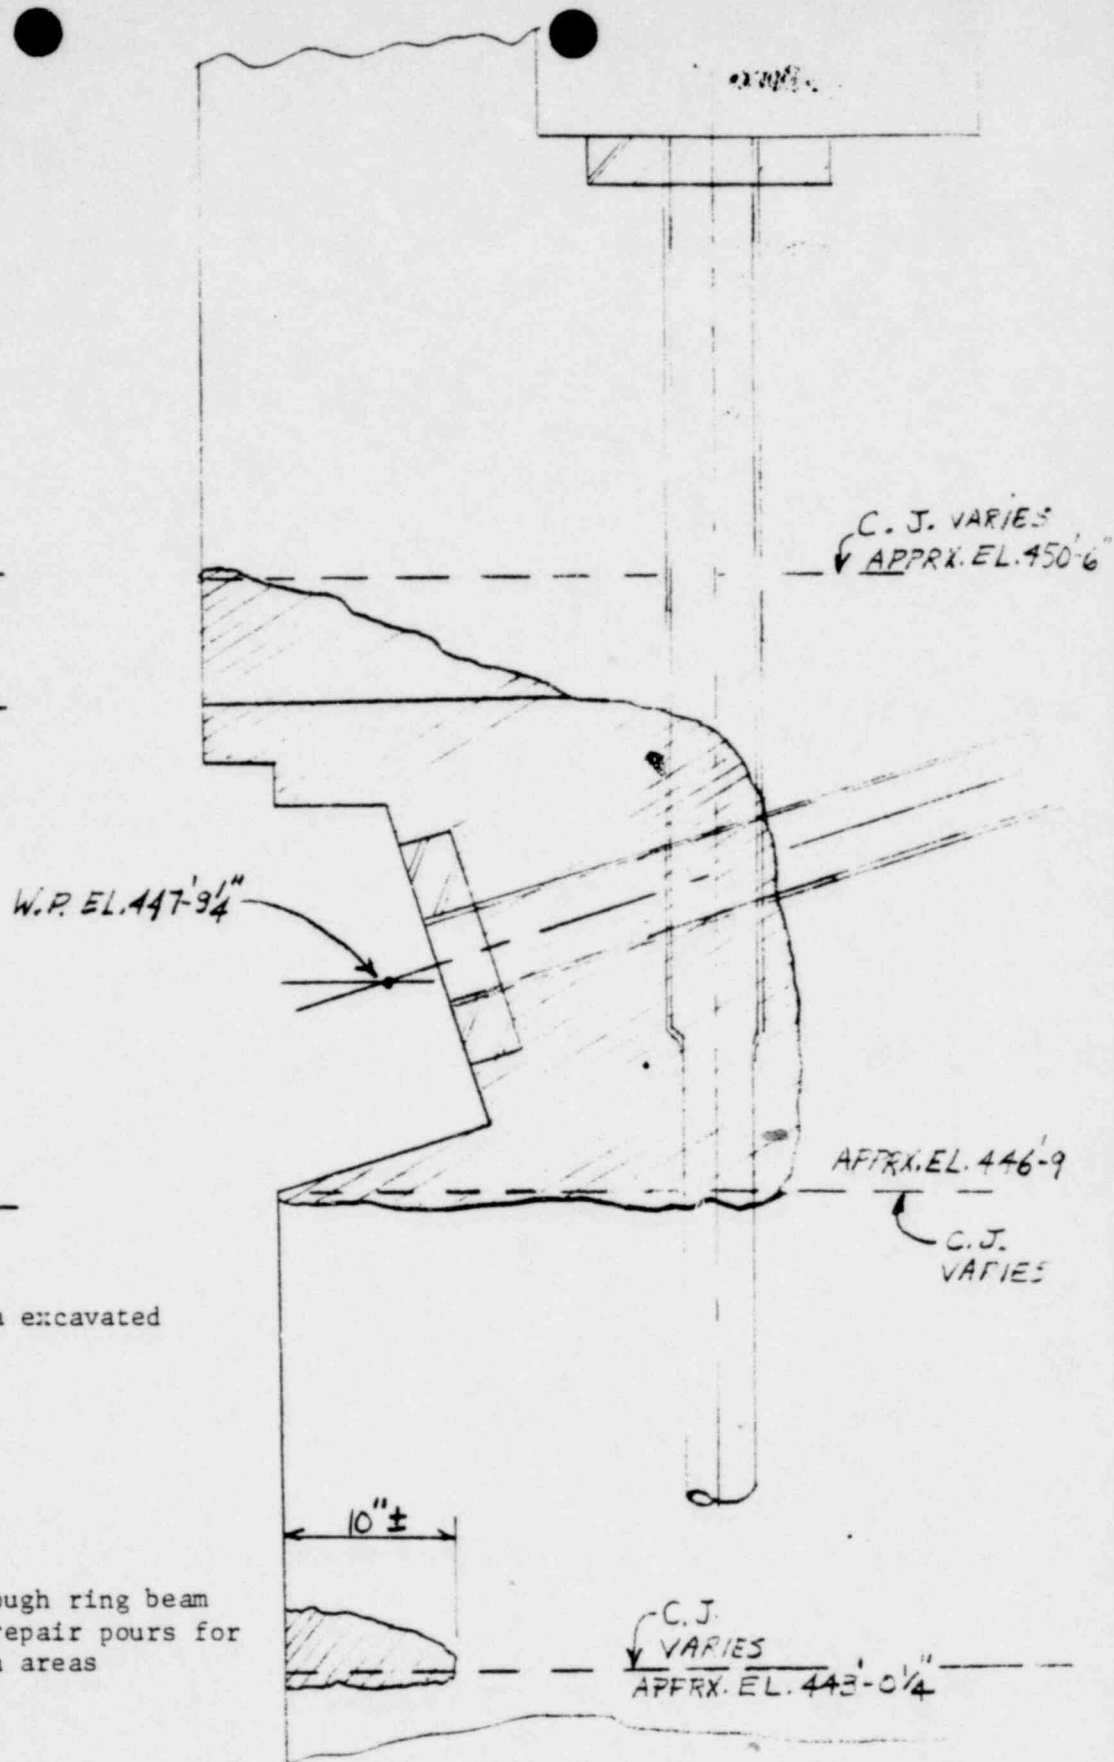
Note: Shading indicates area excavated for repair

FIGURE 3 Part Section through ring beam showing typical repair pours for upper dome tendon areas

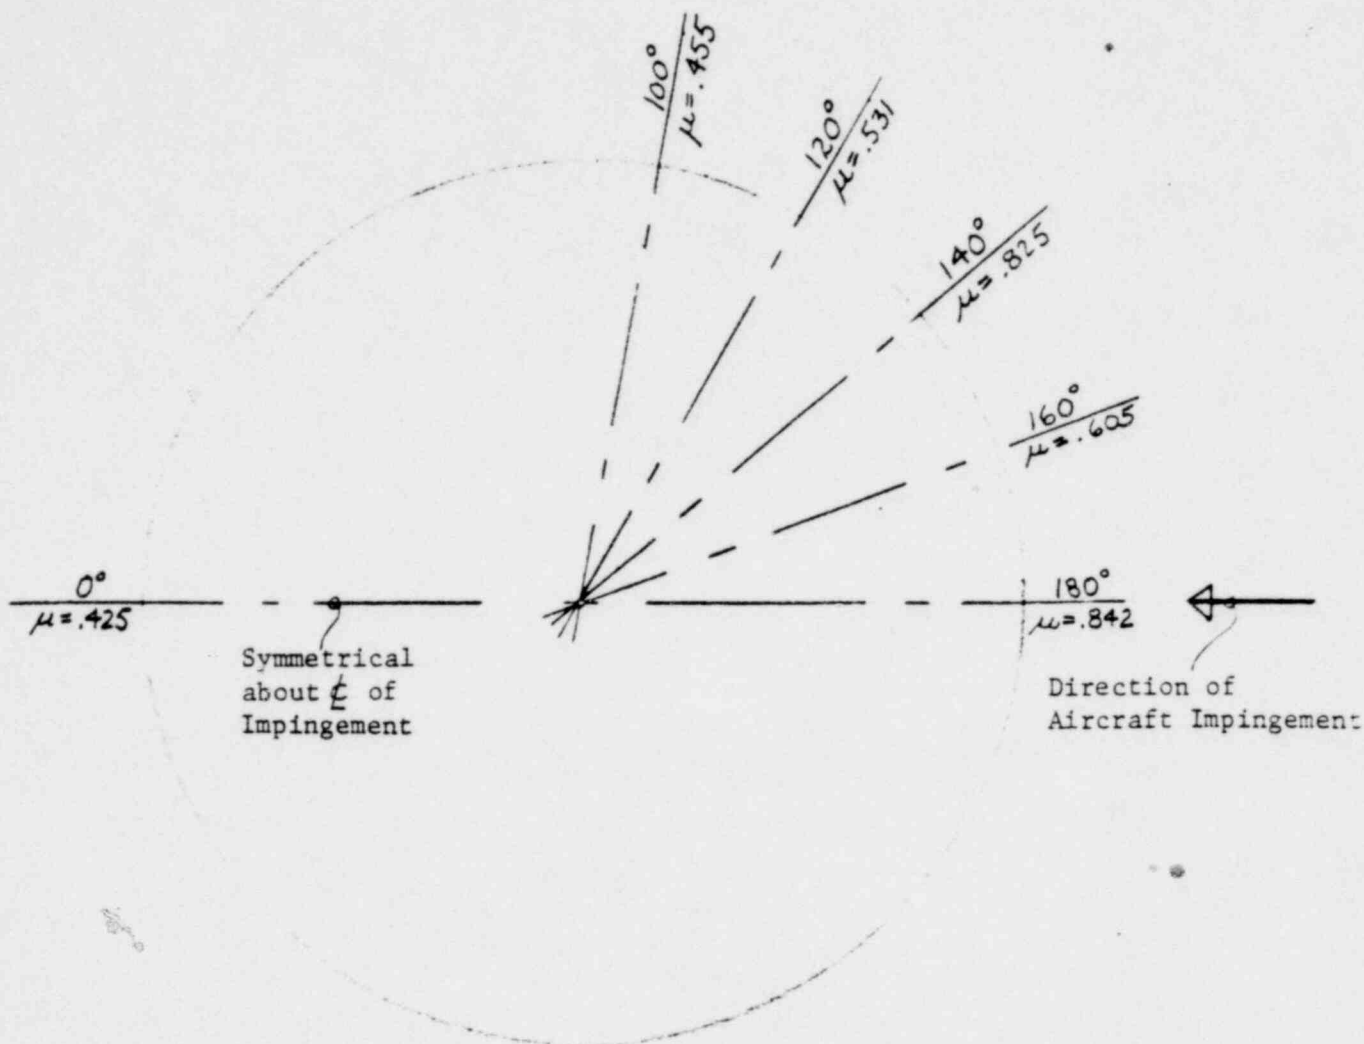
PLAN  
REACTOR BUILDING  
EL. 443'-0

Addendum 3 should be clarified to reflect that the effect of Aircraft Impact Loading on the entire ring beam is generally small for the majority of the ring beam. Figures 4 and 5 indicate the required coefficients of friction to transfer shear at elevations 443 ft-0 in. and 446 ft-9 in. due to Normal Operation plus Aircraft Impact. The coefficients are conservatively derived using the greater of the in-plane shear or radial shear along with the normal force in the conventional friction equation  $F=\mu N$ .

From Figures 4 and 5 the required coefficients of friction are seen to be less than or equal to the allowable value of one. For the majority of the ring beam, the minimum factor of safety is still two under this load. However, for part of the ring beam where the required coefficient of friction is greater than 0.7 (the ultimate coefficient of friction 1.4 divided by a factor of safety 2 is equal to 0.7), the minimum factor of safety will be less than 2.

FIGURE 4 Coefficients of friction  $\mu$  at various azimuths required to transfer shear at elevation 443'-0" due to normal operation plus Aircraft Impingement.

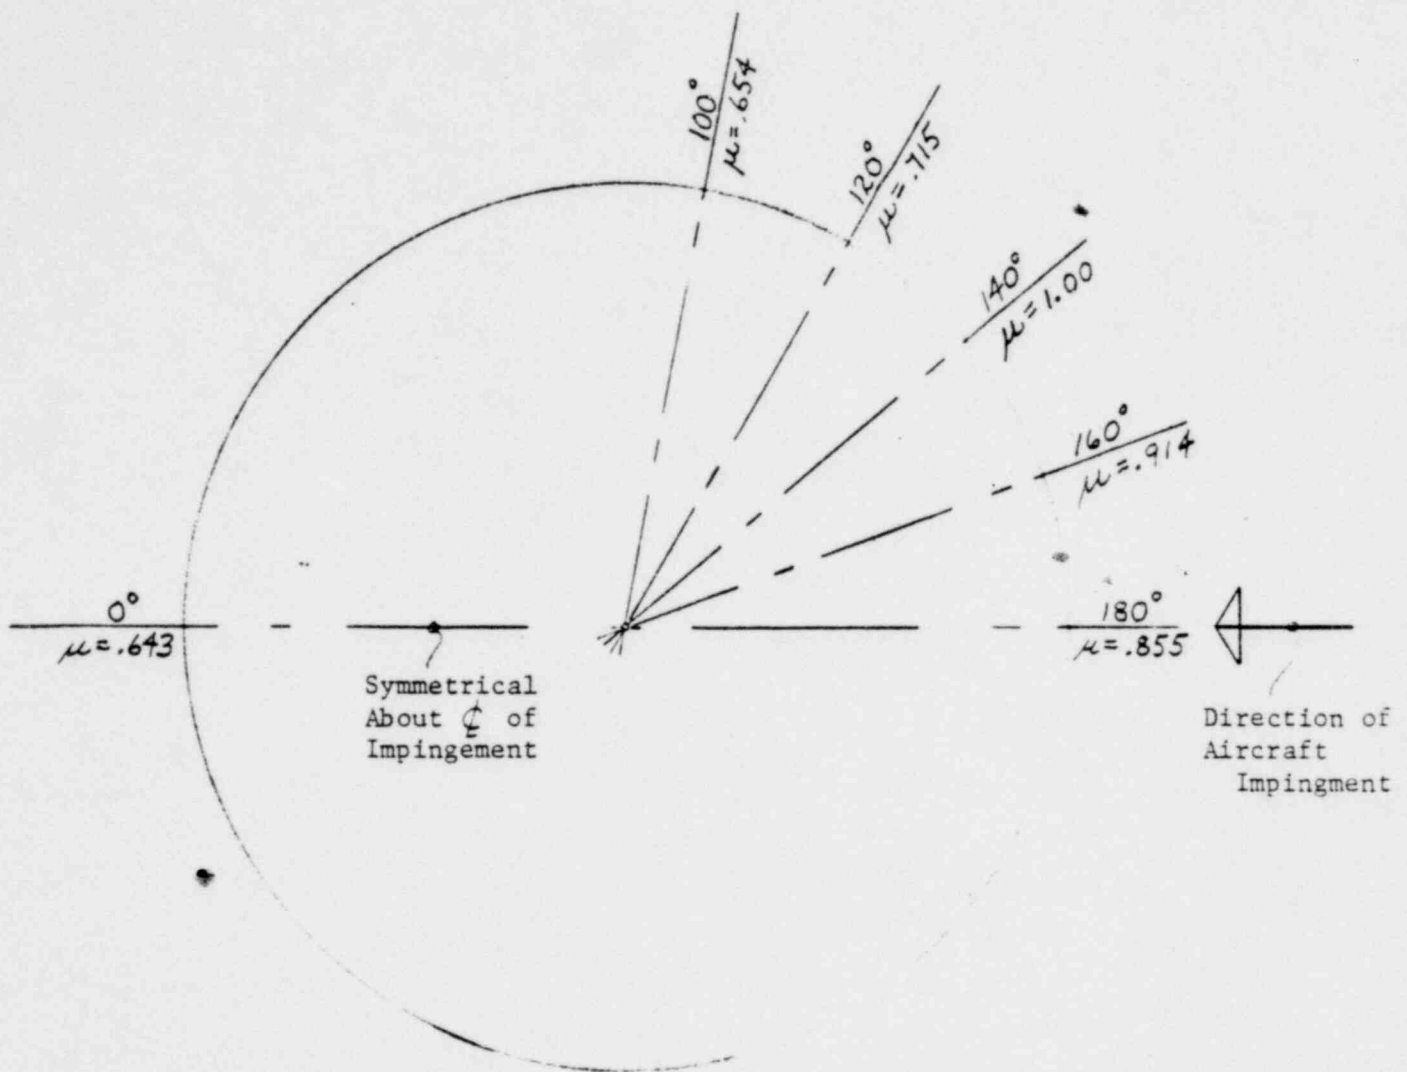
PLAN  
REACTOR BUILDING  
EL. 446'-9"

The lowest factor of safety will be 1.4 in the area around 140° shown on Figure 5. At that location the required coefficient of friction is  $\mu=1.00$ . A factor of safety of 1.4 is derived by dividing the assumed ultimate coefficient of friction 1.4 by the required value of  $\mu=1.00$ . Since it has been conservatively assumed that the shear is carried across the joint only by friction under a normal compressive stress, a minimum factor of safety of 1.4 for a limited portion of the ring beam is considered adequate under the Aircraft Impact Loading.

FIGURE 5 Coefficients of friction  $\mu$ , at various azimuths required to transfer shear at elevation 446'-9" due to normal operation plus Aircraft Impingement.
