**Public Service Company of Colorado**

November 7, 1979  
Fort St. Vrain  
Unit No. 1  
P-79266

REPORTABLE OCCURRENCE 79-45

REPORT NO. 50-267/79-45/03-L-0

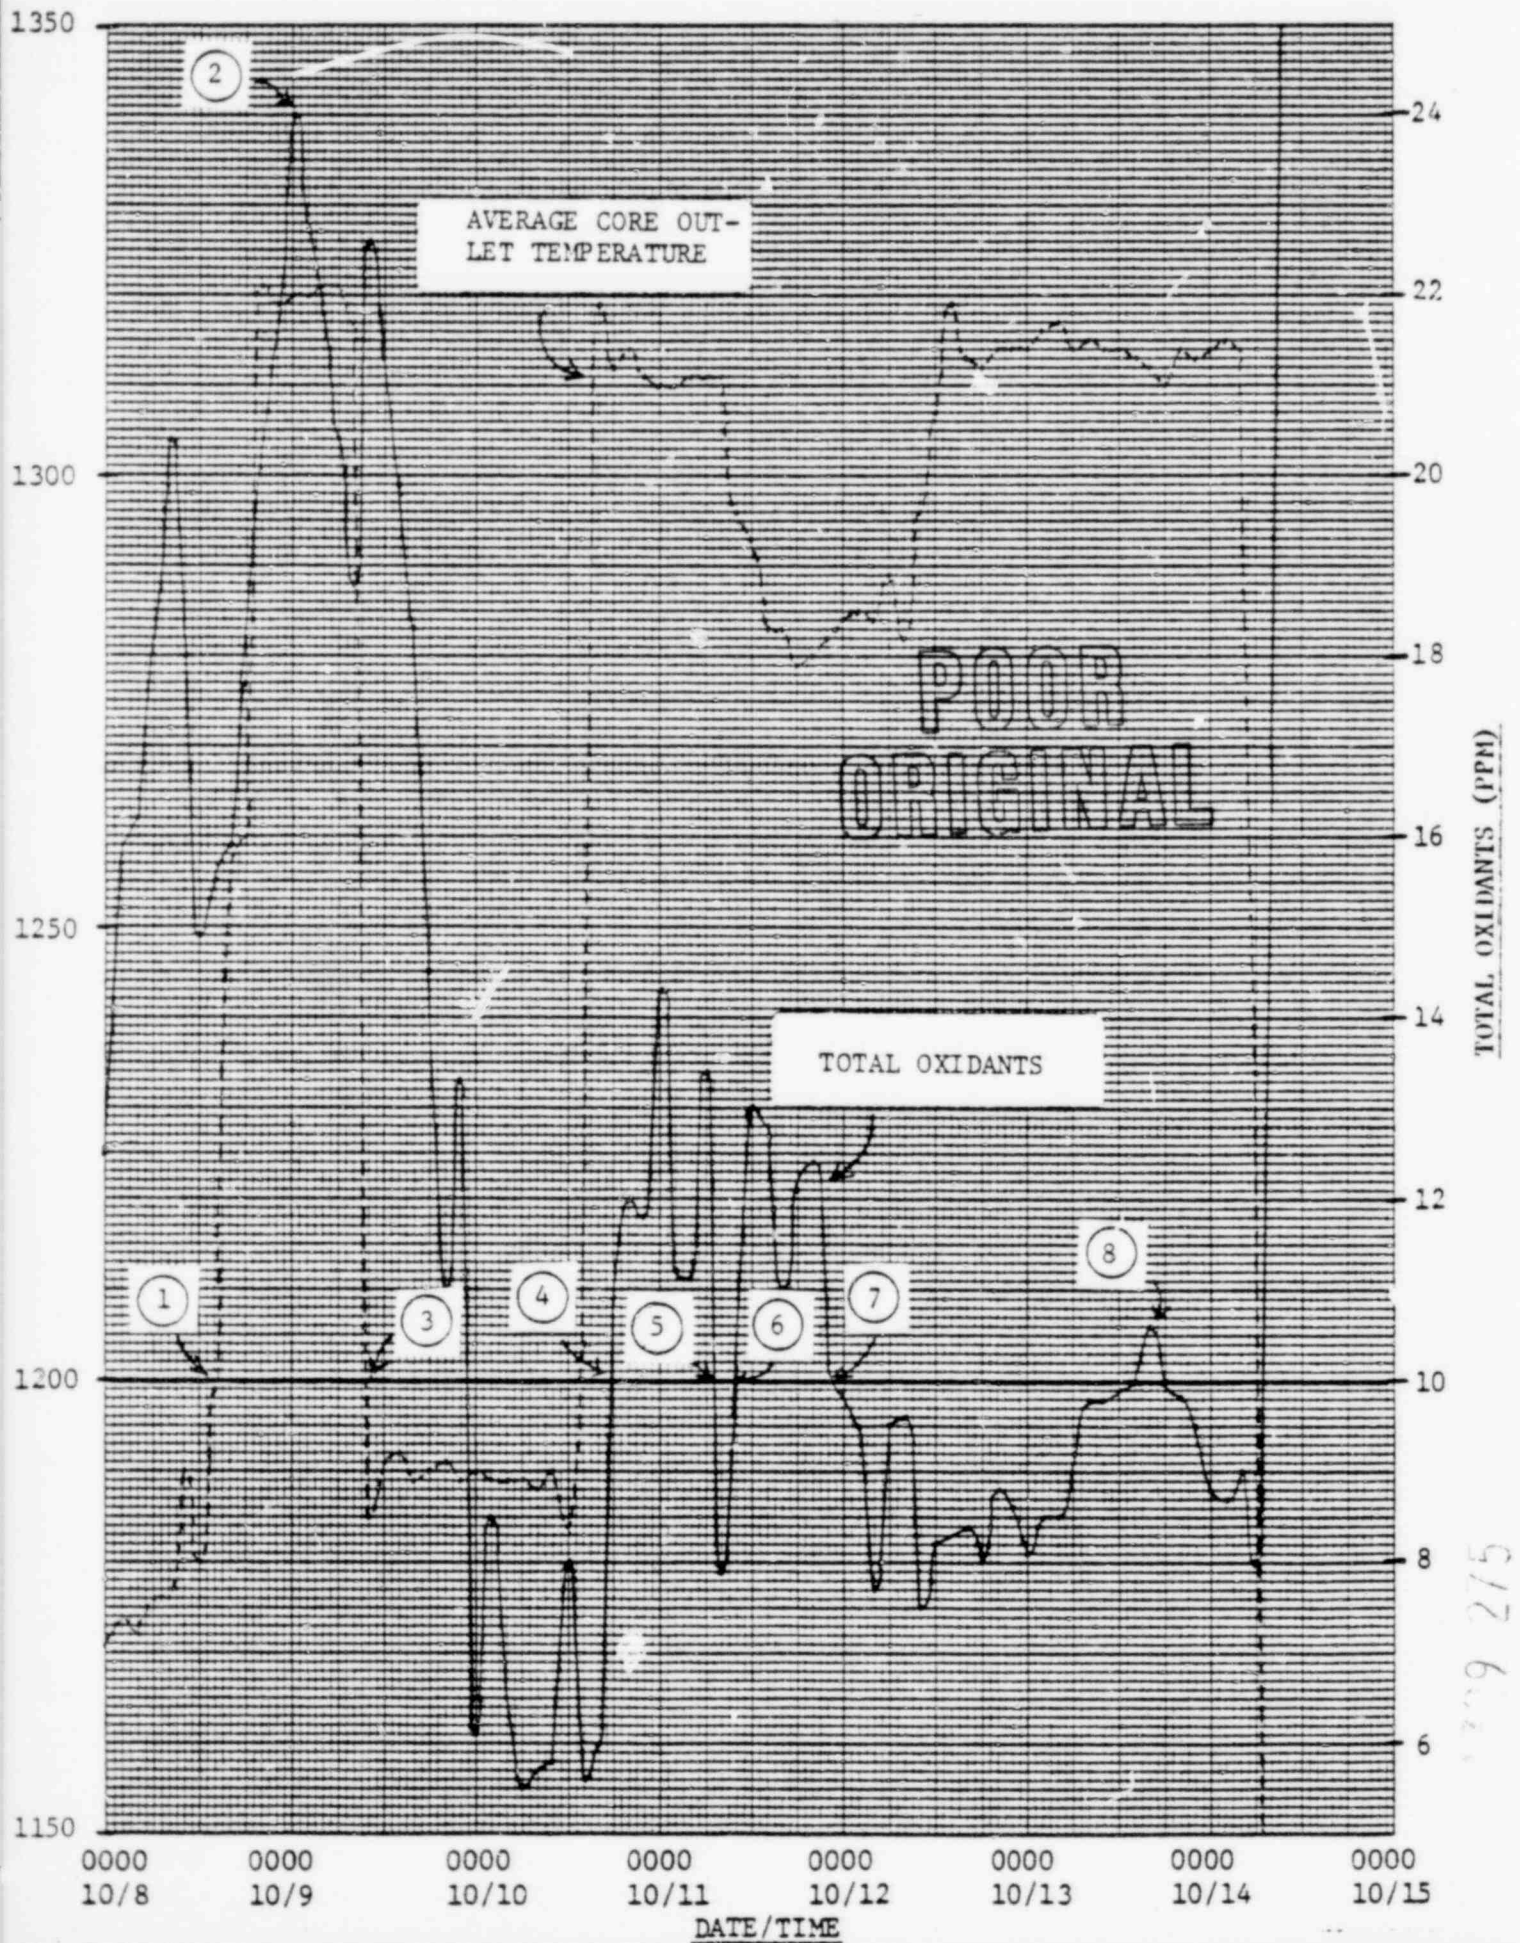
FIGURE 1

1. At approximately 1430 hours on October 8, 1979, average core outlet temperature exceeded 1,200°F for the first time since return to power on September 15, 1979. Reference Figure 1, point (1). At that time, the total primary coolant oxidant level was approximately 15.7 ppm. As reactor power and core outlet temperature were increased to facilitate moisture removal, primary coolant oxidant levels increased as moisture was allowed to outgas from the graphite in the core. A maximum primary coolant oxidant level of 24.0 ppm was reached at 0000 hours on October 9, 1979, with corresponding core outlet temperature of 1,320°F (reference Figure 1, point (2)). Total oxidant levels began a decreasing trend, with average core outlet temperature holding steady.

At 0800 hours on October 9, 1979, it was decided to decrease reactor power to hold average core outlet temperature below 1,200°F until oxidant levels reached a value less than 10 ppm (reference Figure 1, point (3)).

2. Because total oxidants had been less than 10 ppm since approximately 2300 hours October 9, 1979, reactor power was increased at 1340 hours on October 10, 1979. By 1400 hours, average core outlet temperature was greater than 1,200°F. As core outlet temperature was increased, the small amount of moisture remaining in the core was allowed to react with the graphite, resulting in increased primary coolant oxidant levels. At approximately 1700 hours on October 10, 1979, the plant again entered operation under a degraded mode of LCO 4.2.10 (reference Figure 1, point (4)). Following an initial increase due to the rise in core outlet temperature, oxidant levels decreased to less than 10 ppm at 0700 hours on October 11, 1979 (reference Figure 1, point (5)).

3. A small increase in moisture resulted in total primary coolant oxidants again exceeding 10 ppm at 1000 hours on October 11, 1979, (reference Figure 1, point (6)).

After degraded mode operation of approximately 12 hours, sufficient moisture cleanup occurred that total primary coolant oxidants dropped below 10 ppm (reference Figure 1, point (7)).
4. Total primary coolant oxidants remained at less than 10 ppm until 1400 hours on October 13, 1979. Beginning at 0000 hours on October 13, 1979, carbon monoxide began increasing, and this eventually brought the total of primary coolant oxidants to greater than 10 ppm. Following a short period of degraded mode operation (reference Figure 1, point (8)), total oxidants dropped below 10 ppm and no further degraded mode operation was observed.

AVERAGE CORE OUTLET TEMPERATURE VERSUS PRIMARY COOLANT OXIDANTS
