- INTERIM REPORT -

SAFETY INJECTION SYSTEM PIPING DEFICIENCY  
November 21, 1979

SOUTH TEXAS PROJECT  
UNITS 1 & 2

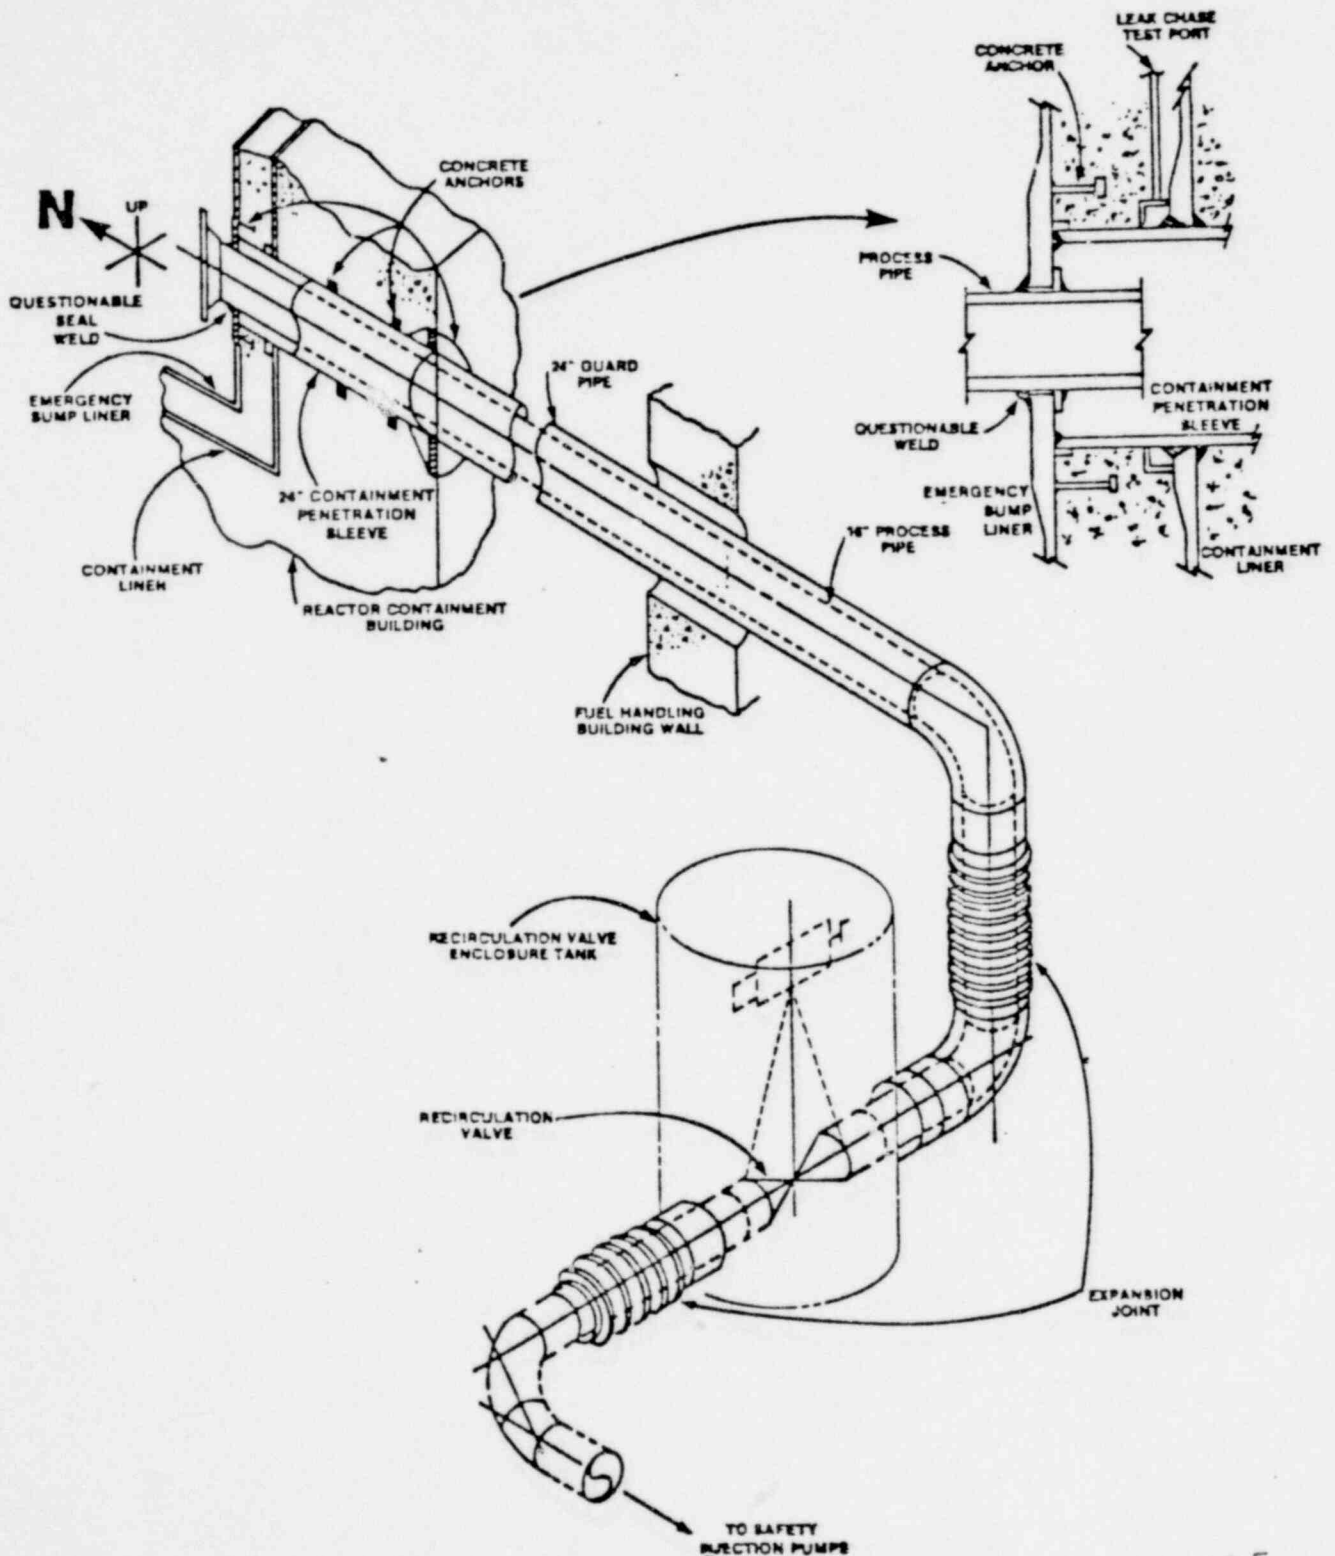
FIGURE 1 PIPING LAYOUT

During a routine review, a design deficiency was discovered which, if left uncorrected, could have adversely affected the safety of operations. The joint between the 16 inch Safety Injection System piping and the emergency sump liner was shown on the construction drawing to be a one-quarter inch seal weld, which does not meet the design load criteria. The location of this weld is shown in Figure 1.

The piping is part of the SIS and CSS and leads from the containment emergency sump through the containment sump isolation valve to the safety injection and containment spray pumps. Following a LOCA, water will automatically be recirculated from the emergency sumps to the reactor by the Safety Injection System. Operation of the containment emergency sump isolation valve is required for recirculation mode operations. The seal weld in question attaches the process pipe to the sump liner. Sketches of this configuration are given in Figures 1 and 2.

If this deficiency were to have been left uncorrected, the weld at the sump liner/process pipe interface could fail. The process pipe would then be free of restraint and would impose a load on the recirculation valve which exceeds the allowable end loads. It could not then be guaranteed that the valve would operate as required. Because this problem affects all three trains, this is a common mode failure which could cause loss of safety system functions.
