Public Service Company ^{of} Colorado

November 26, 1979
Fort St. Vrain
Unit No. 1
P-79280

REPORTABLE OCCURRENCE 79-55

REPORT NO. 50-267/79-55/03-L-0

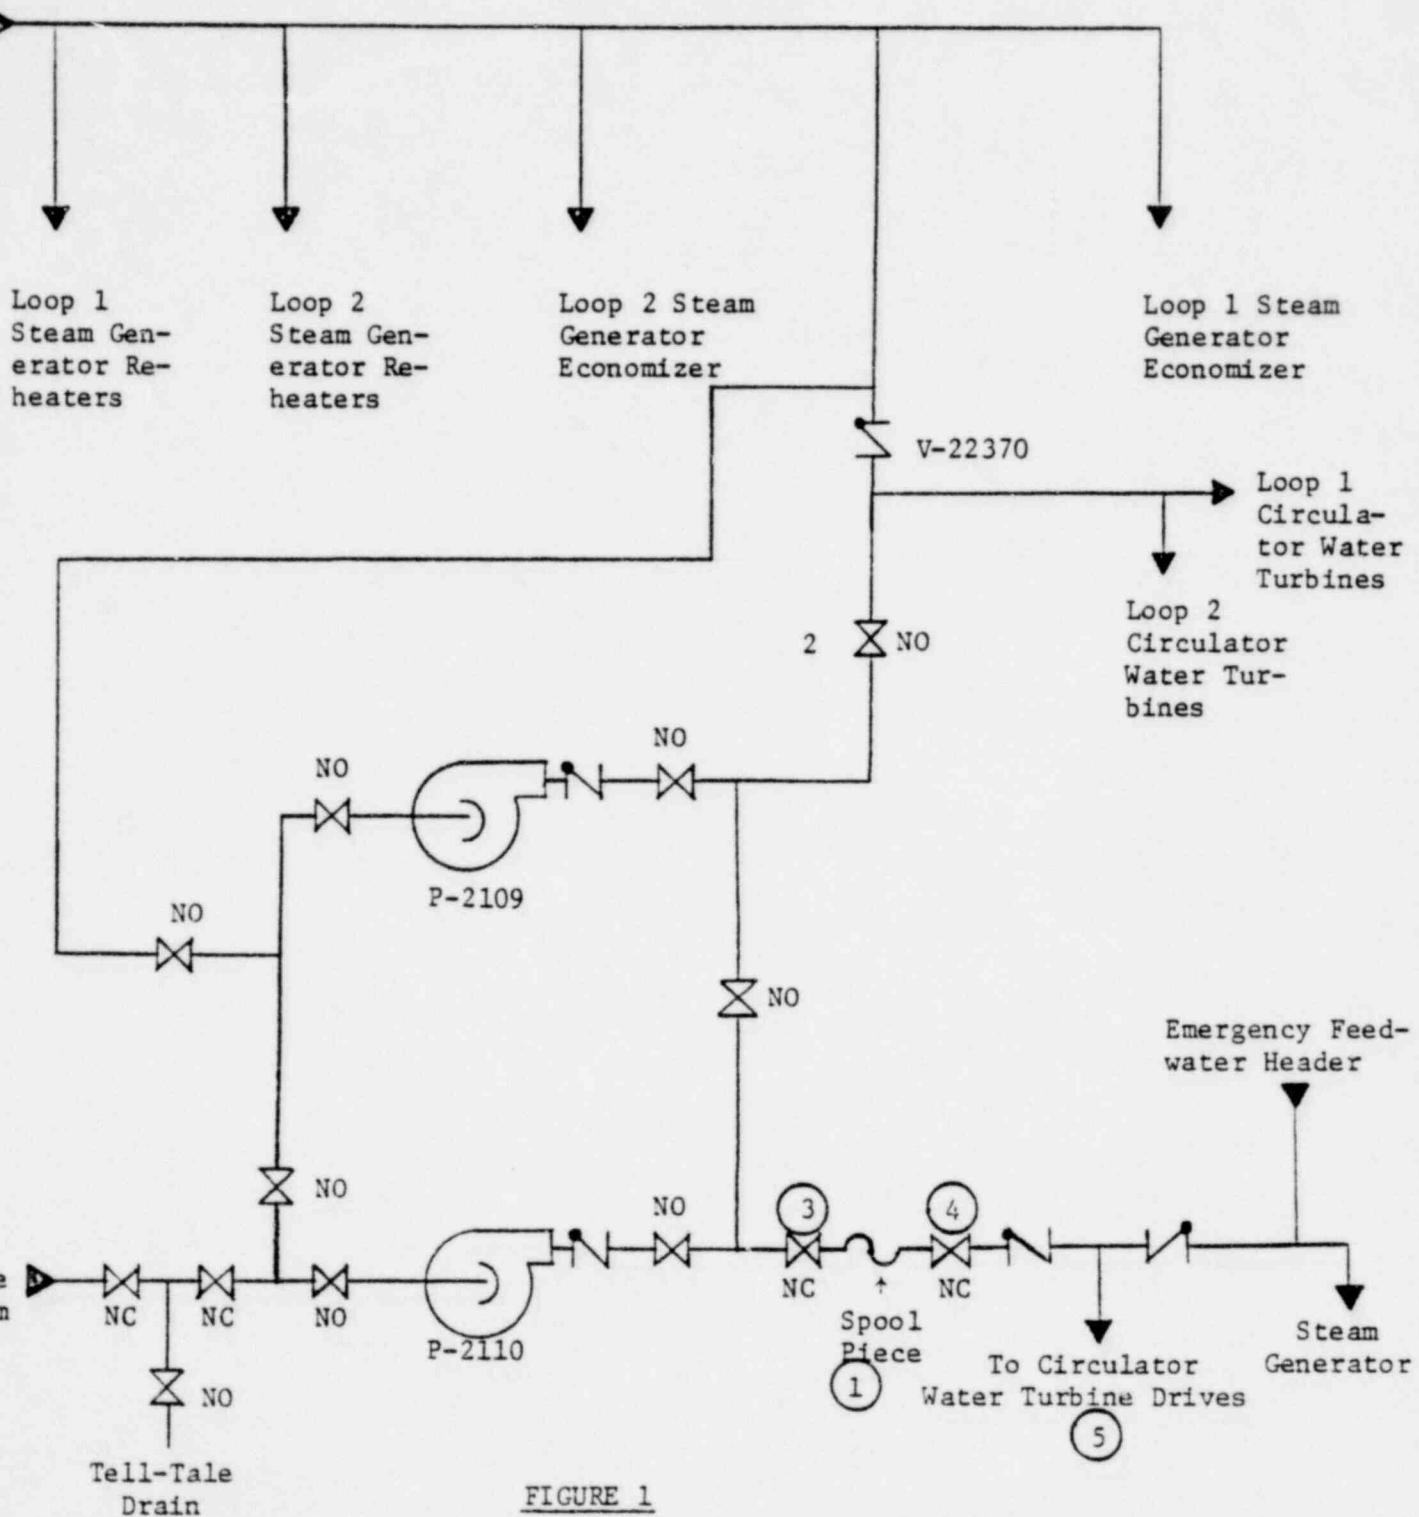
FIGURE 1

The cause of this event was the failure of V-22370 to close when required to do so. Failure of the valve to close in turn rendered both fire water booster pumps inoperable for circulator drive using the emergency condensate supply line. Refer to Figure 1. By installation of the spool piece, (1), closing the NO valve, (2), and opening NC valves (3) and (4), the booster pumps could have been used to supply the circulator water turbine drains via the emergency feedwater header, (5).

EMERGENCY CONDENSATE HEADER AND FIREWATER BOOSTER PUMPS

The immediate corrective action was to free the disc by rapping the valve body sharply.

The valve will be opened and inspected as soon as plant conditions permit. The results of this inspection will be reported in a supplement to this report as soon as they are known.
