November 28, 1979
Fort St. Vrain
Unit No. 1
P-79282

REPORTABLE OCCURRENCE 79-54

REPORT NO. 50-267/79-54/03-L-0

Standby diesel engine 1B tripped on high cooling water temperature during surveillance test because cooling water valves were lined up incorrectly.

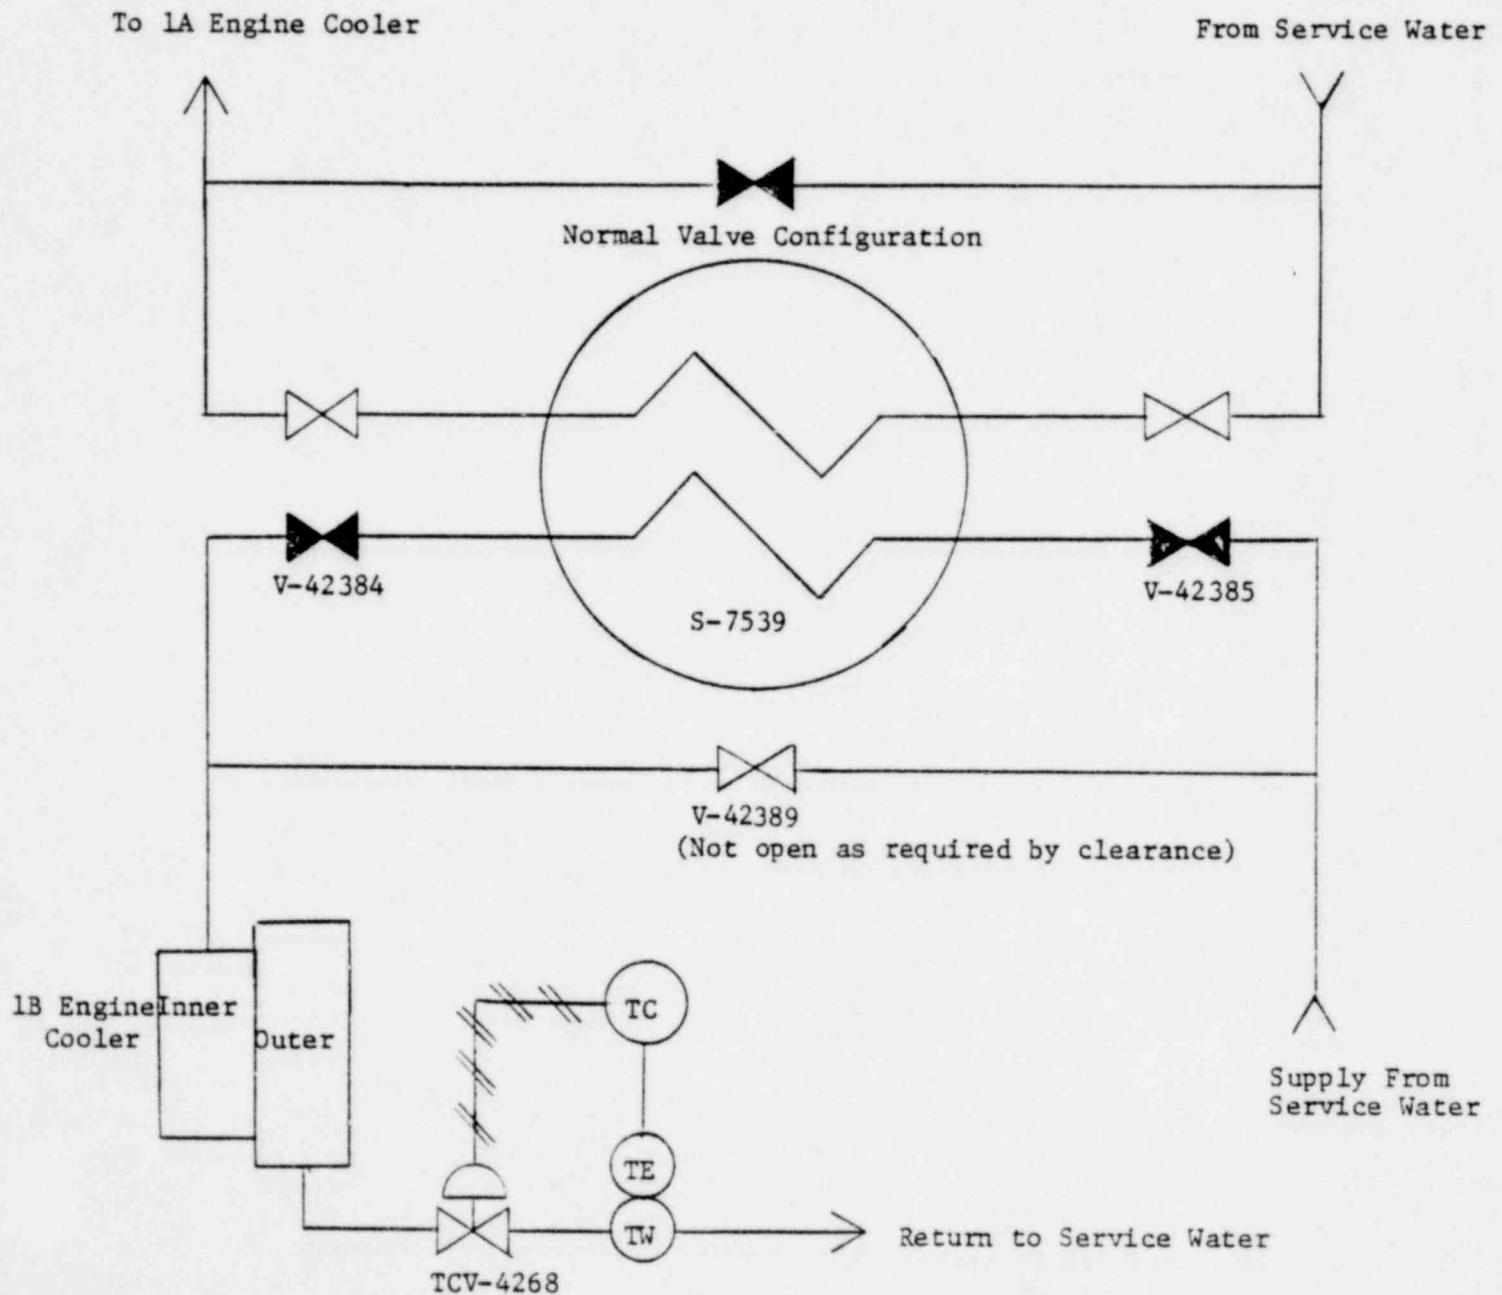
FIGURE 1

On October 24, 1979, while operating at 26% thermal power and 50 MW electrical power, a mechanical clearance was issued at 0845 hours to repair a cooling water tube leak on the standby diesel engine 1B cooler, S-7539. See Figure 1. The cooler, S-7539, has two cooling coils, one for the 1A engine and one for the 1B engine. The standard clearance point form specified that the inlet valve, V-42385, and the outlet valve, V-42384, both be shut and the bypass valve, V-42389 be opened. This isolated the cooler for repair of the leaking tube but still should have allowed the normal temperature control of the 1B diesel engine cooler via TCV-4268 if the diesel generator unit had been required.

However, the bypass valve, V-42389 was not open as specified, thus the cooling water to the 1B diesel engine was isolated.

At 1000 hours, the 1B diesel engine automatically tripped on high cooling water temperature of 500°F and declutched the engine.

An incorrect valve lineup caused the 1B diesel engine to trip on high cooling water temperature.

Cooling water was restored to the 1B diesel engine cooler.

Personnel involved have been reinstructed in the proper methods to be used for clearing out equipment.
