Re: St. Lucie Unit 2  
Docket No. 50-389  
Inservice Inspection Plan  
Forth Ten-Year Interval Unit 2 Relief Request 16

**Proposed Relief Request RR-16**  
**In Accordance with 10 CFR 50.55a(z)(2)**

ASME Code Class:	Code Class 2
Reference:	ASME XI, IWC-2500
Examination Category:	Table IWC-2500-1, Category C-H
Item Number:	C7.10
Description:	St. Lucie Unit 2 (PSL2) 2B boric acid make-up pump (BAMP). (2998-2229 R2 & 2998-2410 R5)
Component:	The BAM PP 2B boric acid makeup pump casing is a casting of type 316 austenitic stainless steel per ASME SA351 CF8M.
Temperature:	Design - 250F (CE Spec 13172-PE-404, R1) Operating - 120F (Discharge)/120F (Suction)
Pressure:	Design - 150psig (CE Spec 13172-PE-404, R1) Operating - Approx. 130psig (Discharge)/0-9psig (Suction)

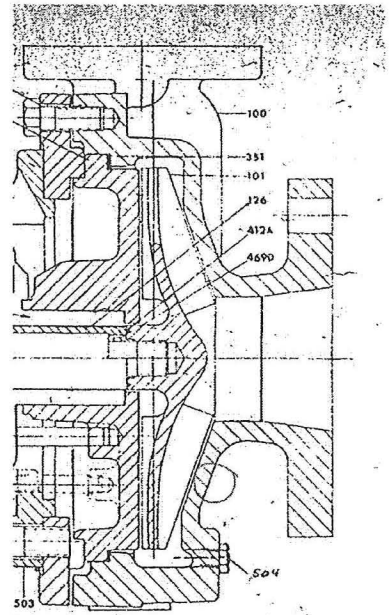
On August 6, 2019, a boric acid follow-up walkdown was performed and dry boric acid residue was found at a previously identified and programmatically tracked location on the Unit 2 2B boric acid makeup pump casing. A dye penetrant (PT) exam was performed with inconclusive results. No indications were identified, however, water weepage was observed through the developer in the area of the residue. To further investigate, the pump was run for one hour. Following the run, a 1/32" diameter deposit of boric acid was visually identified in the same area. The pump was declared inoperable due to evidence of through wall leakage.

Visual examination at 10X magnification characterized the area with the deposit as a roughly 1/32" rounded indication with no branching or crack-like characteristics.

- A dye penetrant (PT) examination was performed on the affected area of the pump casing. As described in Section 4, this examination was inconclusive.
- Leakage was confirmed visually following a pump run, and the location was visually examined with 10X magnification. The flaw was determined to be a rounded indication approximately 1/32" in diameter, with no crack-like characteristics.

Based on the results of the above inspections, the pressure boundary leakage is likely due to small casting void defects or porosity that enabled a through-wall pathway for leakage. This characterization is also supported by the repair attempt on the 2A pump casing, as the flaw was observed to have characteristics of porosity during excavation. Alternate explanations have been considered, but determined to be unlikely, as discussed below.

The figure at the right shows the configuration of the BAMP and the general location of the flaw. The boric acid makeup pump has been in service since initial plant operation. The pump casing is made from cast type 316 austenitic stainless steel per specification ASTM A351-CF8M. Type 316 stainless steel has excellent general corrosion resistance to the boric acid solution that is the process fluid for this pump. Based on testing done for Electric Power Research Institute (Reference 8.2), the general corrosion rate in the process fluid is too small to measure. The other internal parts of the pump are made from cast or wrought type 316 stainless steel. Type 316 stainless steel, either cast or wrought, is not susceptible to pitting or stress corrosion cracking in this environment. The cast version of type 316 stainless steel is not susceptible to thermal aging at the low temperature at which this pump operates. Additionally, mechanical loads due to normal operation, include pump vibration, are low and would not be anticipated to result in service induced flaw growth. With these considerations, it is concluded that there are no active aging degradation mechanisms for this component that would cause initiation and through-wall growth of a planar flaw. The remaining reasonable explanation for leakage is that there is a leakage pathway via small voids, or porosity, originally present in the cast material. Other instances of this phenomenon in the industry are referenced in section 7, Precedents. As discussed below, such small imperfections do not significantly affect the structural integrity of the component.

**Structural Integrity** - Ultrasonic thickness measurements of the pump casing in the area of the leak resulted in thickness readings of 0.282", 0.289" and 0.292". Per the vendor technical manual this exceeds the design required minimum wall thickness of 0.25". Also, observation of the disassembled 2A BAMP casing did not identify any appreciable general corrosion or "wash-out" in the area of the flaw.

Referencing ASME XI Code subparagraph IWB-3142.4, "Acceptance by Analytical Evaluation," FPL proposes to temporarily accept the as-found relevant condition (through-wall flaw) to allow continued service instead of performing immediate flaw correction by a repair/replacement activity described in Code subparagraph IWC-3142.3, "Acceptance by Repair/Replacement Activity." This proposed alternative is based on FPL actions similar to those required by ASME XI Code Case N-513-3 for flaws without a growth rate analysis. These actions are:
