ABNORMAL OCCURRENCE 76-19A

FORT ST. VRAIN NUCLEAR GENERATING STATION
PUBLIC SERVICE COMPANY OF COLORADO
P. O. BOX 361
PLATTEVILLE, COLORADO 80651

REPORT NO. 50-267/76-19A

On June 17, 1976, one steam/water dump valve in each loop was open. This has been identified as an abnormal occurrence per the Fort St. Vrain Technical Specifications, Section 2.1, paragraph f.

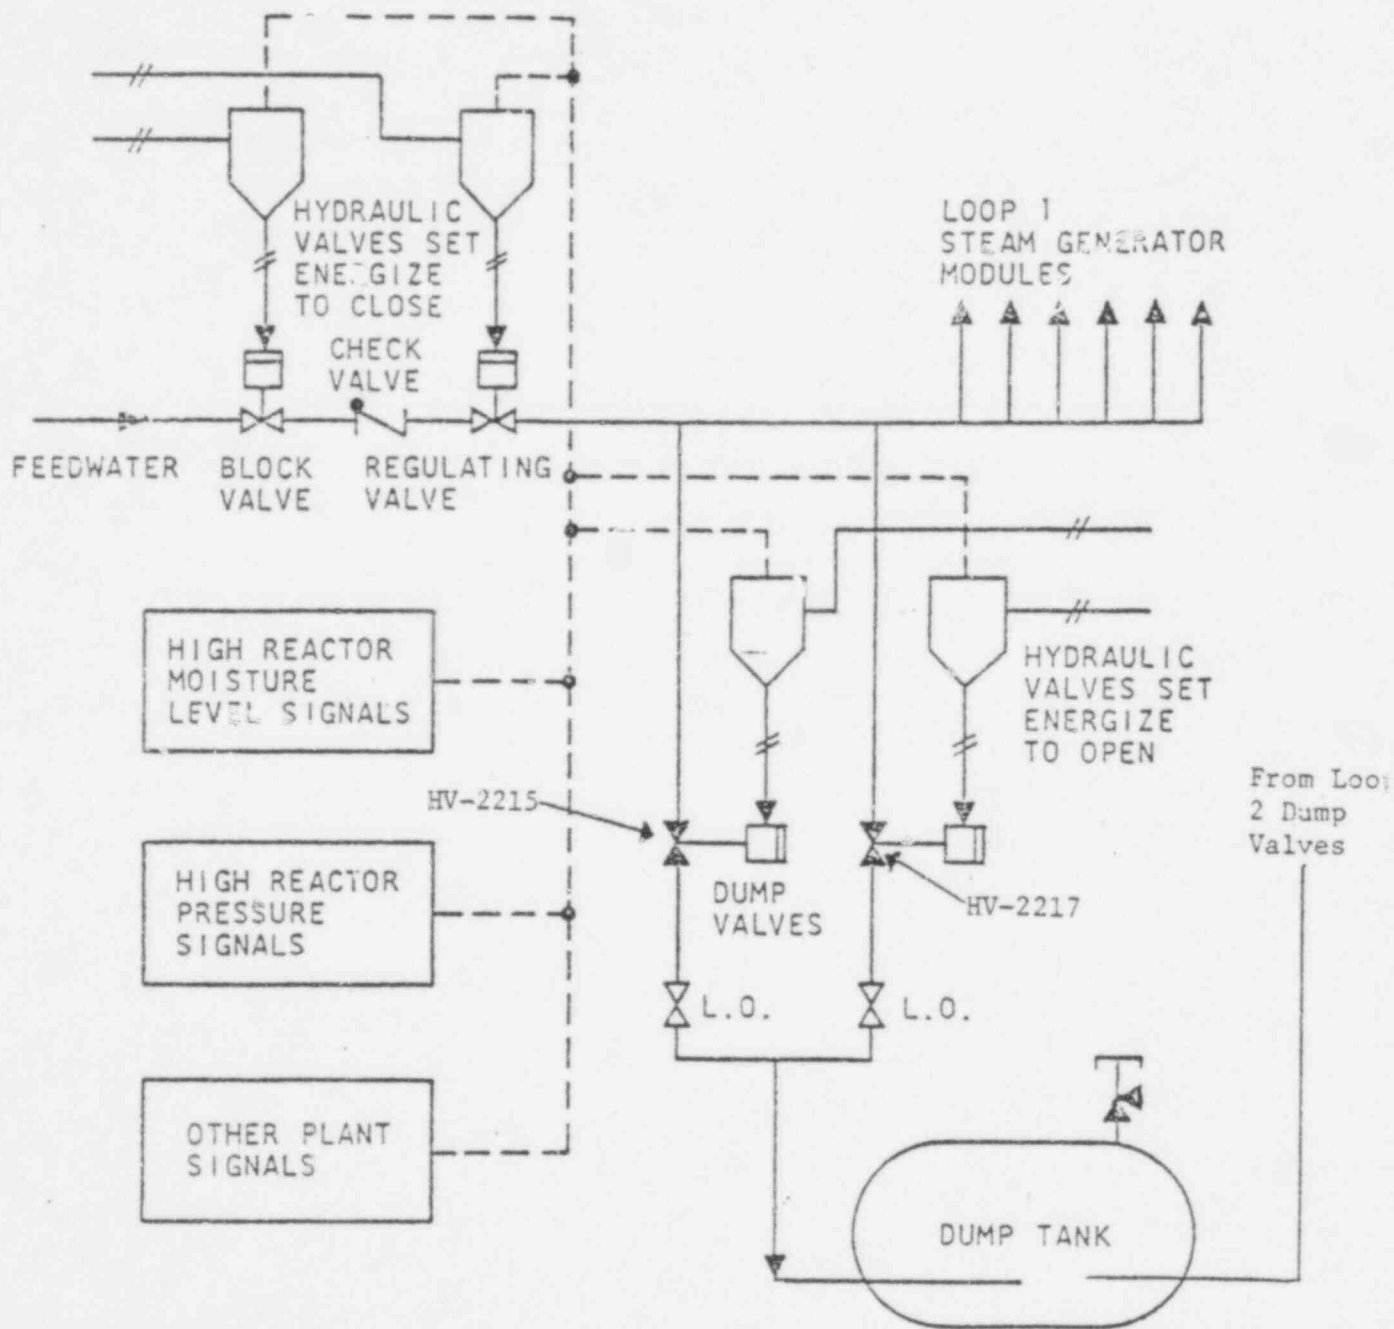
FIGURE 1

Reference attached Figure 1 which shows two parallel dump valves in a loop and the trip signals which will open a dump valve. Loop 1 and Loop 2 dump valves discharge to a common steam/water dump tank. Figure 2 shows the interlocks which were required to be closed to open a steam/water dump valve. If a loop steam/water dump valve is open, its relay must be energized. The energized relay and position switches on the open valve interlock and should prevent automatic opening of either steam/water dump valve in the other loop.

Steam/water dump system (Loop 1)
