THE DETROIT EDISON COMPANY
FERMI 2 NUCLEAR POWER PLANT

EVALUATION OF
CONTAINMENT COATINGS
FOR FERMI 2

REPORT NO. DECO-12-2191
REVISION 2

AUGUST 1984

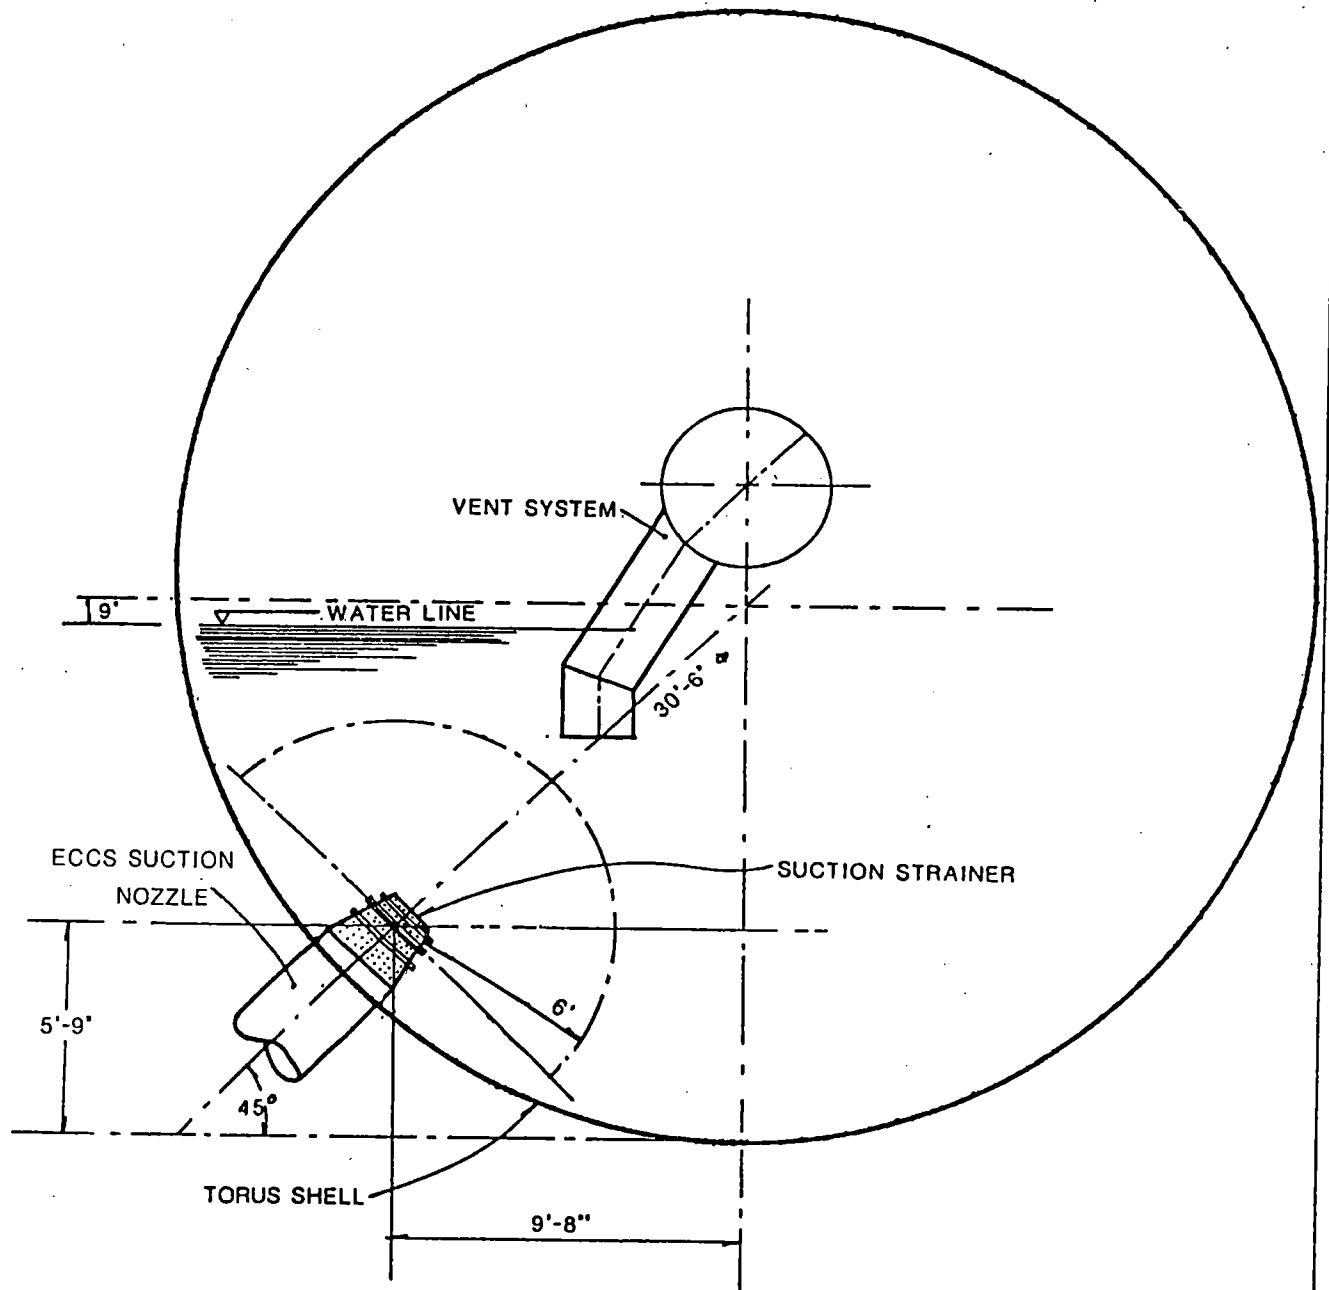
FIGURE 1

Average water velocities within the torus following the initial transient are below 0.25 ft/sec, but approach 0.5 ft/sec within a 6 foot hemisphere of the largest suction strainers at maximum RHR pump capacity. Refer to Figure 1 for the dimension and arrangement within the torus. The maximum surface velocity at the strainer surface was calculated to be 2.5 ft/sec. The strainer intakes are located 9'-8" from the center of the torus and 5'-9" above dead bottom. For these pool velocities hydroxide type particles are therefore not postulated to reach the strainers in a realistic situation.

ECCS SUCTION STRAINER LOCATION
