ITT ENGINEERED VALVES

Final Report to the NRC of
10 CFR 21 Event 54118, reported by ITT 06/14/19
Concerning #25 AM diaphragm valves

Original submittal was 8/13/19; this revision 1 is dated 8/20/19

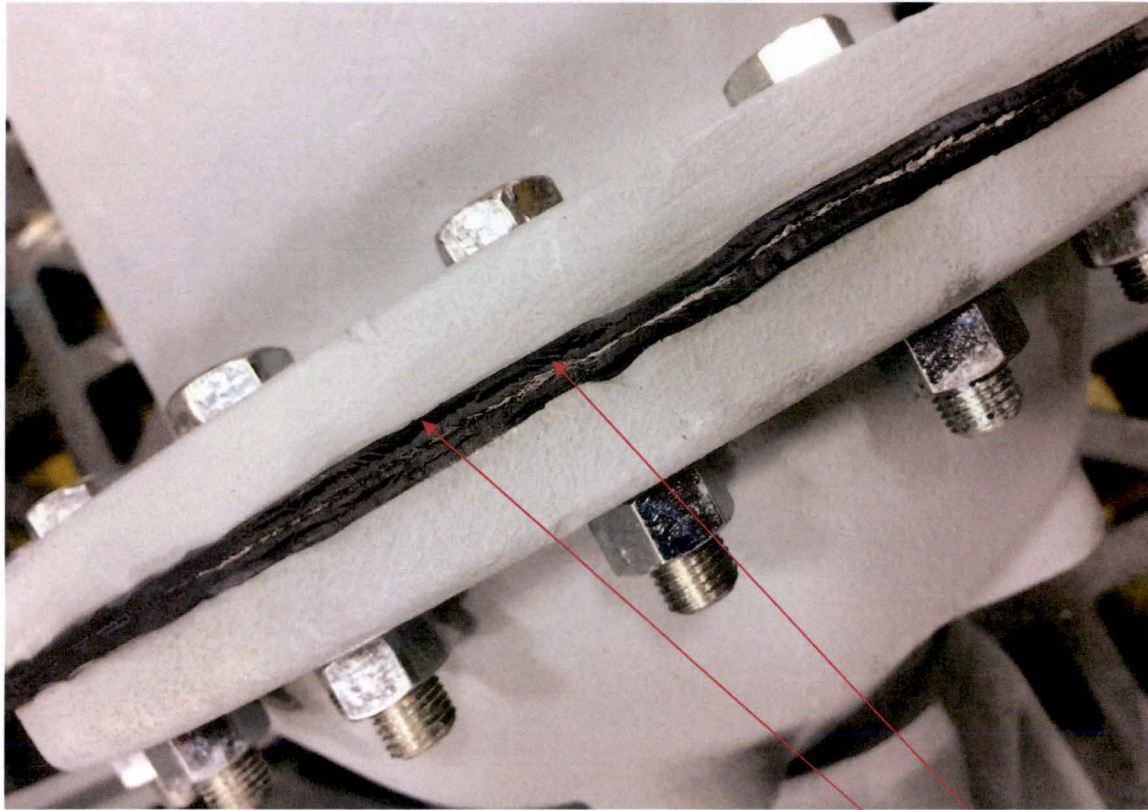
The damage to the airmotor diaphragms was evident once the valves were retrieved from storage and brought out for disassembly. Splitting of the elastomer was visible on the edge of the diaphragm, even before the valves were taken apart, see Figure 1. After disassembly, the splitting could no longer be easily seen, but the delamination of each diaphragm was now plainly visible, see Figure 2. All five diaphragms showed the same type of splitting and delamination, with the delamination ranging from 30% to 75% of the circumference. The delamination in all cases began at the outer diameter of the diaphragm and extended radially to the inner edge of the flange clamping area.

Figure 1: Diaphragm damage noted before disassembly. Note splitting of elastomer on edge of diaphragm.

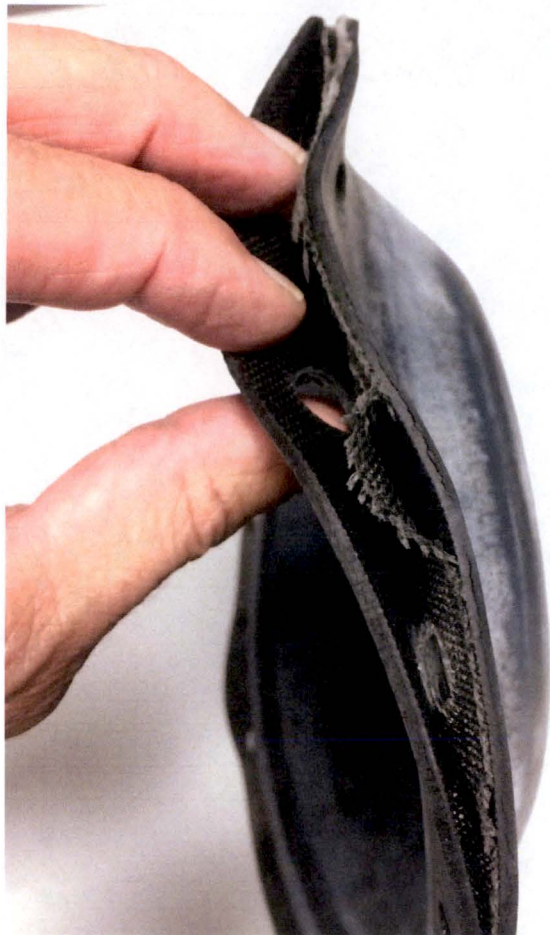
Figure 2: Delamination of fabric from elastomer

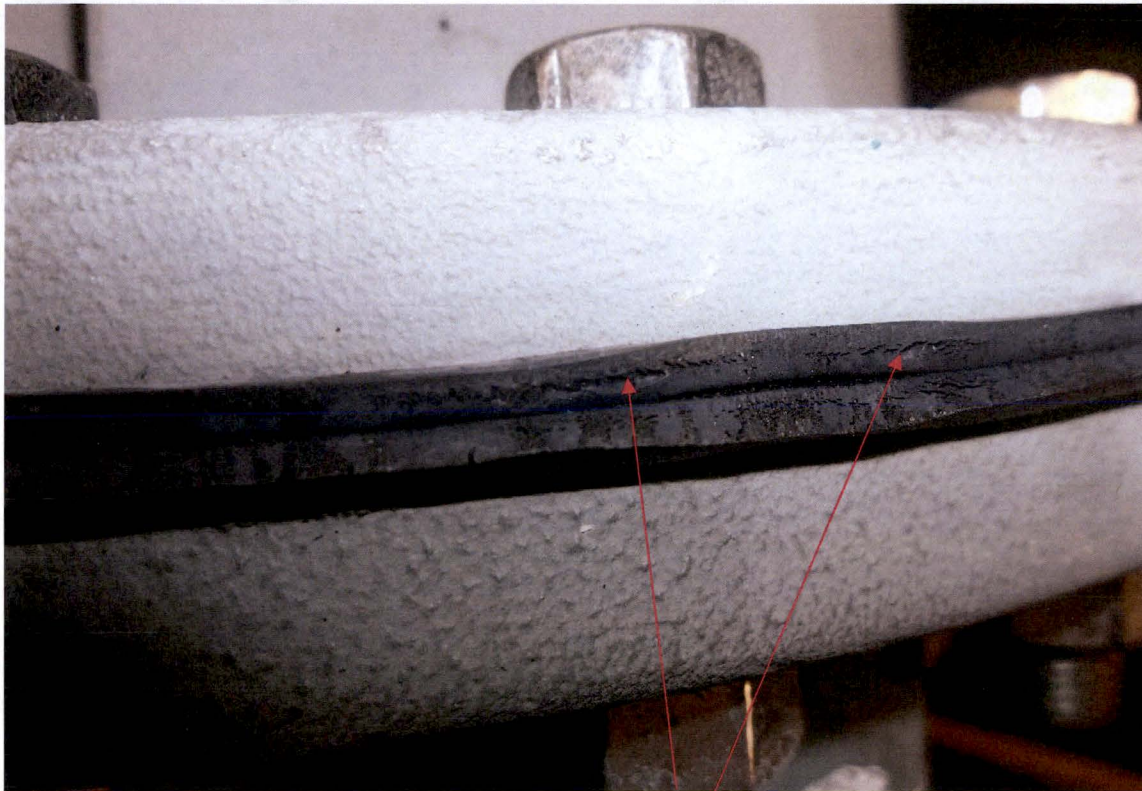
time. At the four week point, cracks were observed on the outer edge of the diaphragm that were not present at initial assembly, similar to those that were seen on the damaged diaphragms (see Figure 3). Repeated observations of the diaphragm over time showed that at week seven more cracks were found that had not been previously seen. In addition, some delamination was observed on the edge of the diaphragm, corresponding to the bolt location, see Figure 4. It became apparent that as time went on more cracks would initiate and existing cracks would deepen. This was seen as clear evidence that the cause of the damage was the high level of assembly torque that in time would manifest itself in permanent damage.

Figure 3: Splitting of diaphragm on simulated test unit

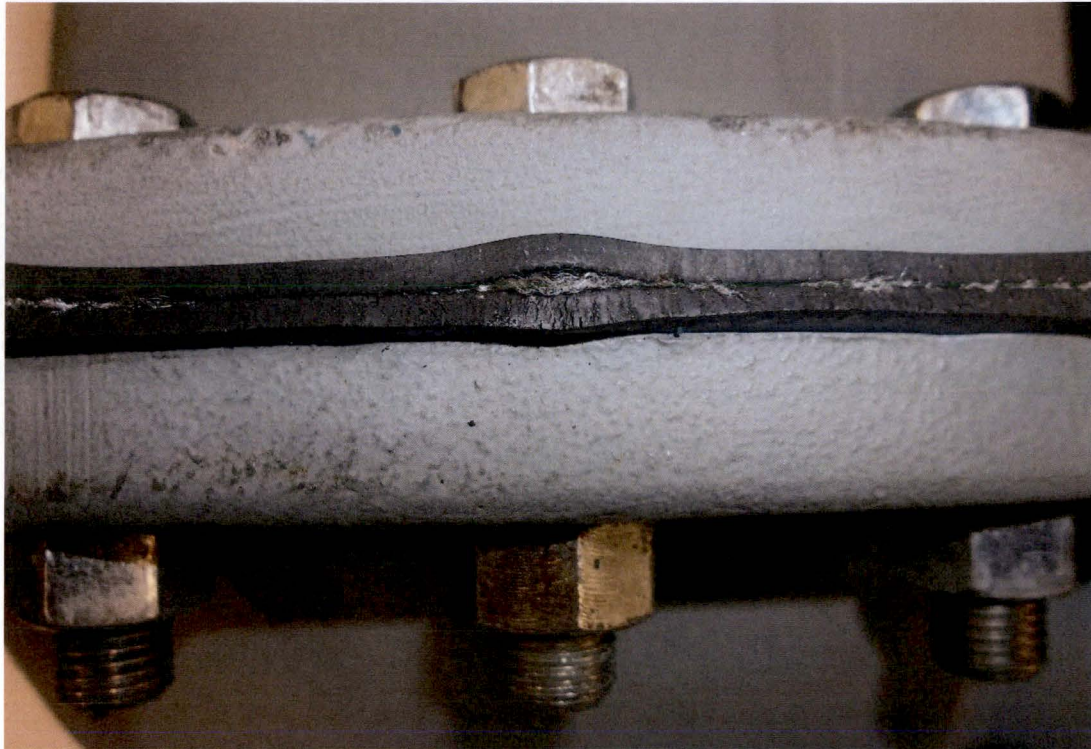
The simulation test proved that over time, the effect of the high bolt torque generates forces that have a long term, deleterious effect on the airmotor diaphragm such that the elastomer material will split and the fabric will delaminate from the elastomer.

Figure 4: Delamination of simulation unit

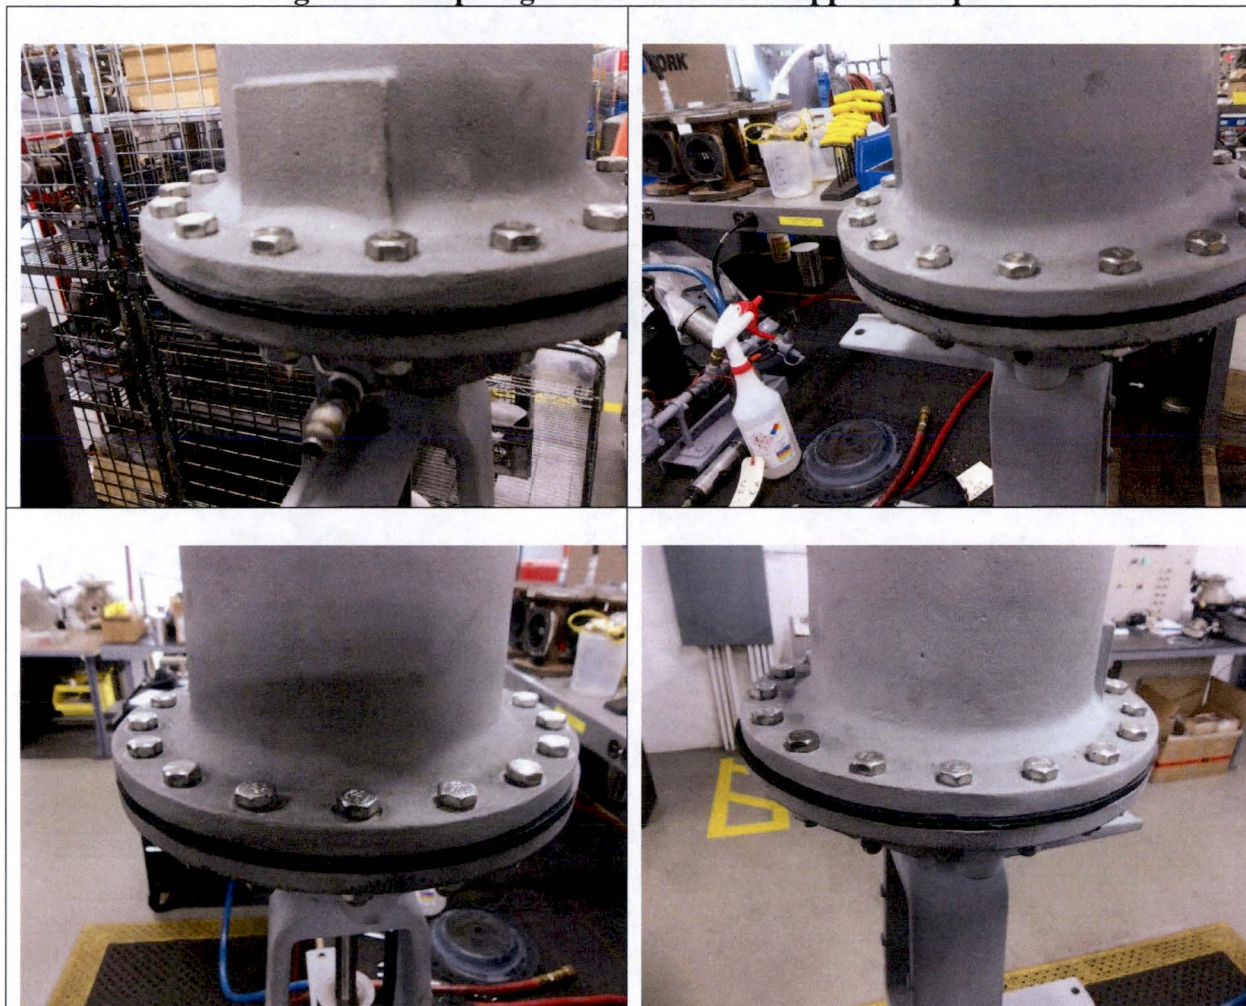
Figure 5: Diaphragm with 72 in lbs of applied torque

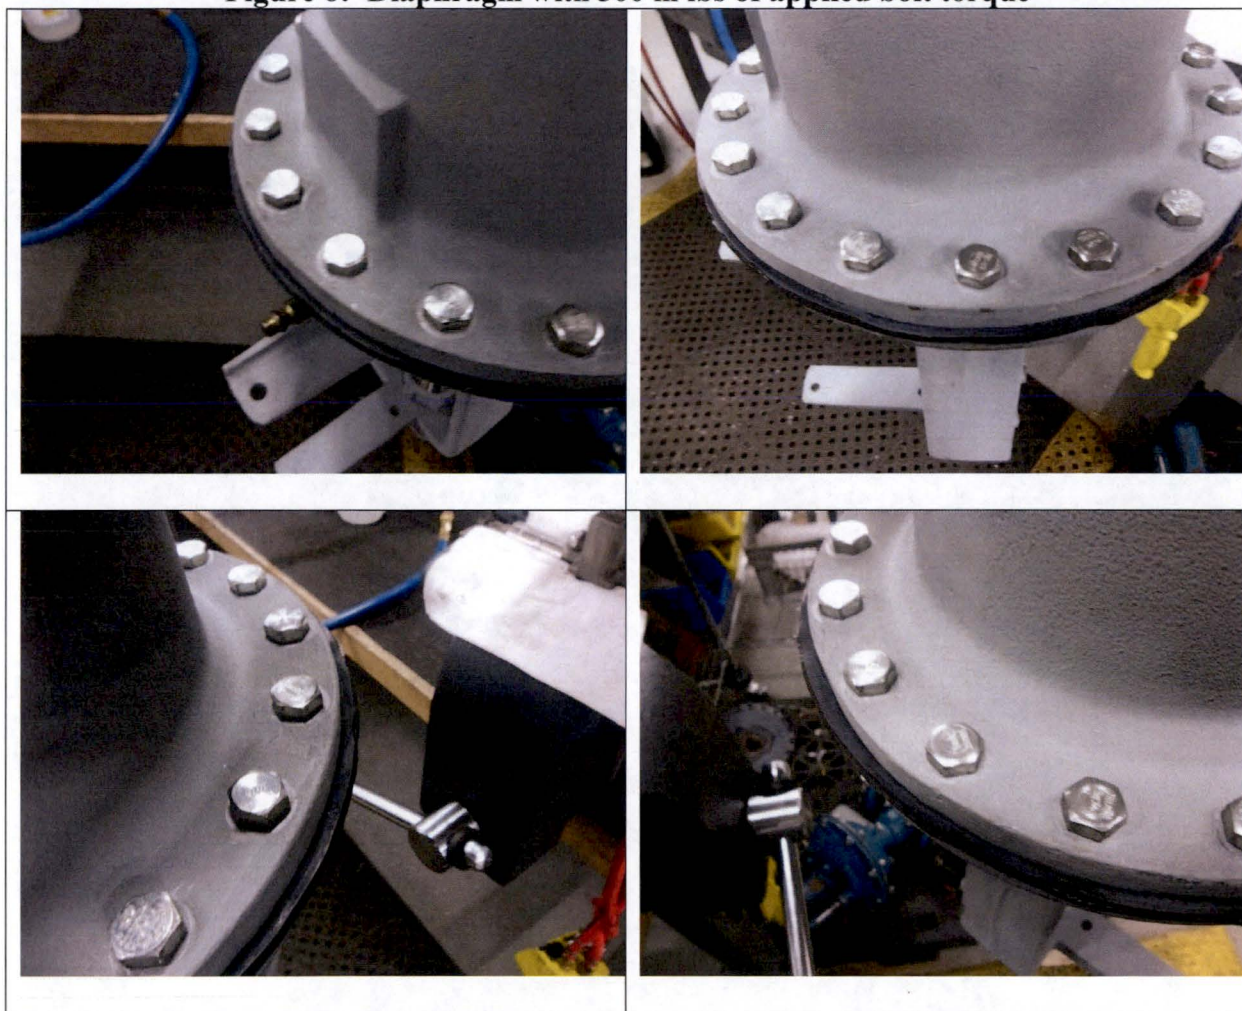
Excessive bolt torque causes damage to the airmotor diaphragm, but it also provides visual indications that enable a user to identify problematic assemblies. See Figures 5 and 6 for a comparison of a properly assembled airmotor versus one with a known excessive bolt torque. Normally the OD of the assembled diaphragm is the same diameter as the metal covers. If excessive torque is applied the elastomer diaphragm may extrude and extend as much as 0.12" beyond the OD of the covers, see Figures 6 and 7.

Figure 6: Diaphragm with 300 in lbs of applied bolt torque

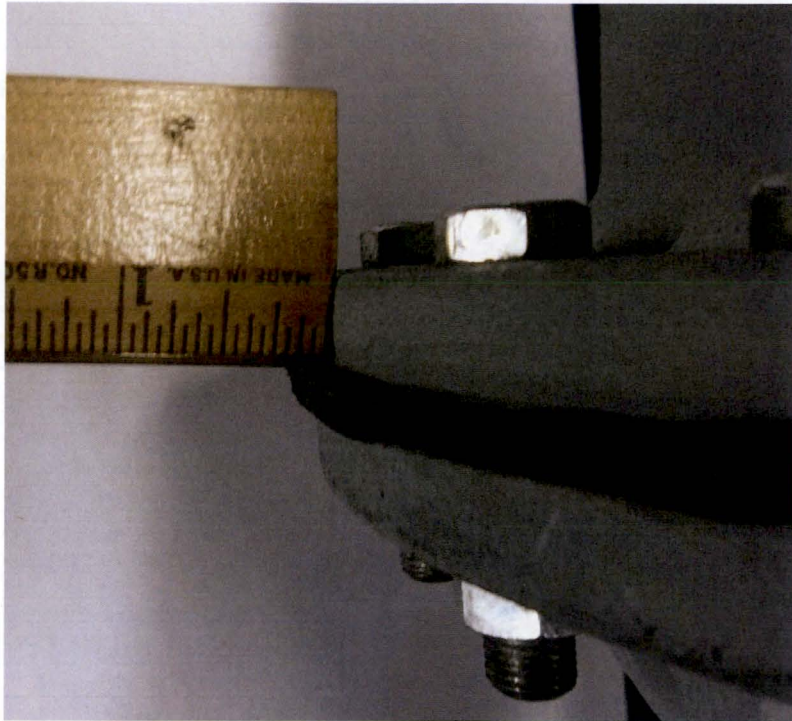
Figure 7: 300 in-lb - Extrusion of edge by 1/8"

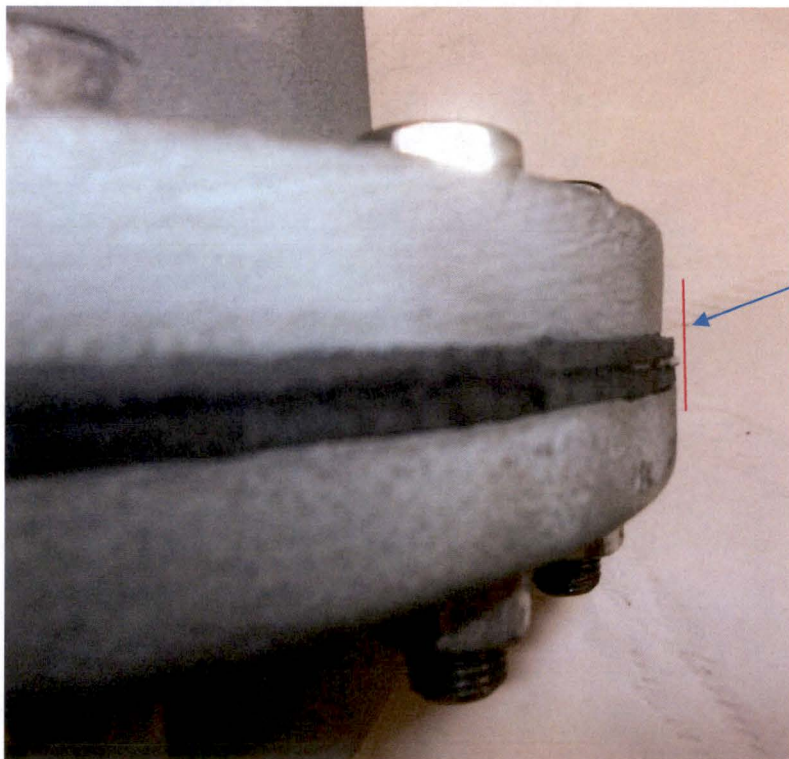
Figure 8: 72 in-lb – nominal extrusion, square edge

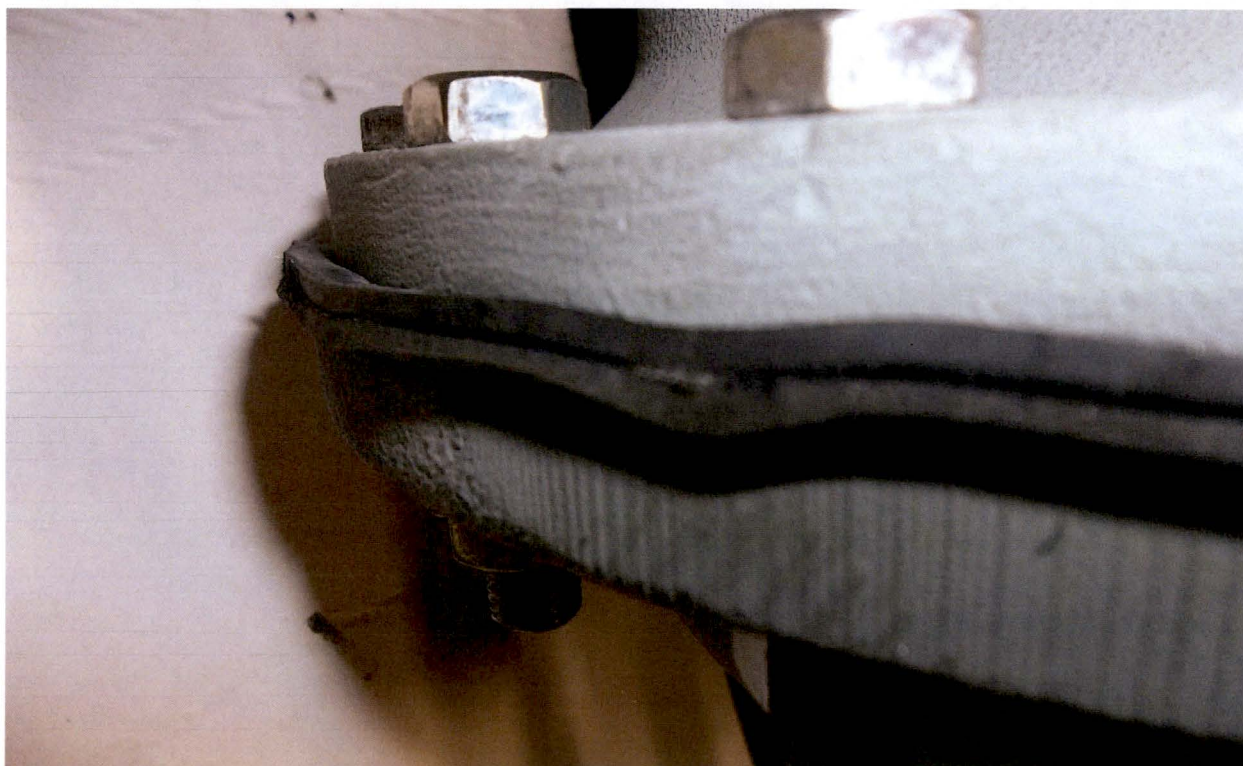
Figure 10: Diaphragm with 300 in-lb applied torque – Distorted, edge not square

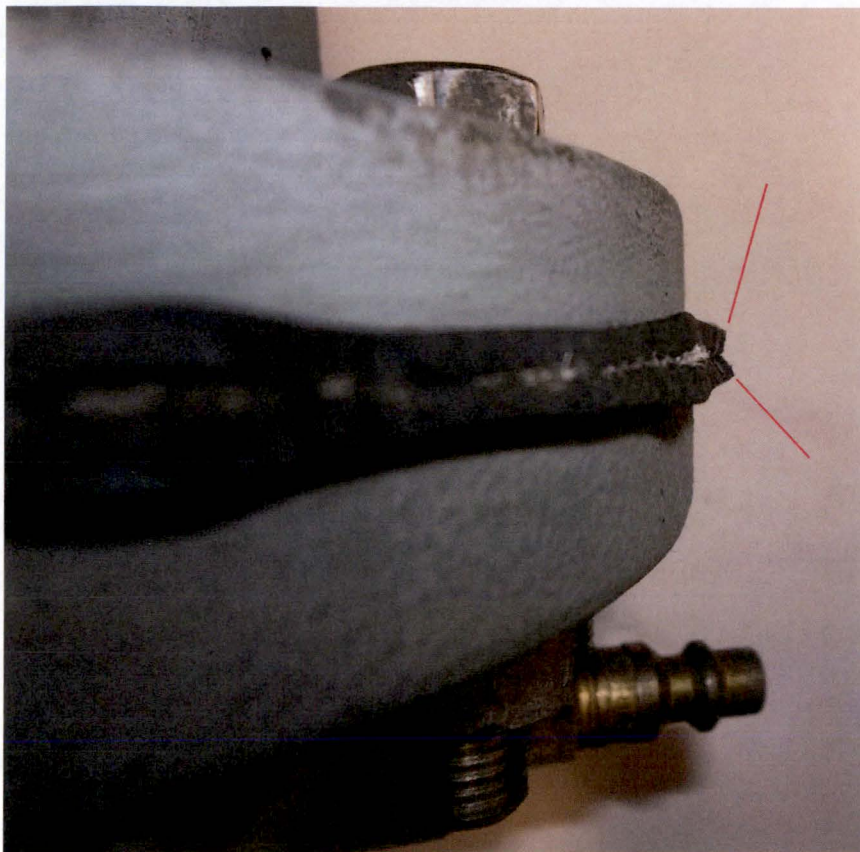
Figure 11: Diaphragm with 300 in-lb applied torque – Distorted, edge not square
