**Wisconsin Electric** POWER COMPANY

DOCKET NOS. 50-266 AND 50-301  
RESPONSE TO IE BULLETIN 79-13  
POINT BEACH NUCLEAR PLANT, UNITS 1 AND 2

Response to  
IE Bulletin 79-13  
July 10, 1979

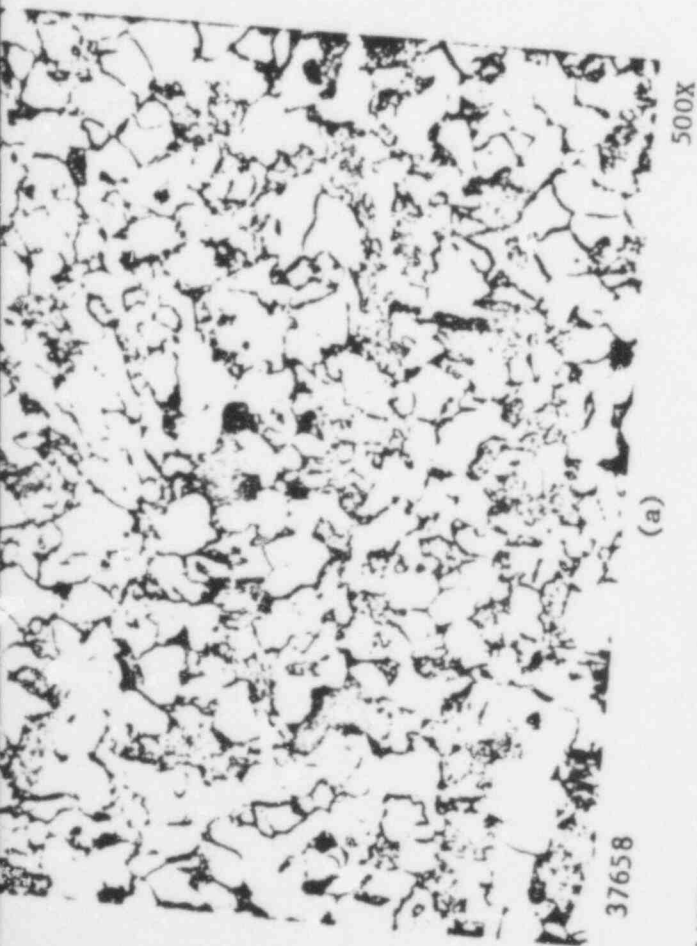
The structure of the reducer in all sections was normal for mild steel, Figure 1. No microstructural abnormalities, such as islands of martensite, weld porosity, or lack of fusion, were evident in the weld or heat-affected zone.

FIGURE 1. TYPICAL MICROSTRUCTURES OF REDUCER AND WELD. Base metal, (a), and heat-affected zone, (b), of reducer; Widmanstatten ferrite in weld bead, (c).

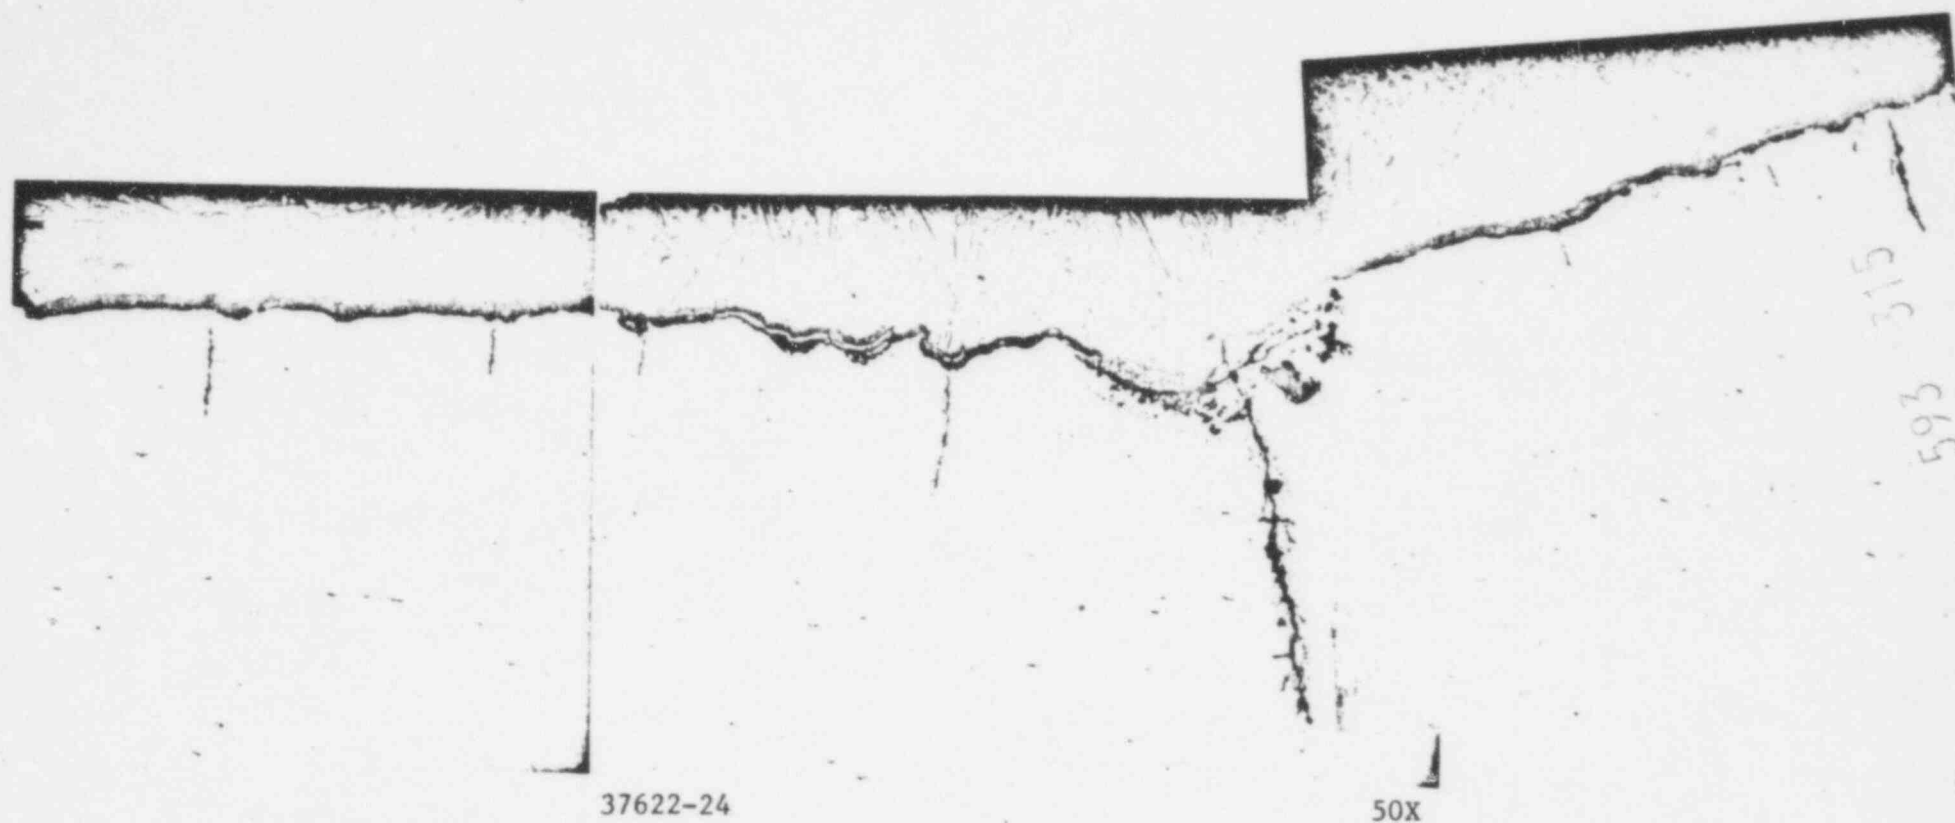
FIGURE 2. LONGITUDINAL SECTION AT STATION #15

Cracking was found in all the sections taken. The depth of the largest crack and the number of cracks in each section are given in Table I. In all cases, multiple cracking was observed, Figures 2 through 4. Although cracks were observed in all areas of the counter-bore, from the weld fusion line to the original reducer I.D., cracking with depths greater than 0.015 in. was restricted to the weld fusion line and counter-bore transition region. Of the two, the counter-bore transition zone contained the deeper cracks, Figure 3.

<u>Section</u>	<u>Maximum Depth (in.)</u>	<u>Number of Cracks Deeper than 0.02 in.</u>
#10	0.018	8
#15	0.043	13
#22	0.014	4
#28	0.008	3
#43	0.042	7

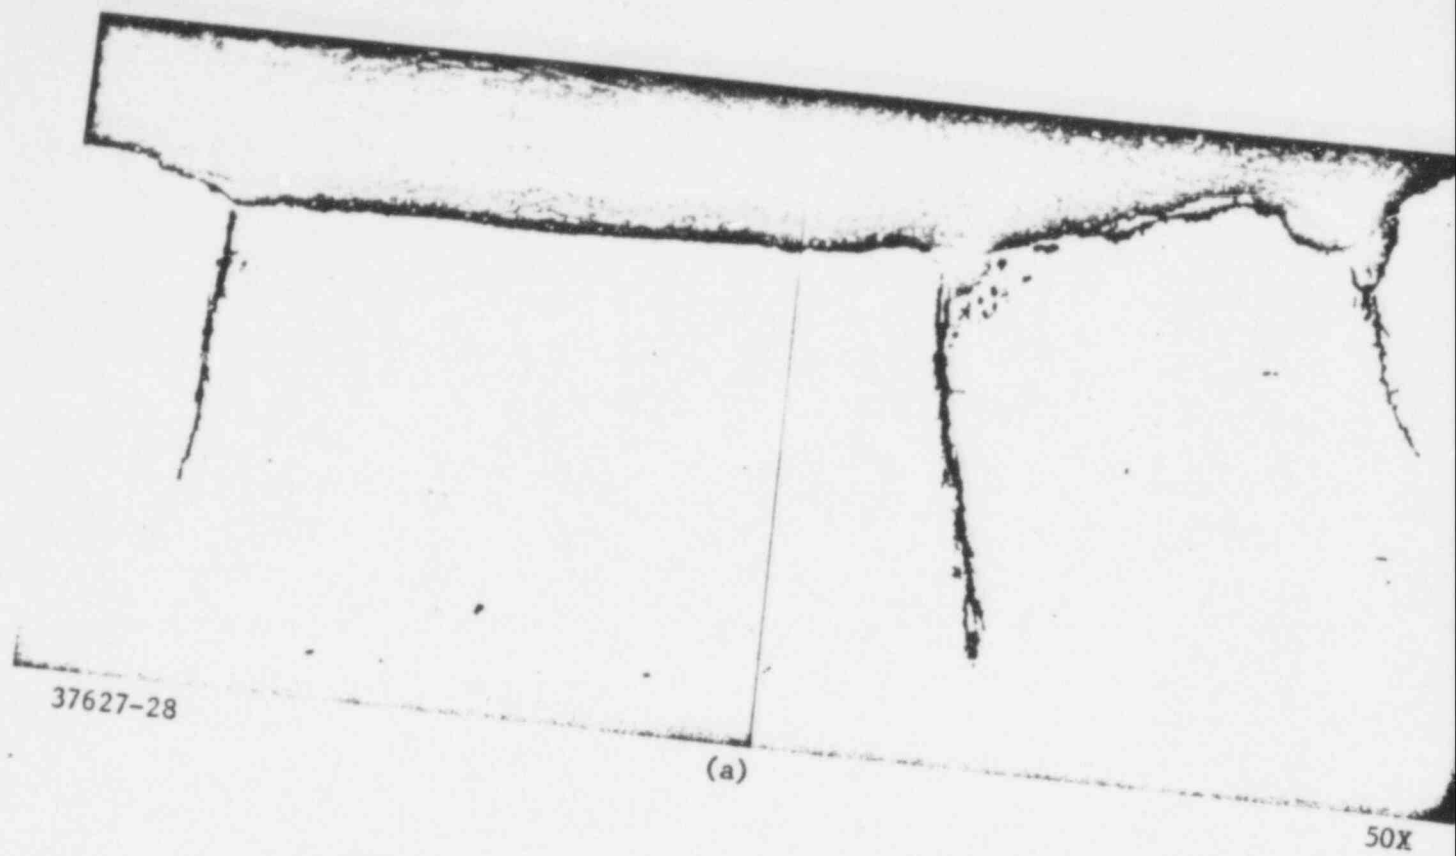
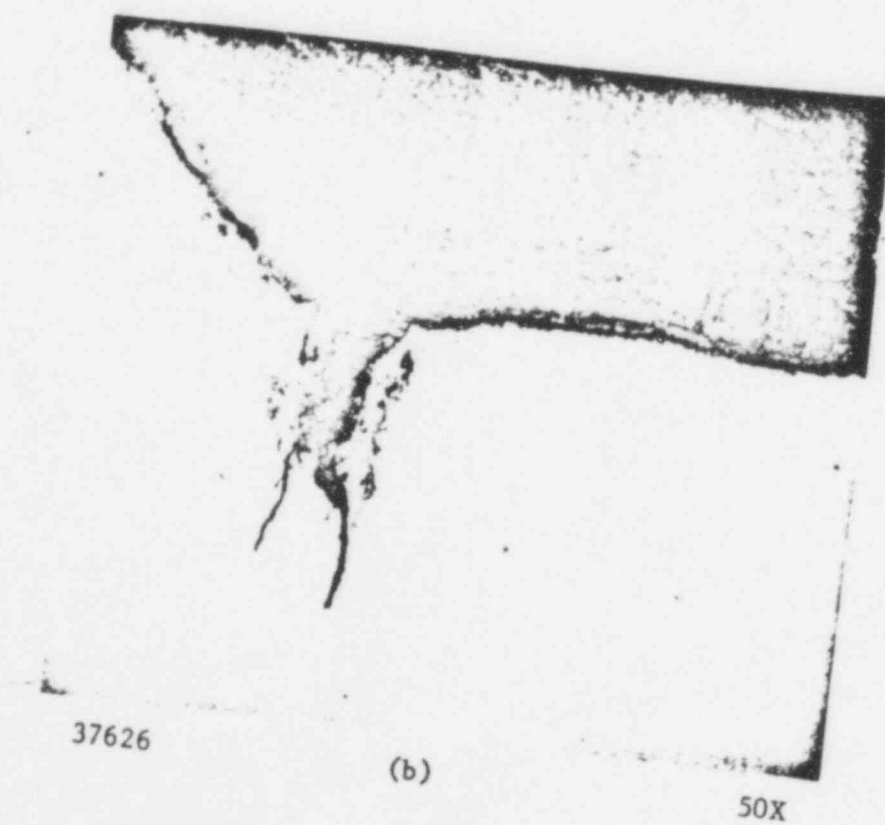
FIGURE 3. LONGITUDINAL SECTION AT STATION #43. Cracking occurred at the counter-bore transition zone, (a), and at the weld fusion line, (b).

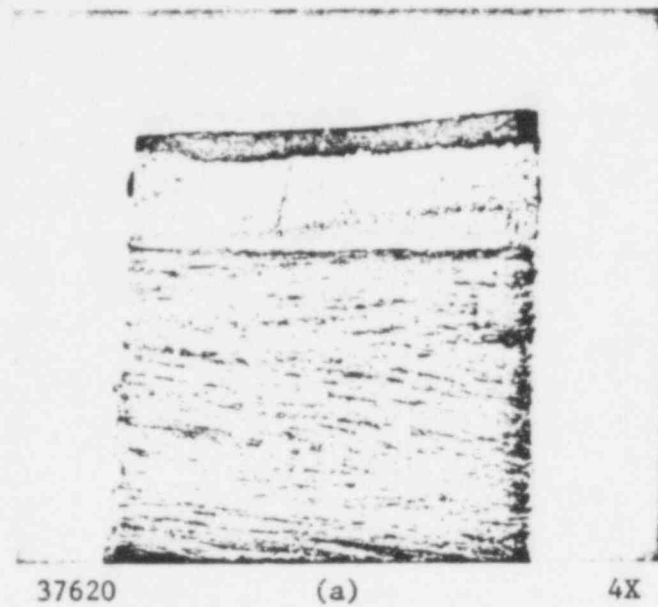
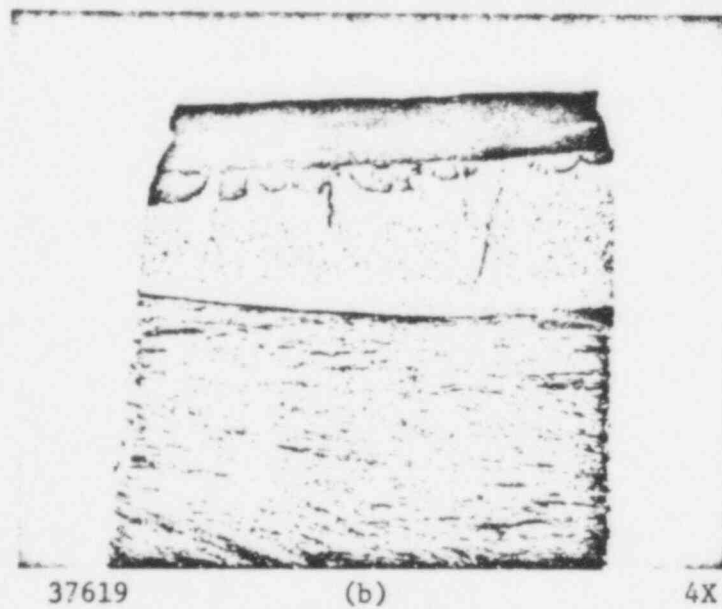
Figure 5 shows the fracture surface of specimens cut at stations #10-10.5 and #43-43.5. The black zone near the edge of the sample is the oxidized inservice crack, the silver area, laboratory cleavage fracture. Both samples were broken in the vicinity of counter-bore transition zone. It is of interest to note that one specimen was notched and impacted at room temperature. In this case, the inservice crack blunted considerably, but no crack extension occurred.

FIGURE 5. SAMPLES FROM STATION #15, (a), AND #43, (b), READY FOR FRAC-  
TOGRAPHIC ANALYSIS

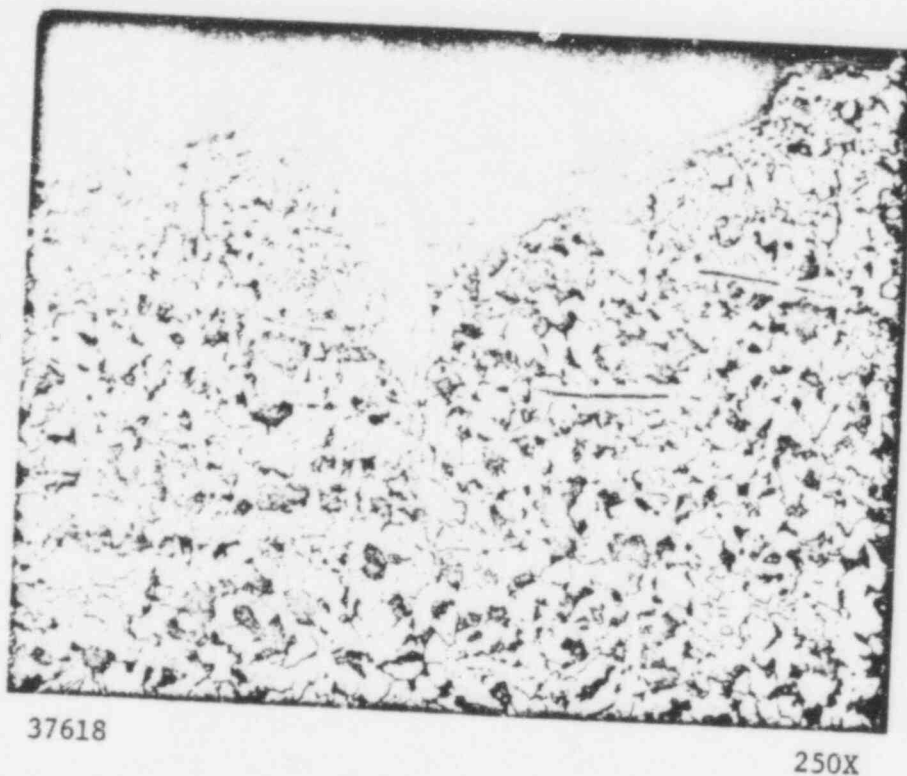
FIGURE 7. HIGHER MAGNIFICATION OF CRACK SHOWN IN FIGURE 4. Etchant, 2% Nital. Note the extent of oxidation at the crack walls.
