INTERIM REPORT
ON THE
STPEGS RCB NO. 1 LIFT 8 CONTAINMENT VOIDS

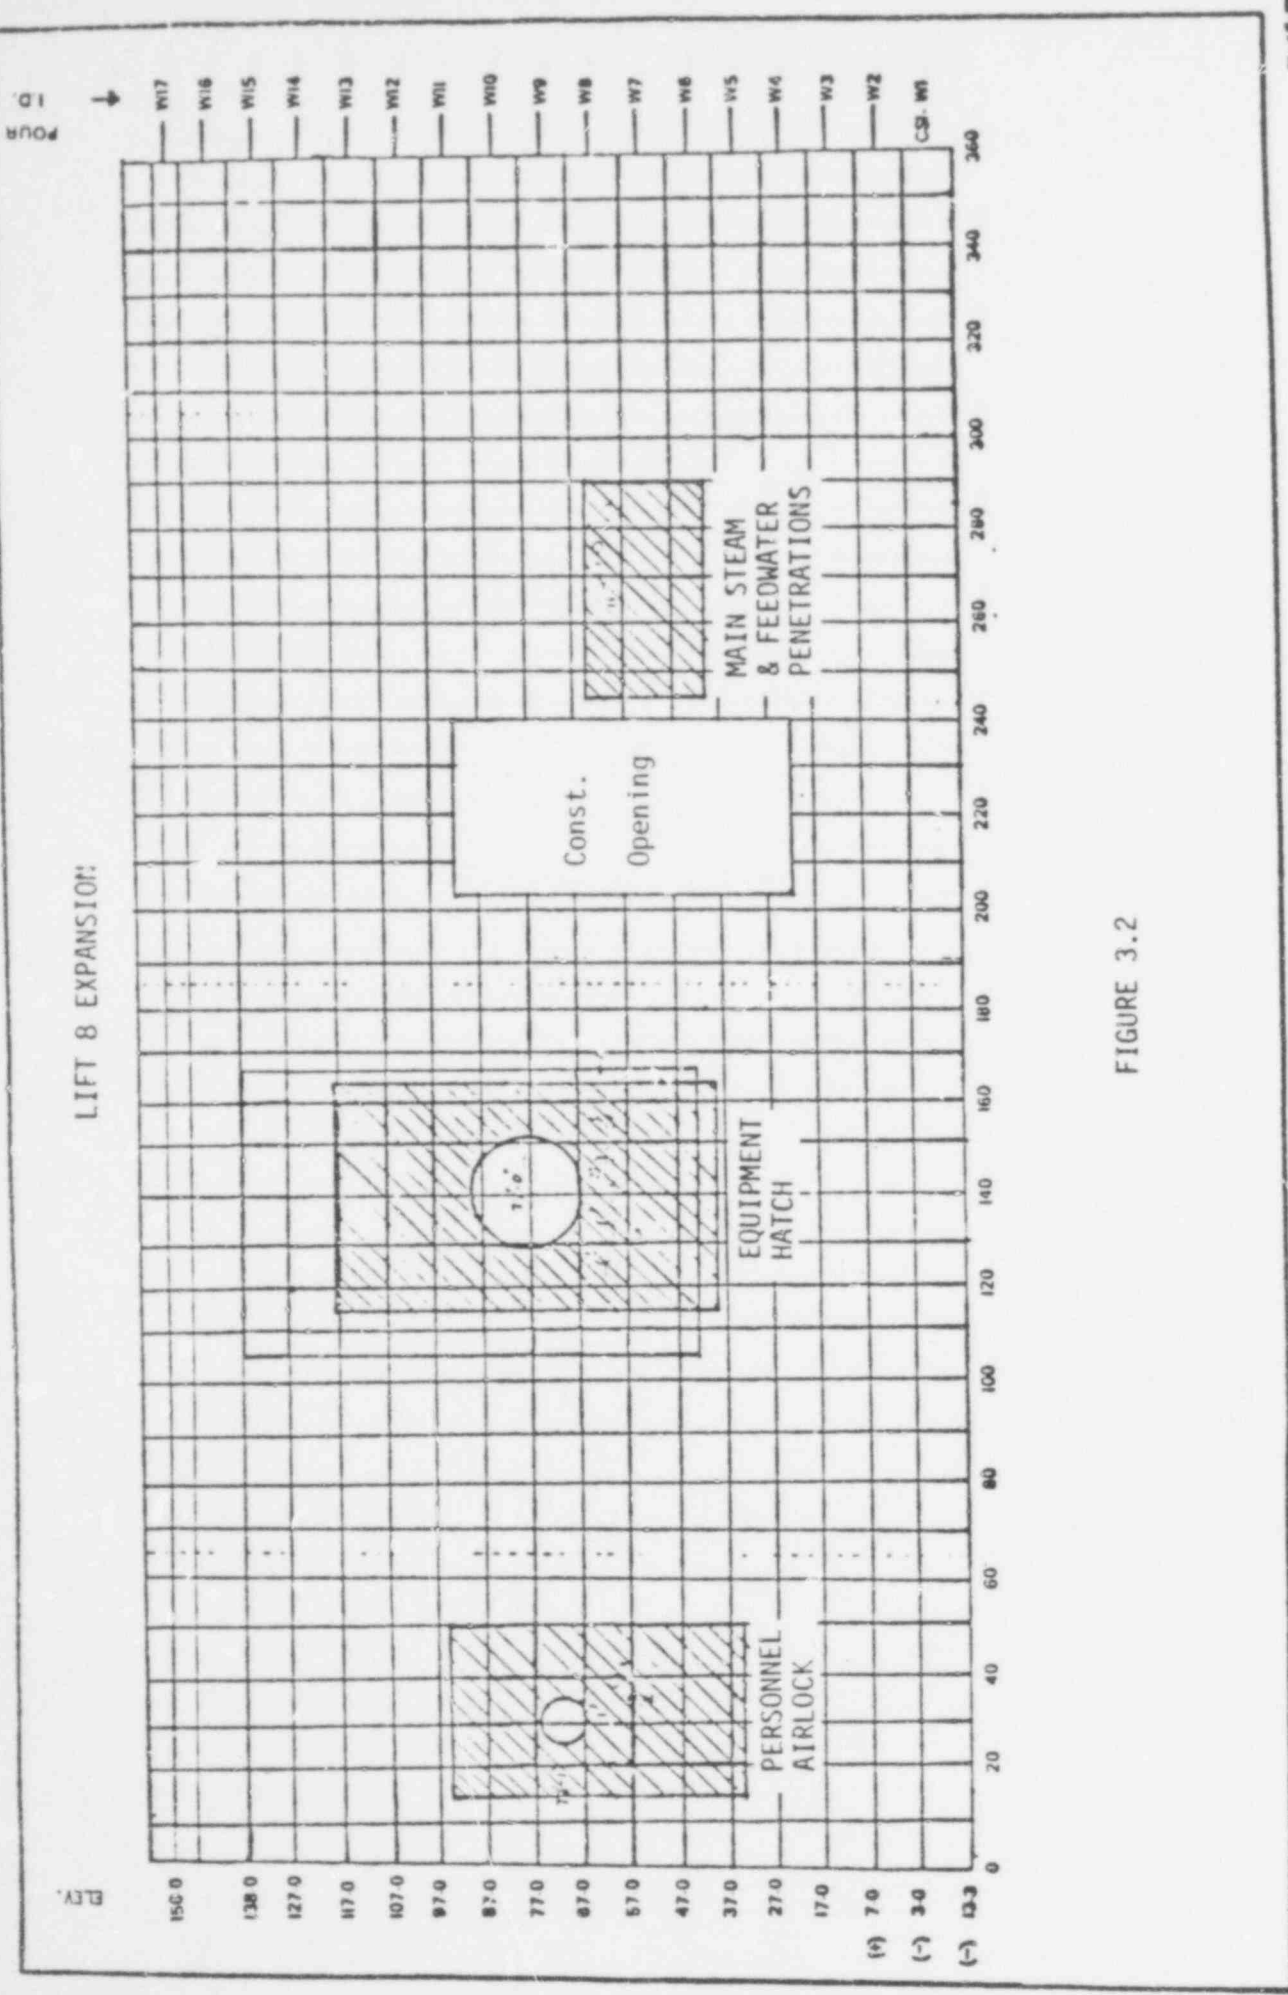
FIGURE 3.2

Based upon the information obtained during this investigation of the voids in Lift 8, it was concluded that other void areas could exist beneath penetrations and the 8" channel and plate stiffeners where additional reinforcing steel is located. Therefore, additional soundings will be made in three general penetration areas of high stress regions and congestion: 1) the equipment hatch, 2) personnel air lock, and 3) the main steam and feedwater lines. The current areas of investigation are shown in Figure 3.1 and 3.2. The logic diagram and plan for the completion of this activity is contained in Figure 3.3.
