Subject: 10CFR21 Reporting of Defects and Non-Compliance -
Engine Systems, Inc. Report No. 10CFR21-0126, Rev. 0

EMD Fuel Injector – Cracked Spray Tip, P/N 5229250

Report No. 10CFR21-0126

10CFR21 REPORTING OF DEFECTS AND NON-COMPLIANCE

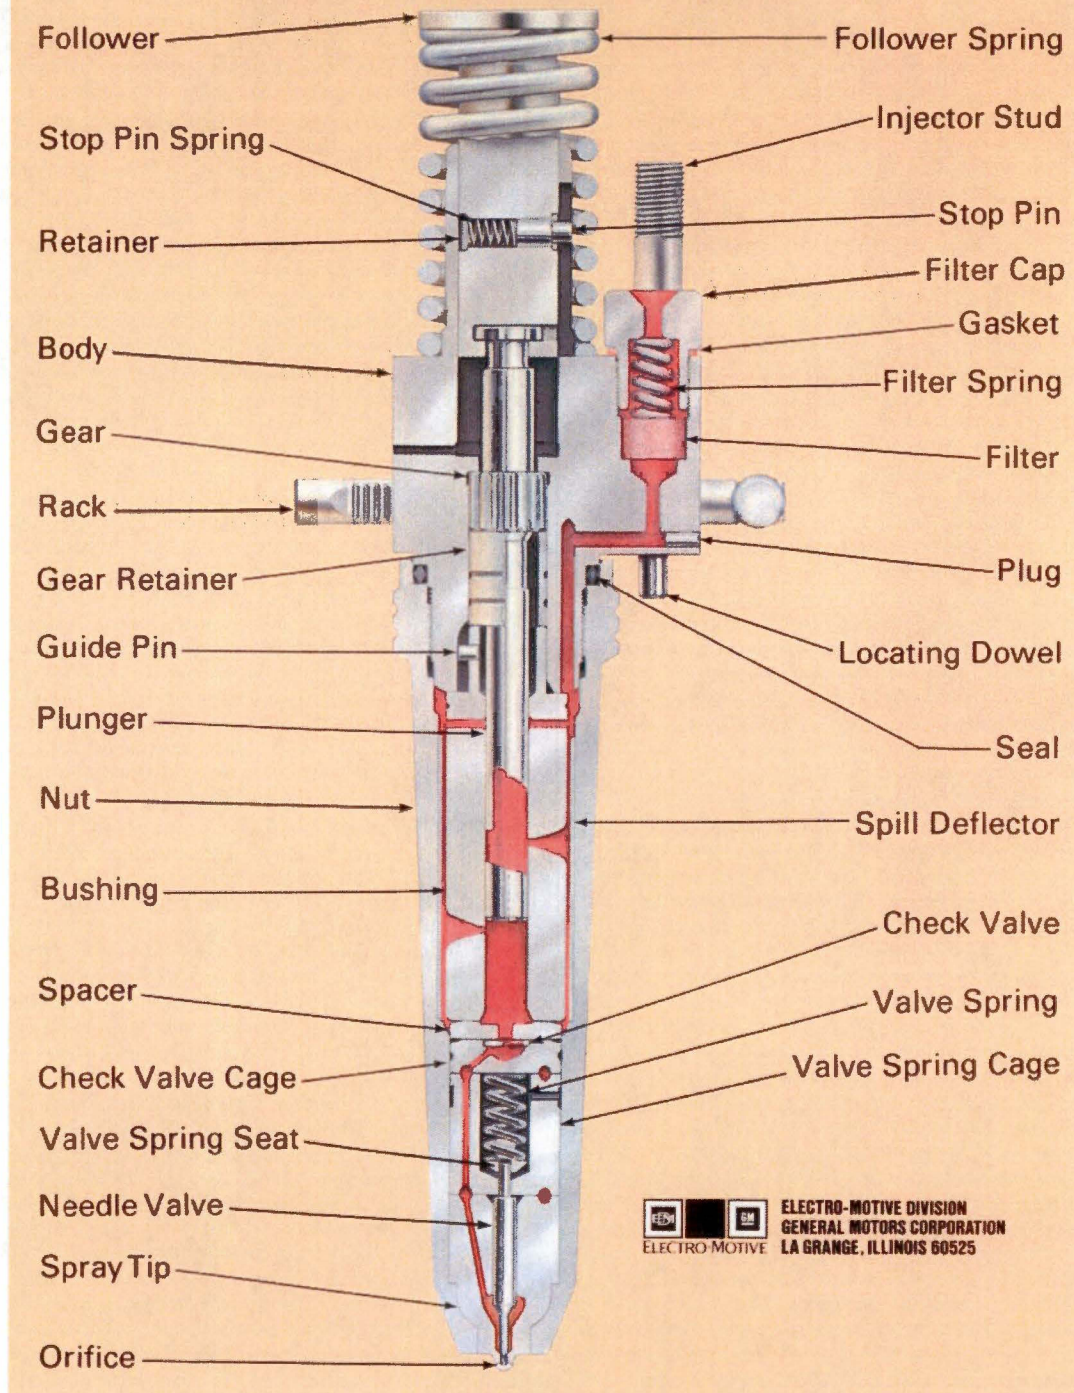
Figure #1
EMD Unit Injector

The injector was placed in operational service in December 2018 and failed soon afterwards. The injector failed to chatter, wouldn't build pressure, and leaked at the nozzle. Disassembly inspection revealed a cracked spray tip. Refer to injector assembly, Figure #1.

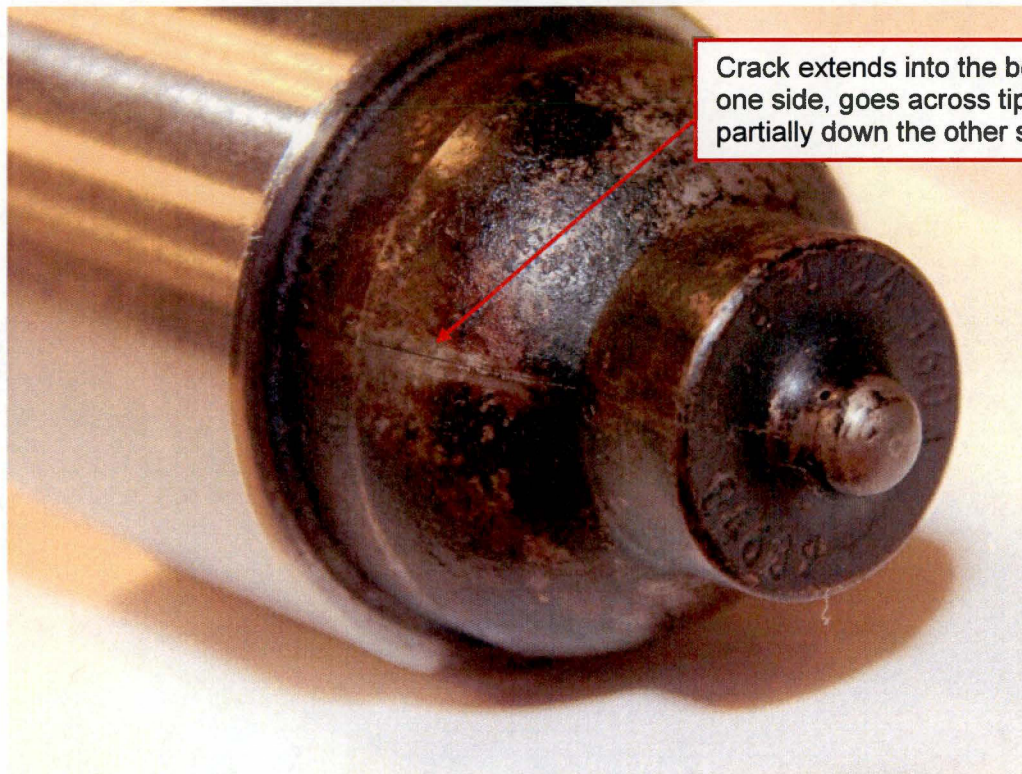
The crack was visible without magnification and extended from the machined outside diameter on one side across the tip and partially down the other side. See Photo #1. It was decided to section the spray tip and inspect the internal machined reservoir.

Photo #1
Cracked Injector Spray Tip

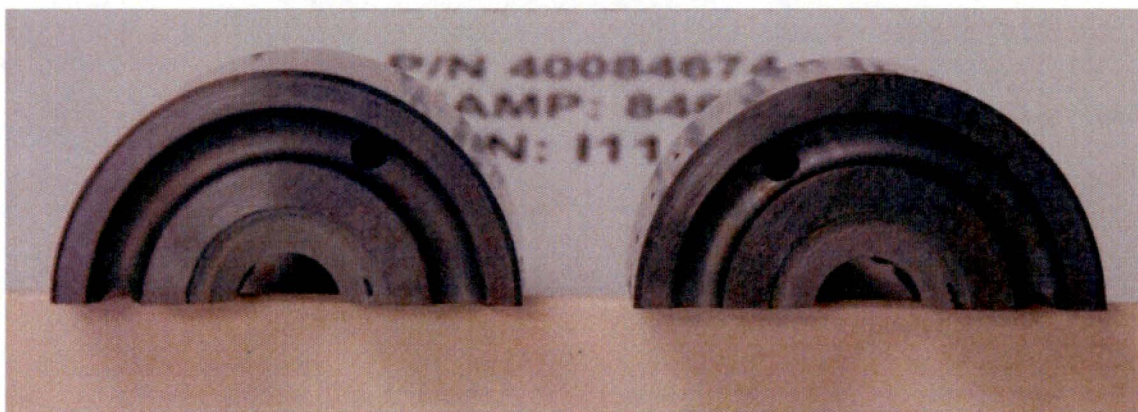
The section was made to bisect the spray tip through one of the fuel feed holes, as shown below. See Photo #2 for end view of sections.

Photo #2
Tip sectioned through one feed hole

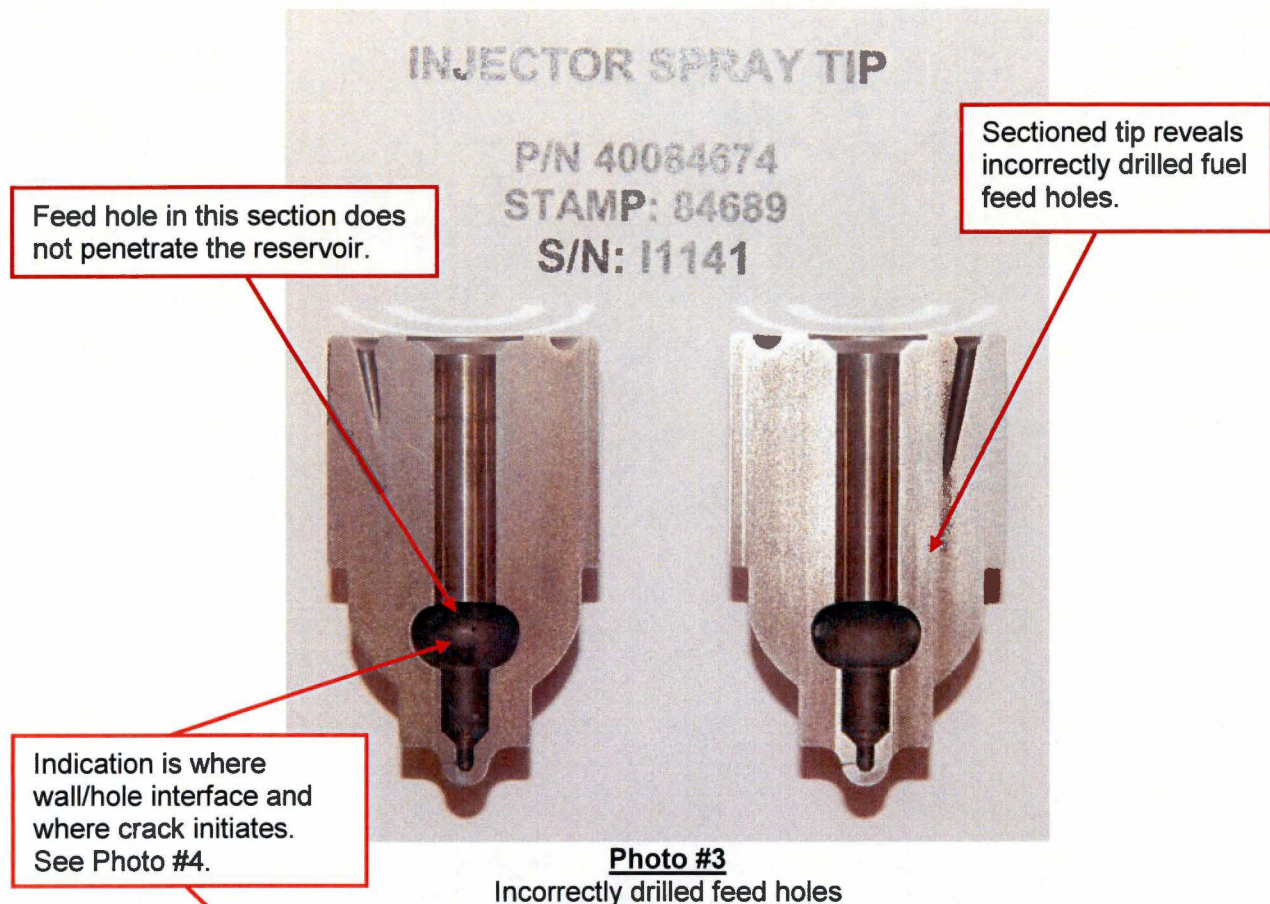
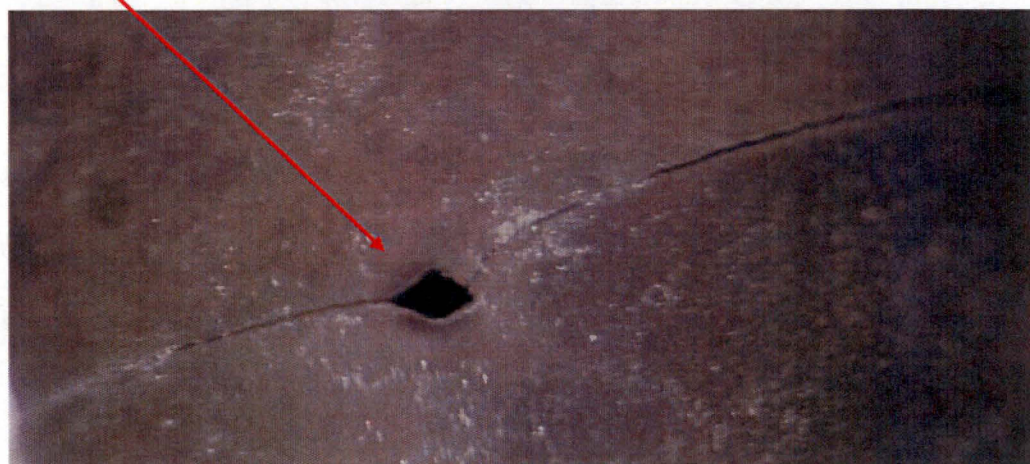
The sectioned spray tip identified the fuel feed holes were not properly oriented. The axis of the feed holes are supposed to be on the centerline of the body, and tilted 10° off vertical. The as-found holes are not on the body centerline as shown in Photo #3.

The incorrect drilling resulted in one of the holes not properly penetrating the reservoir. A small indication is visible in the left hand section where the reservoir and hole have joined. It is in this area where the crack initiated and propagated through the full section of the spray tip. See Photos #3 through #5.

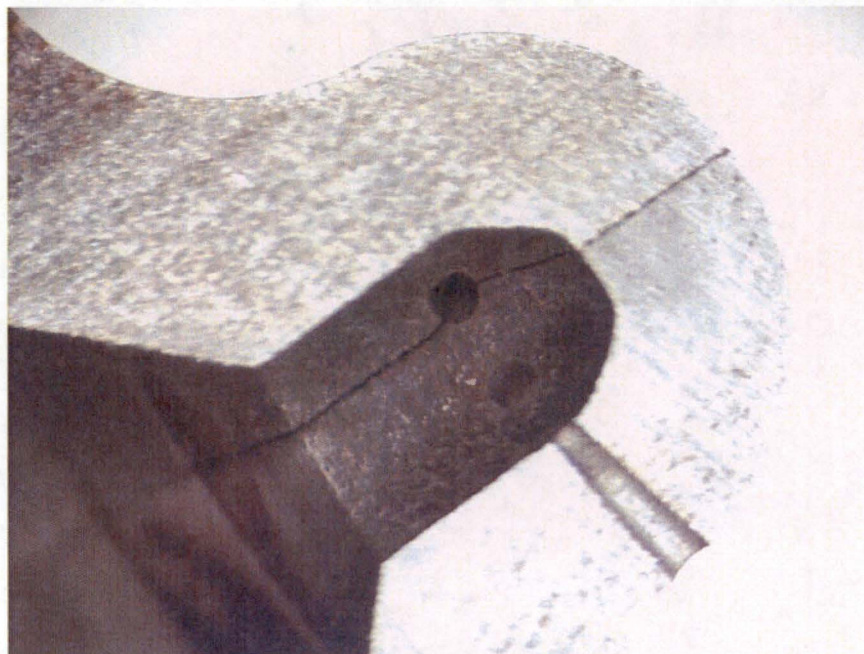
Photo #5
Crack at tip viewed from inside section

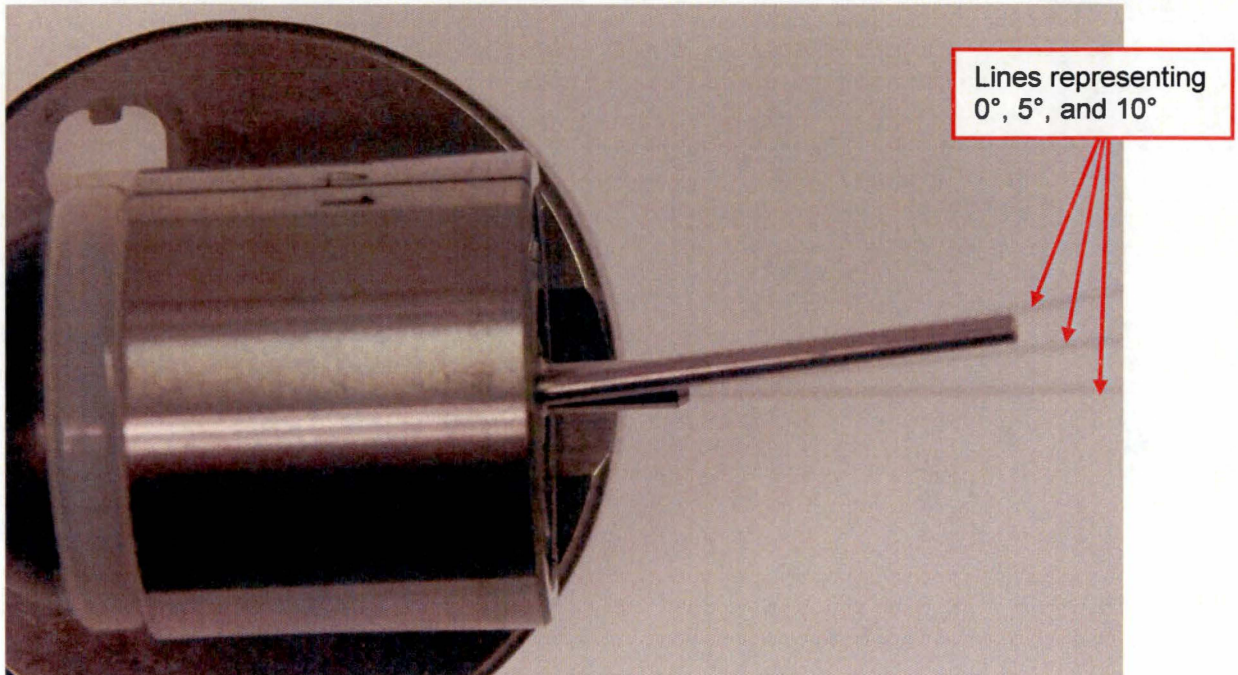
A visual indication of the hole axis orientation is shown in Photos #6 & #7. In these photos a 0.062" diameter pin gage is inserted in the feed hole that doesn't penetrate the reservoir. The needle is inserted in the center of the tip to provide a reference for the centerline of the body. When properly oriented, in Photo #7 the pin gage and valve needle should appear parallel. The angle between these was measured to be approximately 8°.

Spray Tip with 0.062" dia pin gage inserted, side view
