Reference: Beaver Valley Power Station, Unit No. 1
Docket No. 50-334
LER 79-14 (Feedwater Line Elbow Cracks)
Response to IE Bulletin 79-13

BEAVER VALLEY POWER STATION
RESPONSE TO IE BULLETIN 79-13

BEAVER VALLEY UNIT #1
LOOP C - METALLURGICAL EVALUATION

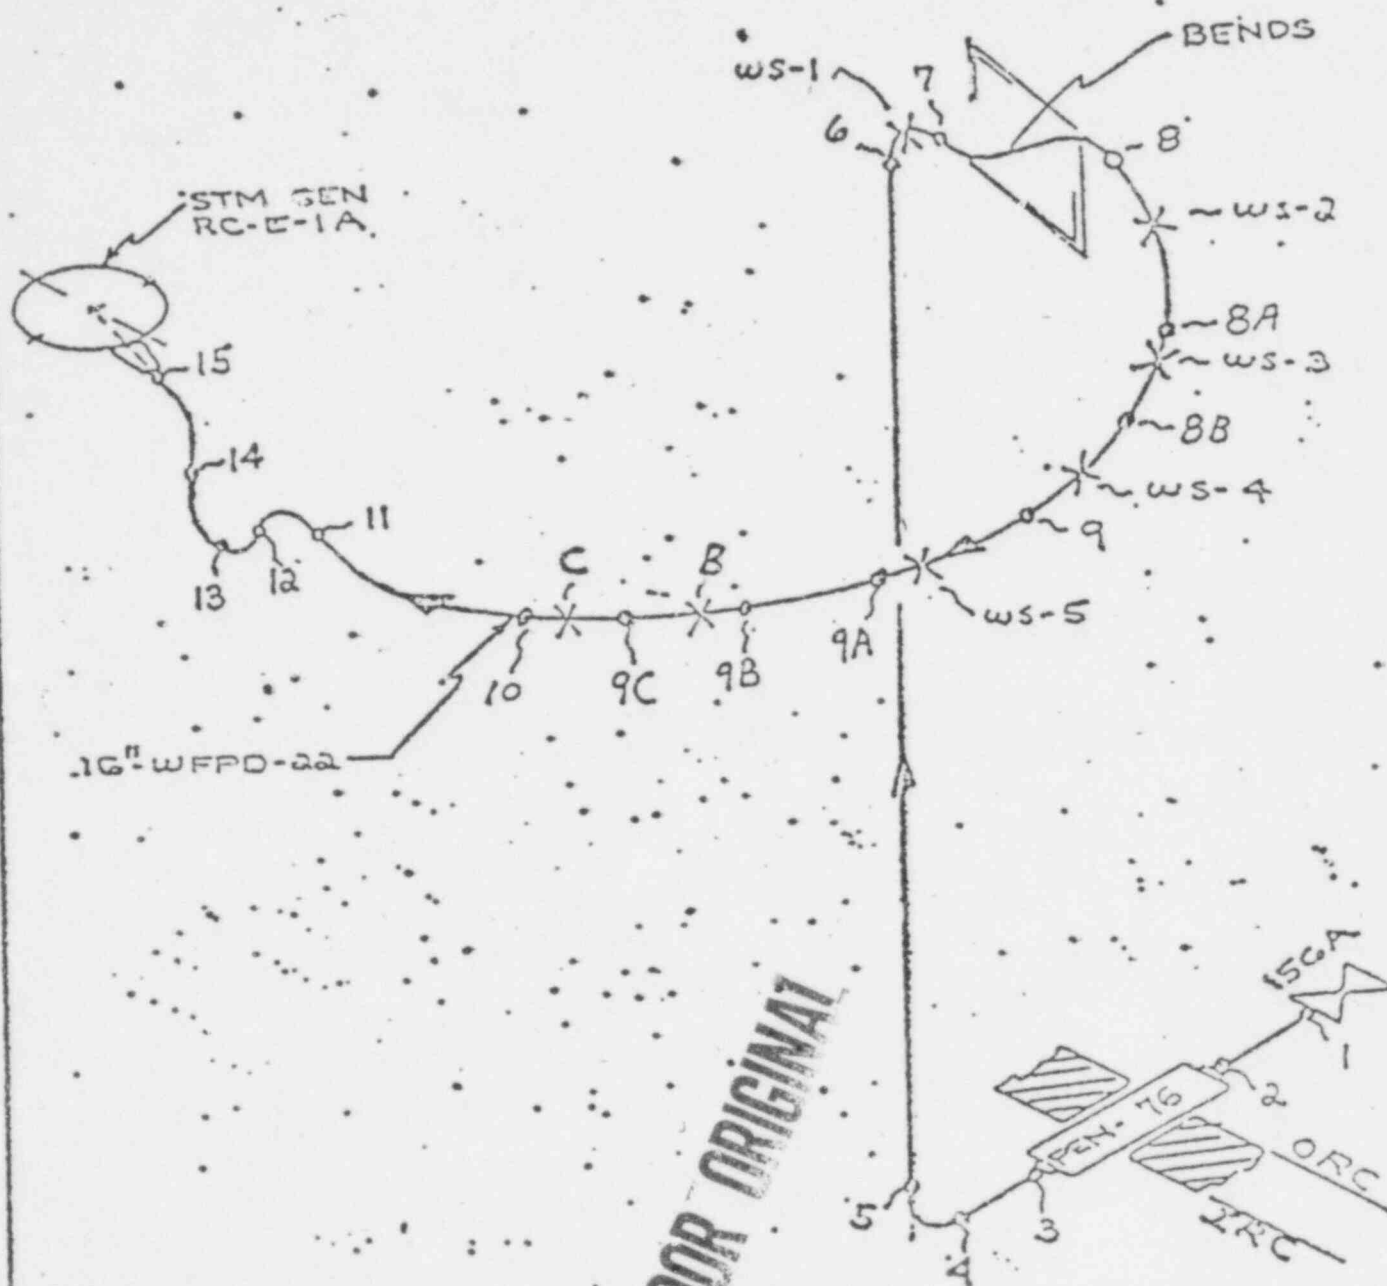
D.LW-2-2210

1 (A)	WELD #	DATE	REJECT	INDICATION	ACCEPT
1 (A)	1				
1 (A)	2	7-7-79			X
1 (A)	3	7-6-79			X
1 (A)	4	7-6-79			X
1 (A)	5	7-5-79			X
1 (A)	6	7-3-79			X
1 (A)	7	7-2-79			X
1 (A)	8	7-2-79	X	INCOMP PENET.	
1 (A)	9	7-1-79			X
1 (A)	10	7-1-79	X	SLAG, INCOMP FUSION	
1 (A)	11	6-28-79	X	INCOMP PENET	
1 (A)	12	6-27-79	X	CRACKS	
1 (A)	13	6-21-79			X
1 (A)	14	6-21-79			X
1 (A)	15	6-19-79	X	CRACKS	
1 (A)	FW-9A	7-7-79	X	INCOMP PENET	
1 (A)	FW-9C	7-7-79			X
1 (A)	FW-9B	7-8-79			X
1 (A)	FW-8A	7-8-79	X	INCOMP PENET	
1 (A)	FW-8B	7-8-79	X	INCOMP PENET	
1 (A)	16" BAND	7-6-79			X
1 (A)	AFW-1	7-6-79			X

A total of 13 welds were found to have indications that required further evaluation. We have decided to repair all thirteen (13) welds that exhibited indications, even though these welds would be acceptable by the inspection requirements of ANSI B.31.1 which is the governing code under which the piping was installed.

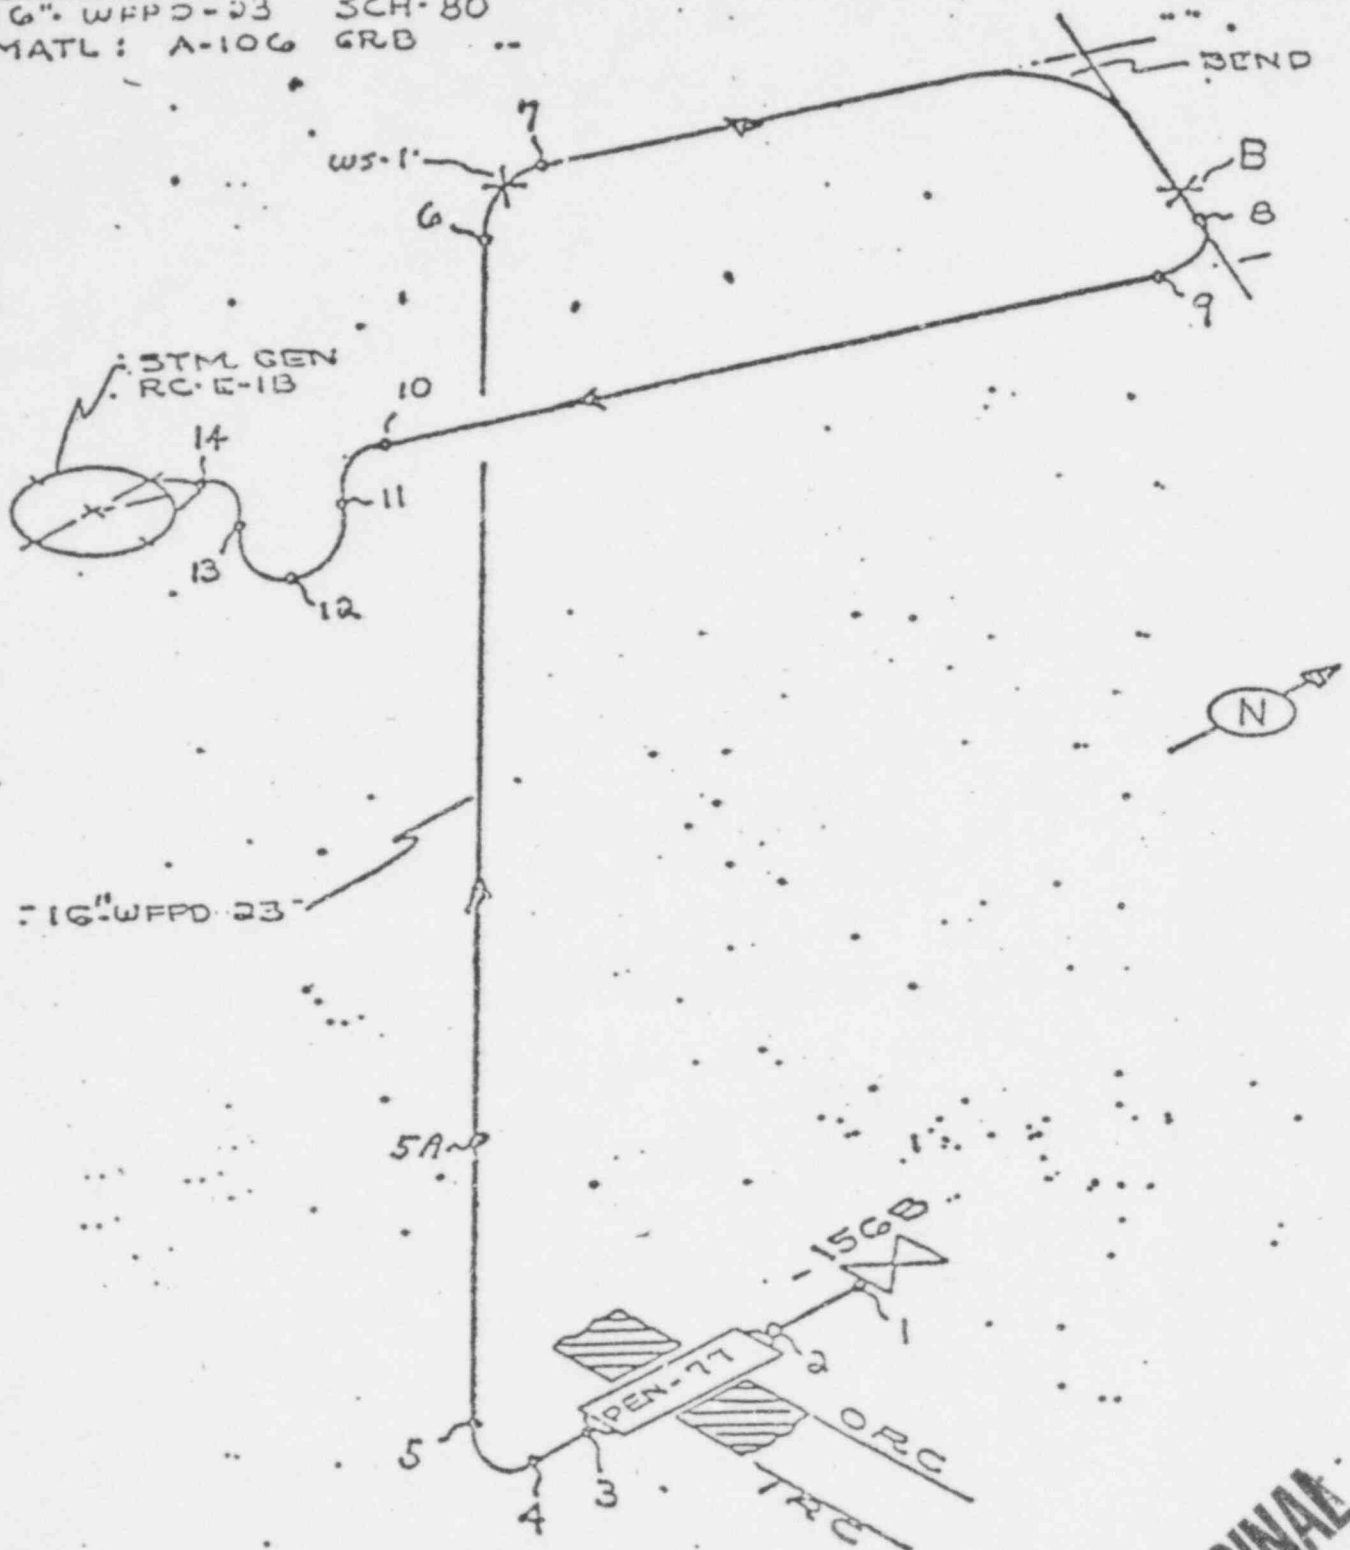
DLW-2-2220

2 (B)	WELD #	DATE	REJECT	INDICATION	ACCEPT
2 (B)	1				
2 (B)	2	7-8-79			X
2 (B)	3	7-6-79			X
2 (B)	4	7-6-79	X	INCOMP PENET	
2 (B)	5	7-5-79			X
2 (B)	6	7-5-79			X
2 (B)	7	7-5-79			X
2 (B)	8	6-29-79			X
2 (B)	9	6-29-79			X
2 (B)	10	6-30-79			X
2 (B)	11	6-19-79			X
2 (B)	12	6-21-79			X
2 (B)	13	6-21-79			X
2 (B)	14	6-18-79	X	CRACKS	
2 (B)	AFW	7-6-79			X
2 (B)	FWS-A	7-9-79			X
2 (B)	16" BAND	7-6-79			X

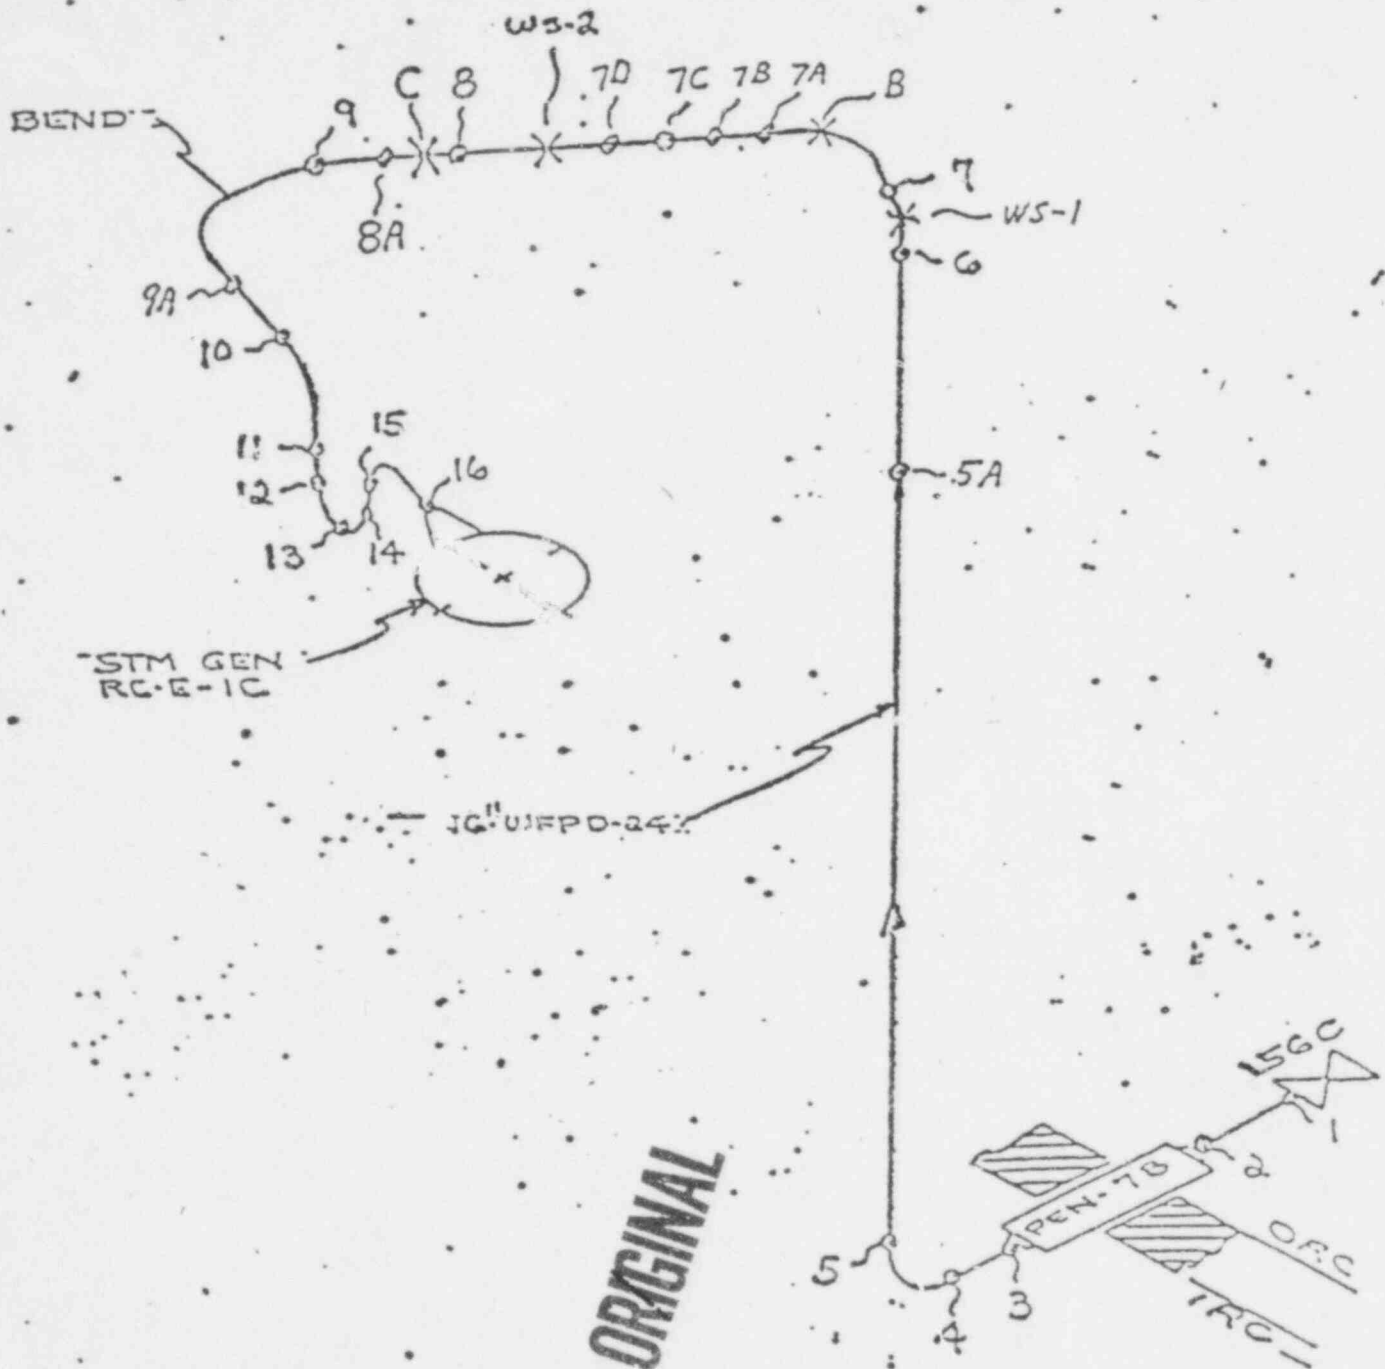
DI.VV 22230

3 (C)	WELD #	DATE	REJECT	INDICATION	ACCEPT
3 (C)	1				
3 (C)	2	7-7-79			X
3 (C)	3	7-6-79			X
3 (C)	4	7-6-79	X	INCOMP PENET CRACK	
3 (C)	5	7-5-79			X
3 (C)	6	7-4-79	X	CRACKS, INCOMP FUSION	
3 (C)	7	7-5-79			X
3 (C)	8	7-4-79			X
3 (C)	9	6-22-79			X
3 (C)	10	6-22-79			X
3 (C)	11	6-22-79	X	CONNECTED POROSITY	
3 (C)	12	6-22-79			X
3 (C)	13	6-22-79			X
3 (C)	14	6-22-79			X
3 (C)	15	6-22-79			X
3 (C)	16	6-18-79	X	CRACKS	
3 (C)	FW9-A	7-7-79			X
3 (C)	FW-8A	7-7-79			X
3 (C)	FW-7D	7-7-79			X
3 (C)	FW-7A	7-7-79			X
3 (C)	FW-7B	7-8-79	X	INCOMP PENET, INCOMP FUSION	
3 (C)	FW-7C	7-8-79			X
3 (C)	AFW-1	7-3-79			X
3 (C)	FW-5A	7-9-79	X	INCOMP PENET, INCOMP FUSION	
3 (C)	16" BAND	7-6-79			X

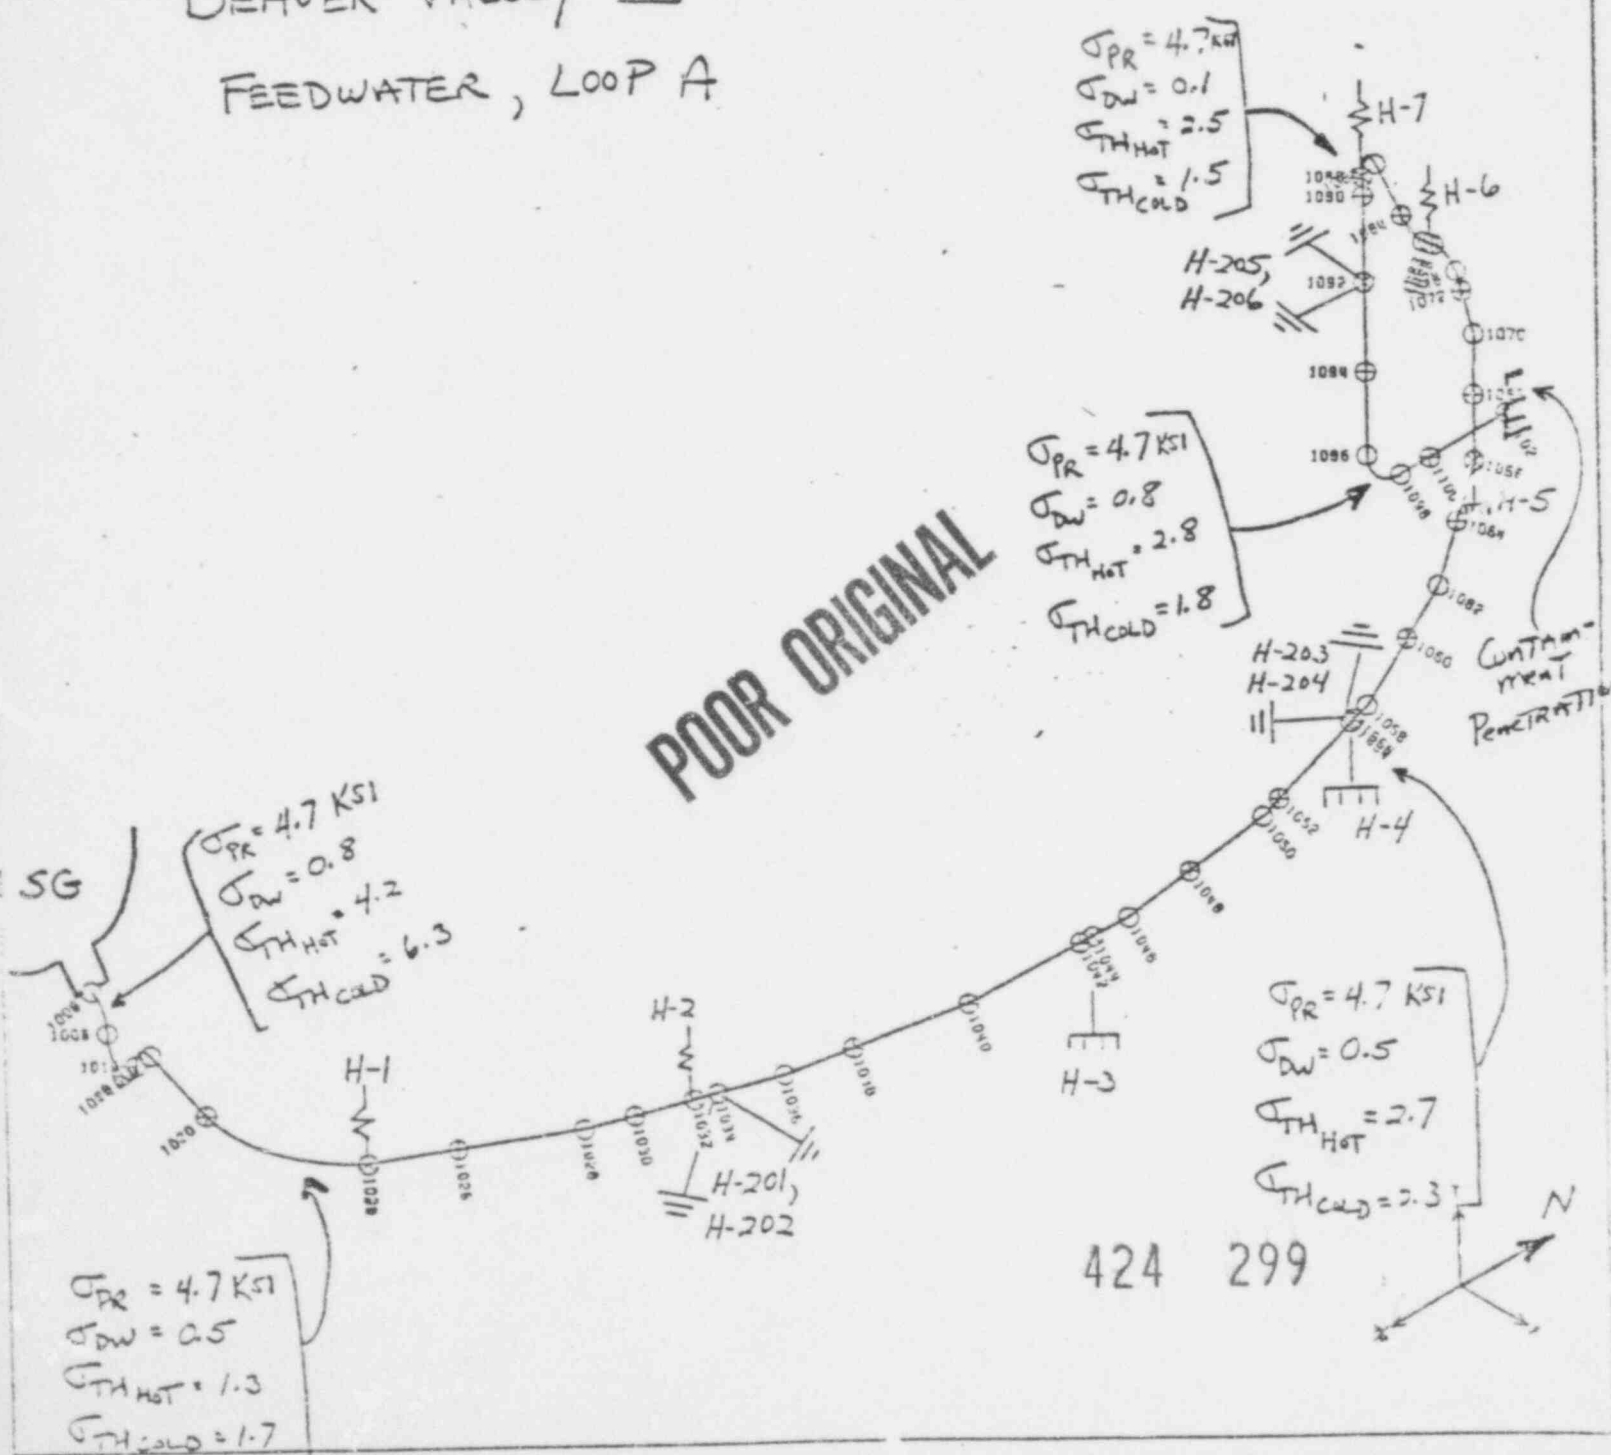
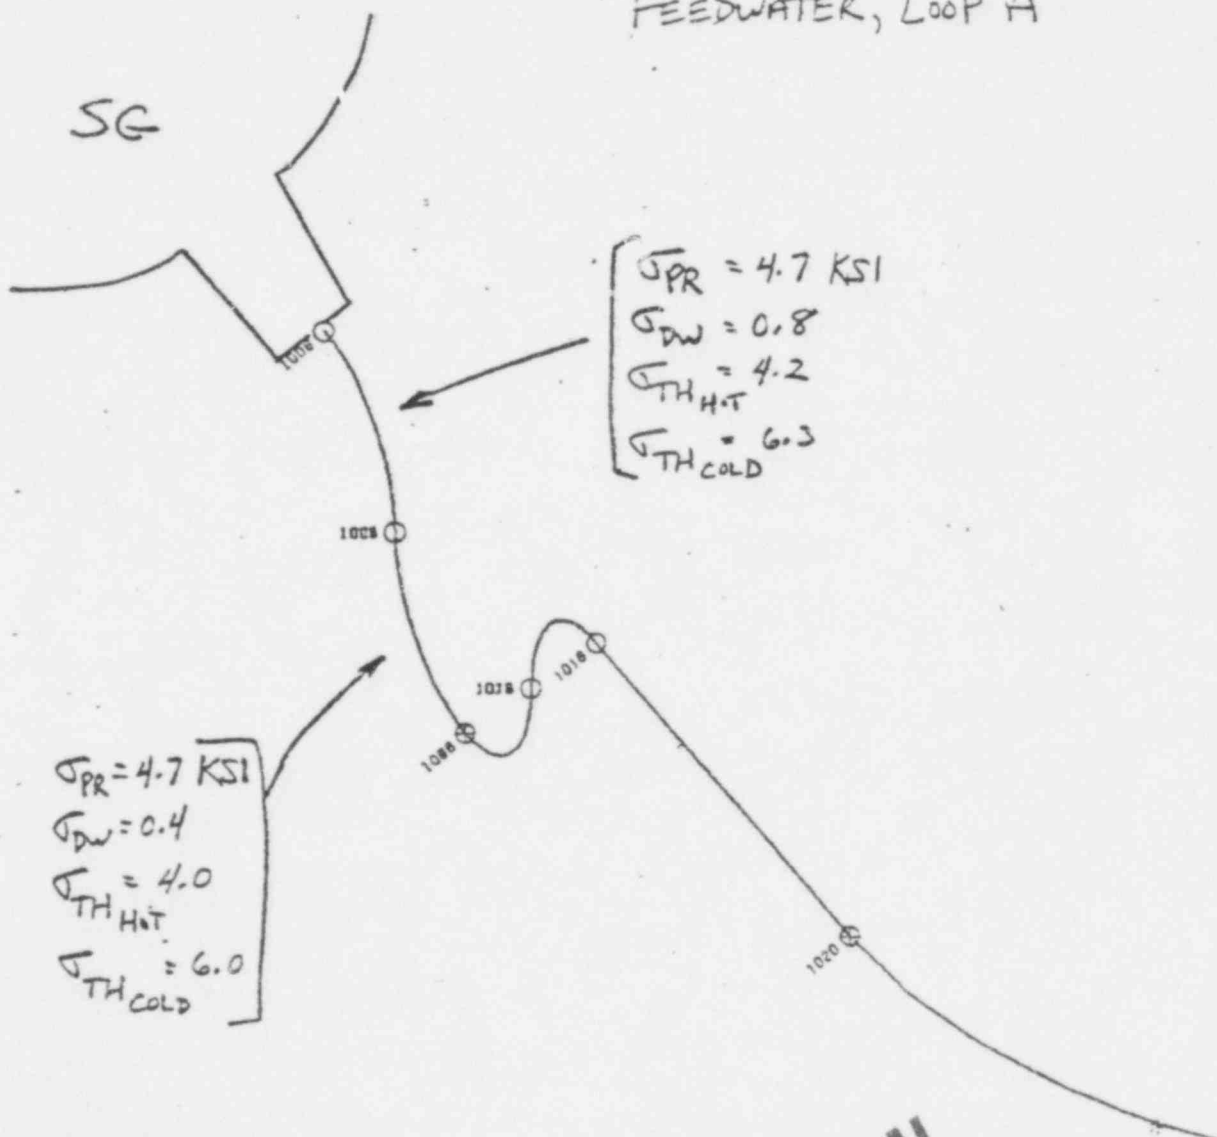
FEEDWATER, LOOP A

Two thermal conditions were run. The first with the SG at ~ 550°F and the feedwater line at ~ 450°F representing normal operation. The second with the SG at ~ 550°F and the feedwater line cold representing the hot shutdown condition. The analyses results show a maximum thermal stress of approximately 12 ksi at the nozzle to pipe junction. The maximum deadweight and pressure stresses

were 2.6 ksi and 4.7 ksi respectively. These stresses are well below code allowable values. The attached sketch shows the basic geometry and the stresses in the feedwater piping.
