Omaha Public Power District

In response to reference (2) above, please find enclosed the completed Steam Generator Operating History Questionnaire for Omaha Public Power District's Fort Calhoun Station. The questionnaire provides updated information relative to steam generator tube inspections performed during the 1978 refueling outage.

Plant: Fort Calhoun Unit No. 1

Inservice Inspection (ISI) Date: October, 1978

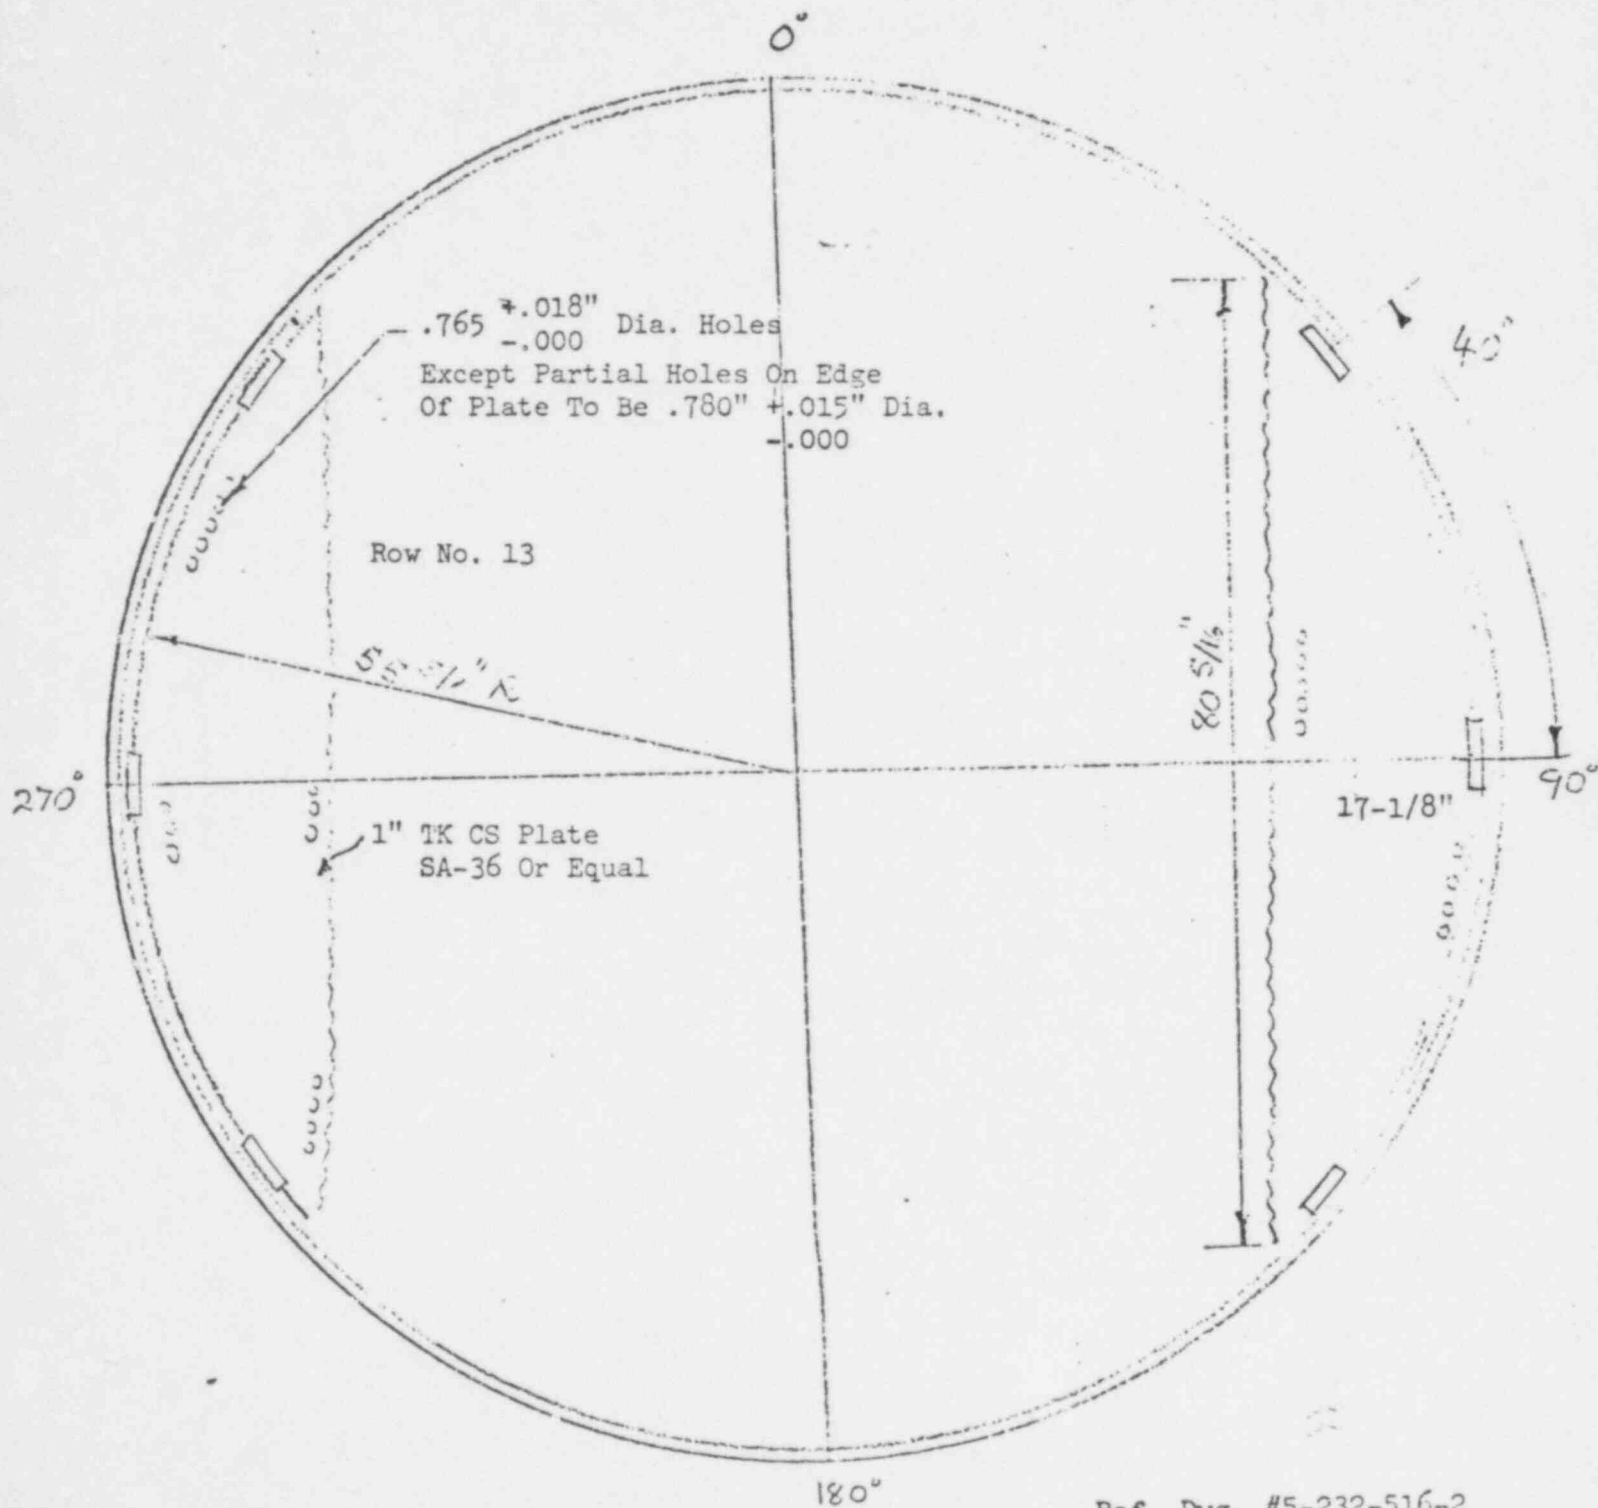
Figure 1

DRILLED PLATE (ELEV. 8)

No. of Tubes - 209

% of Total Surface - 18.2%

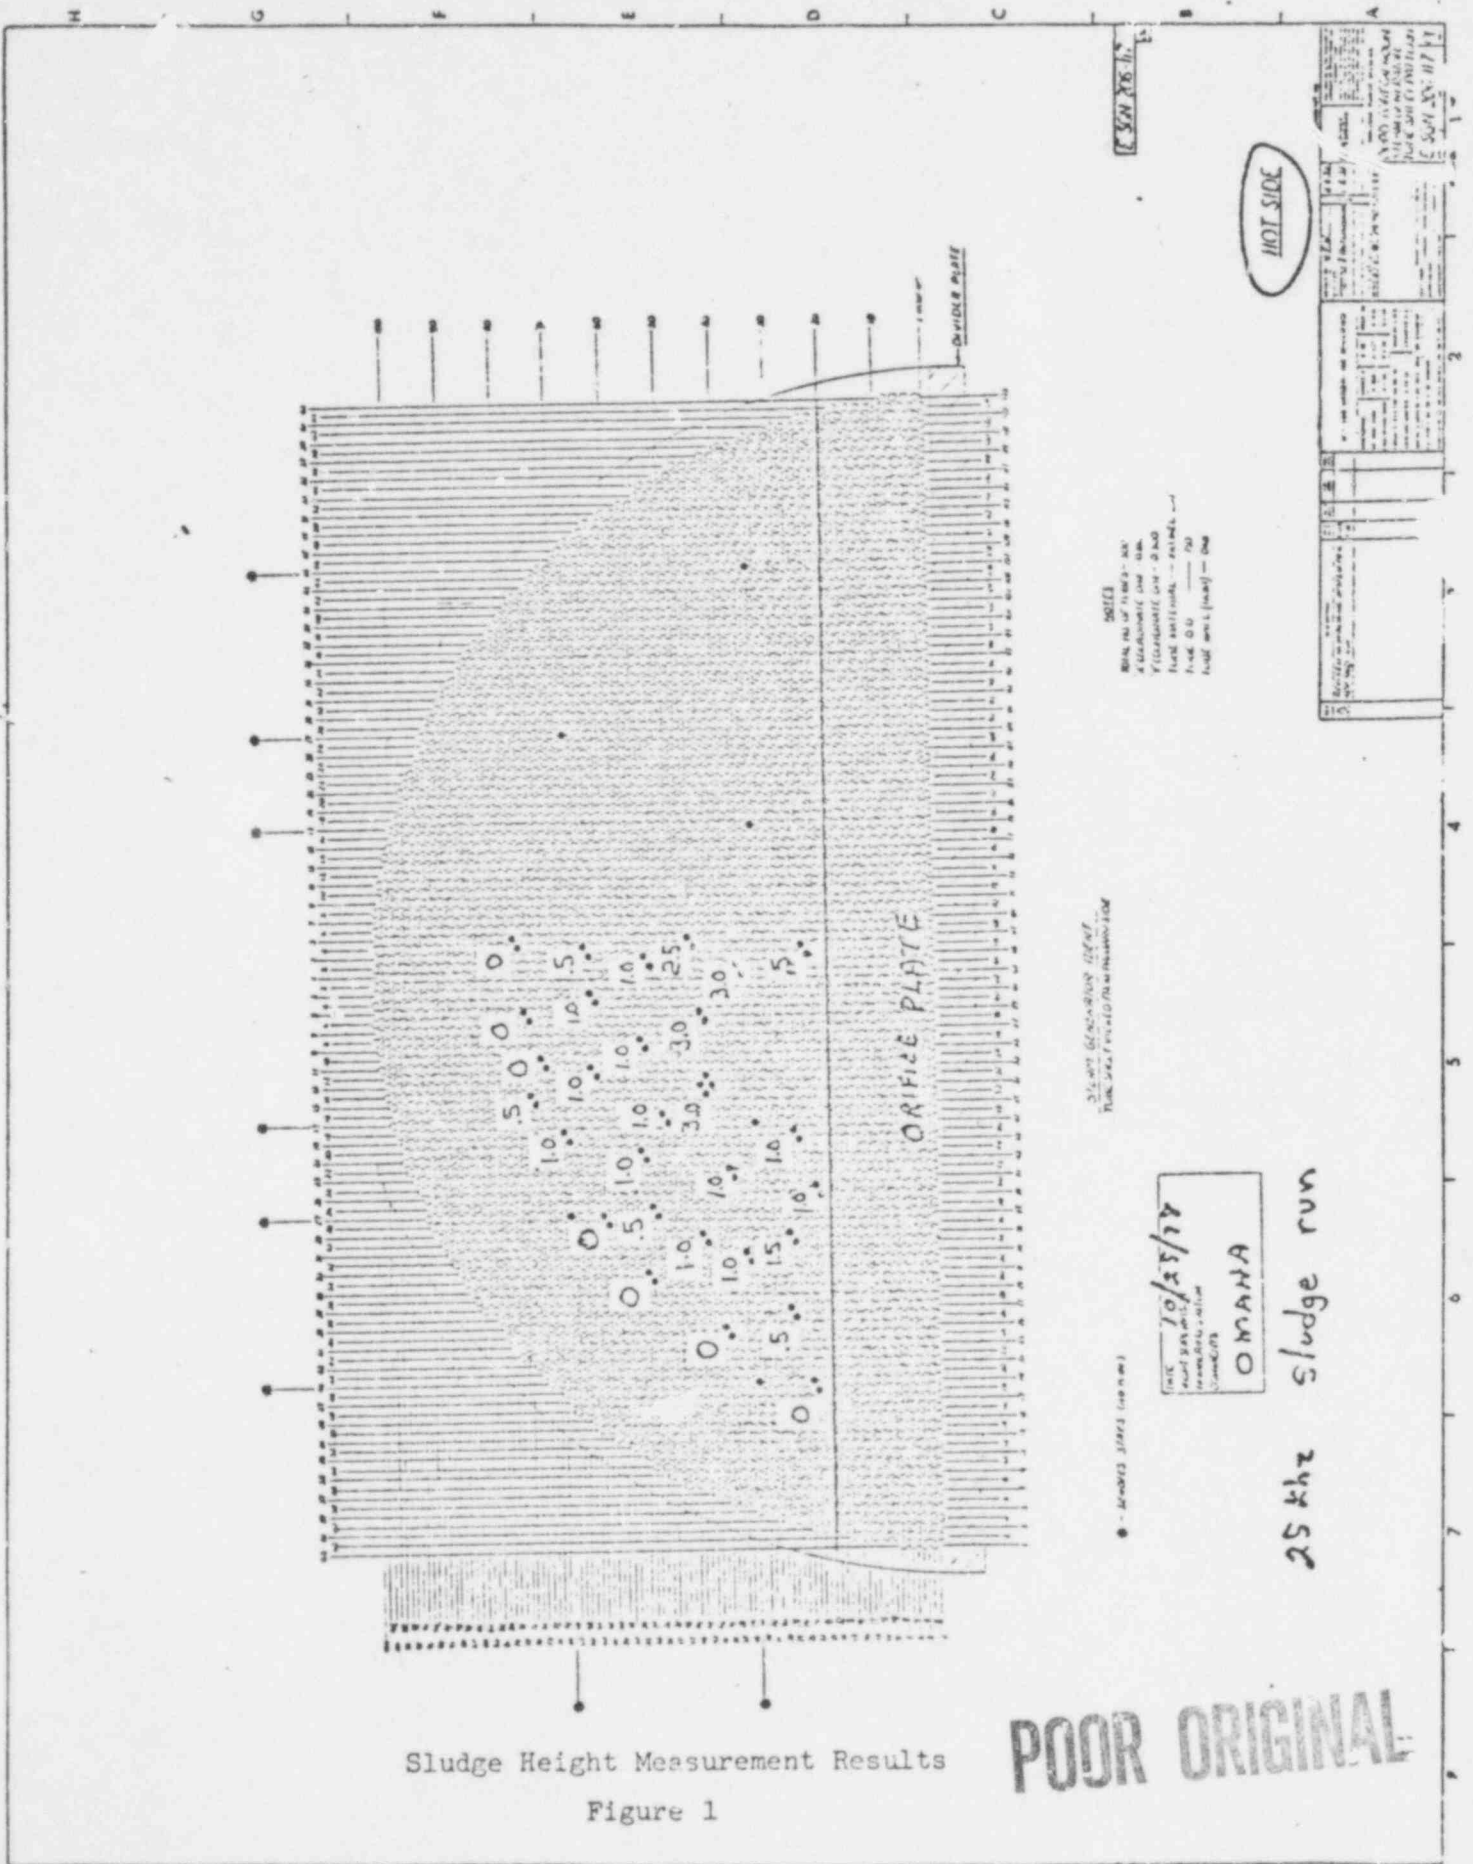
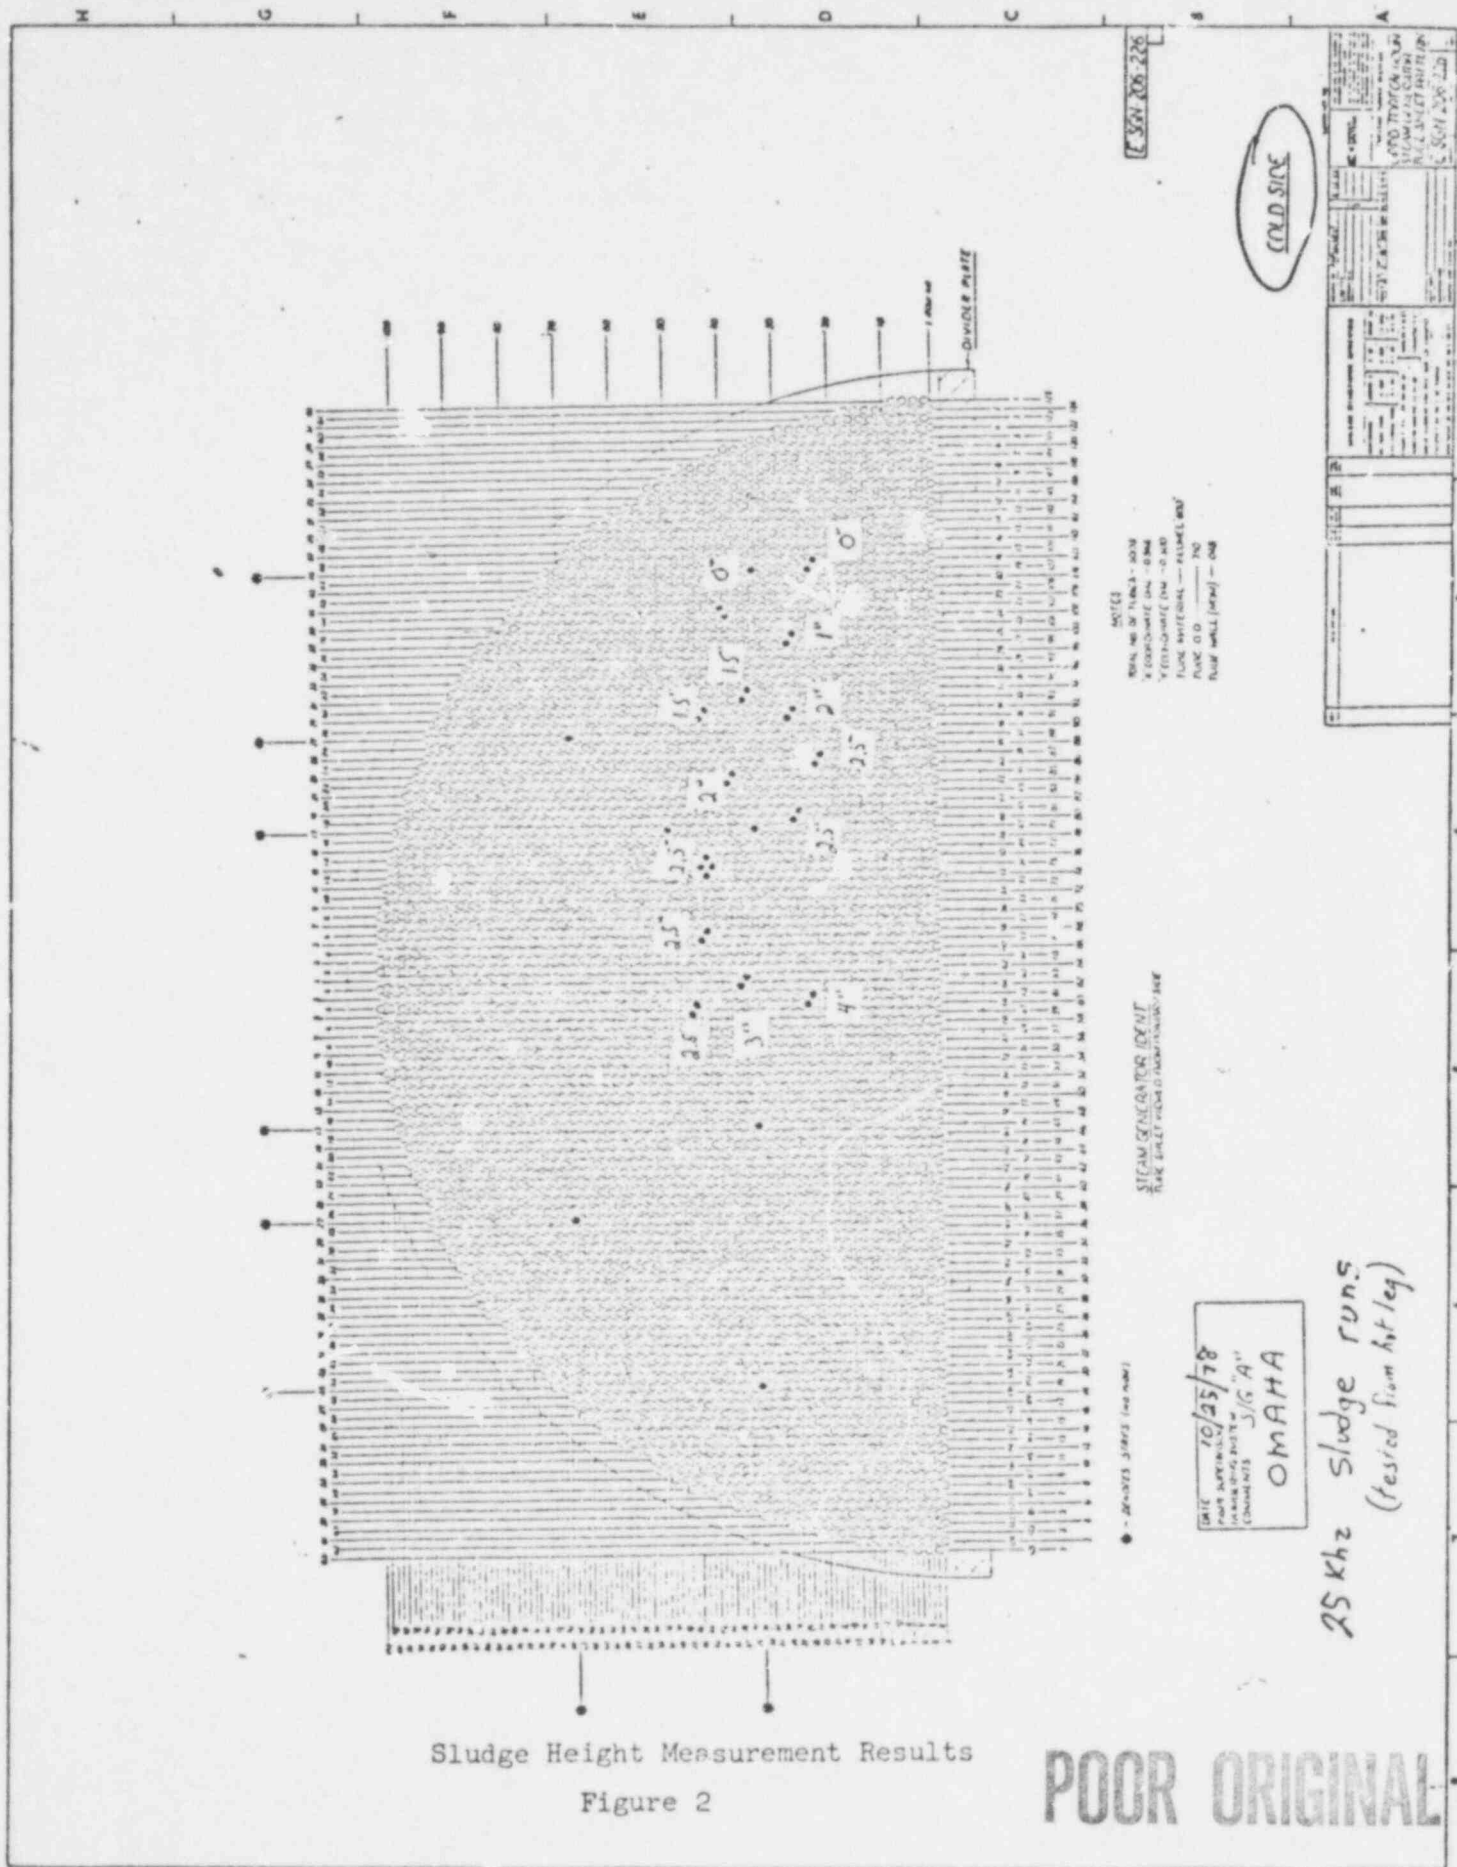
The sludge height measurement results are plotted on the tube sheet maps in Figures 1 and 2 for the hot and cold side. Compared to the 1977 data, the sludge height increased by approximately 1 inch. The hot side observed maximum is 3 inches. The region on the cold side with the maximum sludge height in 1977 (6 inches) was not accessible in 1978 because of the hot side orifice plate.
