**MRP 2019-023**

Subject: Transmittal of MRP-227-A-Related Interim Inspection Guidance Regarding PWR  
Core Barrel

Subject: Transmittal of NEI-03-08 "Good Practice" Interim Guidance Regarding MRP-227-A and MRP-227, Revision 1 PWR Core Barrel and Core Support Barrel Inspection Requirements

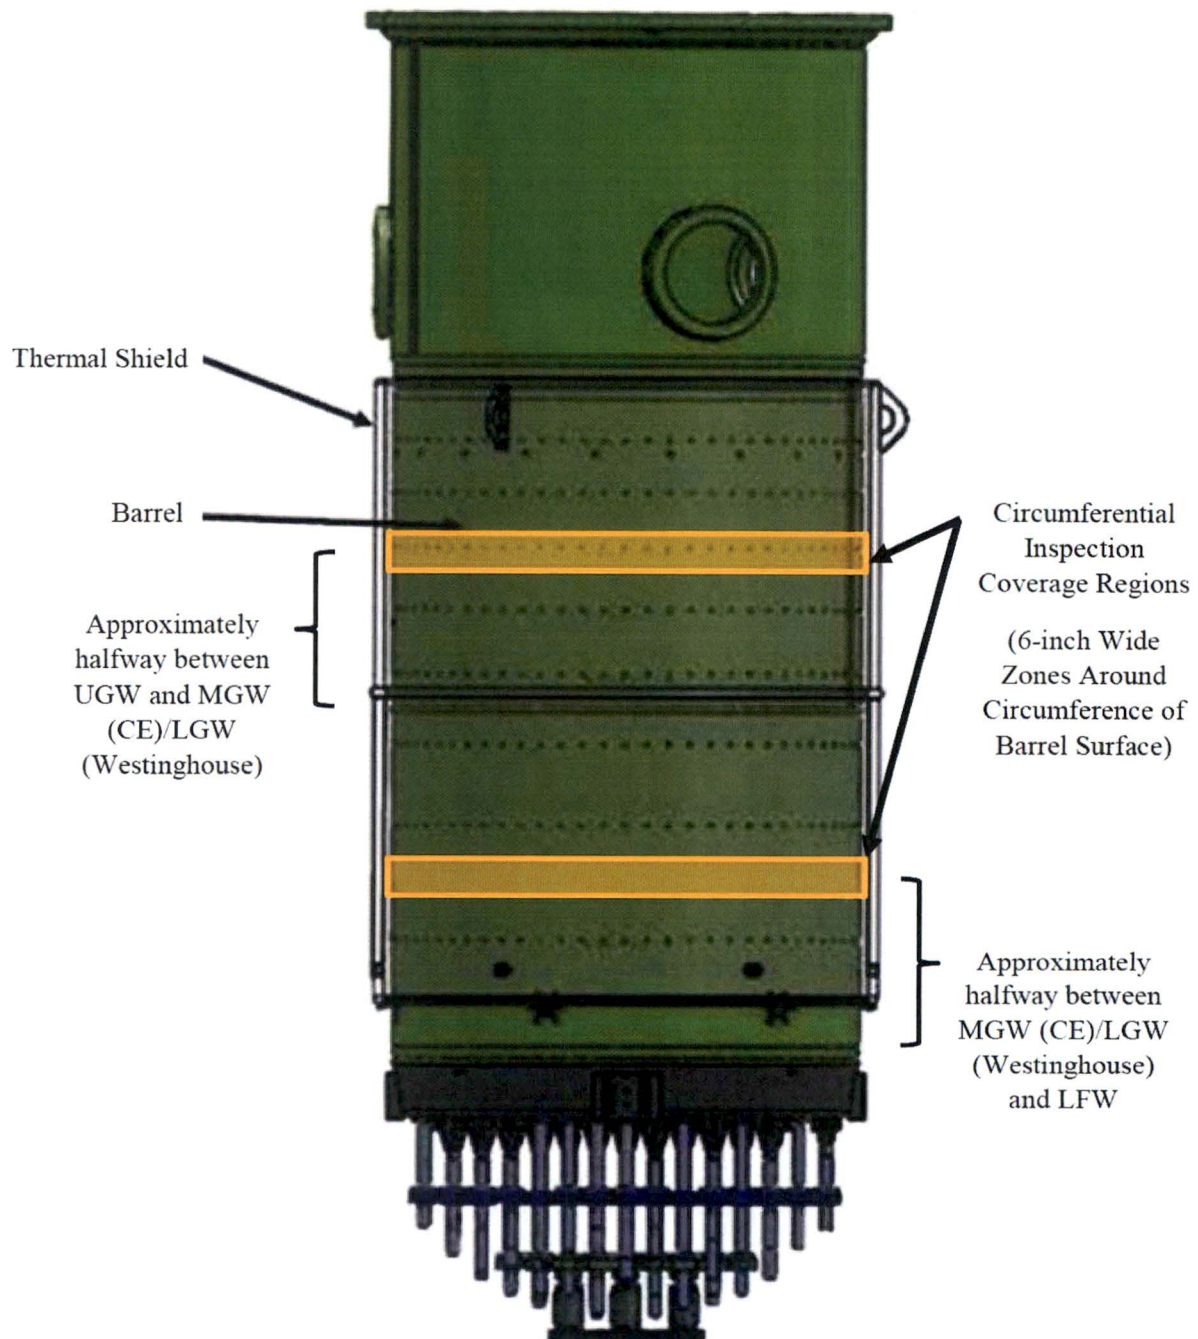
**Figure 4: CE or Westinghouse Thermal Shield Inspection Option – Unknown Axial Weld Locations**

In the third case, for thermal shield plants where axial weld locations are unknown, an alternate inspection strategy is recommended. One of the following two coverage options can be used:

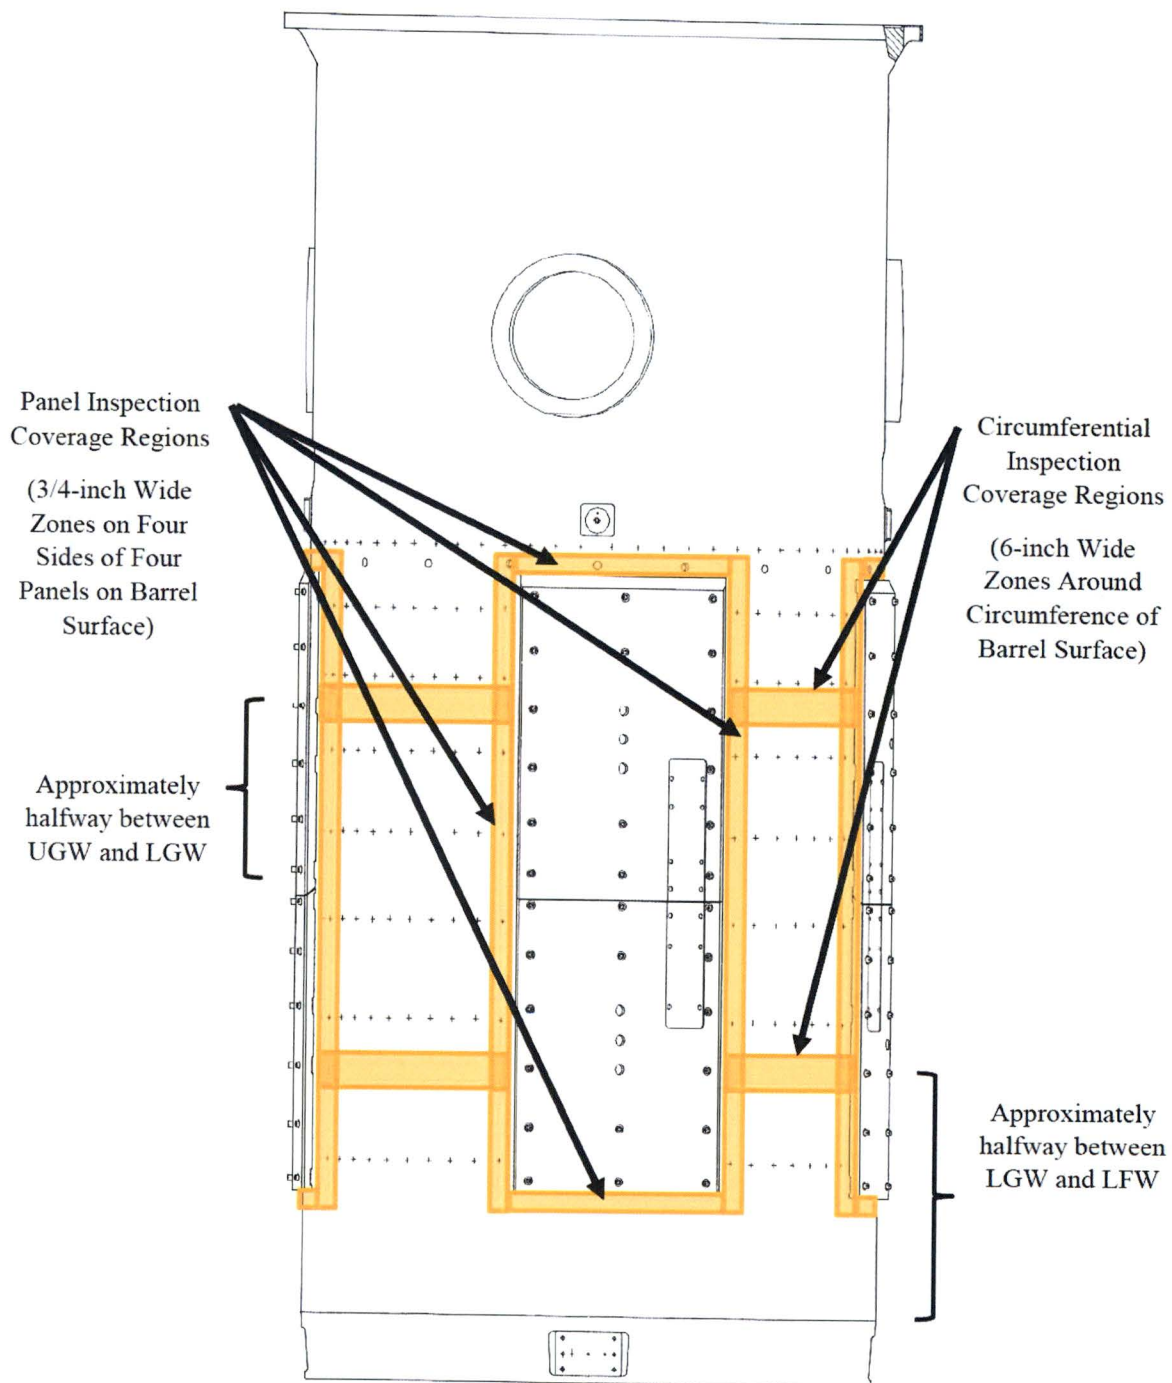
Figure 6: Example of Westinghouse Neutron Panel Inspection Option – Unknown Axial Weld Locations

The third axial weld case also will not support the 75% minimum coverage requirement used for Group 1 plants. The third case also does not fit with the inspection around a single neutron panel recommended for the second case. Since the weld location is not known, it could be located behind any one of the four neutron panels or in one of the areas between panels. It is recommended that this inspection be completed in two parts for this case (see Figure 6):

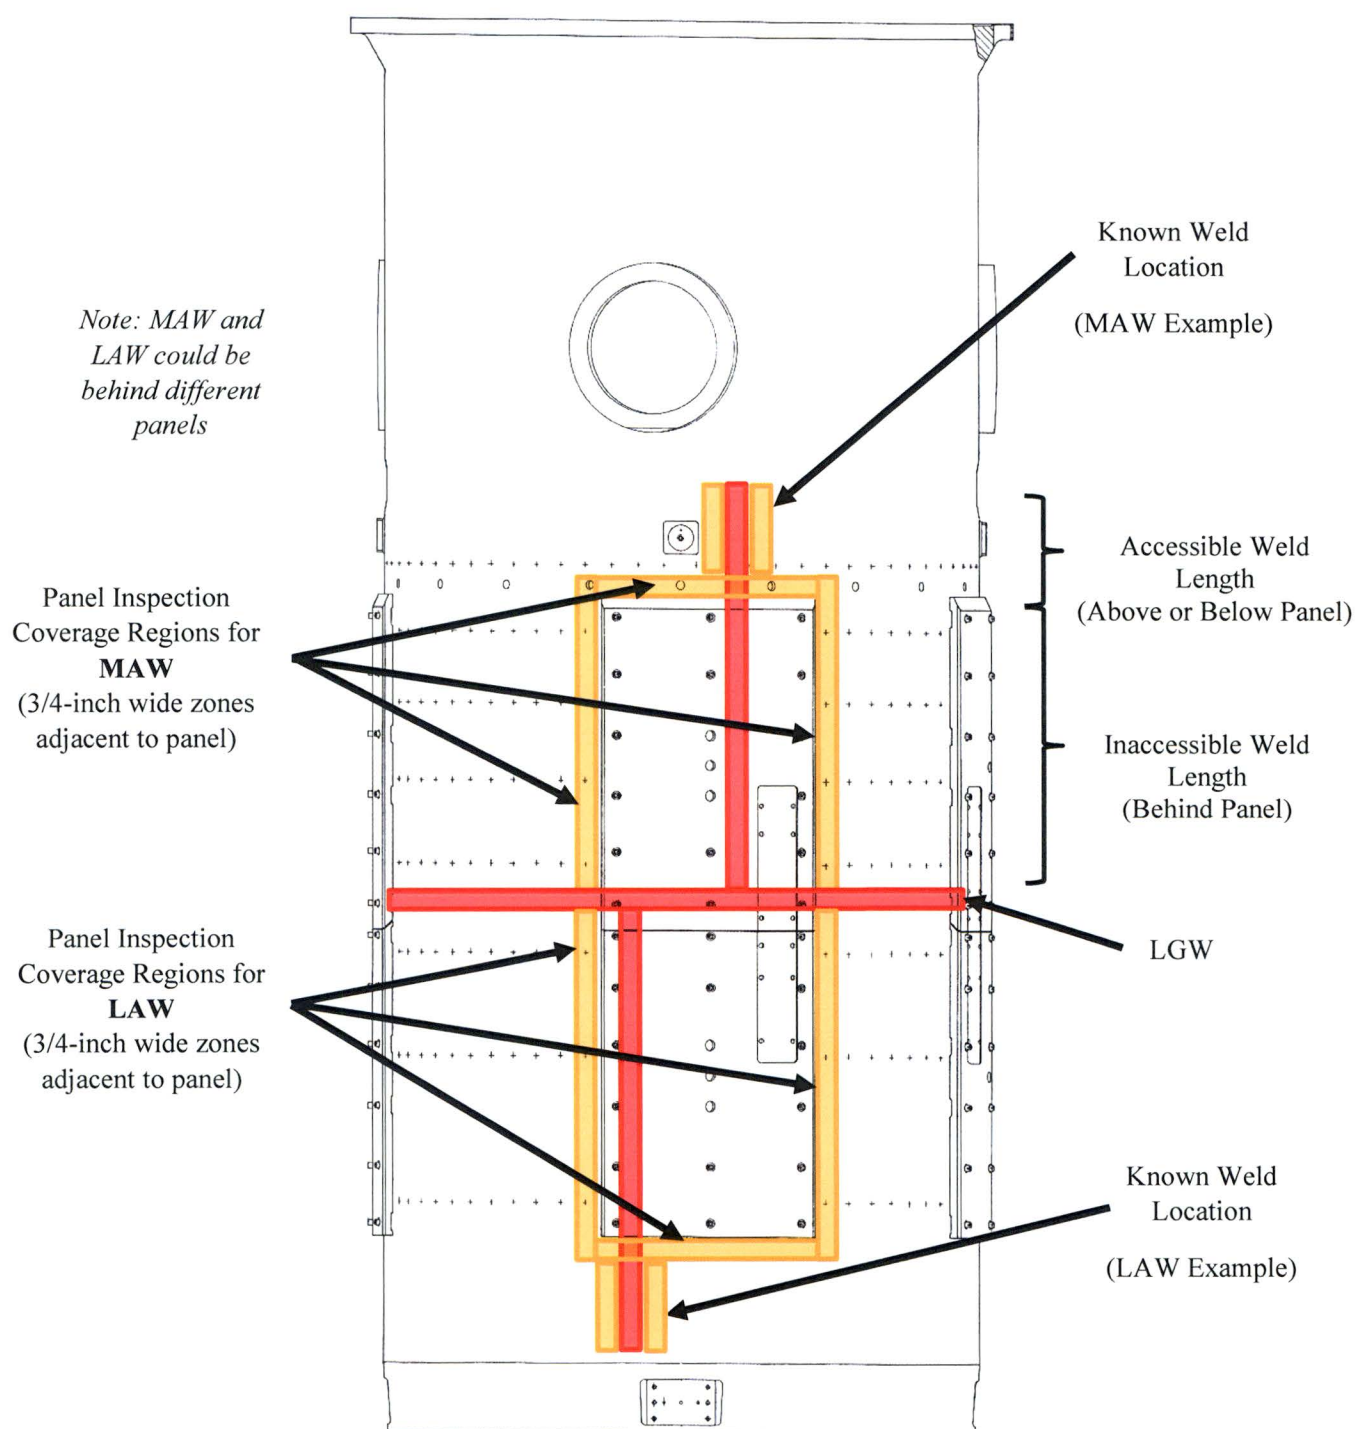
**Figure 5: Neutron Panel Plants - Known Partially Inaccessible MAW and LAW Locations (Second Case)**

The second axial weld case will not support the 75% minimum coverage requirement used for Group 1 plants, since a large portion of the axial weld will be inaccessible behind the neutron panel. In this case, the following alternate inspection is recommended (see Figure 5): 1) inspect 100% of the accessible weld lengths from the barrel OD (portion that is accessible above or below the neutron panel); 2) inspect 3/4-inch minimum wide zones of the CB OD adjacent to each neutron panel that covers the MAW or LAW. The coverage adjacent to each neutron panel should include, at a minimum, the barrel OD along both long, vertical edges of the panel up to the girth weld and either the top edge for MAW or the bottom edge for LAW.

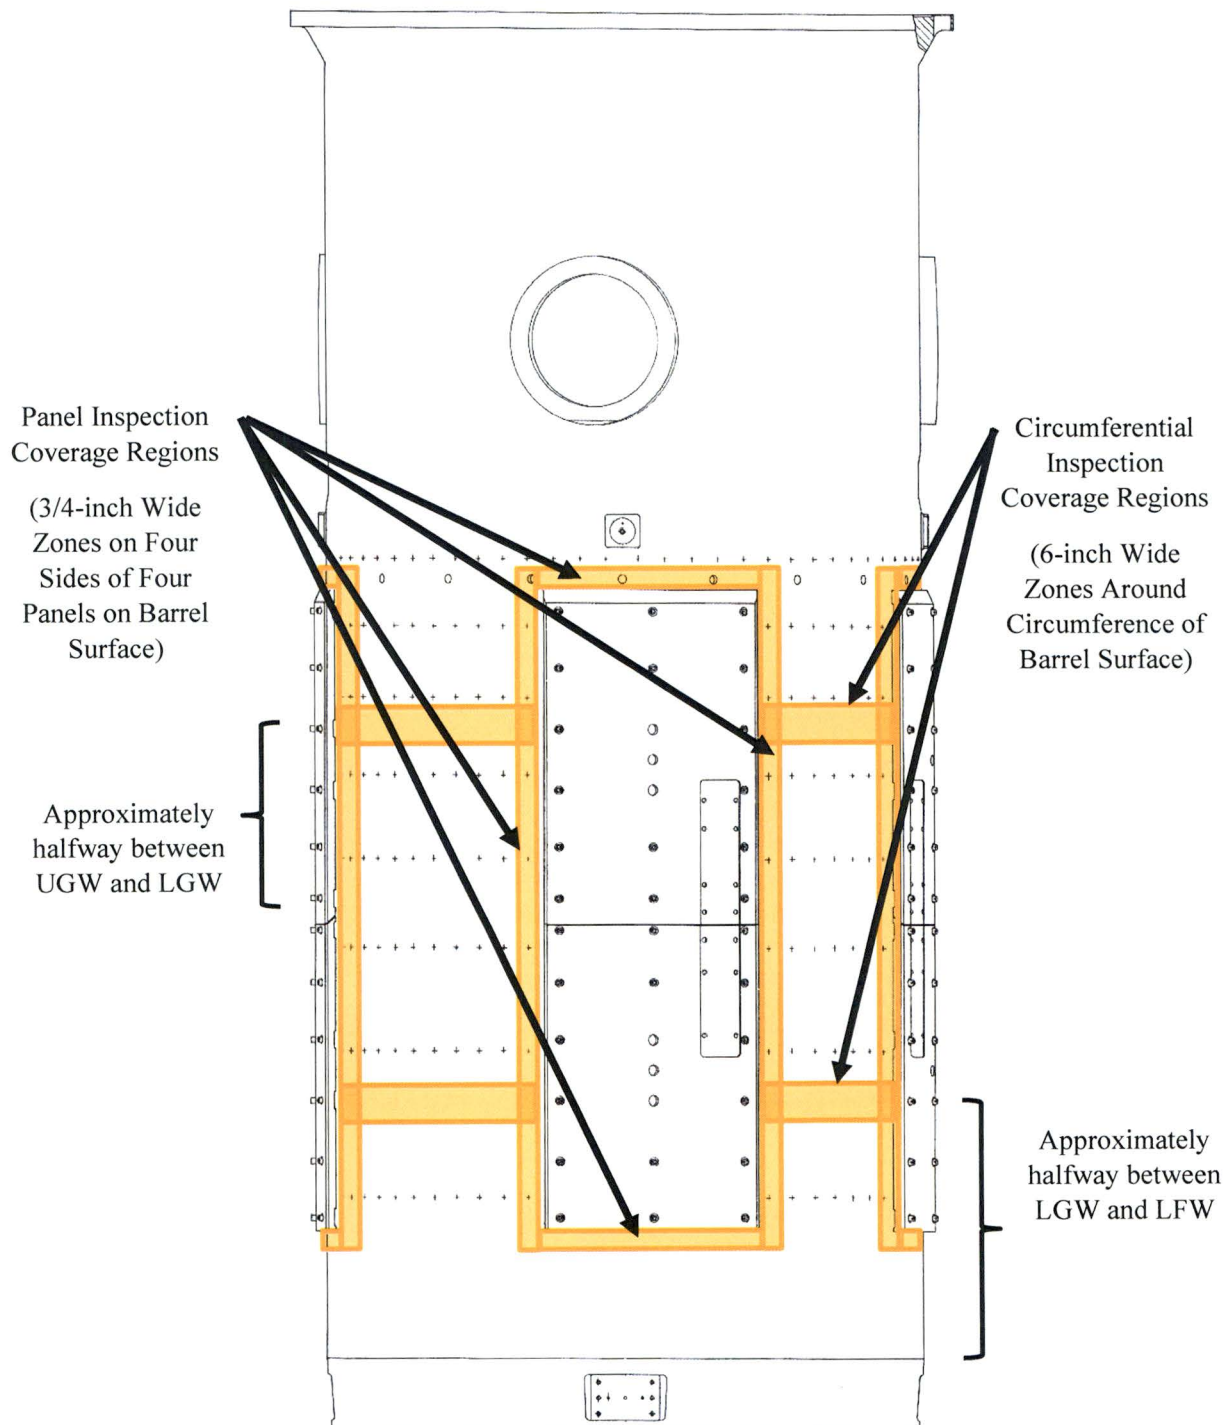
**Figure 6: Neutron Panel Plants - Unknown MAW and LAW Locations (Third Case, Using 6-inch Bands)**

The inspection zones around the neutron panels in the first part also increase the sample area to account for unknown weld locations and to monitor for cracks propagating from the axial weld behind the panel. Inspection of the region immediately adjacent to the panels also focuses the examination on the regions closest to the high fluence portions of the barrel. As irradiation-assisted SCC (IASCC) is driven by neutron fluence [18], inspection of the most highly irradiated material focuses the monitoring on the most likely areas to crack. The root cause for the flaws in the St. Lucie Unit 1 CSB has not been determined, so other aging mechanisms could be attributed to the flaws at St. Lucie Unit 1. The flaws at St. Lucie Unit 1 may have been remnants from an earlier fatigue-induced cracking event due to a thermal shield issue; however, IASCC continues to be one of the expected aging mechanisms in MRP-227 for beltline region barrel welds. Therefore, IASCC cannot be ruled out as an aging mechanism for the barrel, and the requirement to monitor the locations susceptible to IASCC should be maintained.
