LICENSEE EVENT REPORT

REPORTABLE OCCURRENCE 79-30

FORT ST. VRAIN NUCLEAR GENERATING STATION
PUBLIC SERVICE COMPANY OF COLORADO
P. O. BOX 361
PLATTEVILLE, COLORADO 80651

REPORT NO. 50-267/79-30/03-L-0

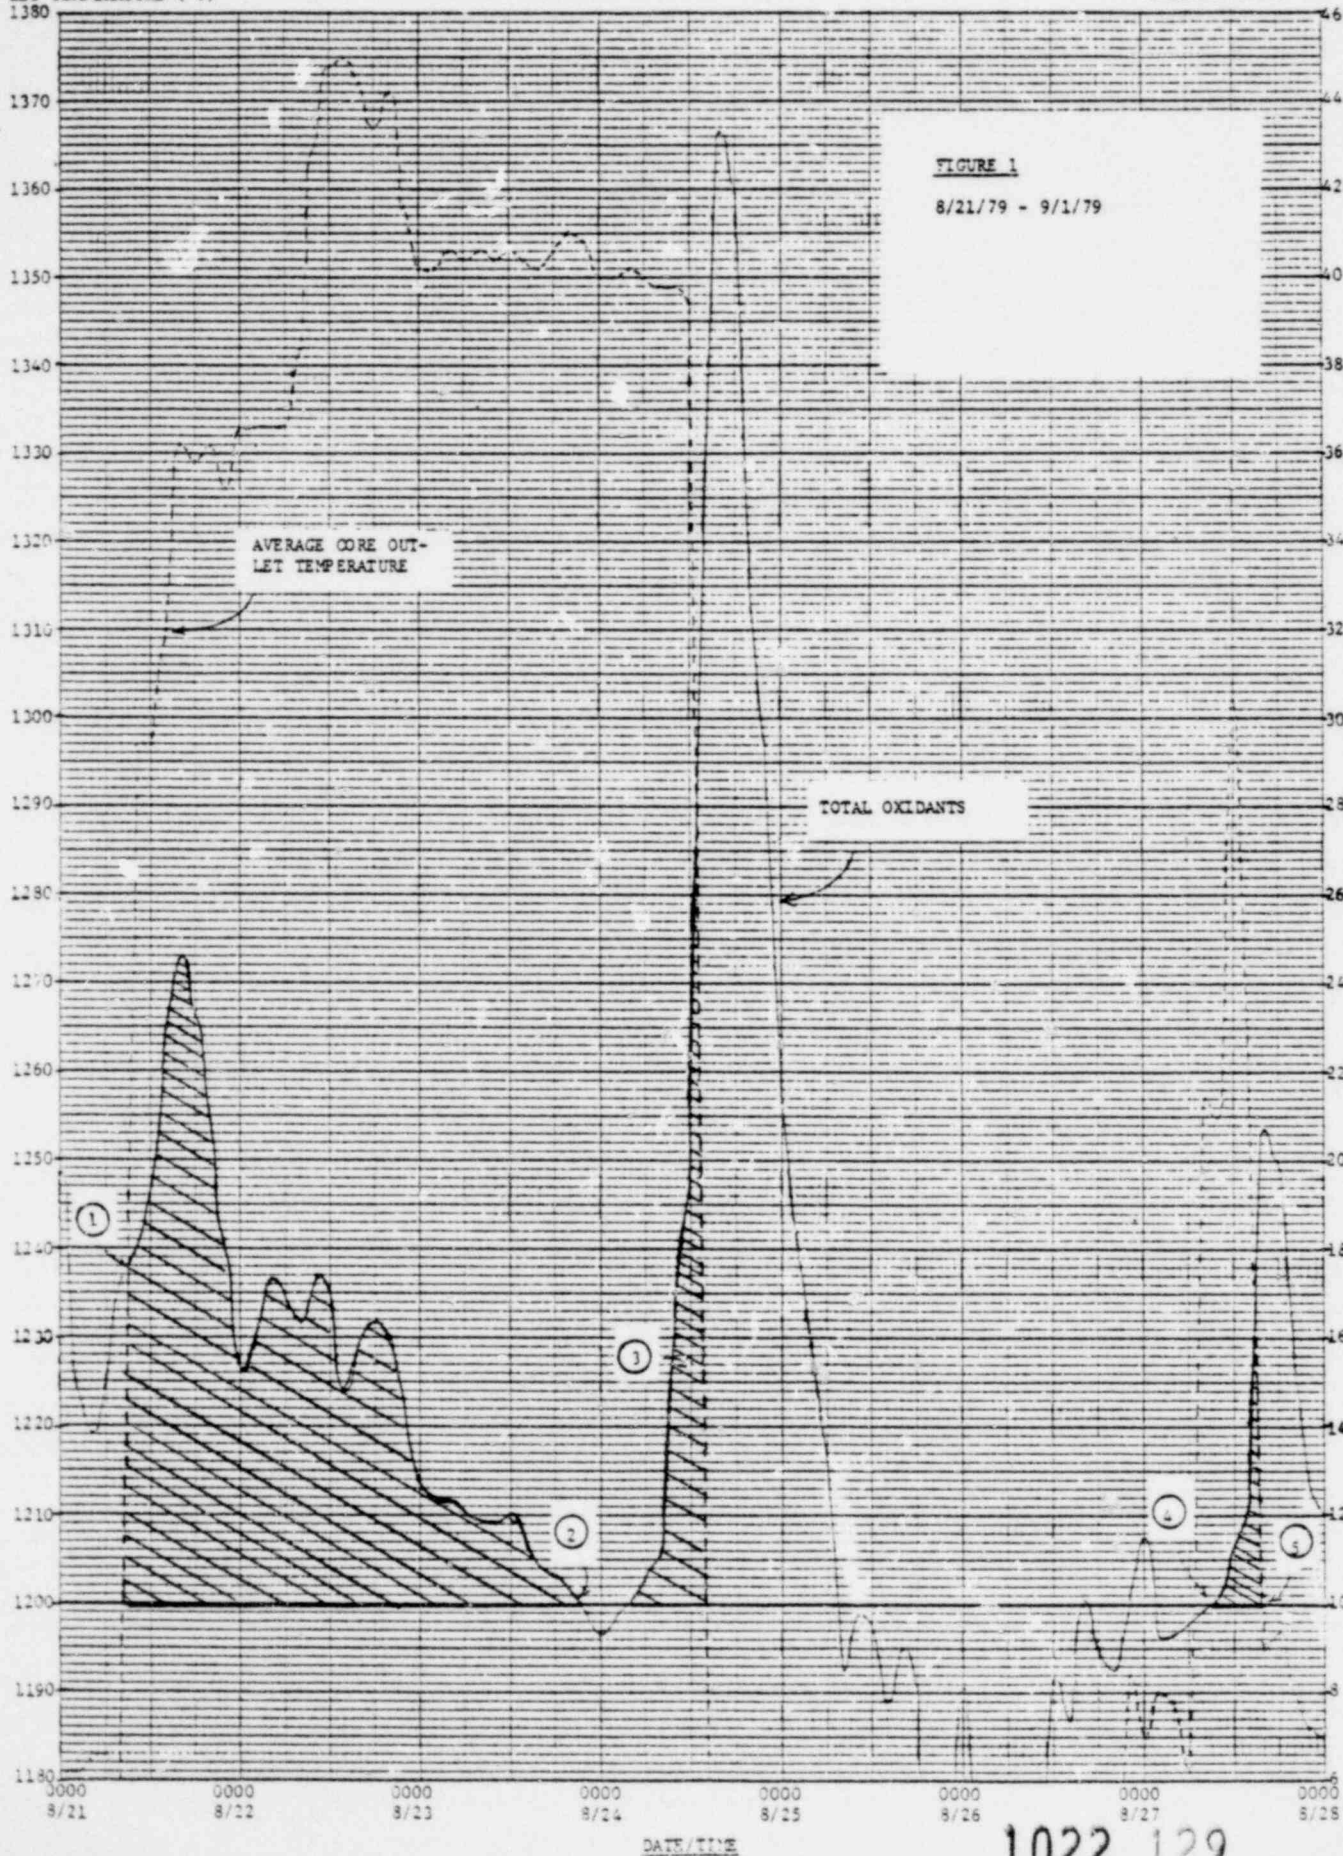
AVERAGE CORE OUTLET TEMPERATURE AND TOTAL PRIMARY COOLANT OXIDANTS

As the plant was being returned to power following recovery from the reactor scram of August 17, 1979, operation was maintained with average core outlet temperature less than 1,200°F until approximately 0830 hours on August 21, 1979. From that time until approximately 1200 hours on September 1, 1979, the plant was operated in a degraded mode permitted by LCO 4.2.10 on six occasions. These occurrences are indicated by the shaded areas of Figure 1, and are described below.

At the point where average core outlet temperature first exceeded 1,200°F, the total of primary coolant oxidants was approximately 17.4 parts per million. (Reference point ①, Figure 1.) As reactor power and temperature were increased, total primary coolant oxidants increased initially and then began to decrease as increased temperatures allowed the moisture to outgas from the graphite in the core.

At approximately 2100 hours on August 23, 1979, (reference Figure 1, point ②) sufficient decrease in primary coolant oxidants had occurred that the plant was no longer operating in a degraded mode of LCO 4.2.10.

2. Primary coolant oxidant levels again reached the 10 parts per million value with average core outlet temperature greater than 1,200°F on August 24, 1979. At approximately 1200 hours, operations personnel observed that primary coolant moisture levels were increasing rapidly, and it was decided to lower reactor power while attempting to determine the cause of the moisture ingress. The duration of this occurrence is the area under the curve of Figure 1 referenced by point (3). At approximately 1415 hours, core outlet temperature had been reduced below 1,200°F.
3. Following the reactor power decrease, primary coolant oxidant levels reached a peak value of 43.3 parts per million with core outlet temperature less than 1,200°F, at 1600 hours on August 24, 1979, and decreased rapidly after that.

As a result of a gradual power increase beginning at approximately 0600 hours on August 26, 1979, and the resultant increase in temperature, oxidant levels began to increase. At approximately 1000 hours on August 26, 1979, the plant was again operating in a degraded mode allowed by LCO 4.2.10 (reference Figure 1, point (4)). Because primary coolant oxidants continued to rise, core outlet temperature was again reduced to less than 1,200°F. By 1600 hours, the plant was again operating within LCO 4.2.10 limits (reference point (5), Figure 1).

4. Core outlet temperature was maintained at less than 1,200°F to facilitate primary coolant moisture removal until approximately 0300 hours on August 31, 1979. At that time, primary coolant oxidants were on a decreasing trend following an earlier helium dryer bypass which resulted in moisture ingress to the core. The one-half hour time period at core outlet temperature greater than 1,200°F was a result of increasing power to 43% per approved fluctuation testing. (Reference point (6), Figure 1.) Reactor power and core outlet temperature were controlled in accordance with fluctuation testing for the remainder of the day.

5. Two more instances of LCO 4.2.10 degraded mode operation occurred on September 1, 1979. As a result of fluctuation testing and accompanying changes in average core outlet temperature (see Figure 1, area referenced by points (7) and (8)), fluctuation testing was suspended at 1130 hours on September 1, 1979, core average outlet temperature was decreased to less than 1,200°F, and no further operation under degraded mode of LCO 4.2.10 occurred.

1. Oxidant levels associated with this event are attributable to outgassing as a result of moisture removal following recovery from the reactor scram of August 17, 1979.
2. The sudden increase in primary coolant moisture on August 24, 1979, appears to be the result of a longer than normal regeneration cycle on the off-line helium dryer, which allowed the on-line dryer to remain in service long enough to become saturated.
3. The six hour time period of degraded mode operation referenced in item 3 is attributable to outgassing as a result of water reacting with the graphite in the core as temperature increased.
4. and 5. The degraded mode operation referenced in items 4 and 5 of the Event Description occurred as a result of increases in power level called out by approved temperature fluctuation testing.

1. For the operation referenced in item 1, sufficient outgassing occurred at the increased temperatures and total primary coolant oxidants eventually decreased to less than 10 parts per million; thus, no specific corrective action was necessary.

2. As a result of the moisture ingress on August 24, 1979, referenced in item 2, reactor power was decreased, and no further degraded mode operation occurred after 1415 hours. After the helium dryer towers swapped, primary coolant oxidants began a decreasing trend.

3. For the occurrence of August 27, 1979, reactor power and core outlet temperature were reduced in order to remain within limits of LCO 4.2.10, and total primary coolant oxidants began a decreasing trend shortly afterwards.

4. and 5. The remaining periods of degraded mode operation all occurred as a result of power increases per approved fluctuation testing. Following termination of testing on September 1, 1979, no further operation occurred under a degraded mode of LCO 4.2.10.
