Joseph M. Farley Nuclear Plant - Unit 2
Auxiliary Feedwater System
File: A-35.62.47
Log: 78-248

ALABAMA POWER COMPANY
JOSEPH M. FARLEY NUCLEAR PLANT-UNIT 2

Report of Modified Corrective Action for Auxiliary Feedwater System

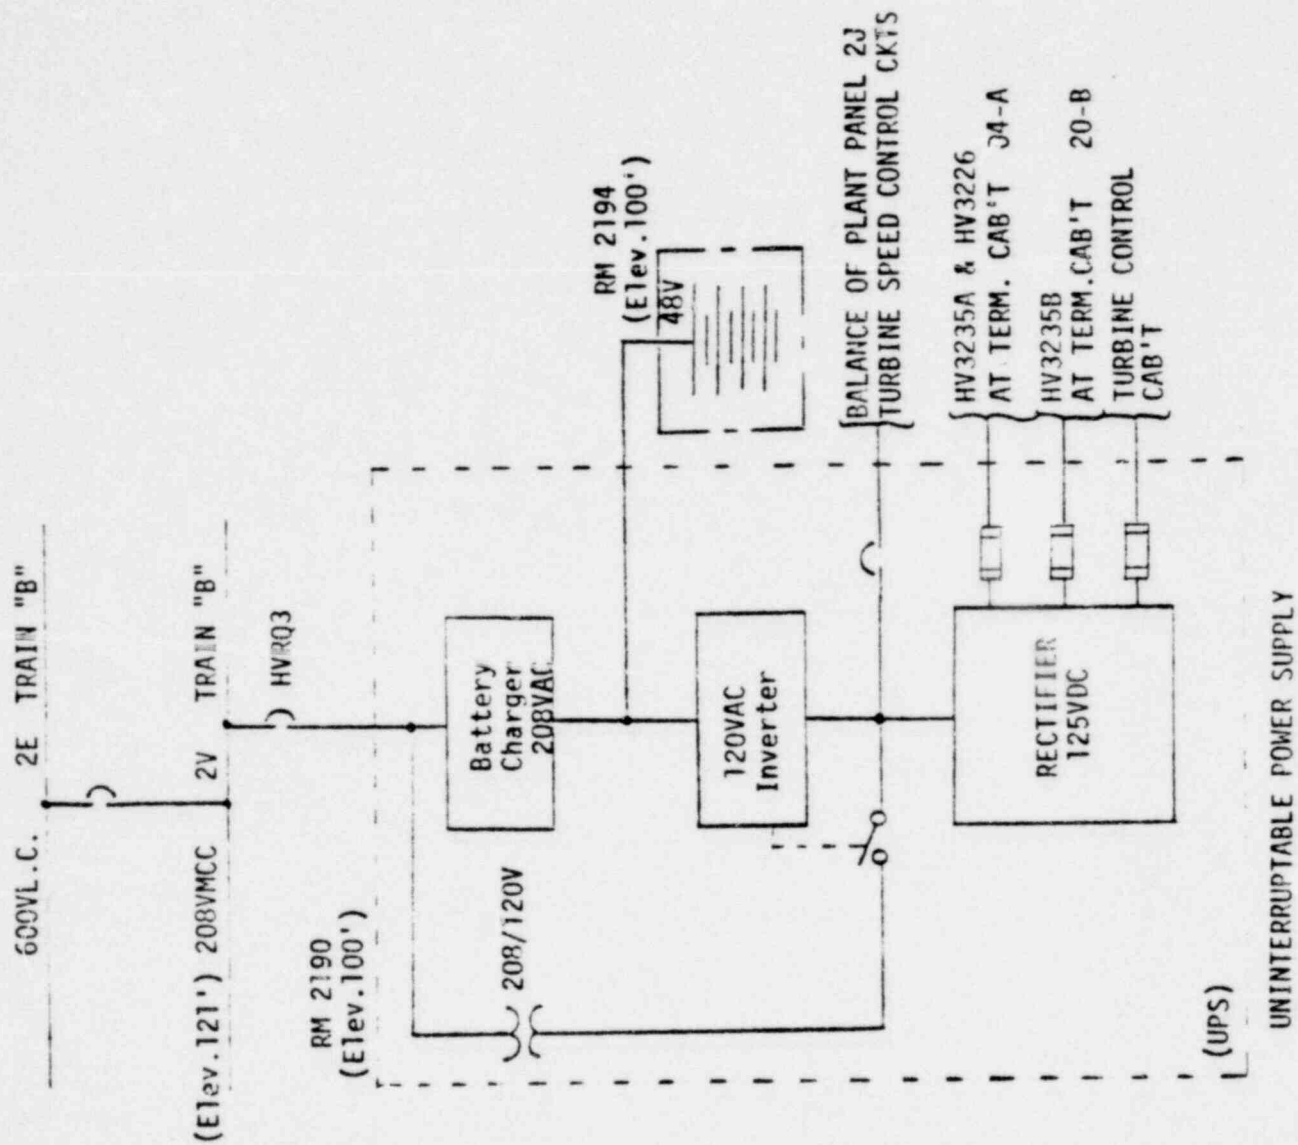
The problem concerning the DC power supplies for the auxiliary feedwater system was originally reported to the NRC by our letter dated January 10, 1978. It was determined at that time that a single failure of DC Bus 2A would render the A train motor-driven auxiliary feedwater pump unable to start and would also result in loss of the turbine-driven auxiliary feedwater pump.

A separate UPS (Uninterruptible Power System) will be added to the auxiliary feedwater system (Attachment 1). This system will be a 3KVA UPS and will have a Seismic Category I 48V battery which will be able to supply the required power to the turbine-driven auxiliary feedwater system for two hours. This system will also have a battery charger and inverter to furnish the required DC and AC. This UPS system will be located in the northwest portion of the auxiliary building in Room 2194 at elevation 100' where there is an existing ventilation system.

This UPS will supply power to the following loads:

- ...DC to the turbine-driven auxiliary feedwater pump control panel.
- ...DC to the turbine-driven auxiliary feedwater pump steam admission valves HV-3235A, HV-3235B, and HV-3226.
- ; ...AC to BOP Panel 2J for turbine speed control.

In addition to the above modification, as we previously described in our letter dated June 19, 1978 the control circuitry of the turbine-driven auxiliary feedwater pump steam admission valves HV-3235A, HV-3235B and HV-3226 will be modified to provide an automatic opening signal from both solid state protection panels, Train A and Train B. In order to maintain train separation, auxiliary relays will be used as isolation devices.

By above modifications, as long as offsite power or diesel is available AC as well as DC will be available through this unit without using stored energy of the battery. When loss of AC power is experienced at the MCC, which powers the UPS unit, DC and AC will still be obtained directly from the UPS. Switching to the battery will be automatic upon loss of AC input.

These modifications will be implemented on Unit 2 before initial fuel loading.
