INVESTIGATION OF FIELD CONDITION OF
THE VENTILATION STACK BASE RING GIRDER

Commonwealth Edison Company
LaSalle County Station - Units 1&2
Project No. 4266-00

Revision 0 - August 24, 1979

Report No.
SAD-337

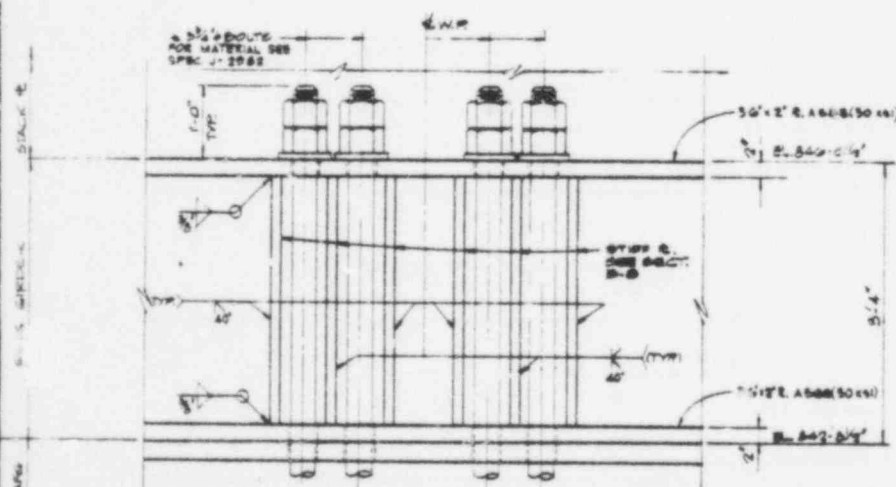
AWAY FROM SUPPORTS

FIG.2 - CROSS SECTION OF RING GIRDER
