THREE MILE ISLAND NUCLEAR STATION  
UNIT 1

REACTOR CONTAINMENT BUILDING  
RING GIRDER  
SURVEILLANCE TEST  
SIX MONTHS AFTER S.I.T.

November 8, 1974

GAI REPORT NO. 1855

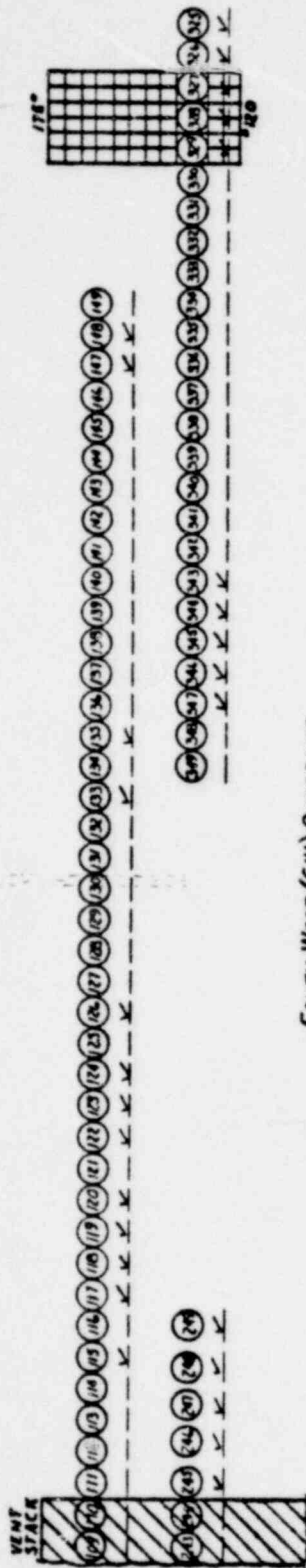
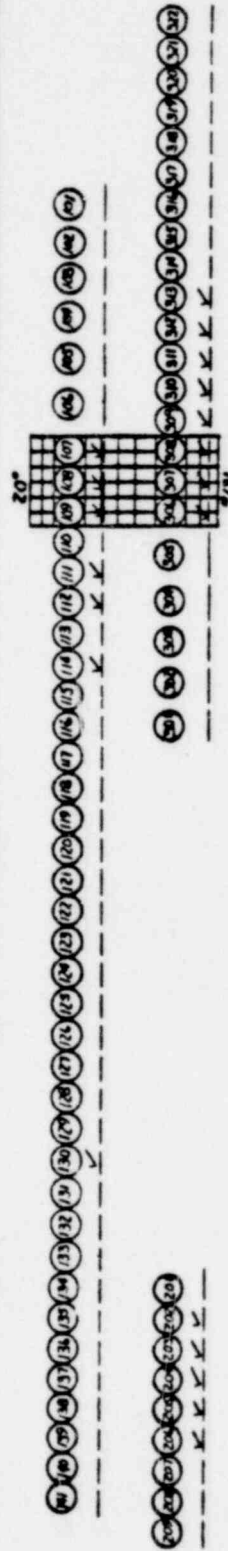
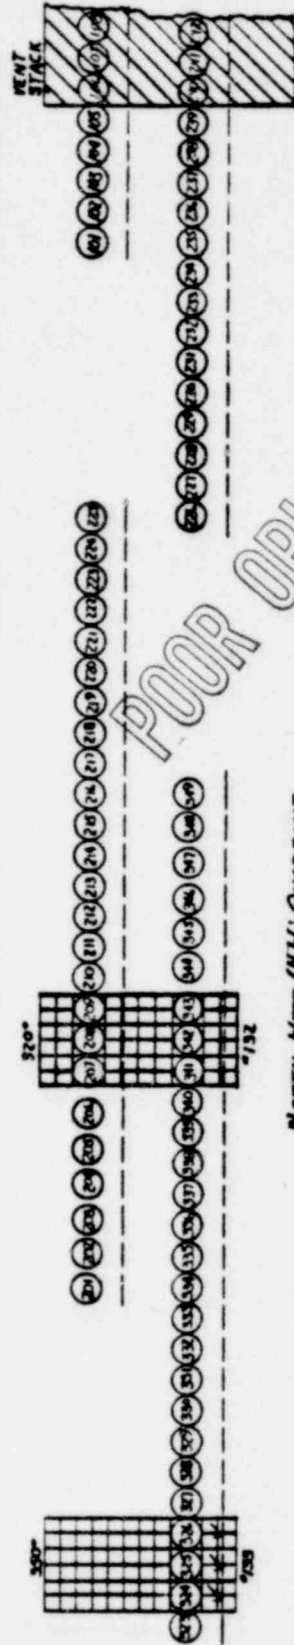
FIGURE 2

Of the cracks observed in the concrete surface around the accessible dome tendon bearing plates, one measures 0.035 inch wide and is discussed later, one measures 0.005 inch wide, and the remainder are less than 0.005 inch wide. Table 2 gives the location of these cracks.

The one concrete crack adjacent to tendon number D-303 in the southeast quadrant measuring 0.035 inch wide and about 2 inches long was further examined and a corner section broken off. The crack continues across the bottom of tendon anchorage number D-302 as a crack less than 0.005 inch wide. Examination of the removed section reveals that the concrete is lacking coarse aggregate and shows two layers, with cavities. This appears to result from a poorly made mortar repair.

NOTE: AREAS WITH CRACKS NOTED THUS ✓  
SEE TABLE 2 FOR DESCRIPTION.

RING GIRDER SURVEILLANCE TEST  
DOME TENDON BEARING AREAS

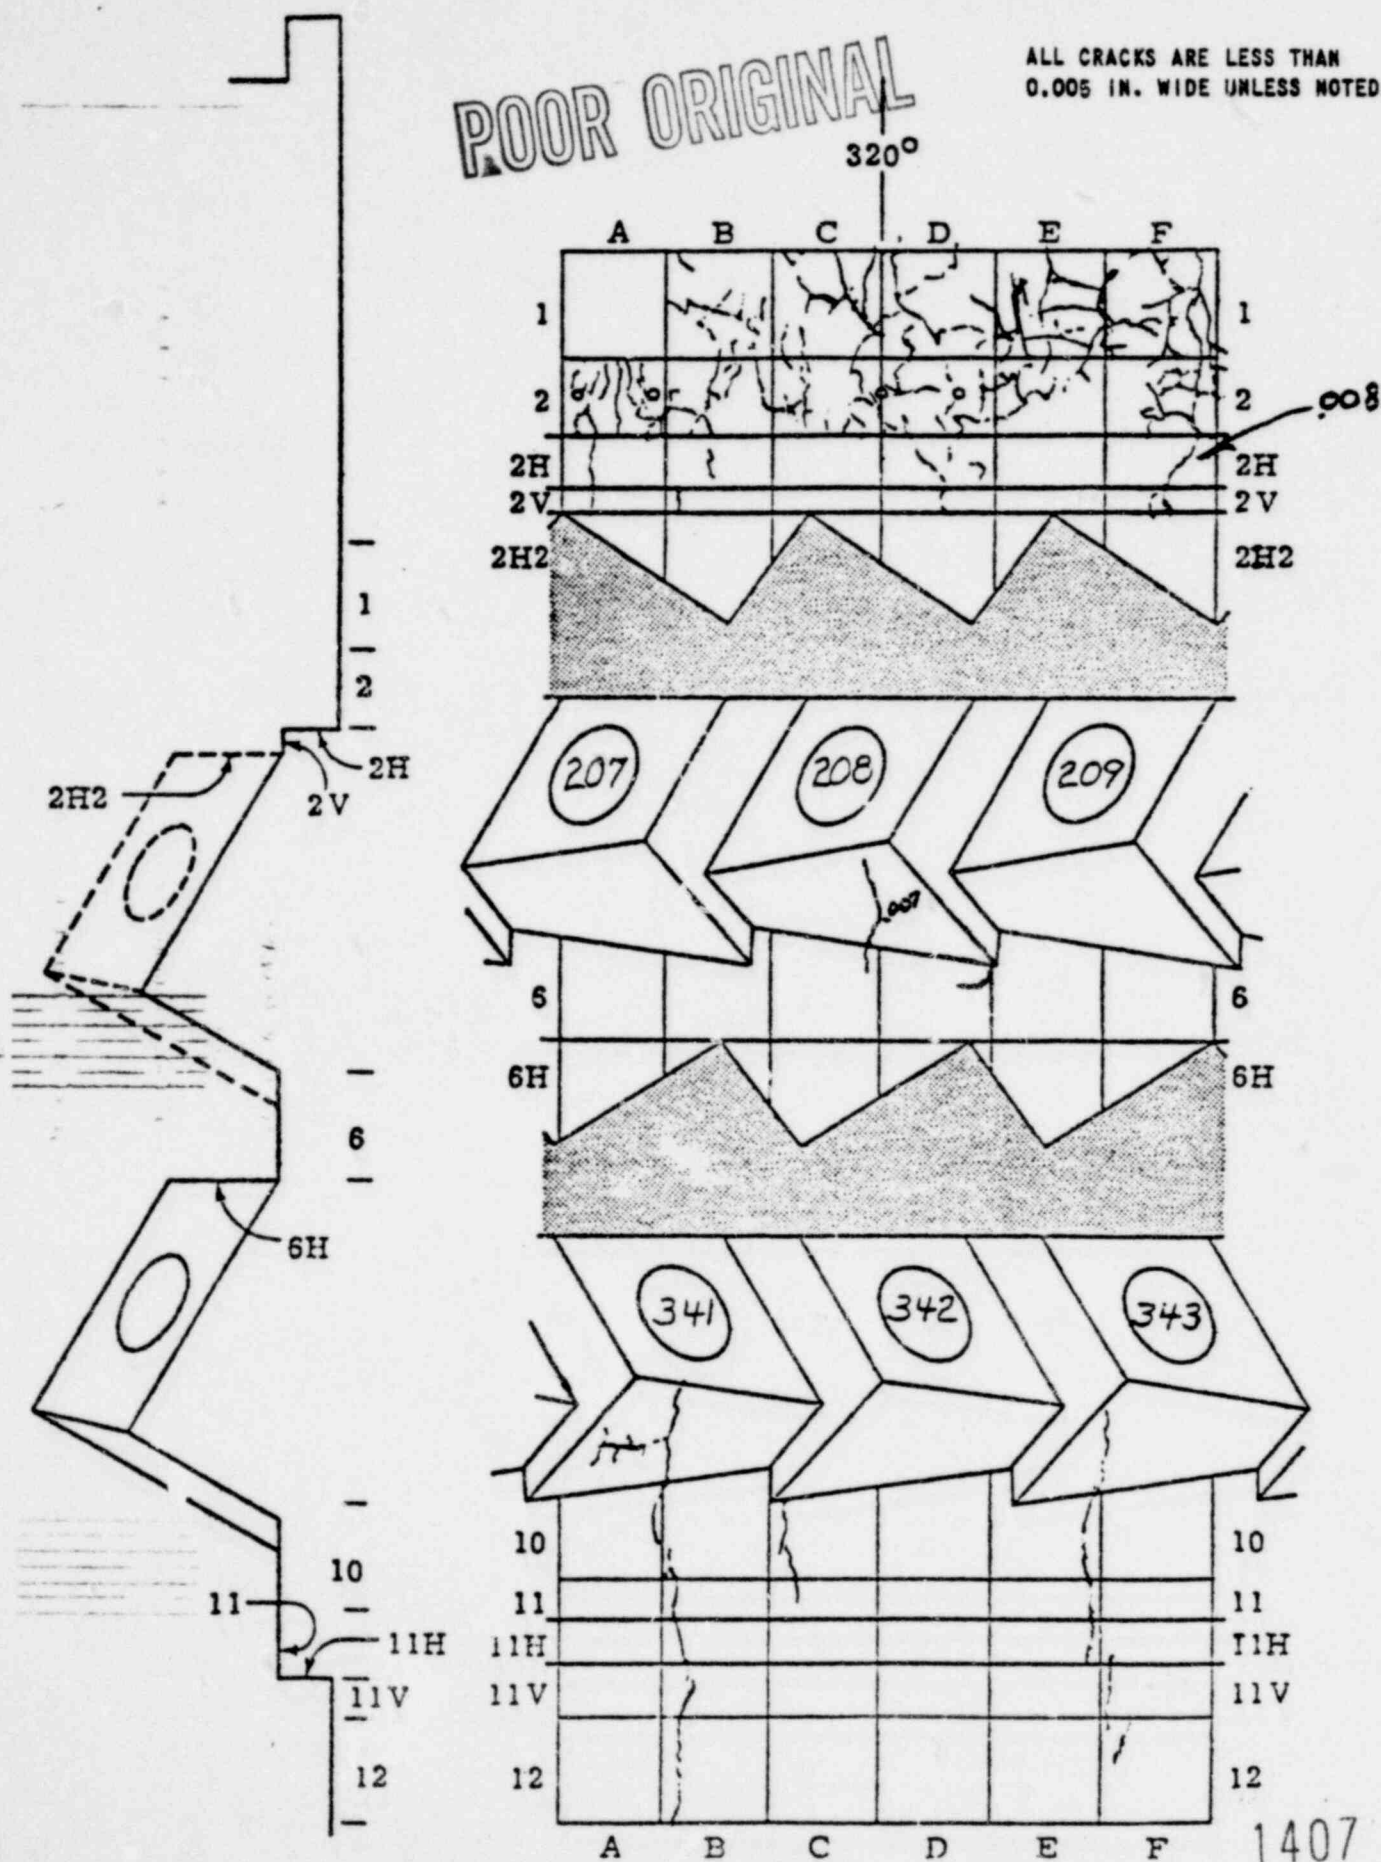
FIGURE 5

None of the cracks observed in the whitewash areas of the ring girder are greater than 0.008 inch wide. Most are less than 0.005 inch wide. The cracks are random in pattern and characteristic of shrinkage cracks, with the lack of any stress cracking.

ALL CRACKS ARE LESS THAN  
0.005 IN. WIDE UNLESS NOTED.

CRACK PATTERN AREA AT AZIMUTH 320°  
AREA NO. 132

These surface shrinkage cracks are all less than 0.010 inch and do not impair the ability of the concrete to function as intended in the design. Future ring girder surveillance includes inspection of these same whitewash areas. The crack growth rate will be carefully monitored during these future tests.
