METROPOLITAN EDISON COMPANY
THREE MILE ISLAND NUCLEAR STATION
UNIT NO. 1

REACTOR BUILDING RING GIRDER
SURVEILLANCE REPORT

THREE MILE ISLAND NUCLEAR STATION

RING GIRDER SURVEILLANCE

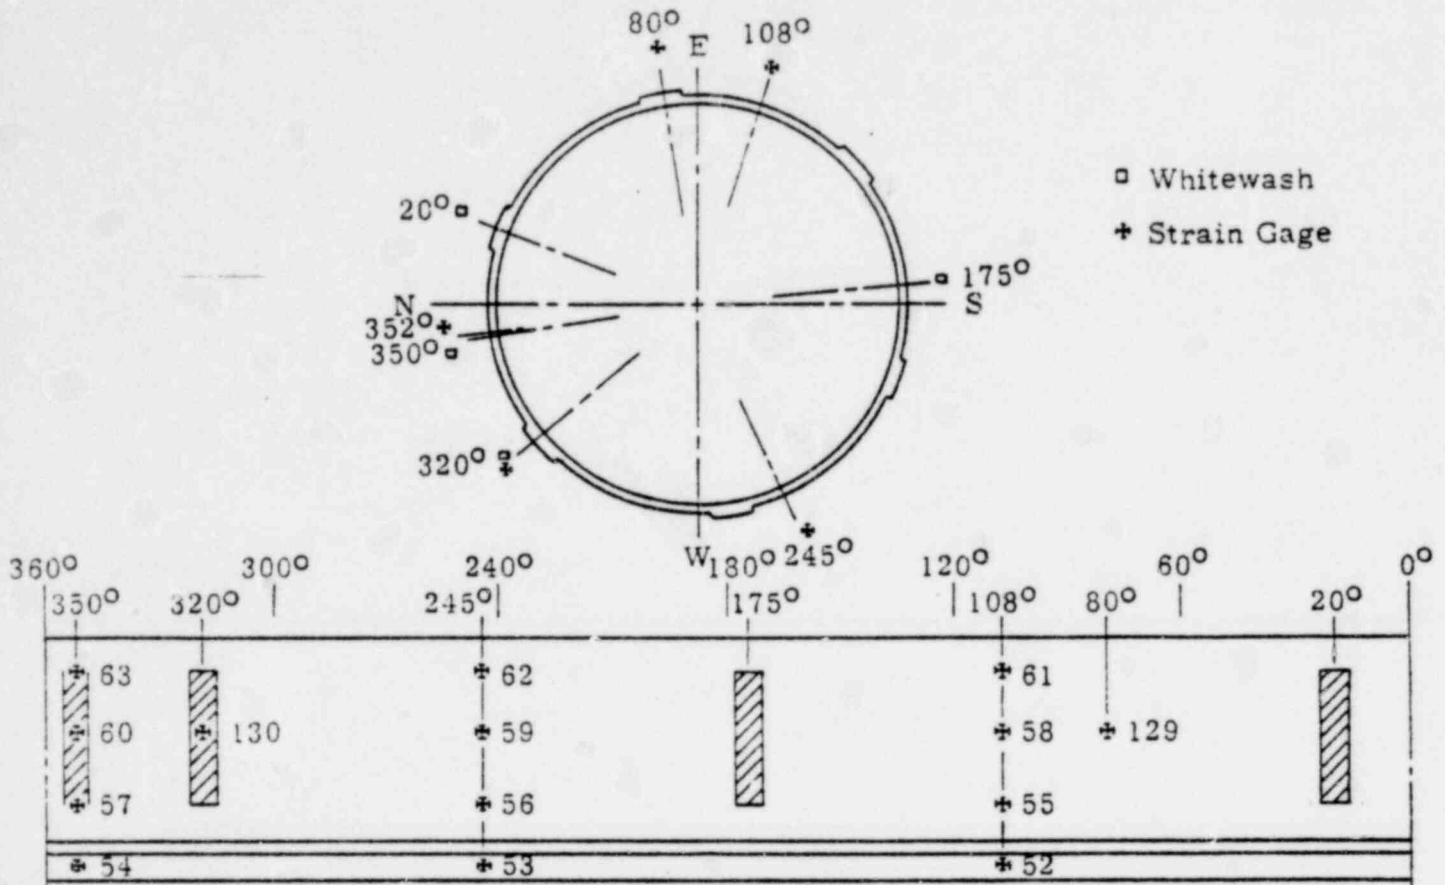
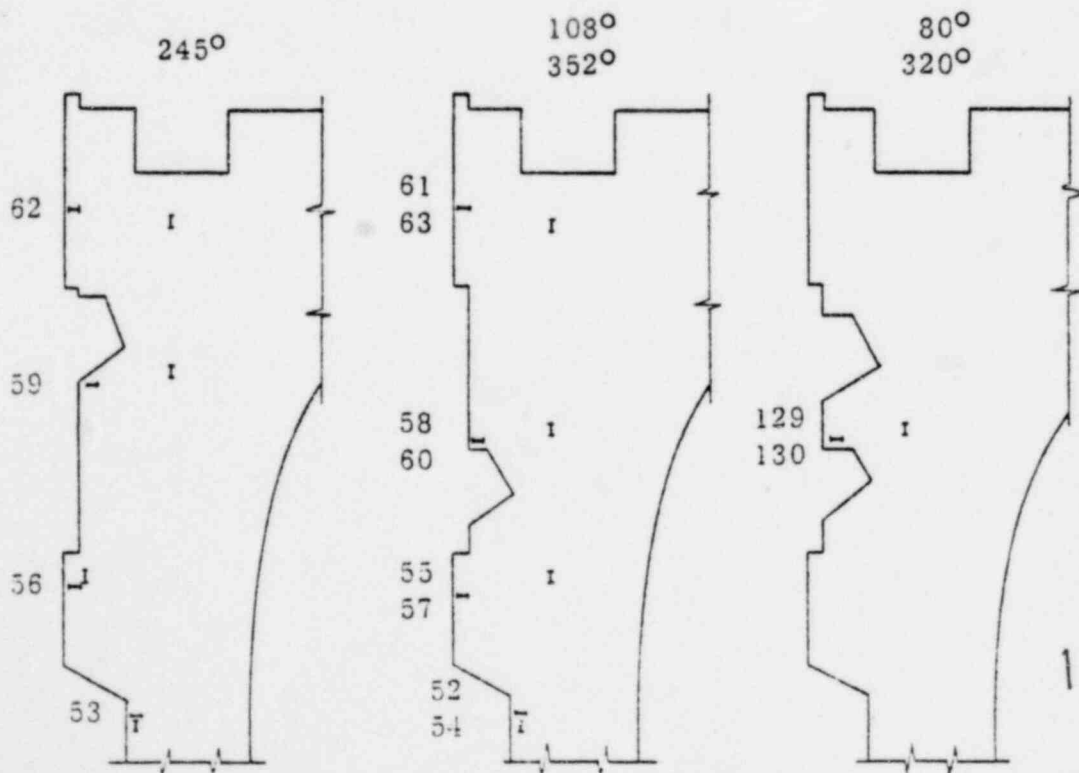
FIGURE 1. RING GIRDER DIAGRAM.

2.1.1 The surveillance consisted of two phases; one visual and one electrical. The visual phase consisted of crack pattern charting at four selected whitewash areas; and the electrical phase of strain measurements at fourteen locations on both hoop and meridional reinforcing bars. Figure 1 shows the area in detail.

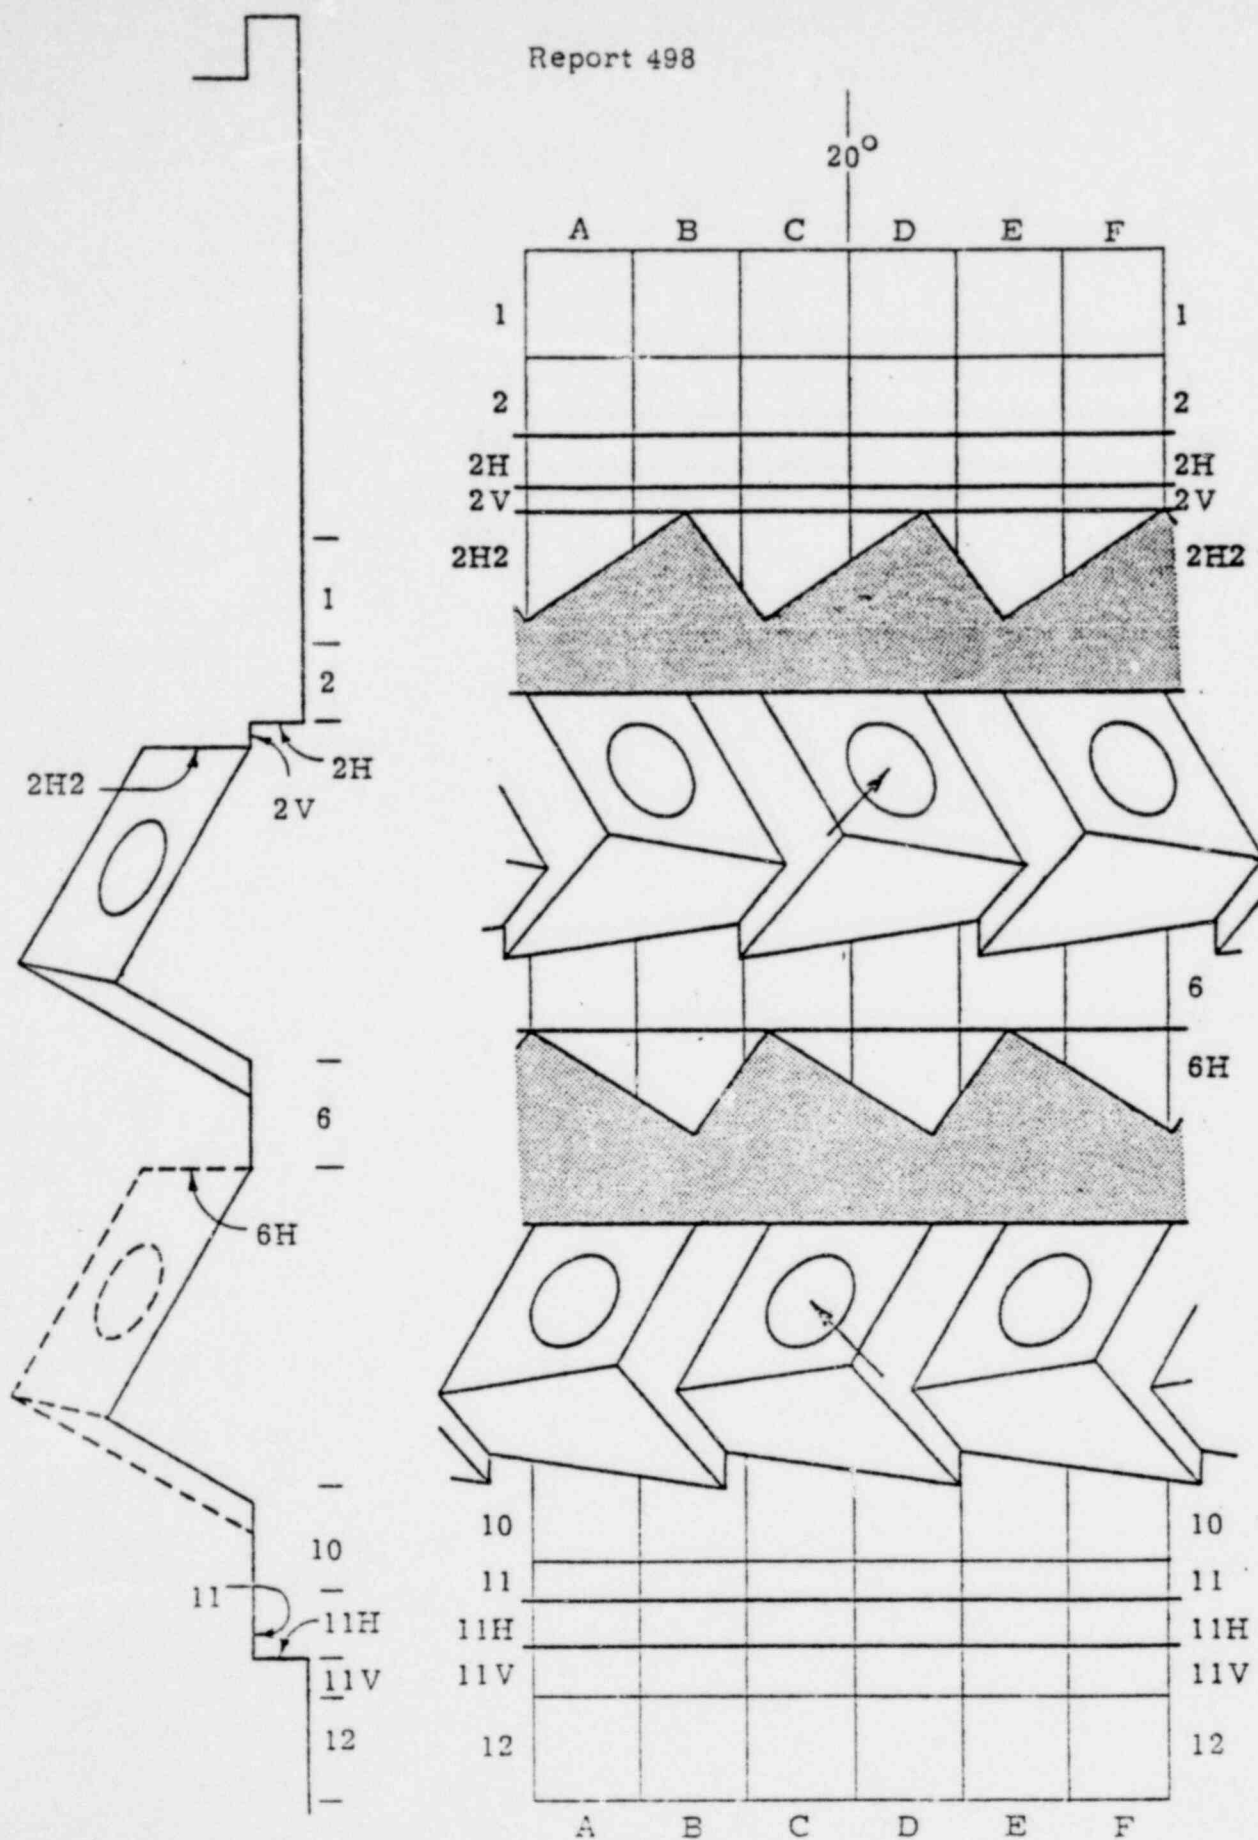
FIGURE 2. CRACK PATTERN AREA AT AZIMUTH 20° .

2.2.1 Four 6-foot by 12-foot areas were selected:¹ Three in the north sector and one in the south. The areas run between Elevations 451' and 439' and are centered on Azimuth 20° , 175° , 320° , and 350° (see Figures 2 through 5).

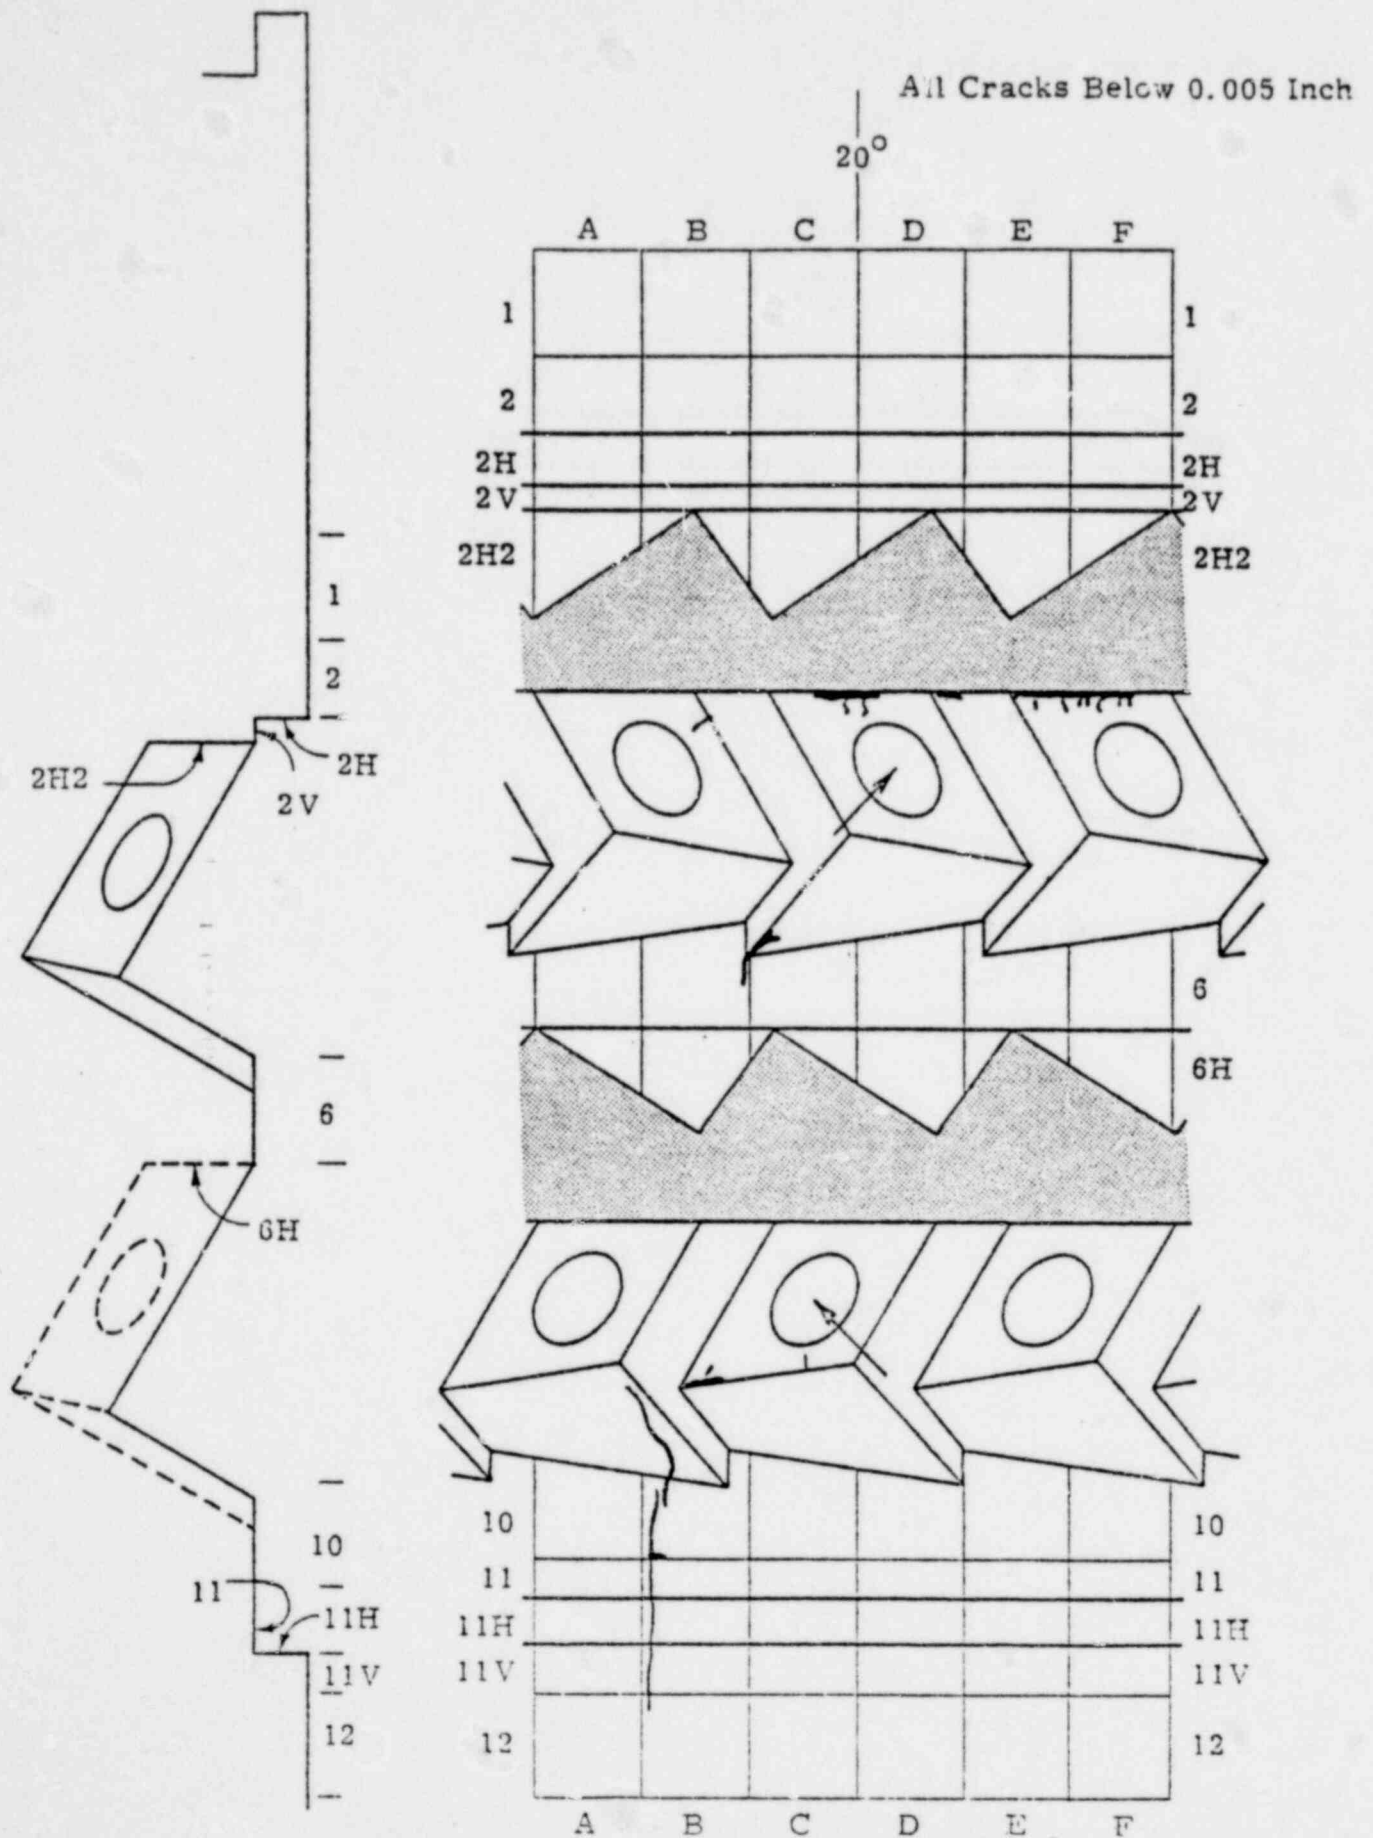
FIGURE 7.

CRACK PATTERN AT AZIMUTH 20°
PRIOR TO PRESTRESS, 5-14-73.

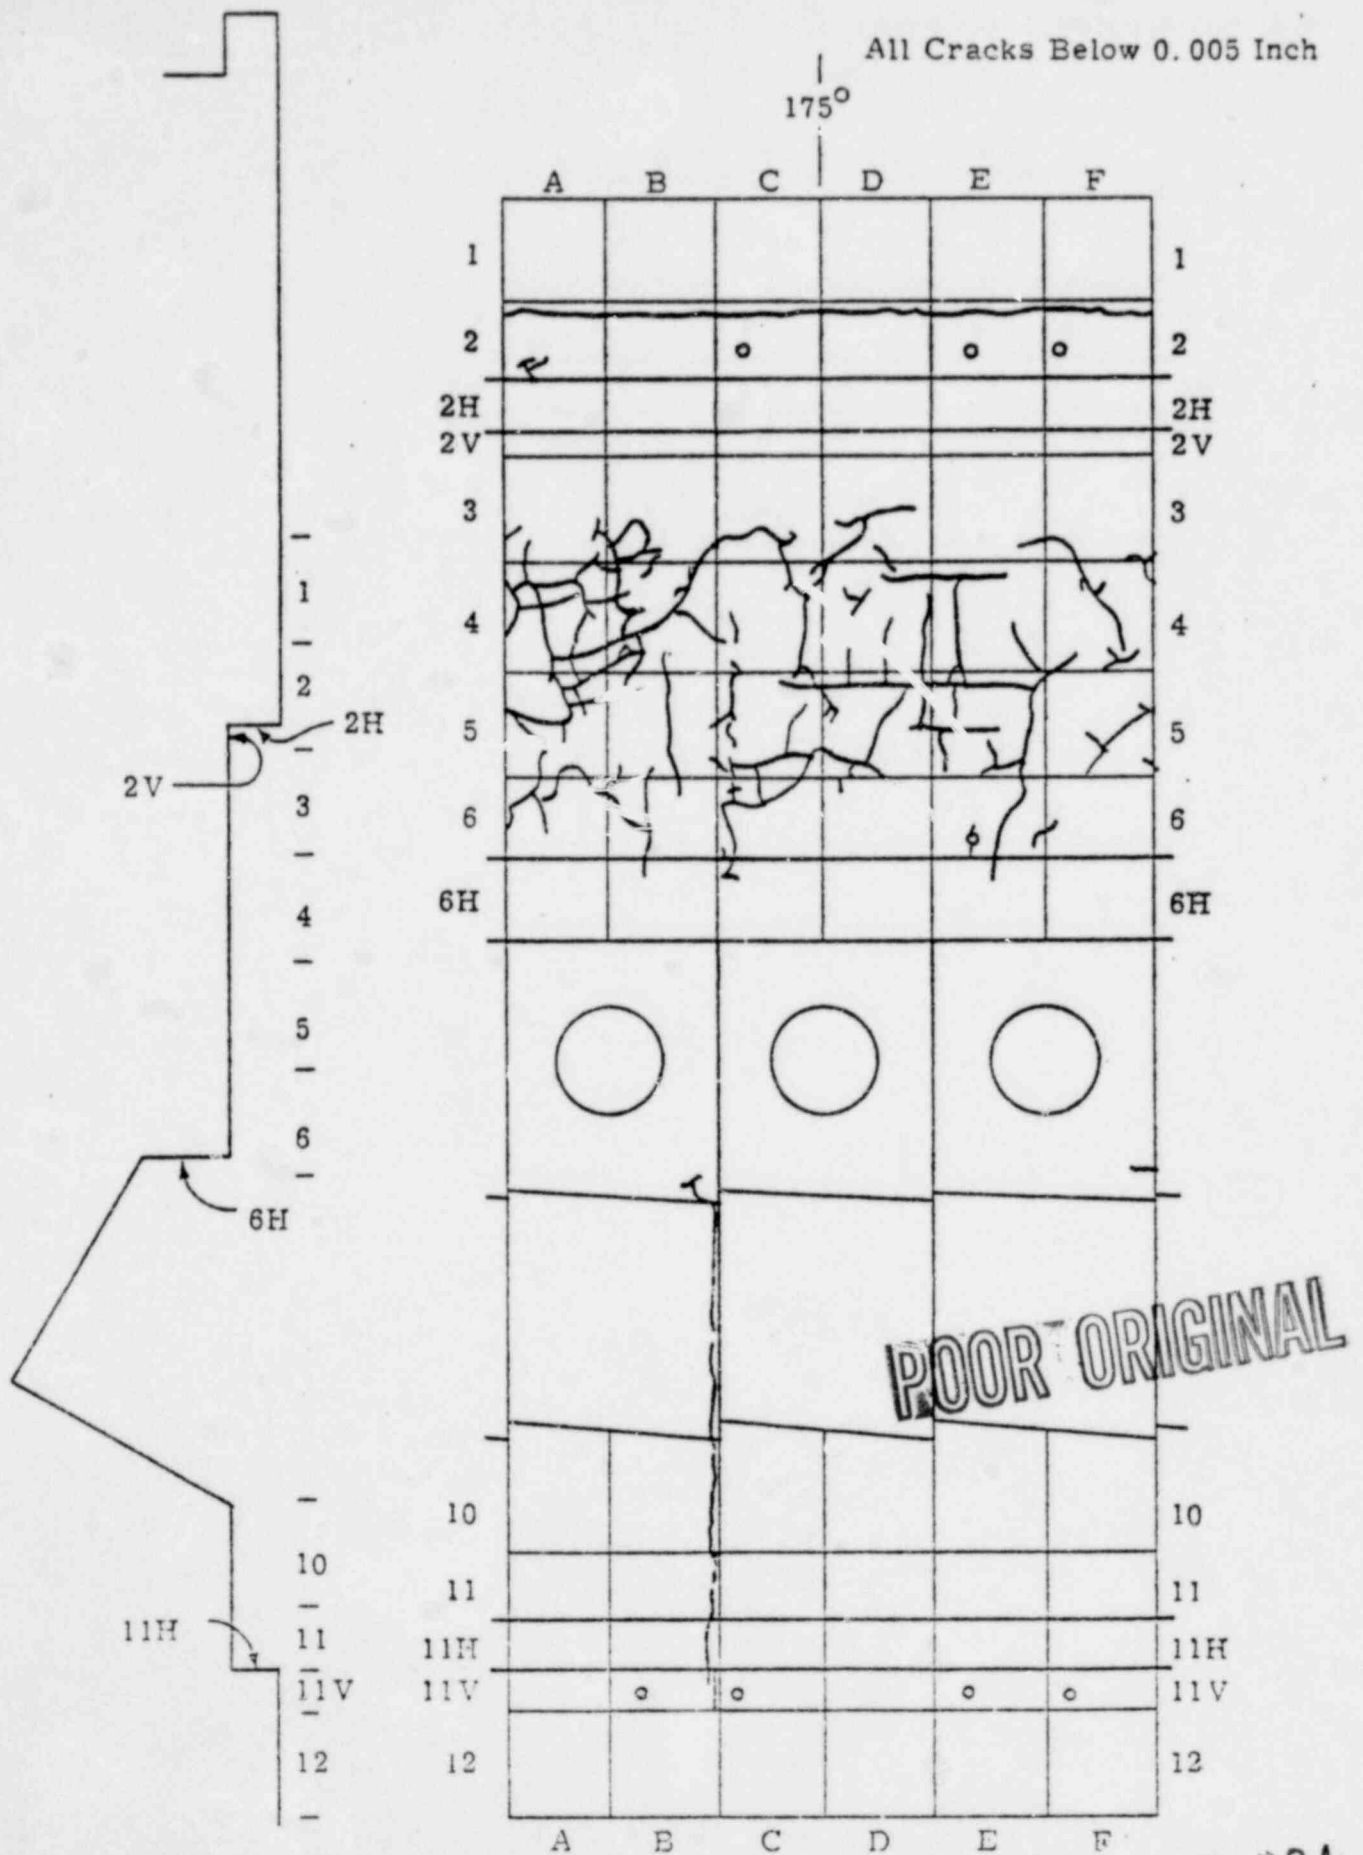
FIGURE 3.

CRACK PATTERN AT AZIMUTH 175°
PRIOR TO PRESTRESS, 5-14-73.

All Cracks Below 0.005 Inch

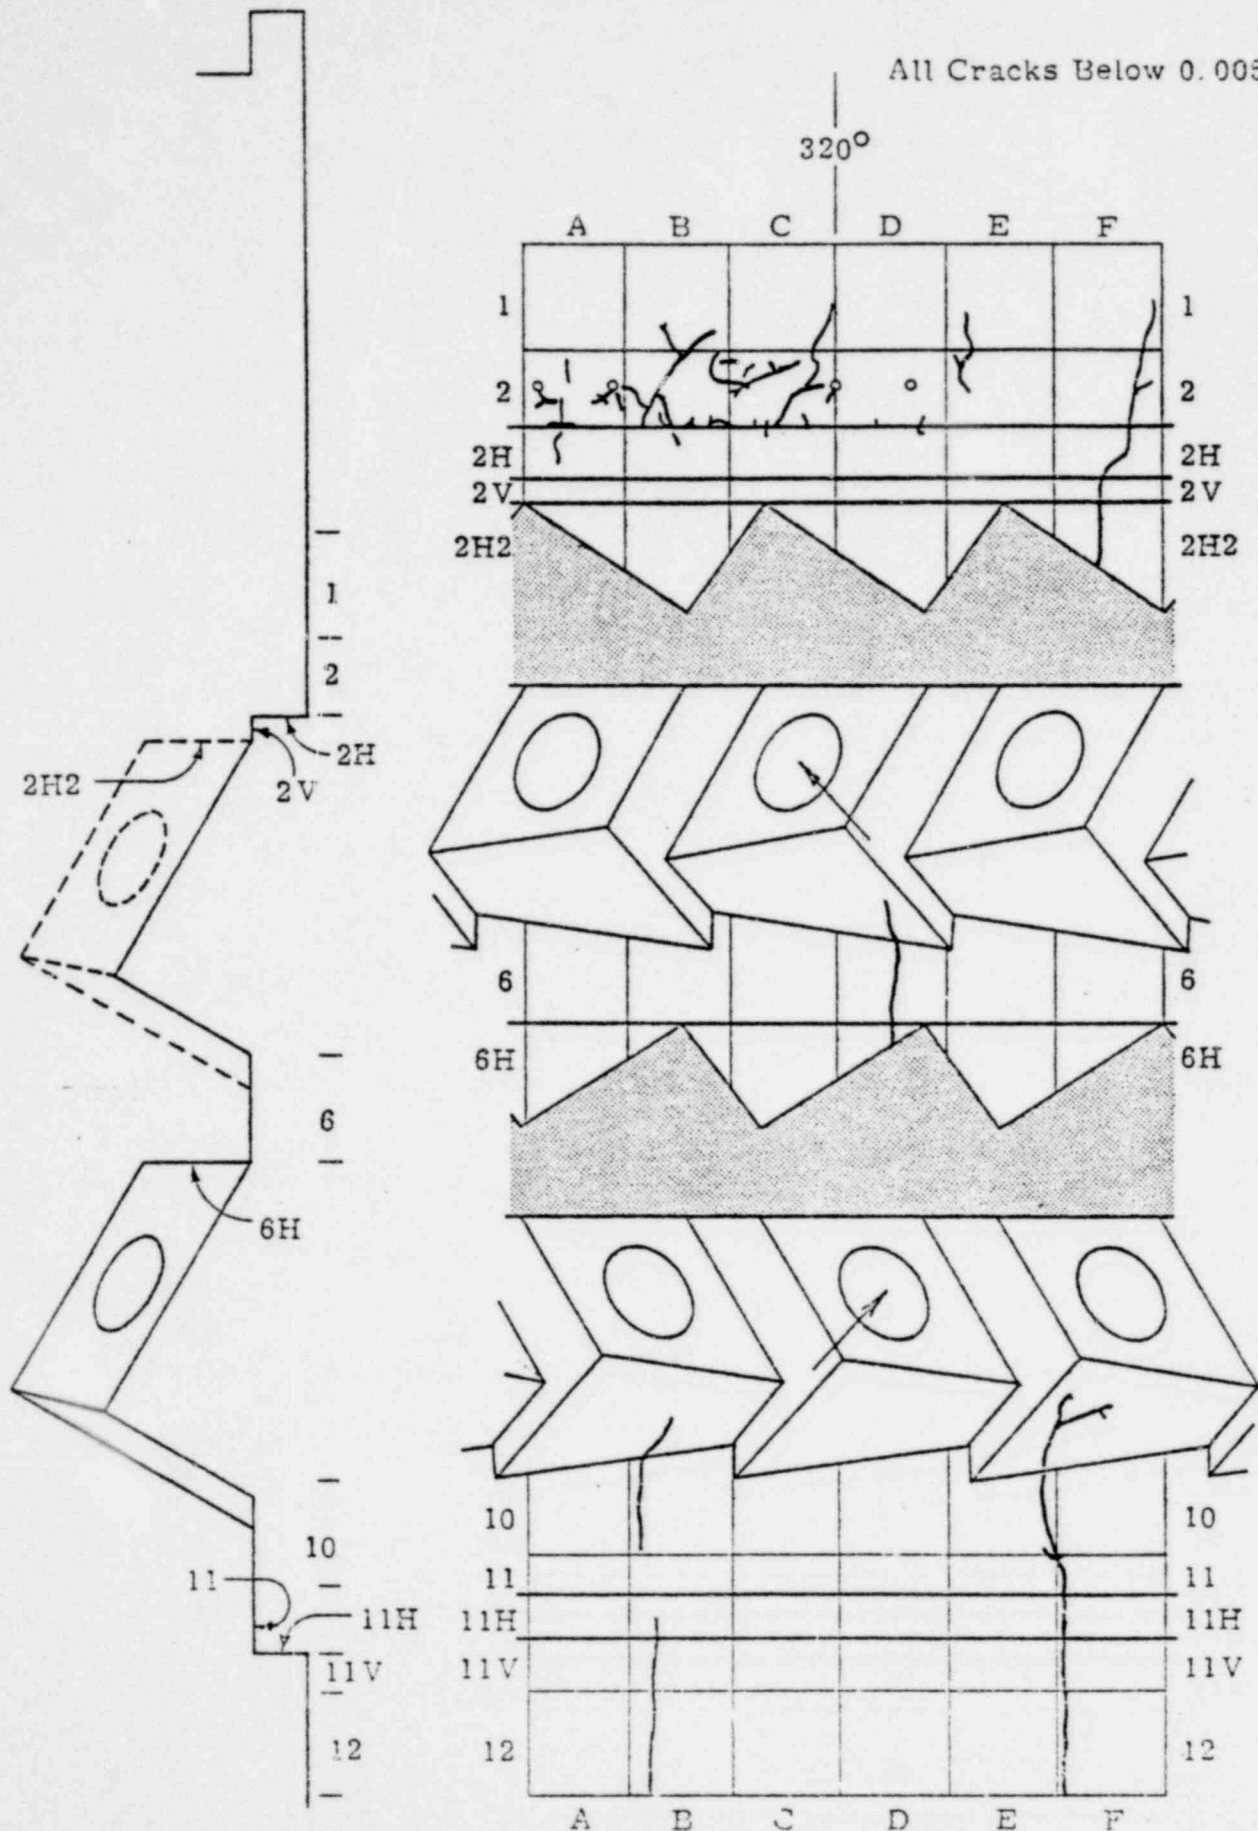
FIGURE 9.

CRACK PATTERN AT AZIMUTH 320°
PRIOR TO PRESTRESS, 5-14-73.

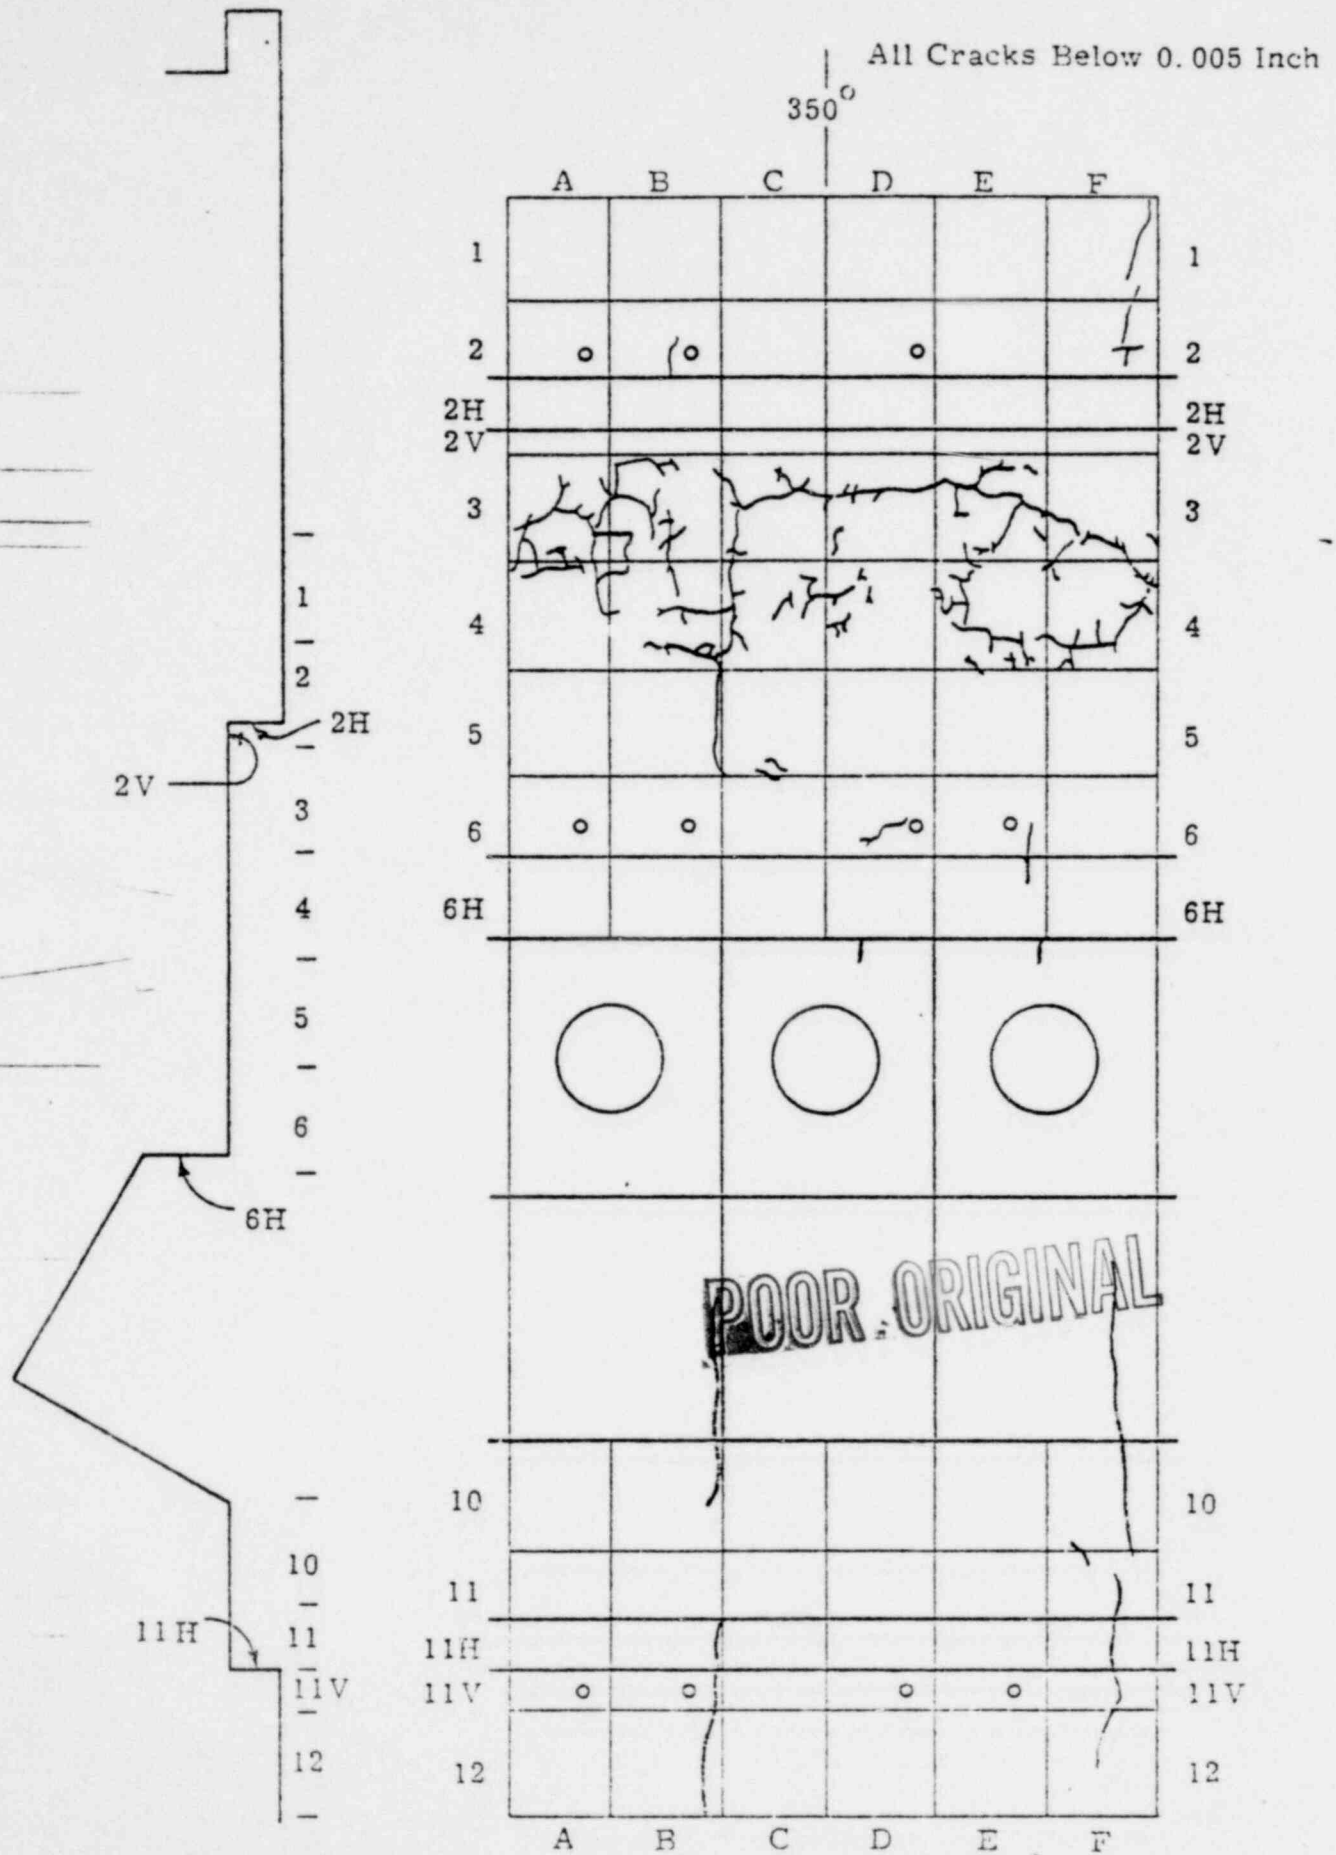
FIGURE 10.

CRACK PATTERN AT AZIMUTH 350°
PRIOR TO PRESTRESS, 5-14-73.

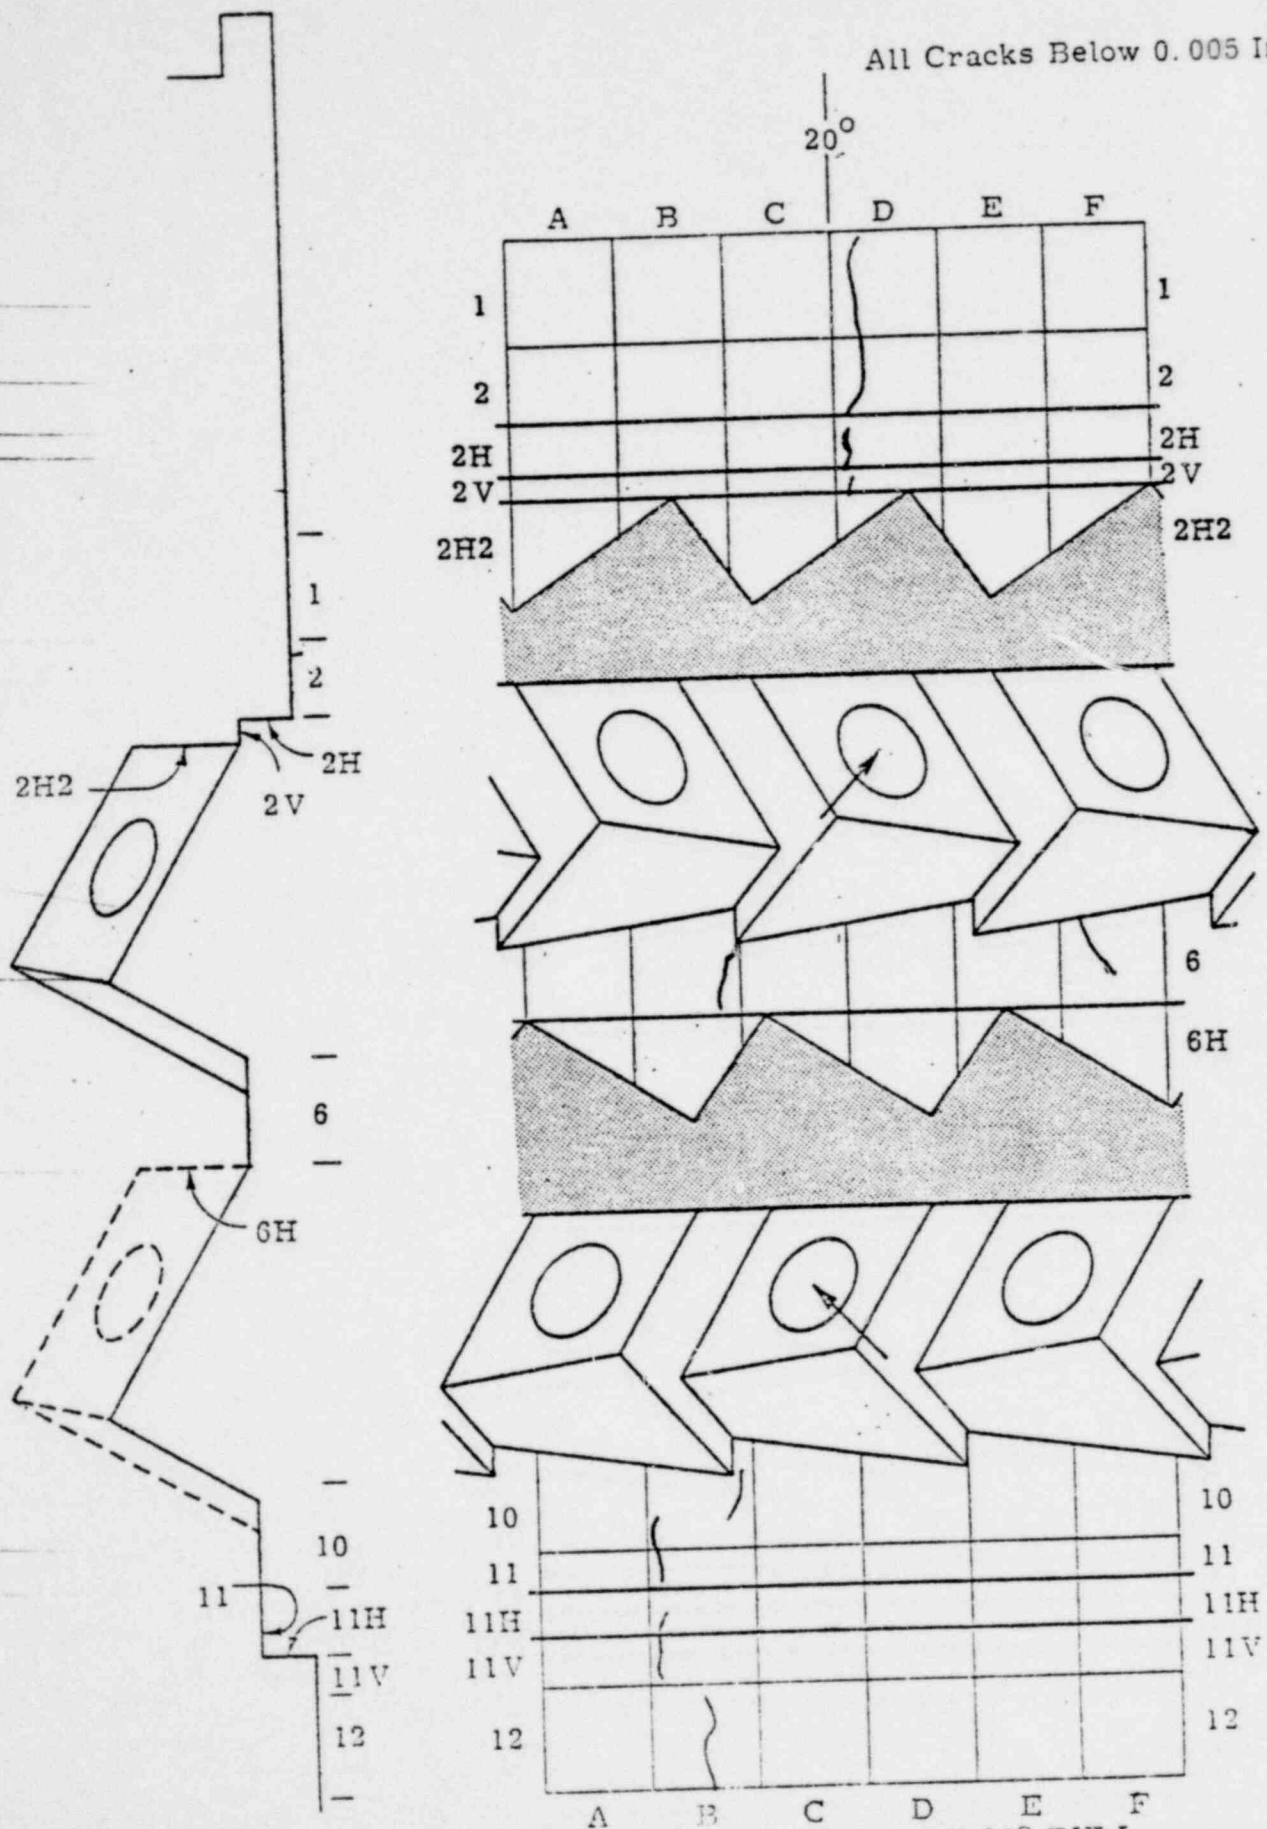
FIGURE 11.

CRACK PATTERN AT AZIMUTH 20° FULL
VERTICAL PRESTRESS, 6-6-73.

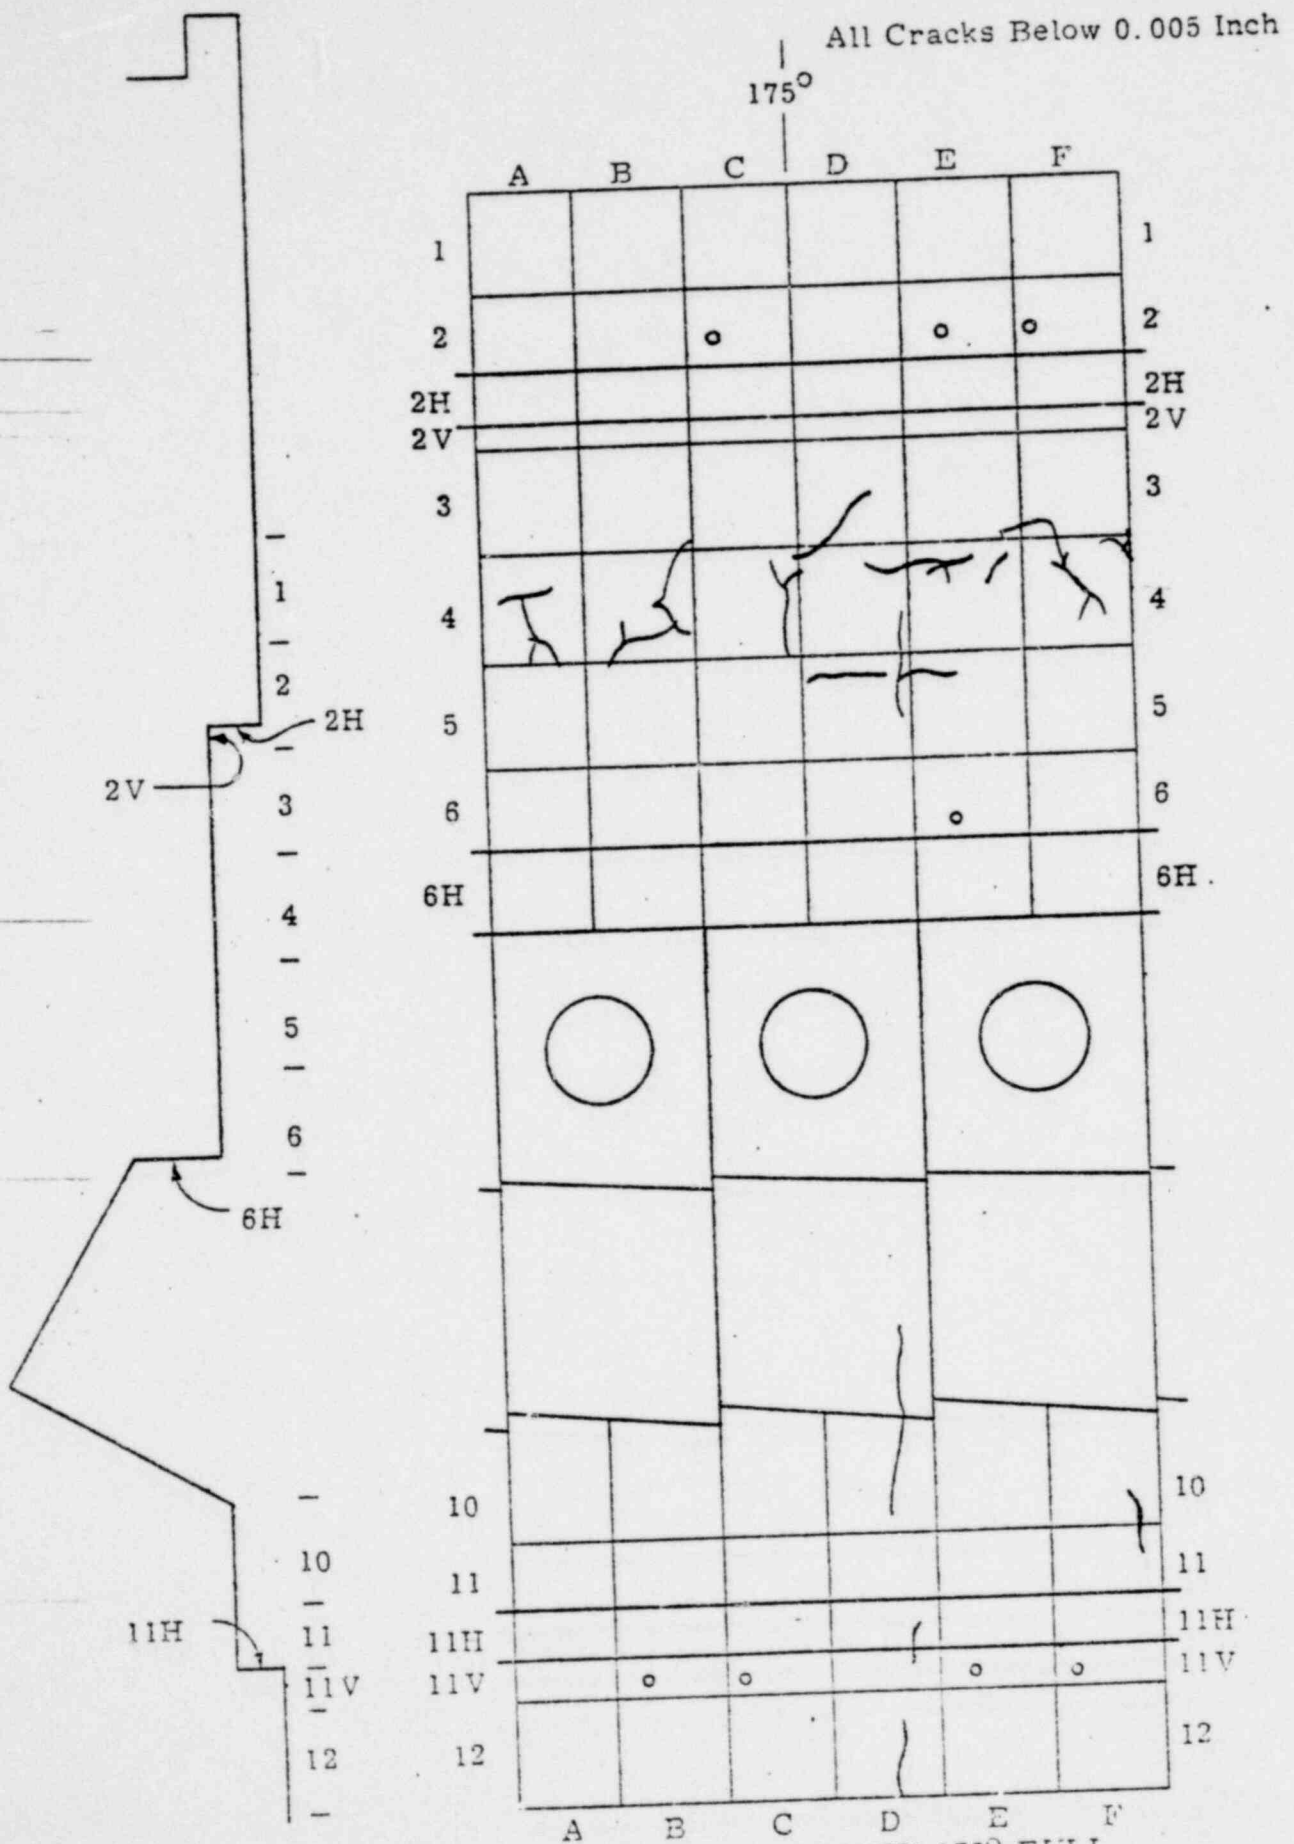
FIGURE 12

CRACK PATTERN AT AZIMUTH 175° FULL
VERTICAL PRESTRESS, 6-6-73.

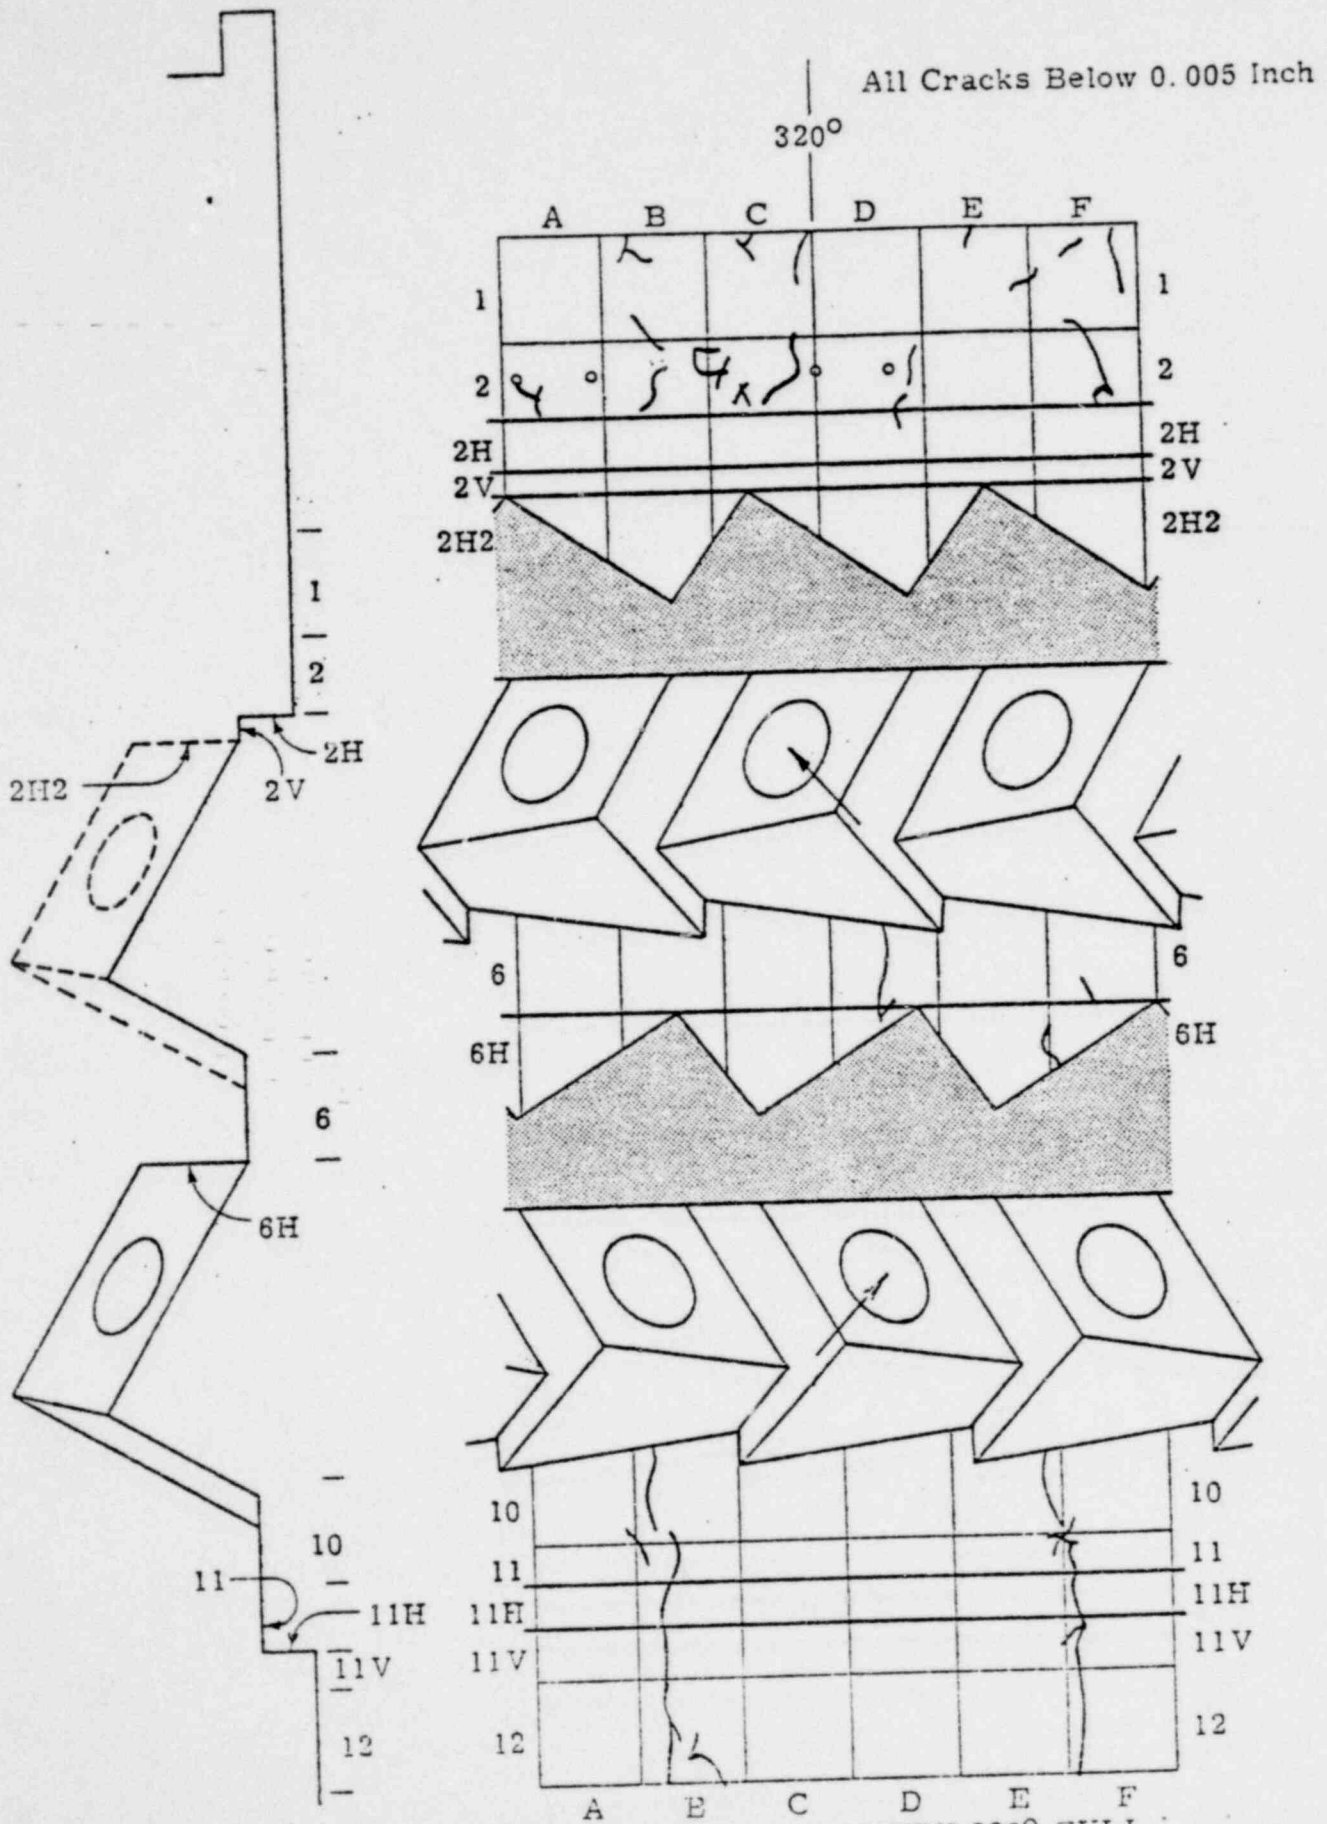
FIGURE 13.

CRACK PATTERN AT AZIMUTH 320° FULL :
VERTICAL PRESTRESS, 6-6-73.
