METROPOLITAN EDISON COMPANY
THREE MILE ISLAND NUCLEAR STATION
UNIT NO. 1

REACTOR BUILDING RING GIRDER
SURVEILLANCE REPORT

THREE MILE ISLAND NUCLEAR STATION

RING GIRDER SURVEILLANCE

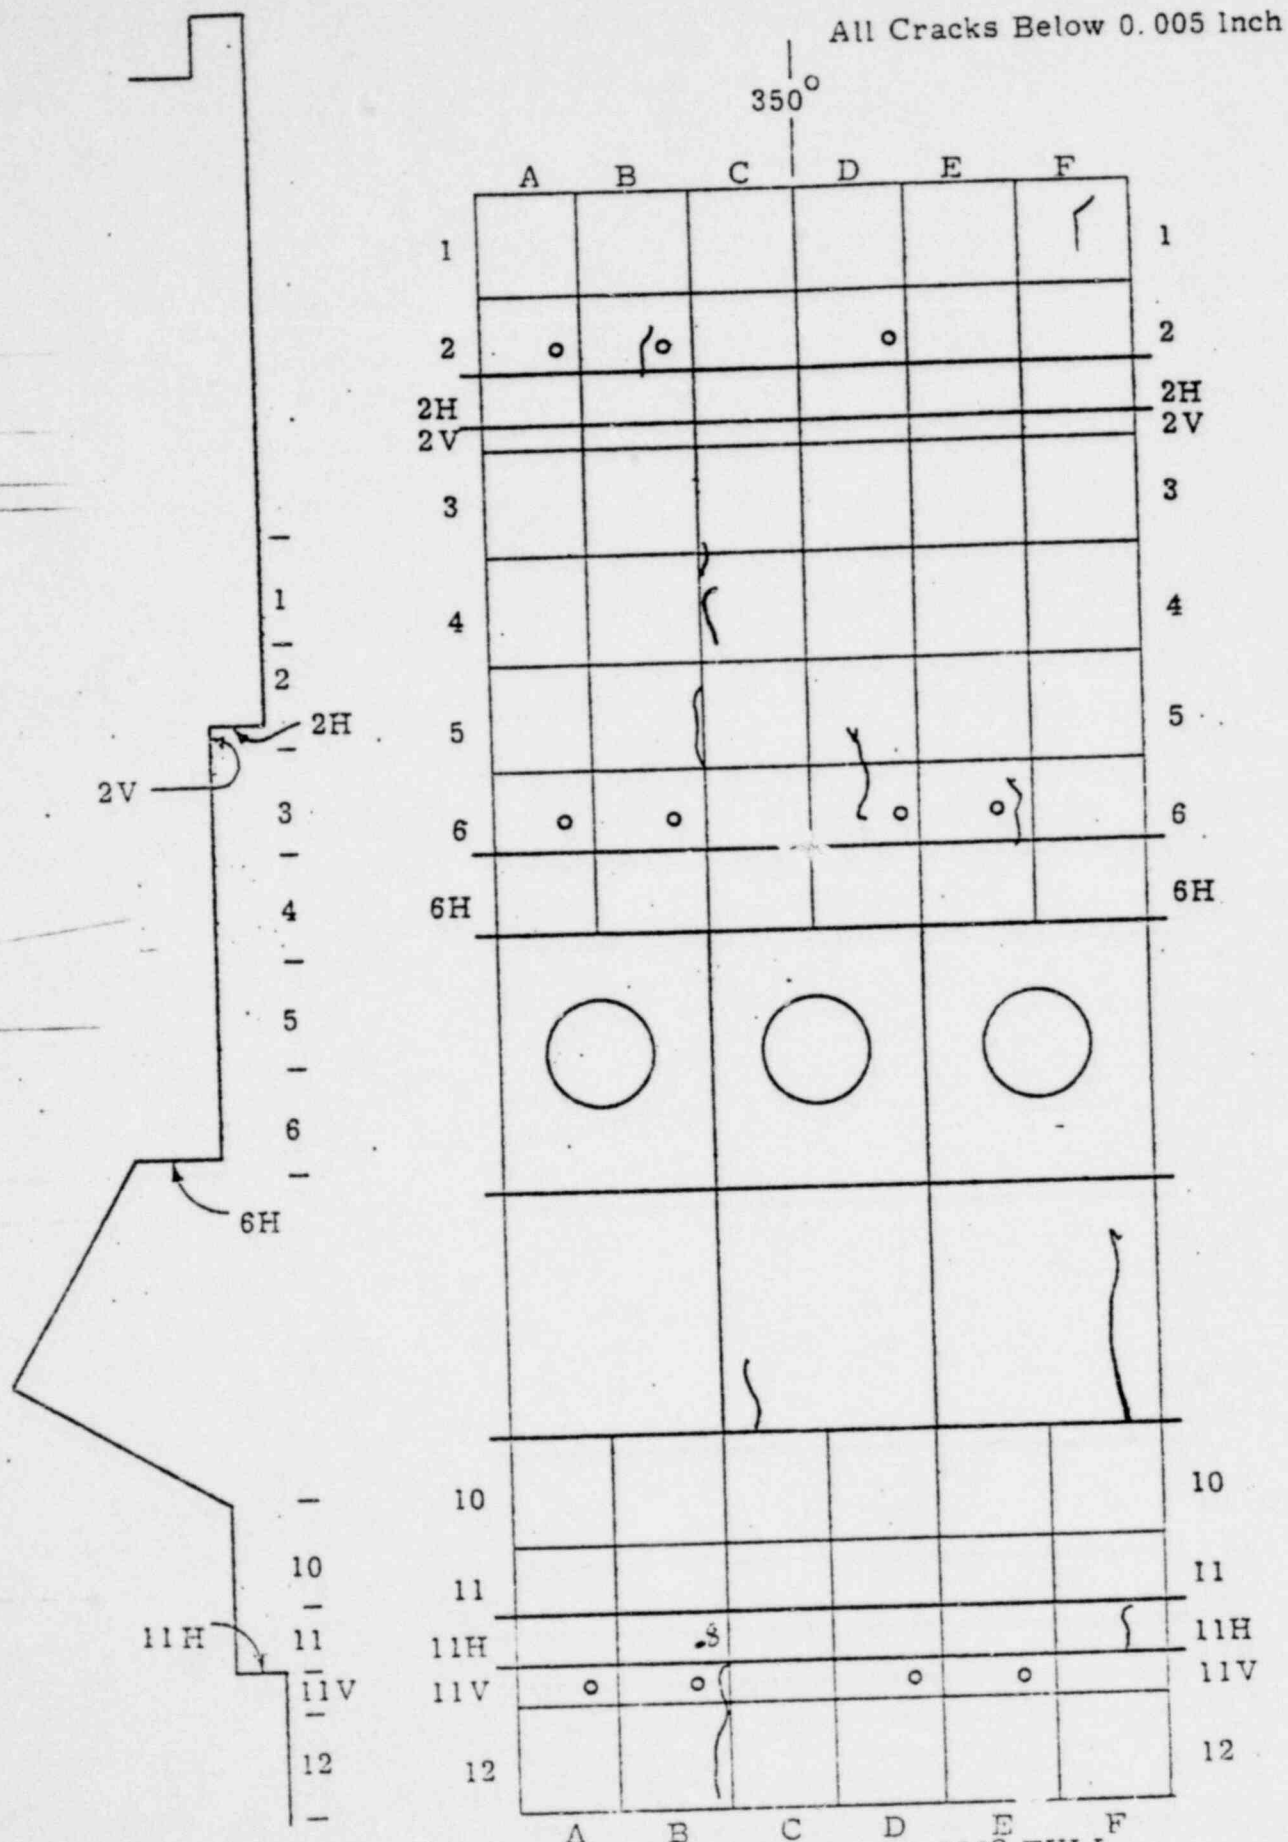
FIGURE 14.

CRACK PATTERN AT AZIMUTH 350° FULL
VERTICAL PRESTRESS, 6-6-73.

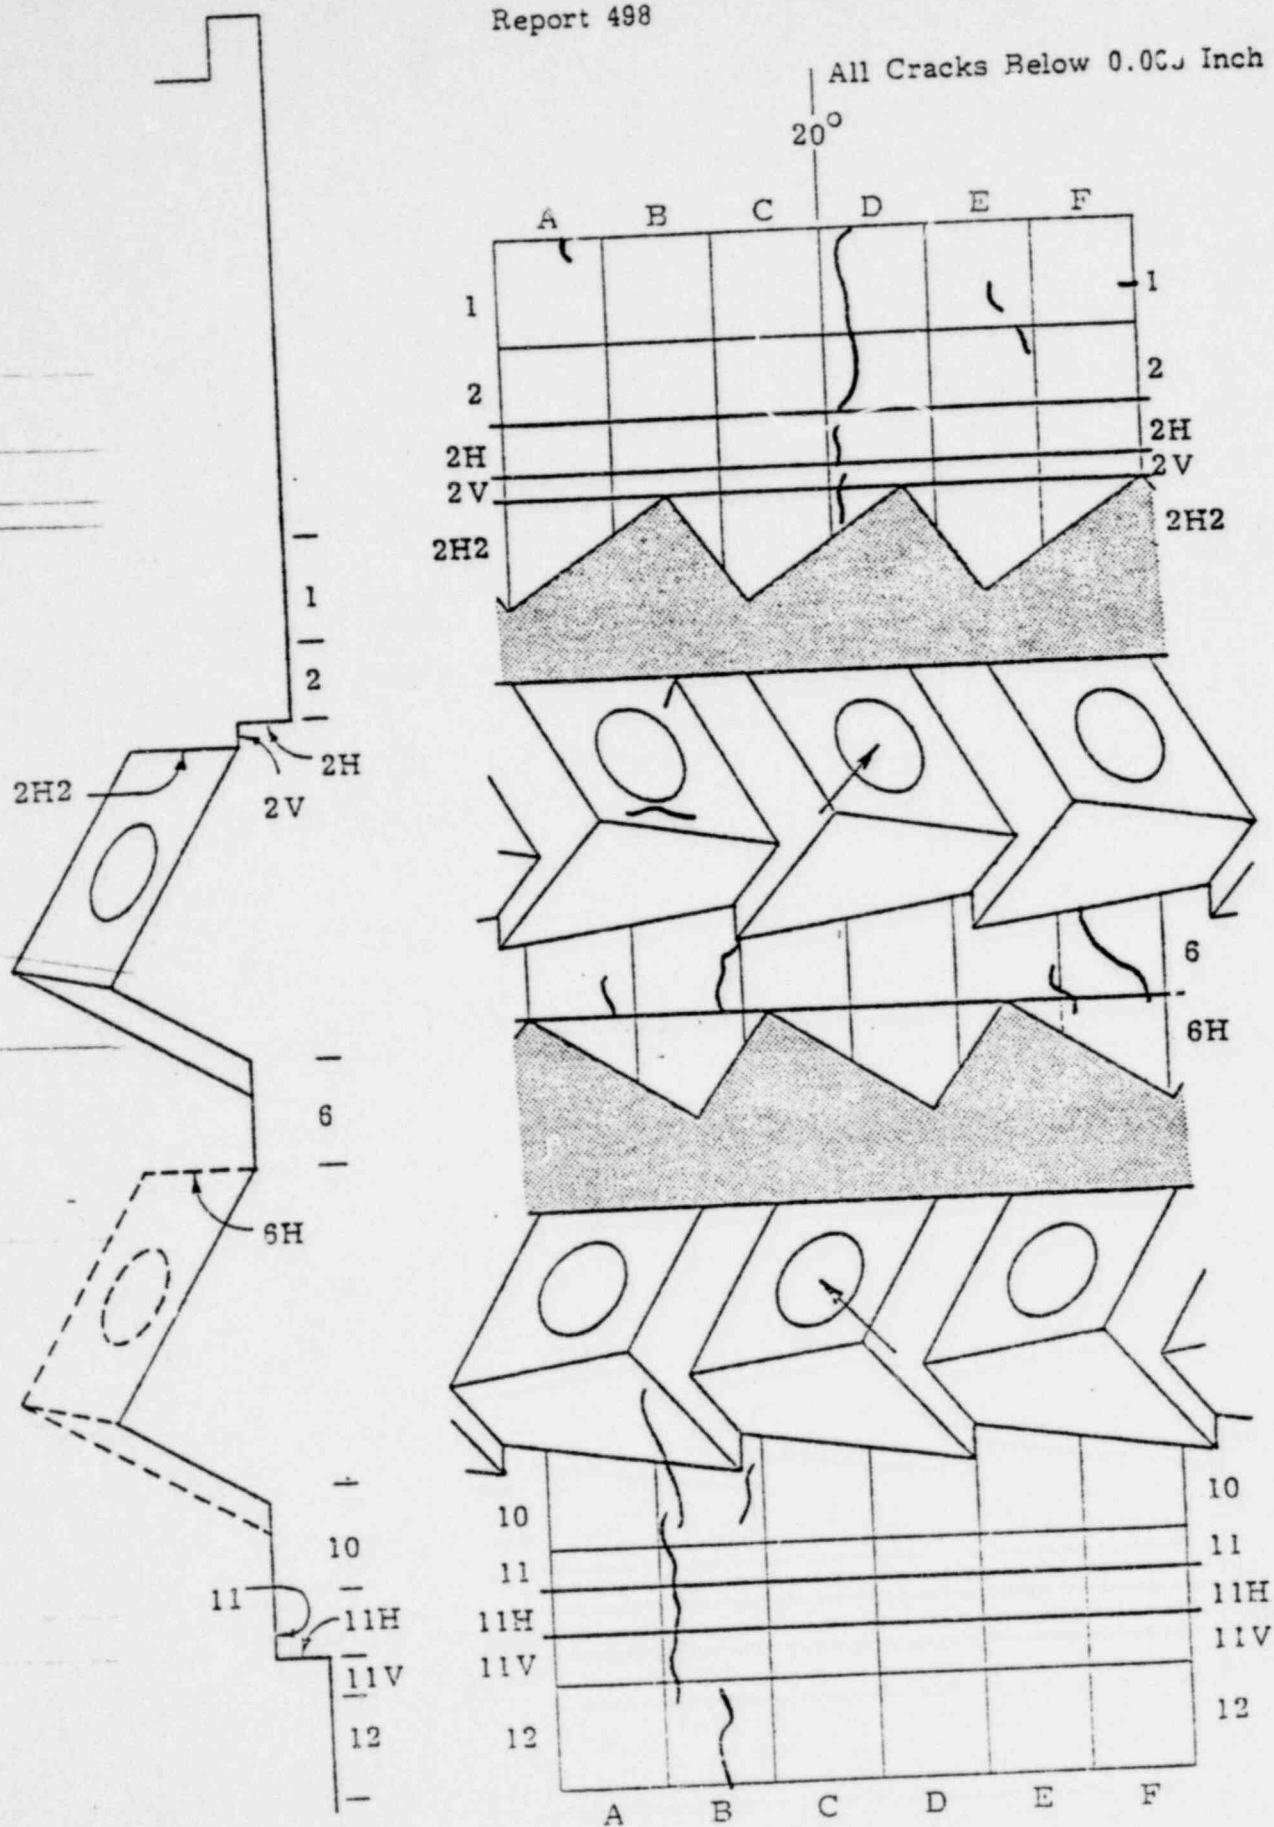
FIGURE 15.

All Cracks Below 0.005 Inch

CRACK PATTERN AT AZIMUTH 20° FULL VERTICAL
AND DOME PRESTRESS, JULY 5, 1973.

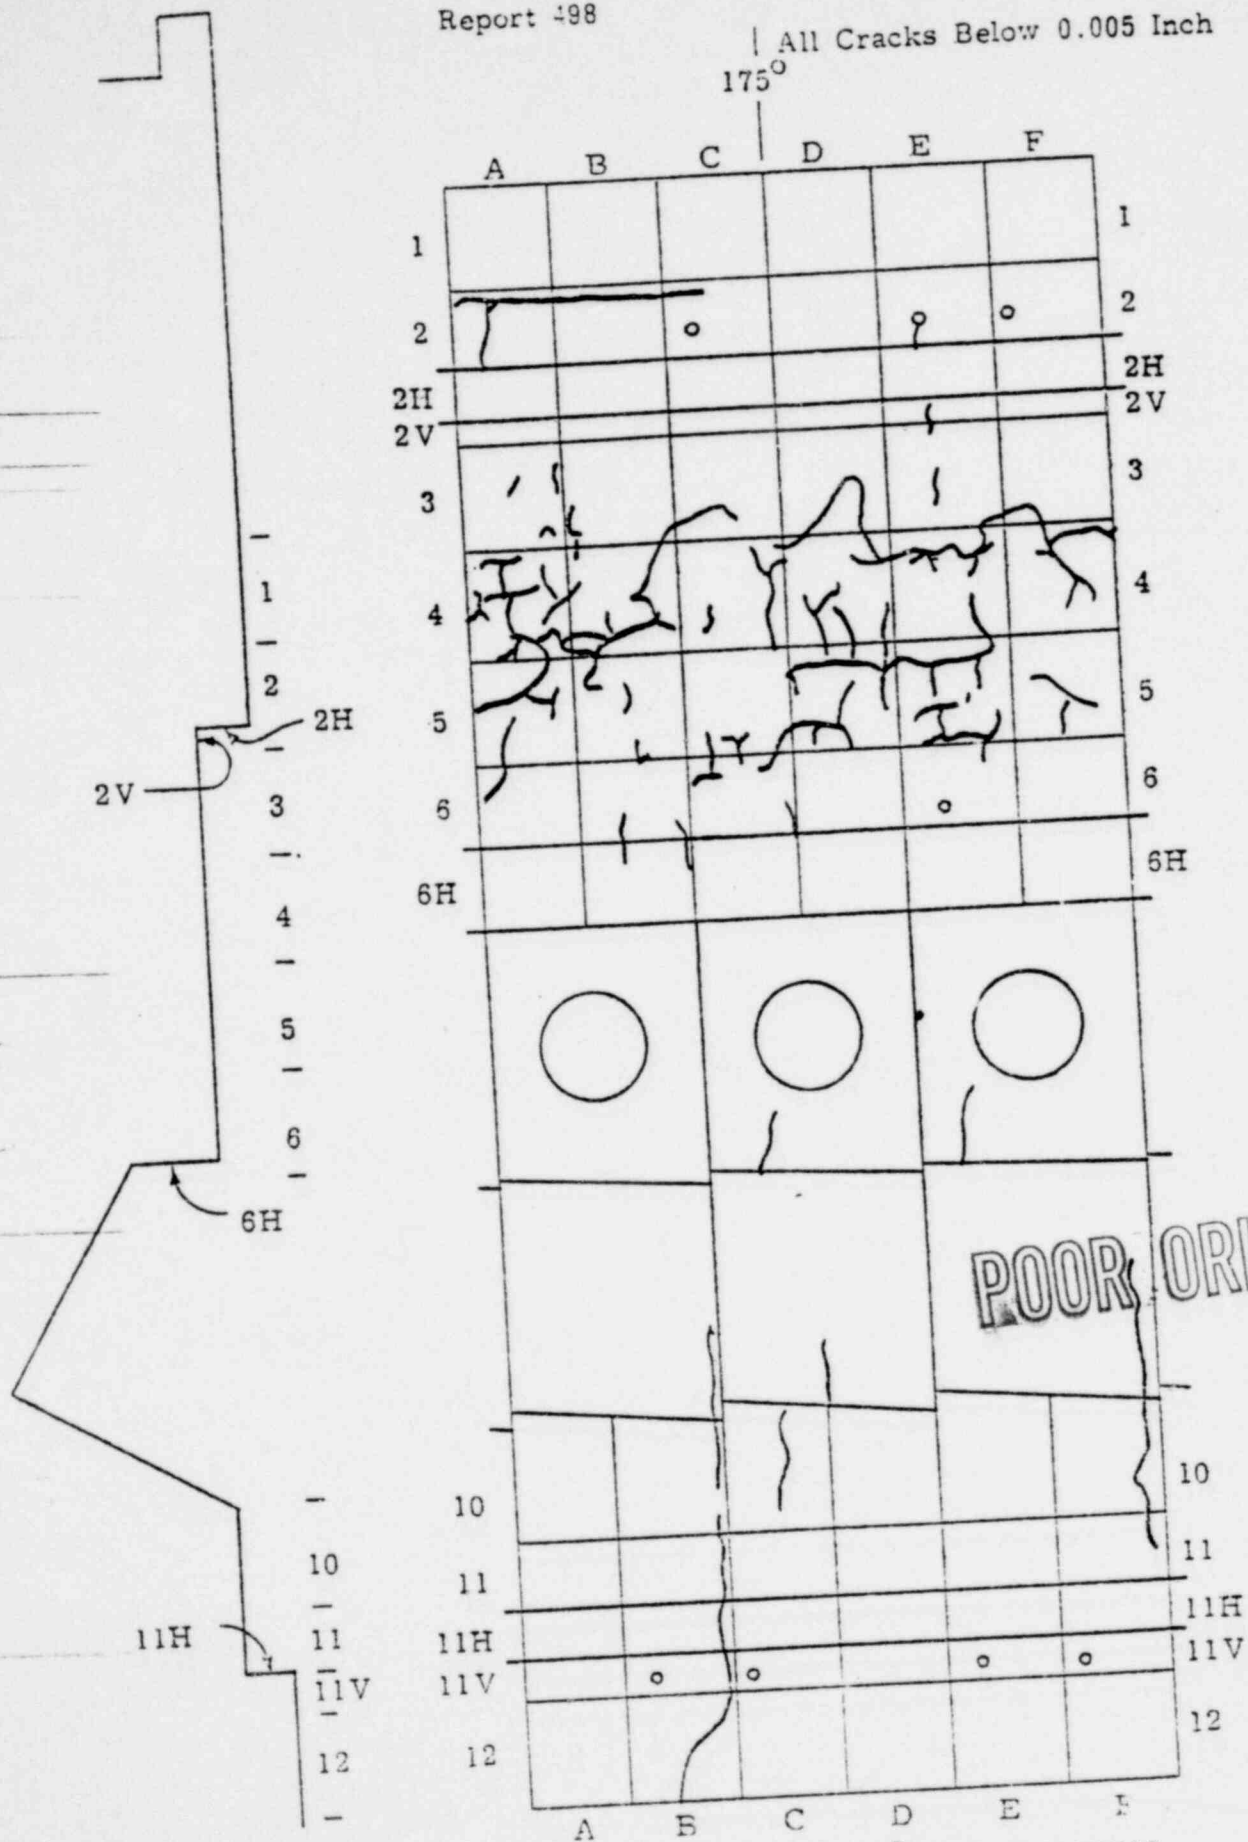
FIGURE 16.

All Cracks Below 0.005 Inch

CRACK PATTERN AT AZIMUTH 175° FULL VERTICAL
AND DOME PRESTRESS, JULY 5, 1973.

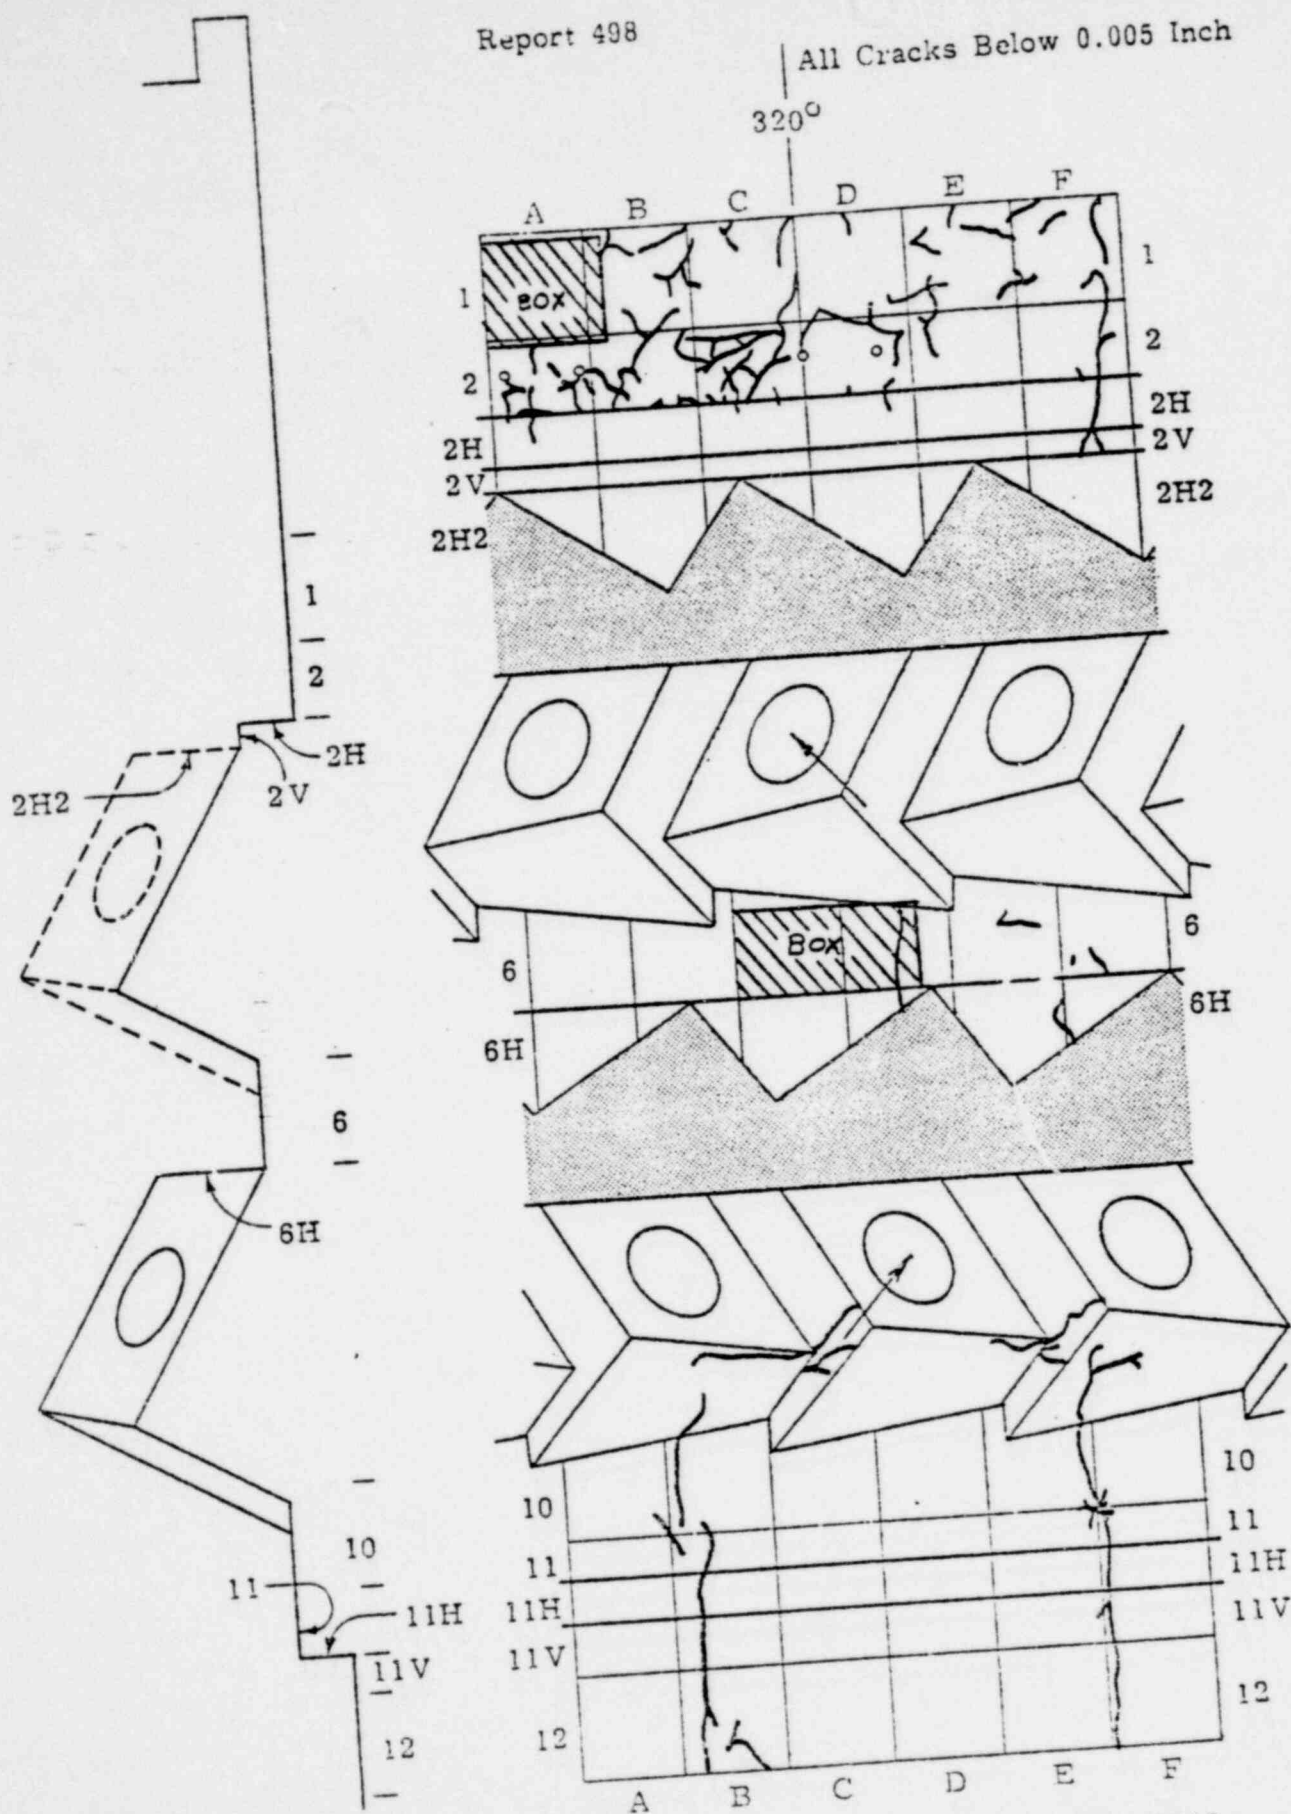
FIGURE 17.

CRACK PATTERN AT AZIMUTH 320° FULL VERTICAL
AND DOME PRESTRESS, JULY 5, 1973.

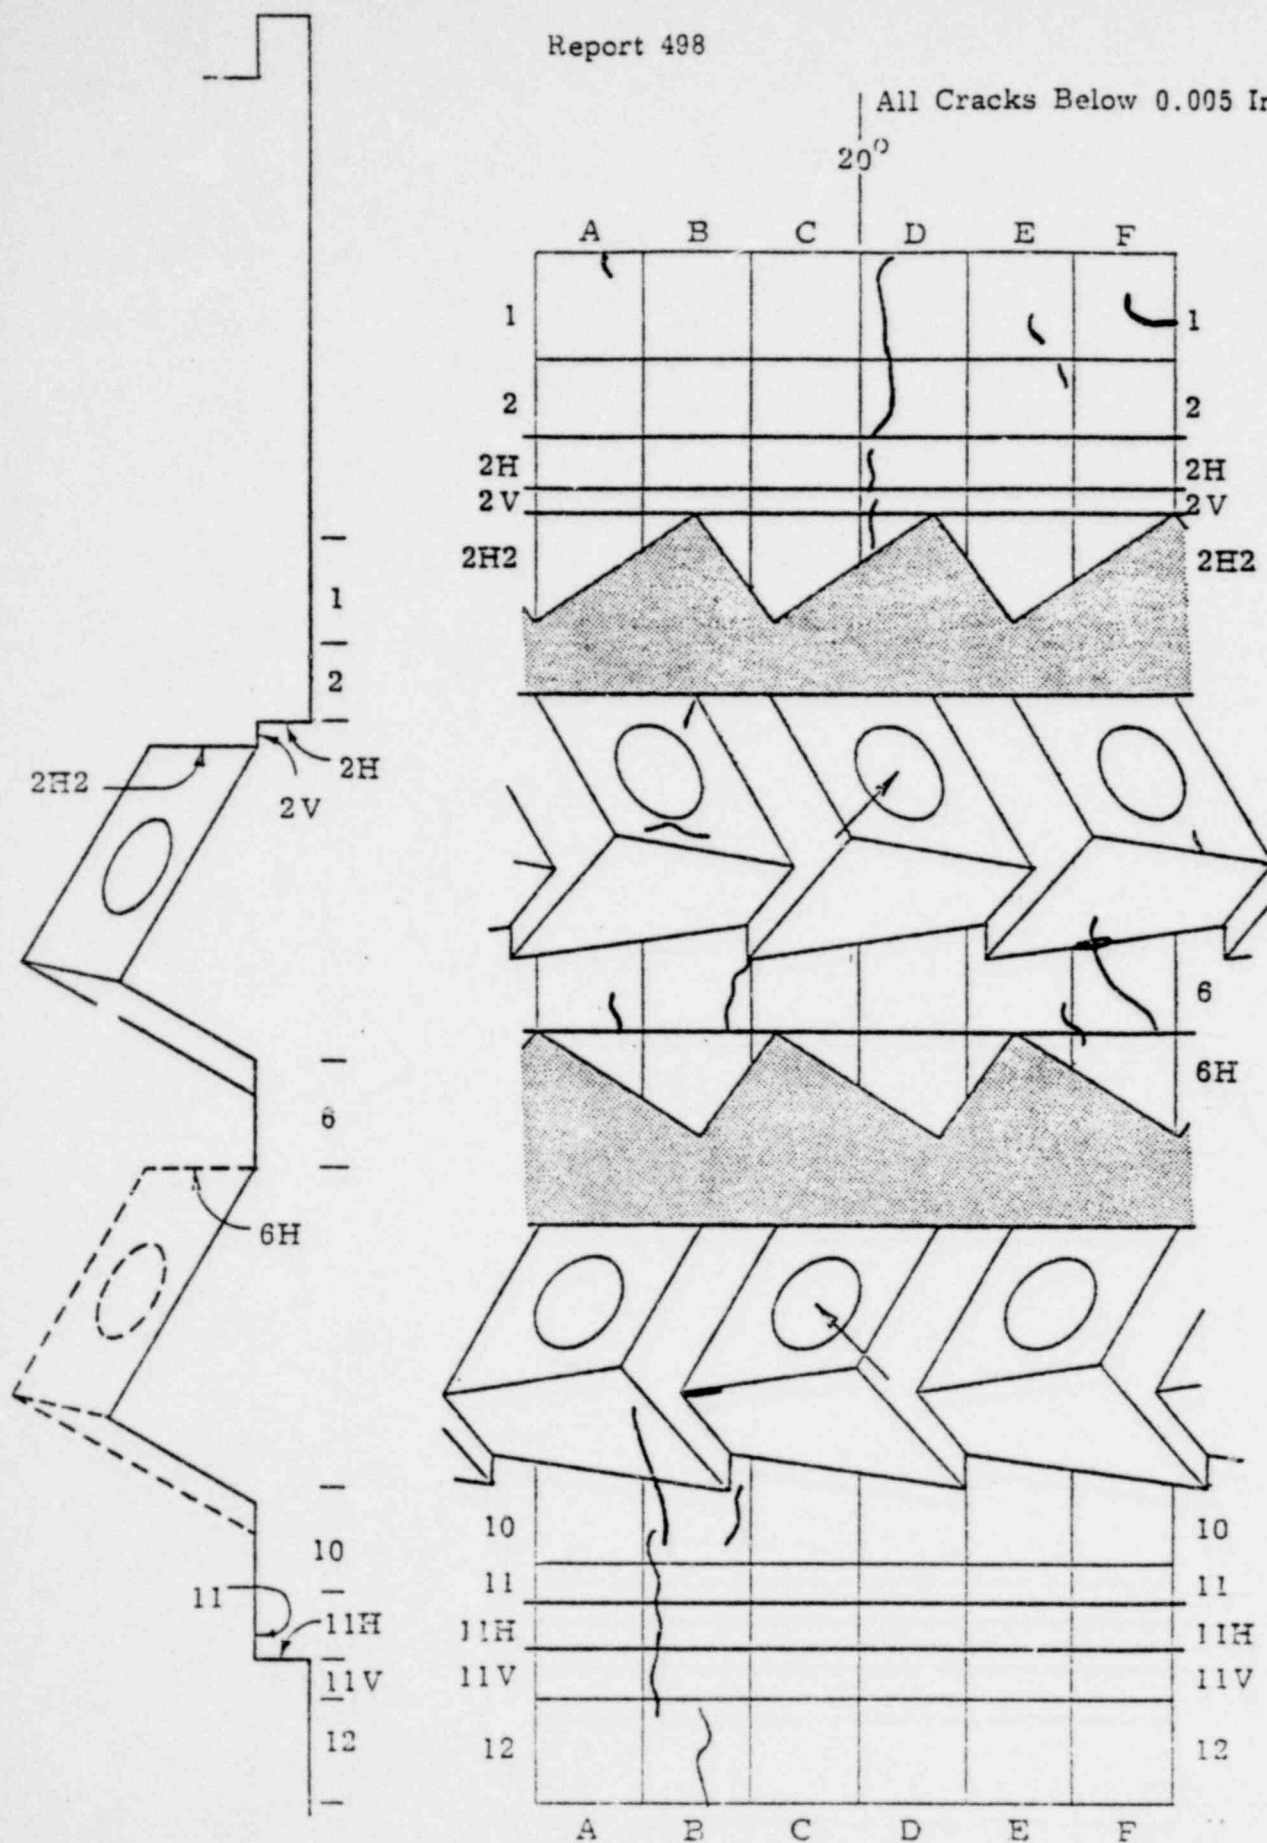
FIGURE 19.

All Cracks Below 0.005 Inch

CRACK PATTERN AT AZIMUTH 20° AFTER FULL
PRESTRESS, SEPTEMBER 18, 1973.

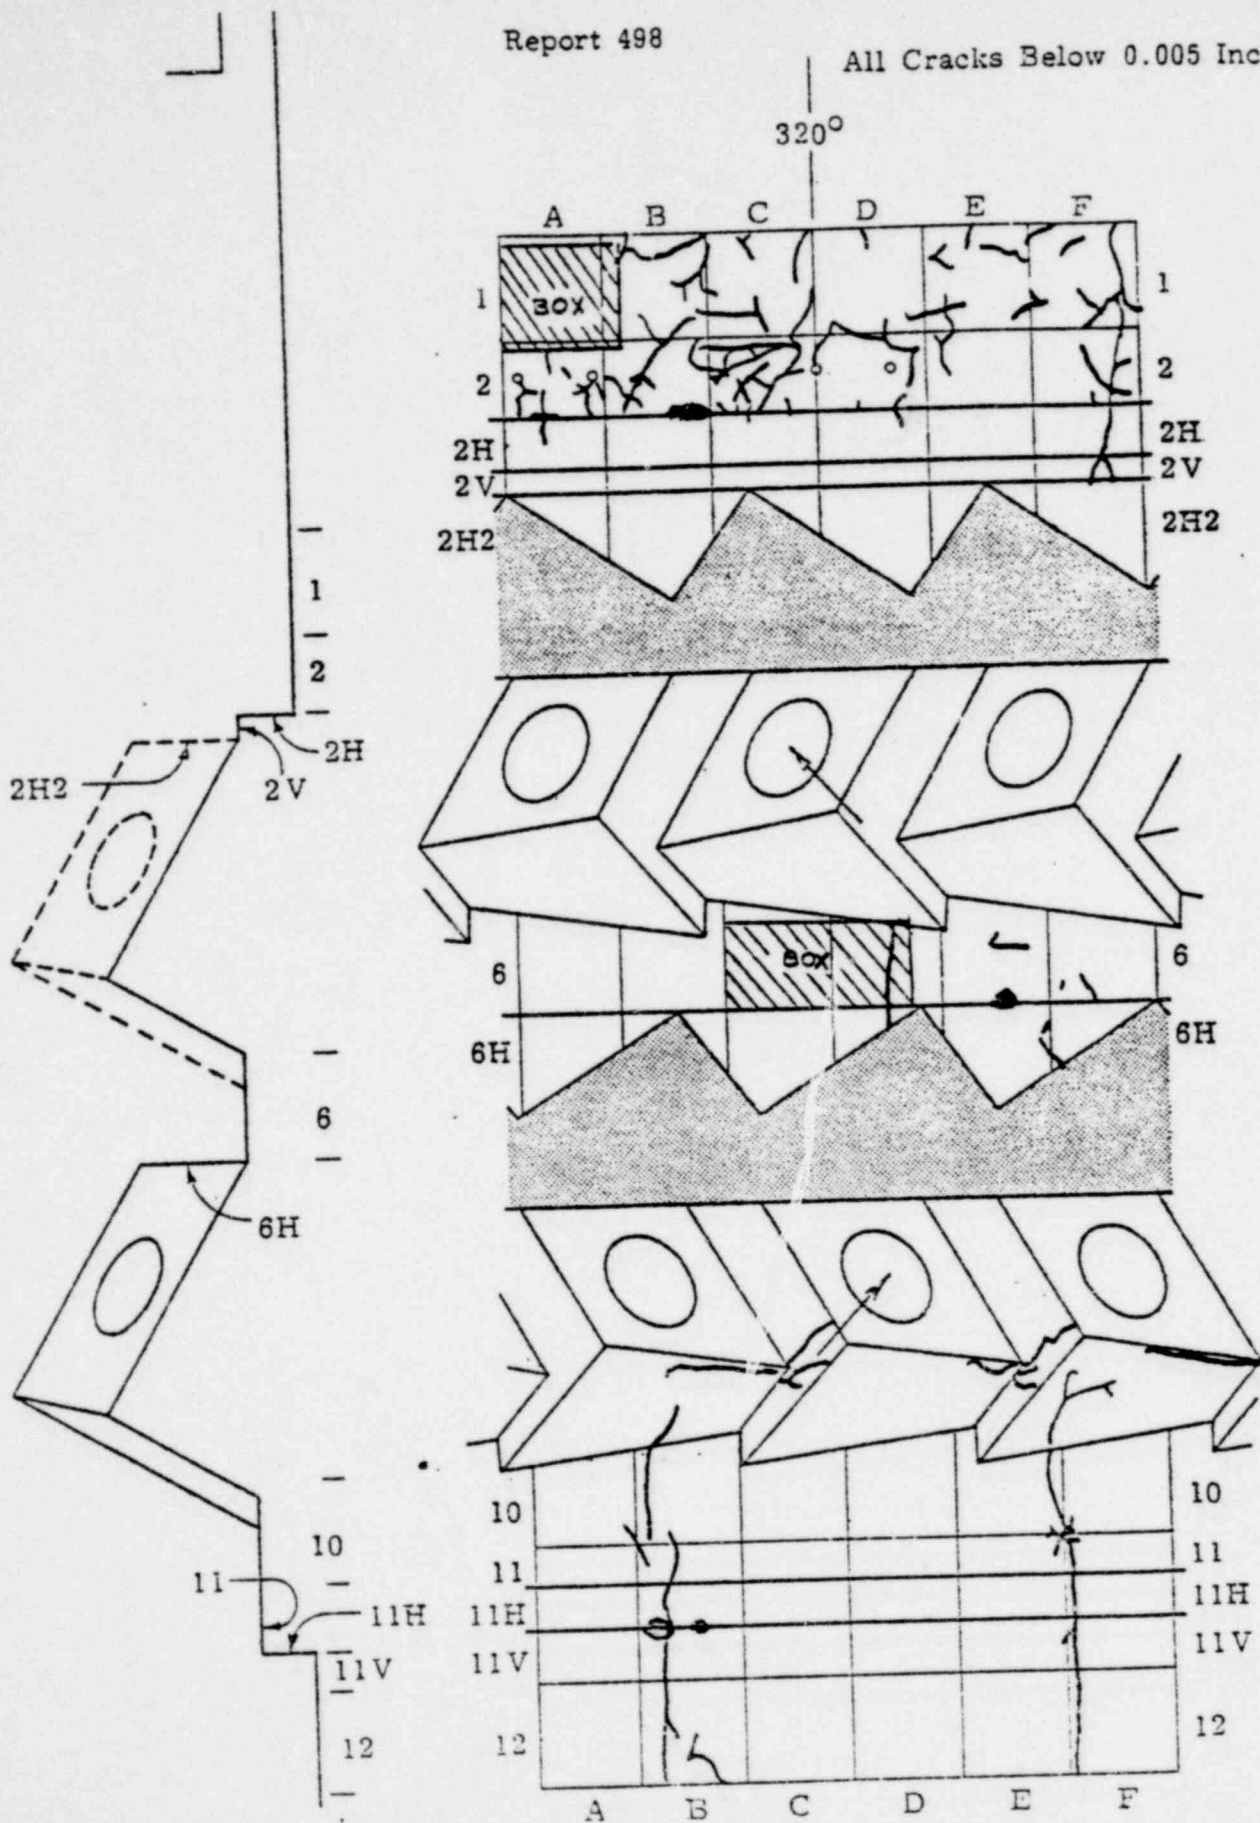
FIGURE 21.

CRACK PATTERN AT AZIMUTH 320° AFTER FULL
PRESTRESS, SEPTEMBER 18, 1973.

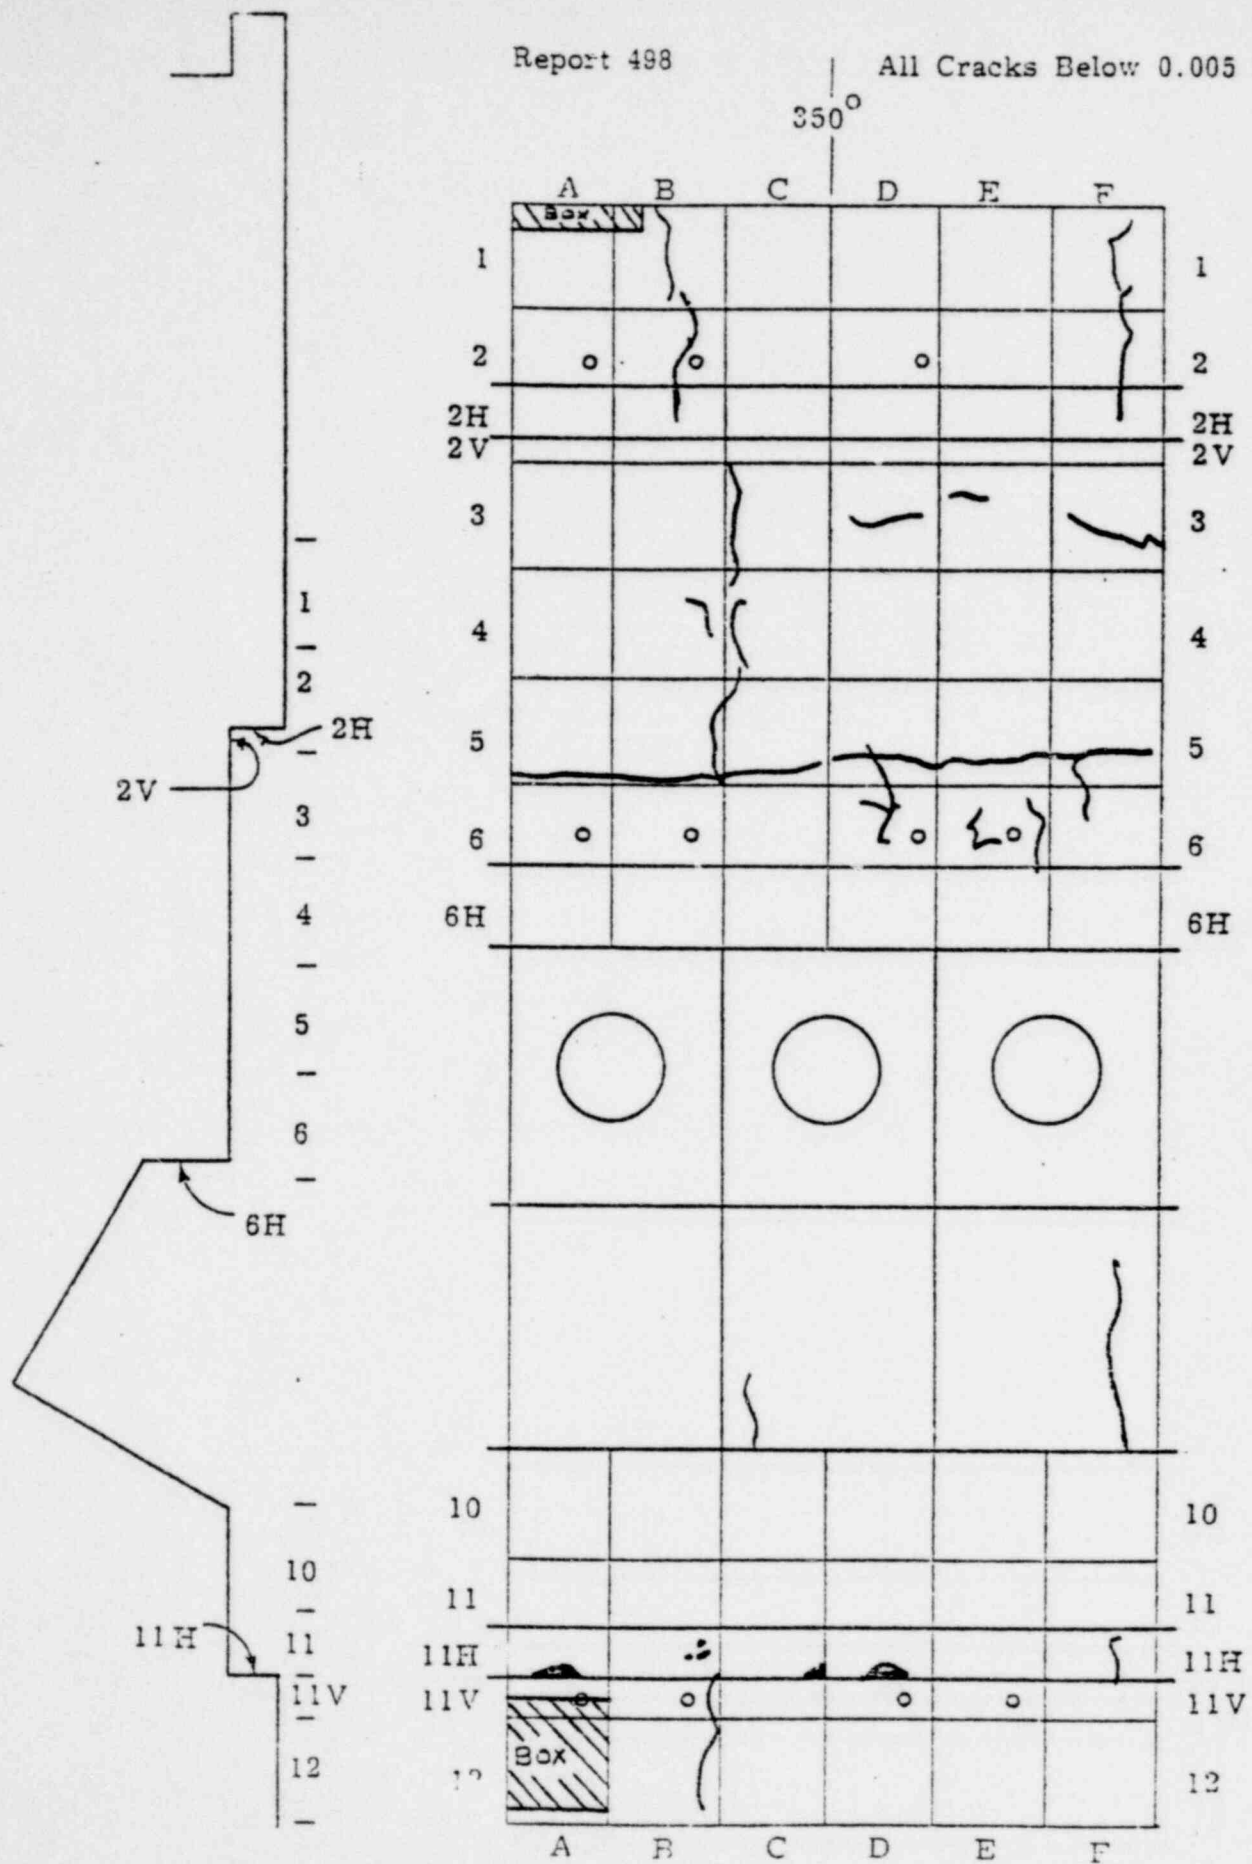
FIGURE 22.

CRACK PATTERN AT AZIMUTH 350° AFTER FULL
PRESTRESS, SEPTEMBER 19, 1973.
