THREE MILE ISLAND NUCLEAR STATION
UNIT 1

REACTOR CONTAINMENT BUILDING
RING GIRDER SURVEILLANCE TEST
TWO YEARS AFTER S.I.T.

September 17, 1976

METROPOLITAN EDISON COMPANY
Subsidiary of General Public Utilities, Corp.

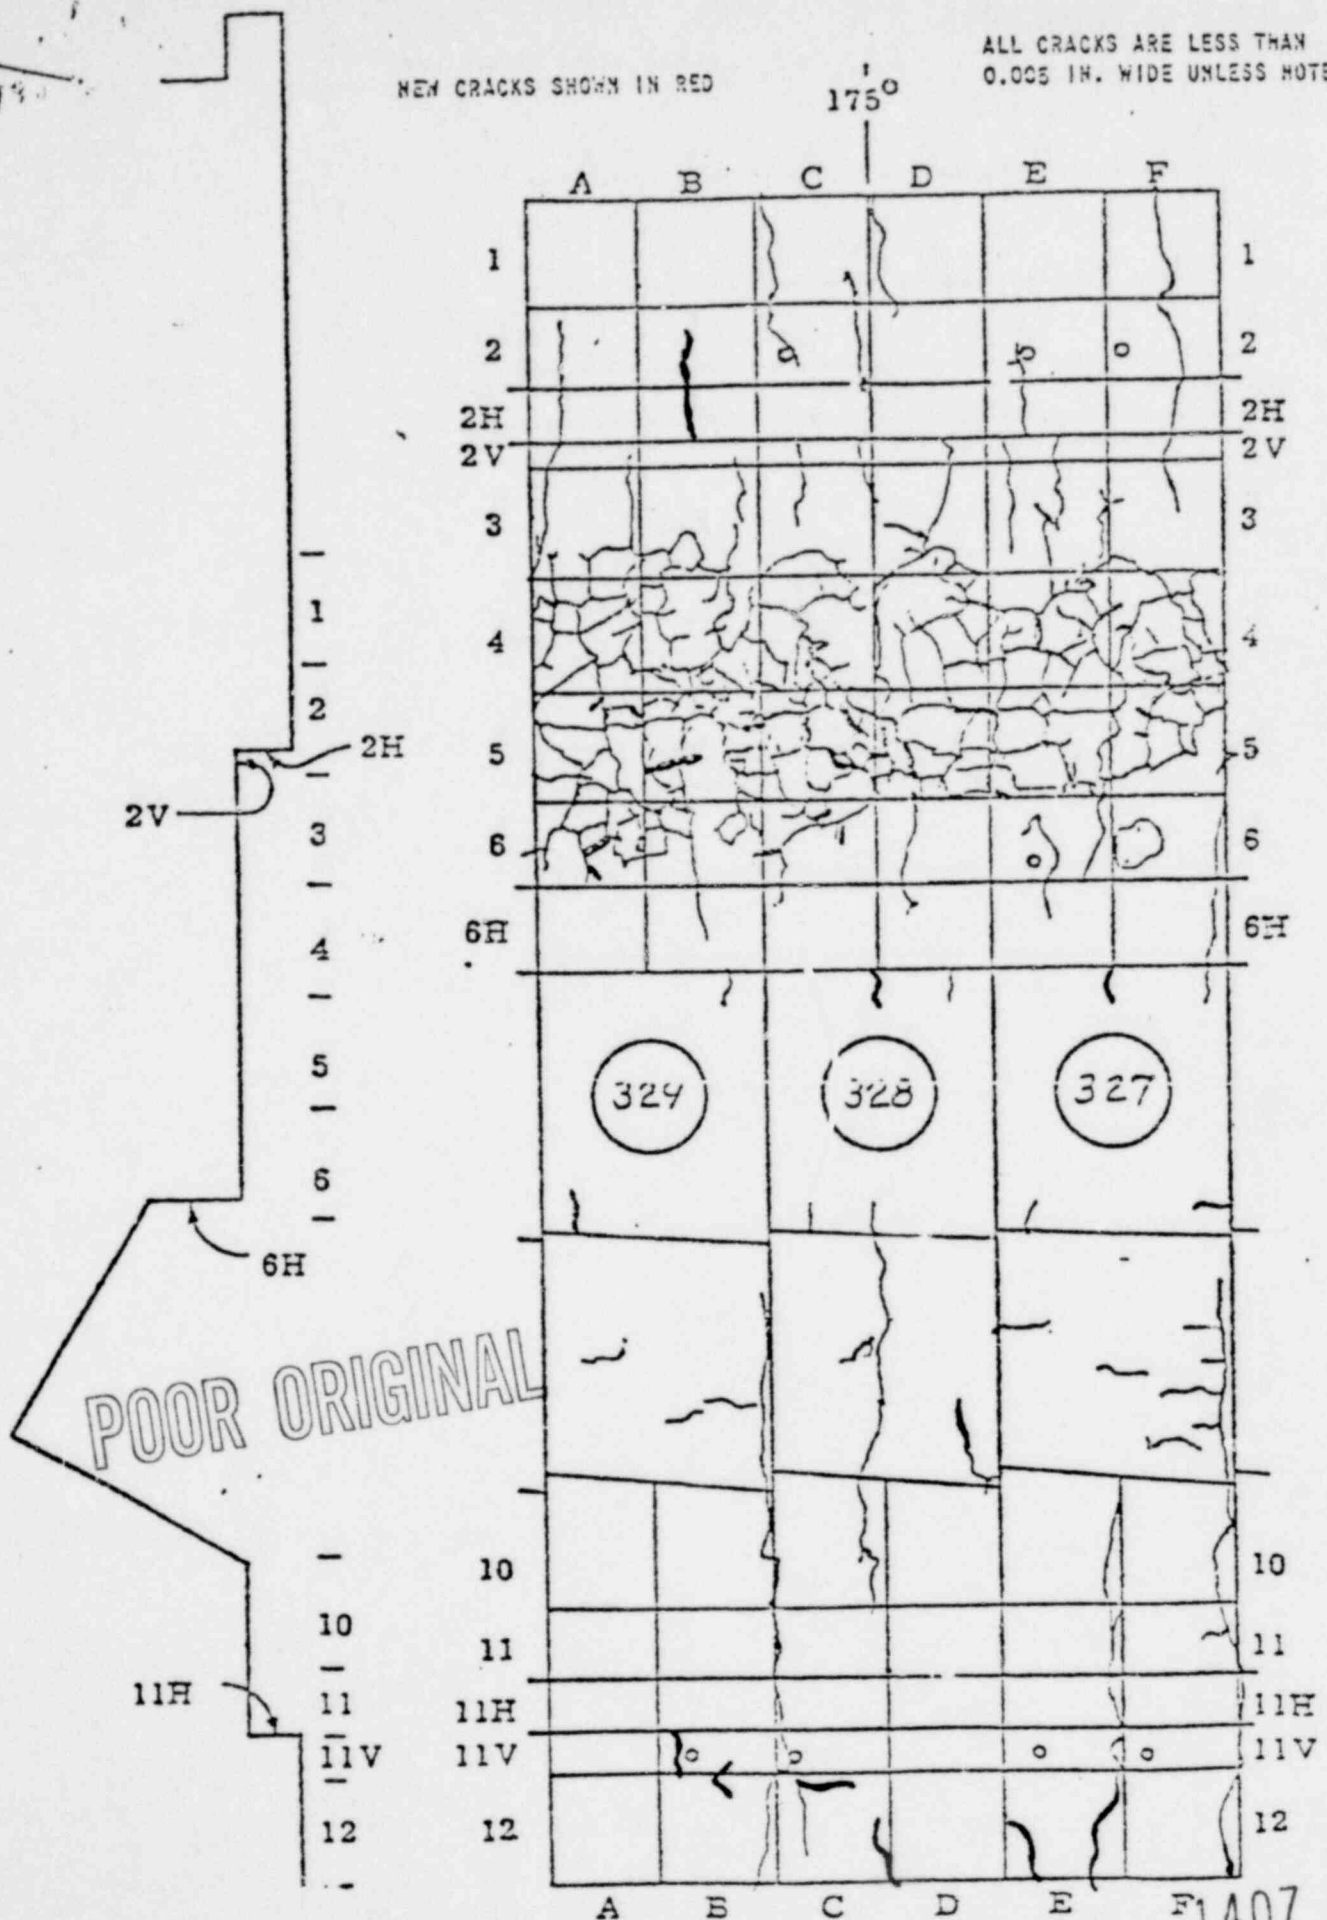
FIGURE 2

<u>Area No.</u>	<u>Comments</u>
120 (Fig. 2)	8 Additional cracks and 3 crack extensions between Elev. 439 ft and 451 ft, total length approximately 44. inches. One old crack has decreased in width to less than .005 inch.
131 (Fig. 3)	2 additional cracks between Elev. 439 ft. and 451 ft., total length approximately 10 inches.
132 (Fig. 4)	8 additional cracks and 1 crack extension between Elev. 439 ft and 451 ft, total length approximately 37 inches. One Old crack has decreased in width to less than .005 inch.
133 (Fig. 5)	19 additional cracks and 6 crack extensions between elev. 439 ft and 451 ft, total length approximately 50 inches. One old crack has decreased in width to less than .005 inch.

NEW CRACKS SHOWN IN RED

ALL CRACKS ARE LESS THAN
0.005 IN. WIDE UNLESS NOTED.

CRACK PATTERN AREA AT AZIMUTH 175°
AREA NO. 120

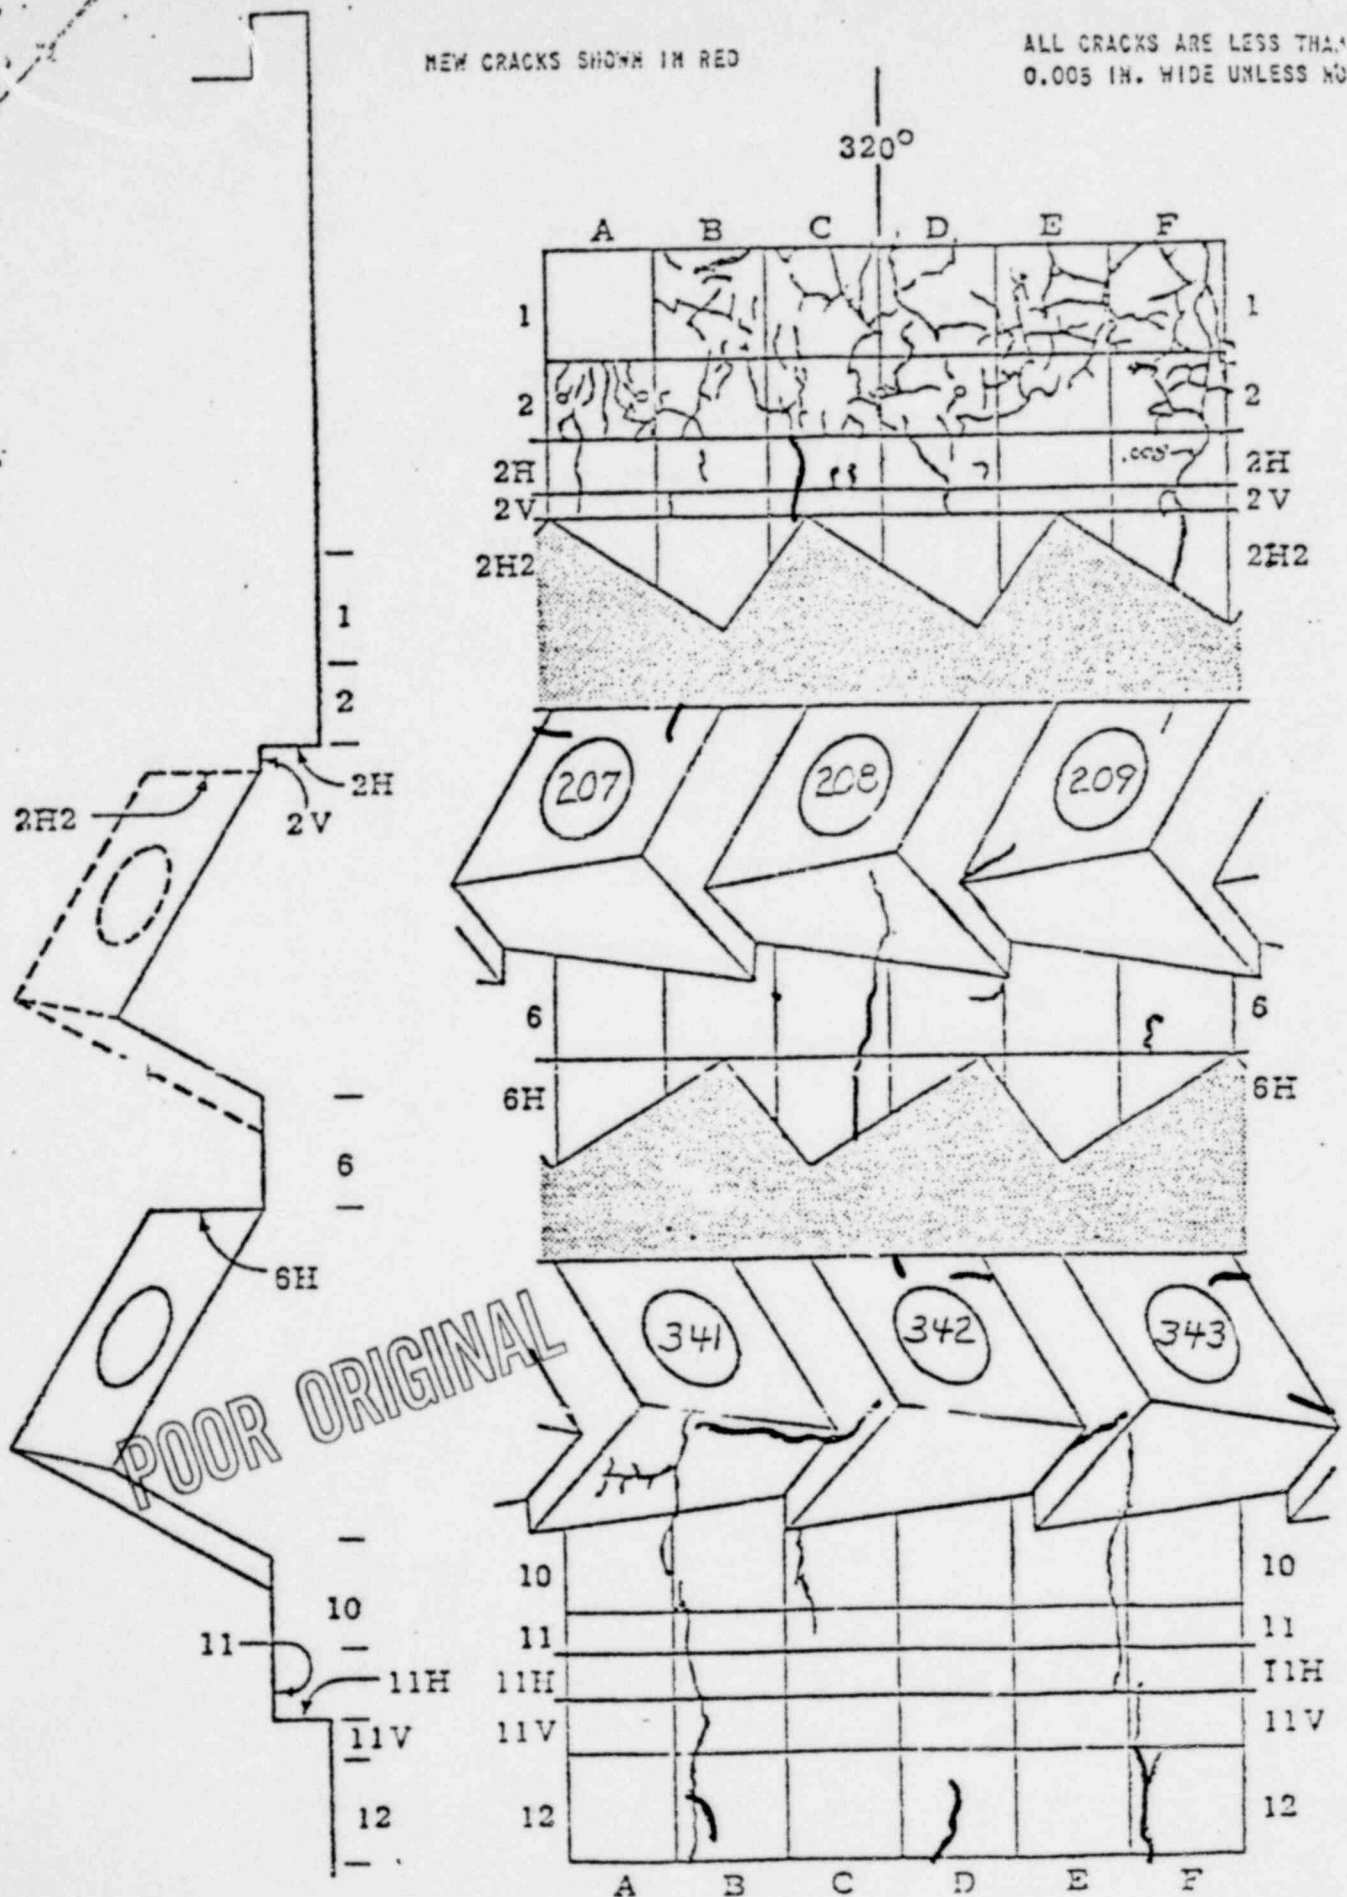
FIGURE 4

NEW CRACKS SHOWN IN RED

ALL CRACKS ARE LESS THAN
0.005 IN. WIDE UNLESS NOTED.

CRACK PATTERN AREA AT AZIMUTH 320°
AREA NO. 132

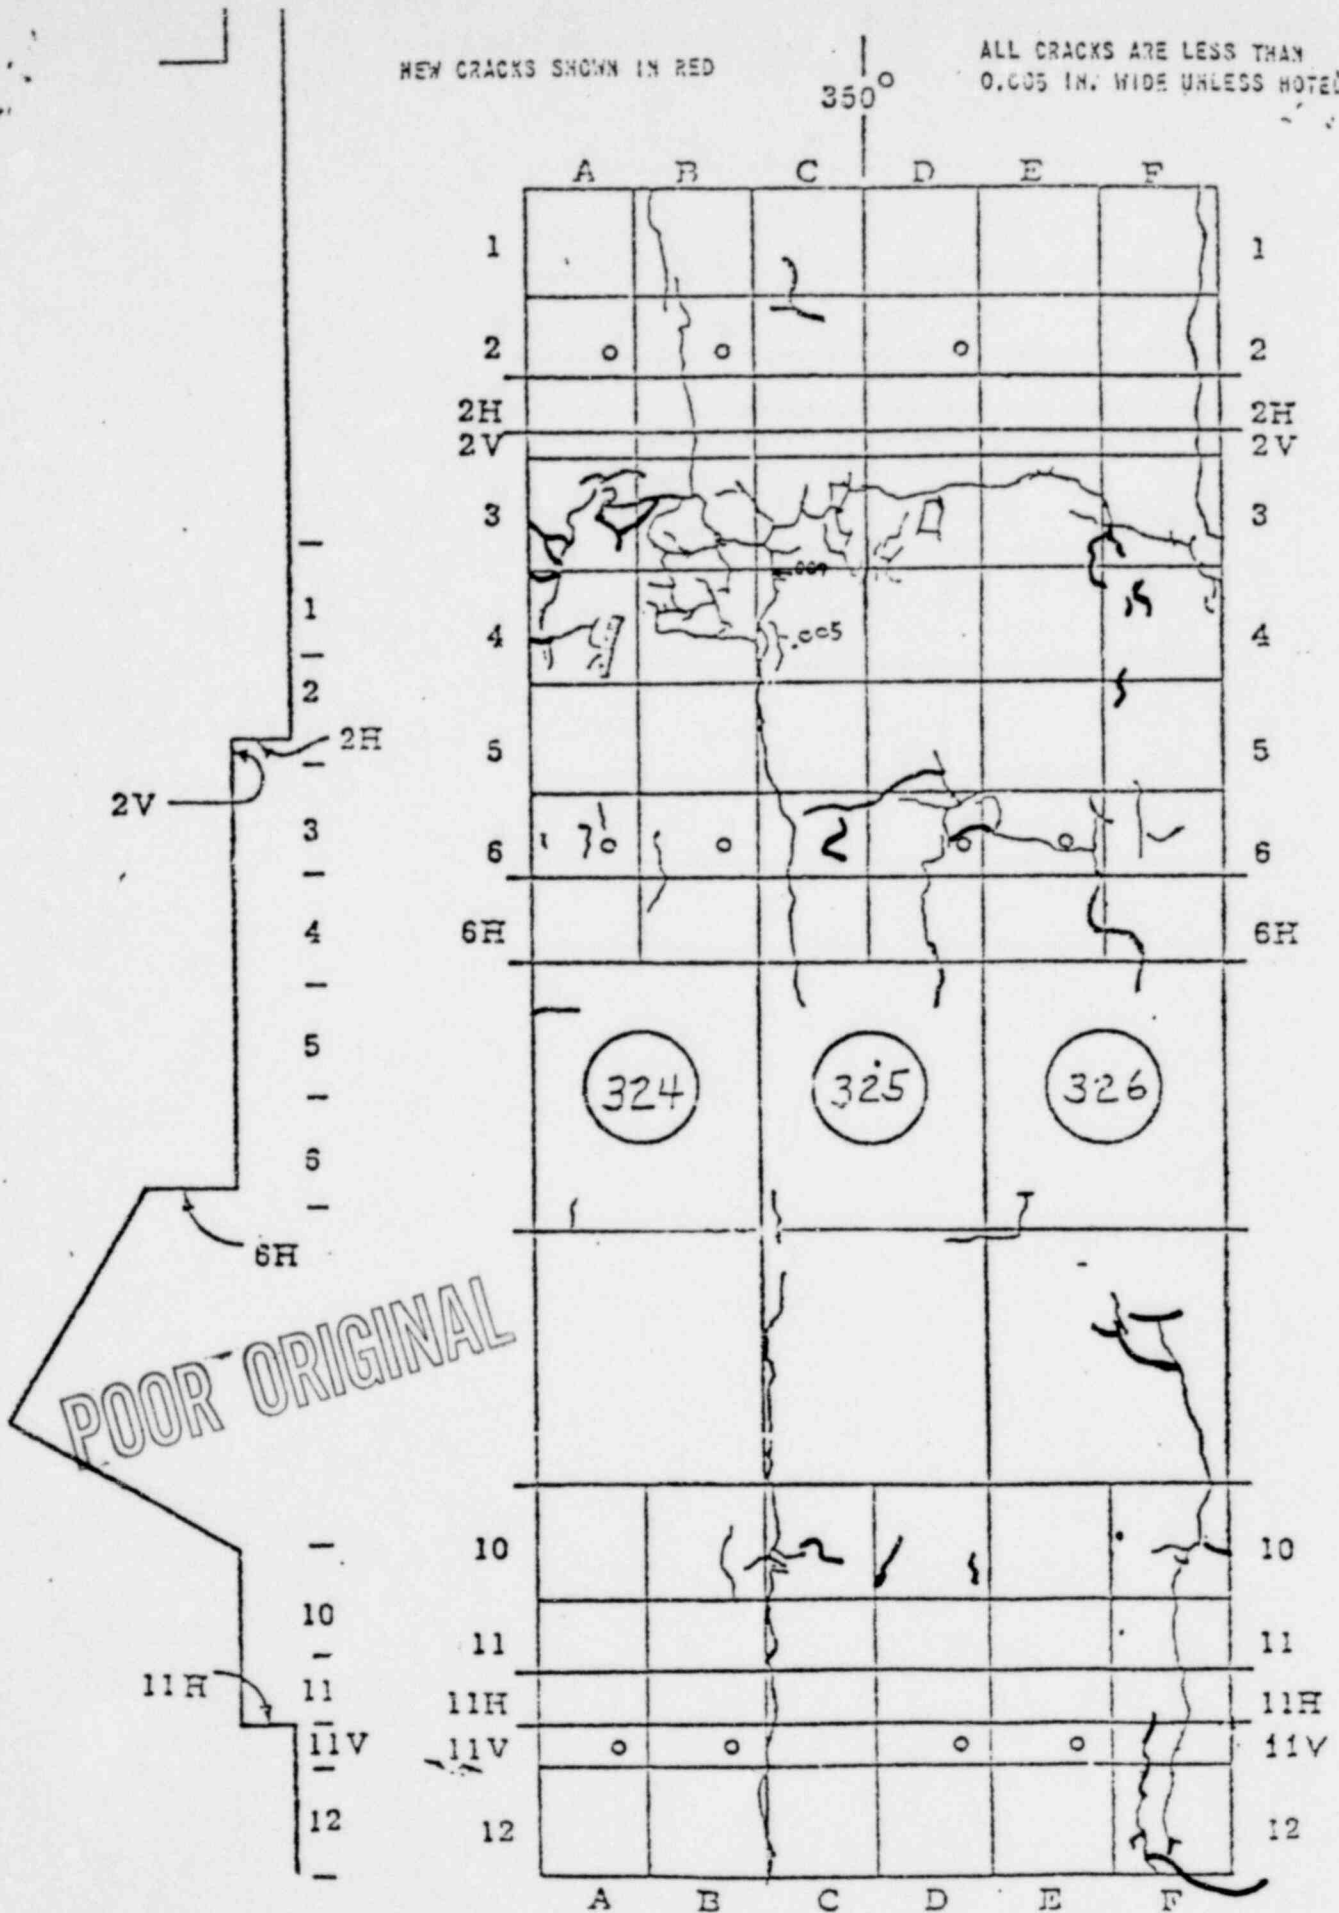
1407 270 FIGURE 5

NEW CRACKS SHOWN IN RED

ALL CRACKS ARE LESS THAN
0.005 IN. WIDE UNLESS NOTED.

CRACK PATTERN AREA AT AZIMUTH 350°
AREA NO. 133

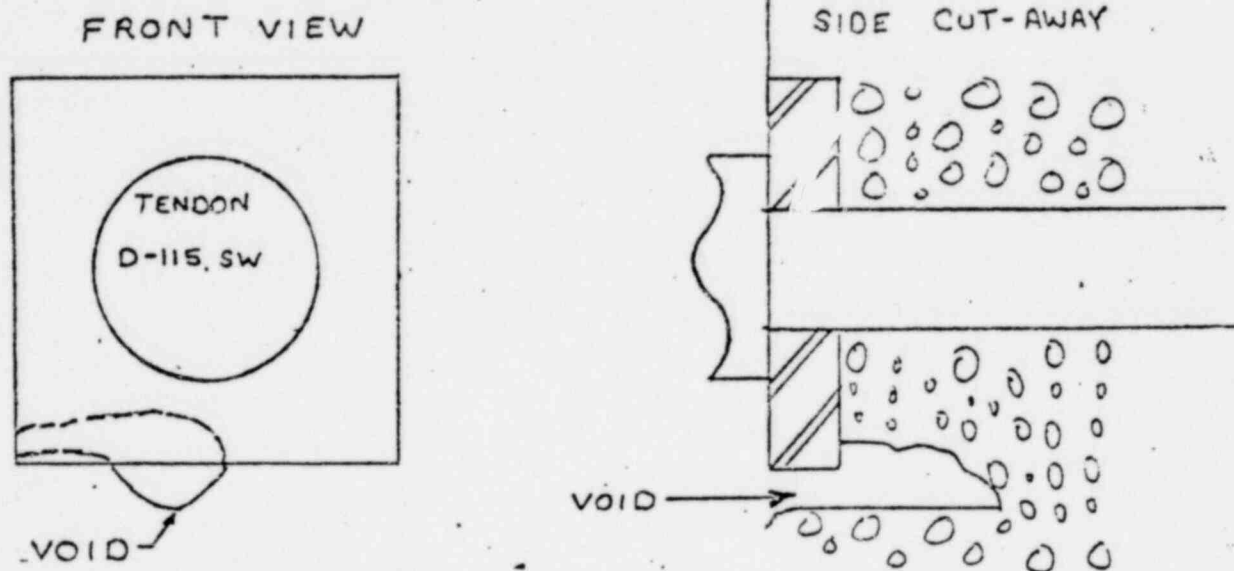
REACTOR BUILDING VOID #1

EST. VOLUME OF VOID - 90 IN^3
REAR SURFACE AREA, EXPOSED - 4 IN^2
OPENING AREA - 12 IN^2
DEPTH OF VOID - 12 IN

FIGURE-6
RING GIRDER VOID AT
DOME TENDON D-115
S.W. QUADRANT

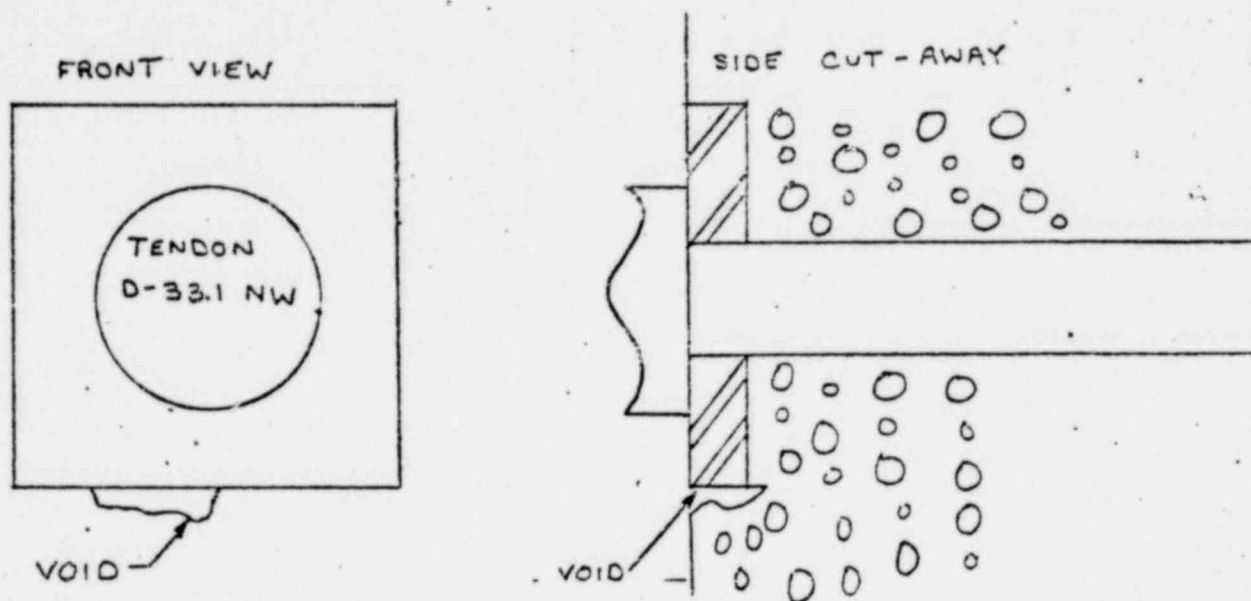
REACTOR BUILDING VOID#2

EST. VOLUME OF VOID - 40 IN^3

REAR SURFACE AREA EXPOSED - 0

OPENING AREA - 3 IN^2

DEPTH OF VOID - 4 IN

RING GIRDER VOID AT
DOME TENDON D-331
N W QUADRANT

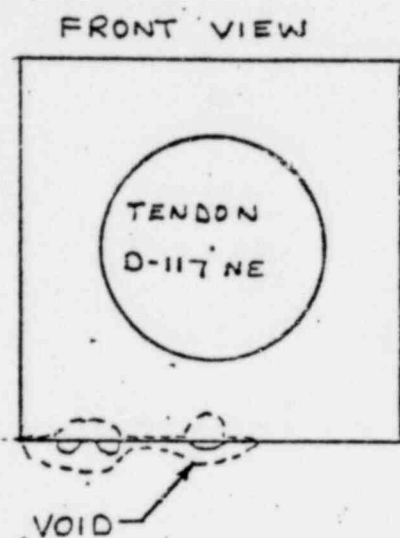
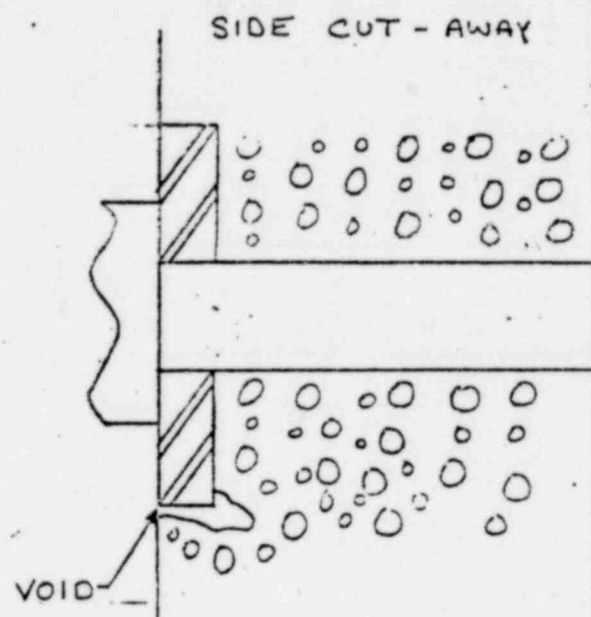
REACTOR BUILDING VOID #3

EST. VOLUME OF VOID - 22 IN^3

REAR SURFACE AREA EXPOSED - 3 IN^2

OPENING AREA - 1 IN^2

DEPTH OF VOID - $6\frac{1}{4} \text{ IN}$

RING GIRDER VOID AT
DOME TENDON D-117
N.E. QUADRANT

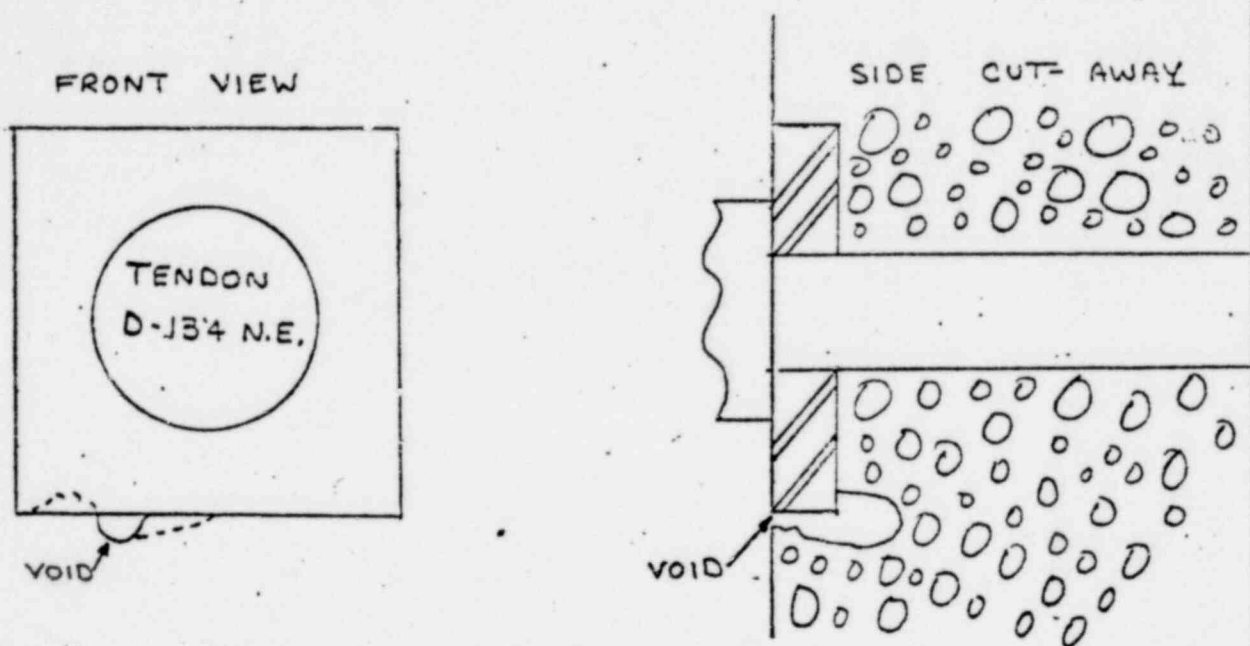
REACTOR BUILDING VOID #4

EST. VOLUME OF VOID-6 IN³
REAR SURFACE AREA EXPOSED-3 IN²
OPENING AREA-1 IN²
DEPTH OF VOID-6 IN

FIGURE-9
RING GIRDER VOID AT
DOME TENDON D-134
N.E. QUADRANT

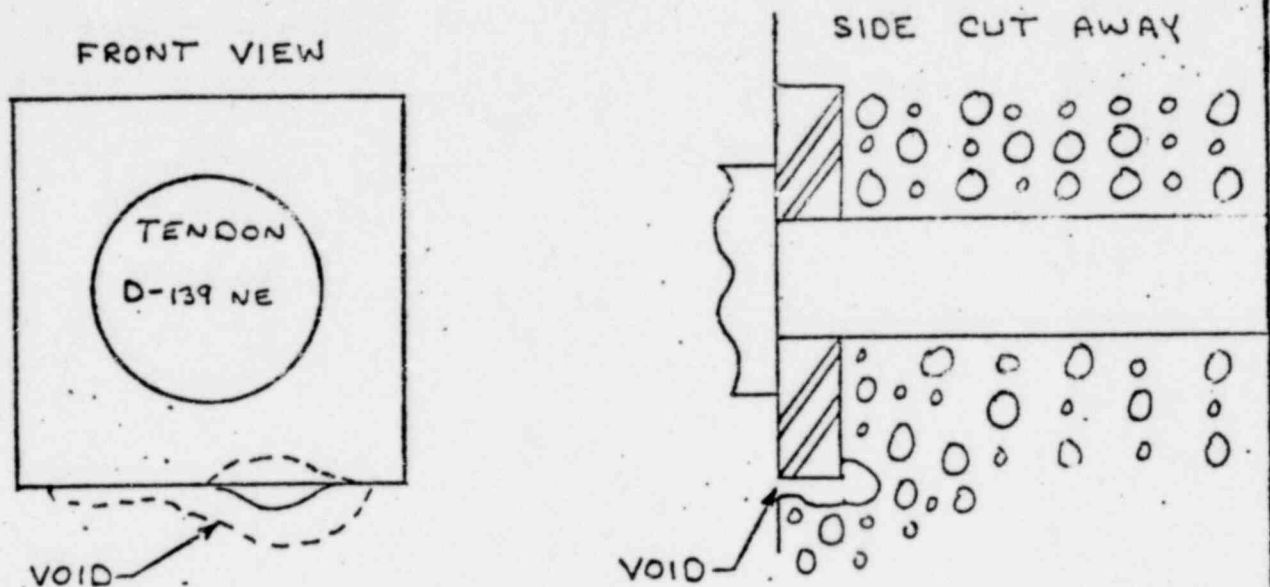
REACTOR BUILDING VOID*5

EST. VOLUME OF VOID-50 IN³
 REAR SURFACE AREA EXPOSED-2 IN²
 OPENING AREA-1½ IN²
 DEPTH OF VOID-5 IN

FIGURE-10
 RING GIRDER VOID AT
 DOME TENDON D-139
 N.E. QUADRANT

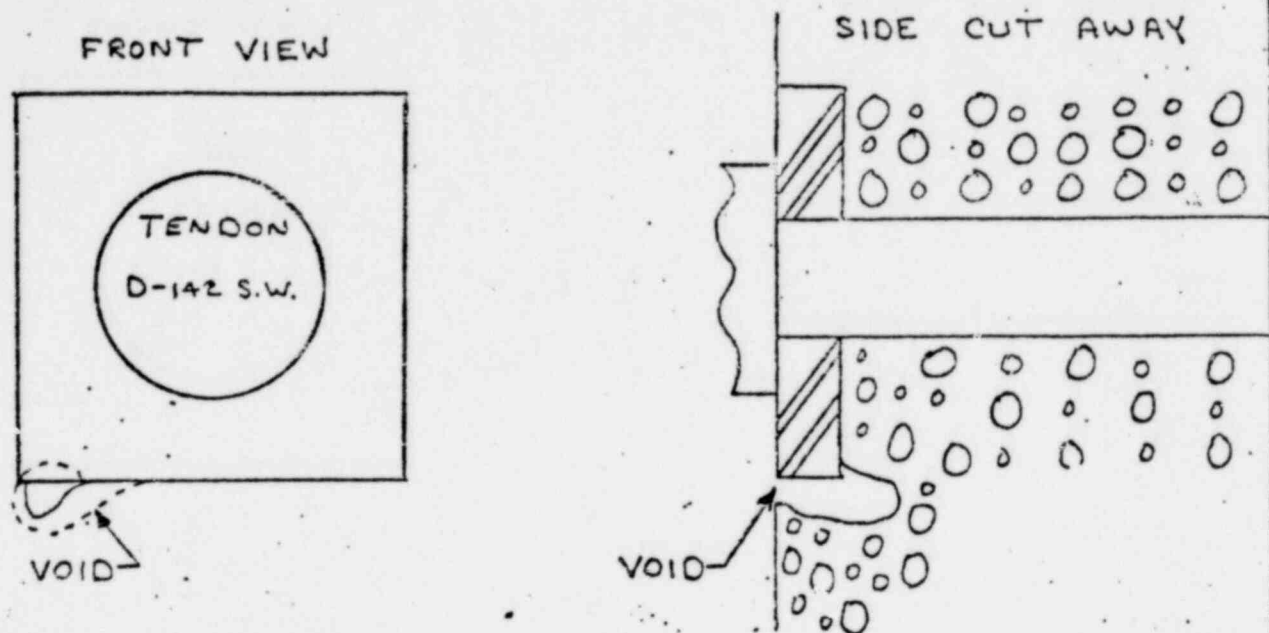
REACTOR BUILDING VOID*6

EST. VOLUME OF VOID-40 IN³
REAR SURFACE AREA EXPOSED-1 IN²
OPENING AREA-2 IN²
DEPTH OF VOID-5½ IN

FIGURE-II
RING GIRDER VOID AT
DOME TENDON D-142
S.W. QUADRANT

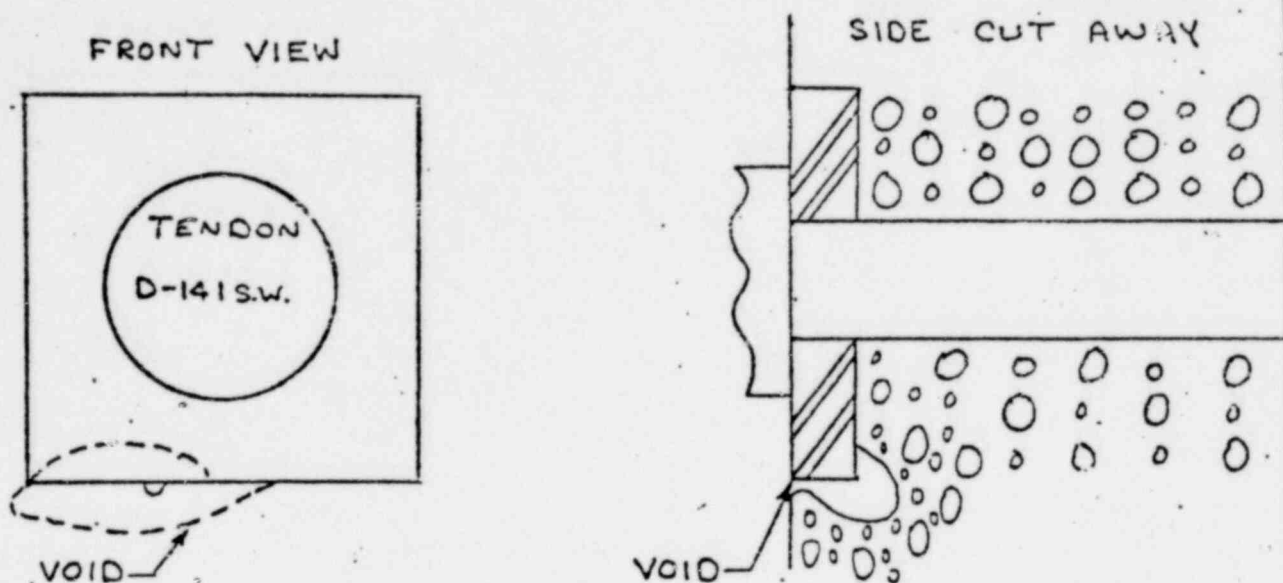
REACTOR BUILDING VOID*7

Of the seven concrete voids (shown in Figures 6-12), Void #7 on the tendon bearing plate D-141 in the Southwest Quadrant is the largest in terms of area of exposed backing. The void entrance is located at the bottom of tendon D-141-SW bearing plate and is approximately 1 inch wide by 1/2 inch high. Average depth of the void is approximately 4 inches; maximum measured depth, 5 inches; average height, approximately 1-1/2 inches; maximum width, 10-1/4 inches. Volume of the void is approximately 0.03 ft³. Approximately 6 in² (approximately 3/4 by 8 inches) of bearing area behind the bearing plate is lost due to the void. Figure 12 is a sketch of the void.

Considering the loss of bearing area, described, and the reduced tendon force, the ratio of allowable to actual bearing stress was calculated to be 1.17. This ratio indicates a nine percent increase in the margin above the code allowable bearing stress. During the life of the plant, tendon force will continue to decrease, resulting in a corresponding increase in the safety factor.

EST. VOLUME OF VOID-50 IN³
 REAR SURFACE AREA EXPOSED-6 IN²
 OPENING AREA- $\frac{1}{2}$ IN²
 DEPTH OF VOID-5 IN

FIGURE-12
 RING GIRDER VOID AT
 DOME TENDON D-141
 S.W. QUADRANT

- 4
- c. Cracks in the concrete surface around all accessible dome tendon bearing plates, with the exception of the concrete voids, are less than 0.005 inch wide which is less than the acceptance criteria of 0.010 inch and is acceptable.
 - d. The Seven Concrete voids were reported to the unit superintendent for evaluation, upon discovery. The seven voids were evaluated, and it was found that they did not decrease the safety factor to which the plant was built. Immediate filling of the voids is not considered to be necessary, however, they will be filled as soon as practicable.
