PRAIRIE ISLAND NUCLEAR GENERATING PLANT

PRAIRIE ISLAND UNIT 1
STEAM GENERATOR TUBE BREAK
LICENSEE EVENT REPORT

October 16, 1979

NORTHERN STATES POWER COMPANY
MINNEAPOLIS, MINNESOTA

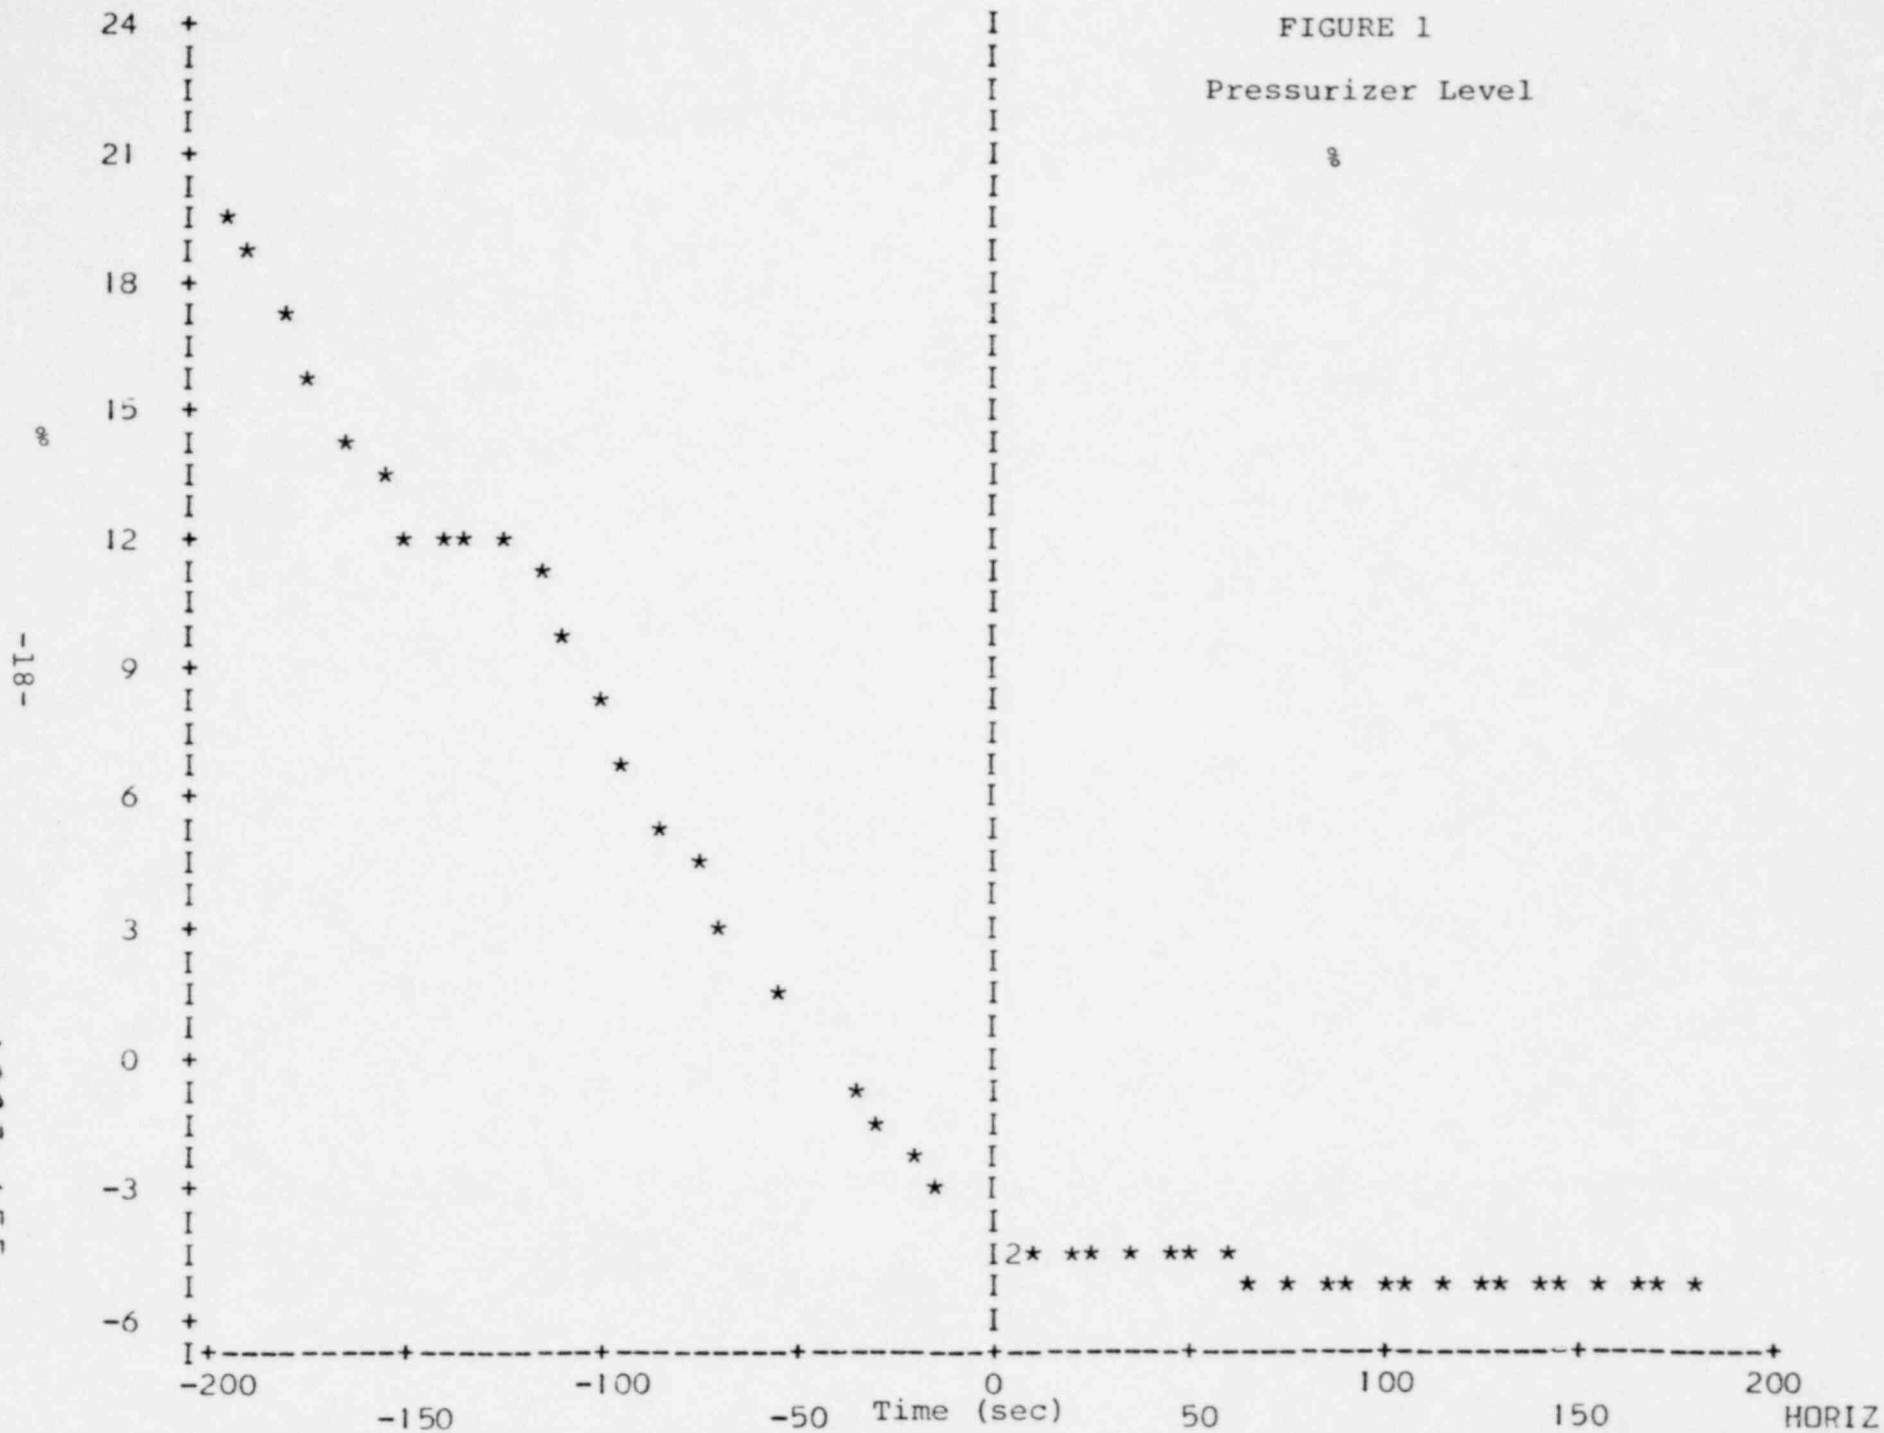
It is worthwhile noting that pressurizer level went off scale before the safety injection occurred due to low pressurizer pressure at 1815 psig. Accident analyses in the past had assumed initiation of the SI signal due to the coincident low pressurizer level (5%) and low pressurizer pressure (1815 psig) signals. In May 1979, the SI actuation scheme had been modified, as a result of Three Mile Island followup evaluations, to a 2-out-of-3 coincidence low pressurizer pressure actuation logic. With either scheme, SI signal initiation would have had to wait until pressure had dropped below 1815 psig. Thus, the safety analysis still bounds the plant response.

This calculation is based on pressurizer level vs time from the post trip review data (Table 1 and Figure 1).

Least squares fit of data was performed for those areas of the curve in which pressurizer level was decreasing uniformly, as follows:

- (1) 14h 20m 57s to 14h 21m 29s (32 sec.)

$$\text{Leak rate} = -0.163750 \%/\text{sec}$$

- (2) 14h 22m 25s to 14h 22m 57s (32 sec.)

$$\text{Leak rate} = -0.168749 \%/\text{sec}$$

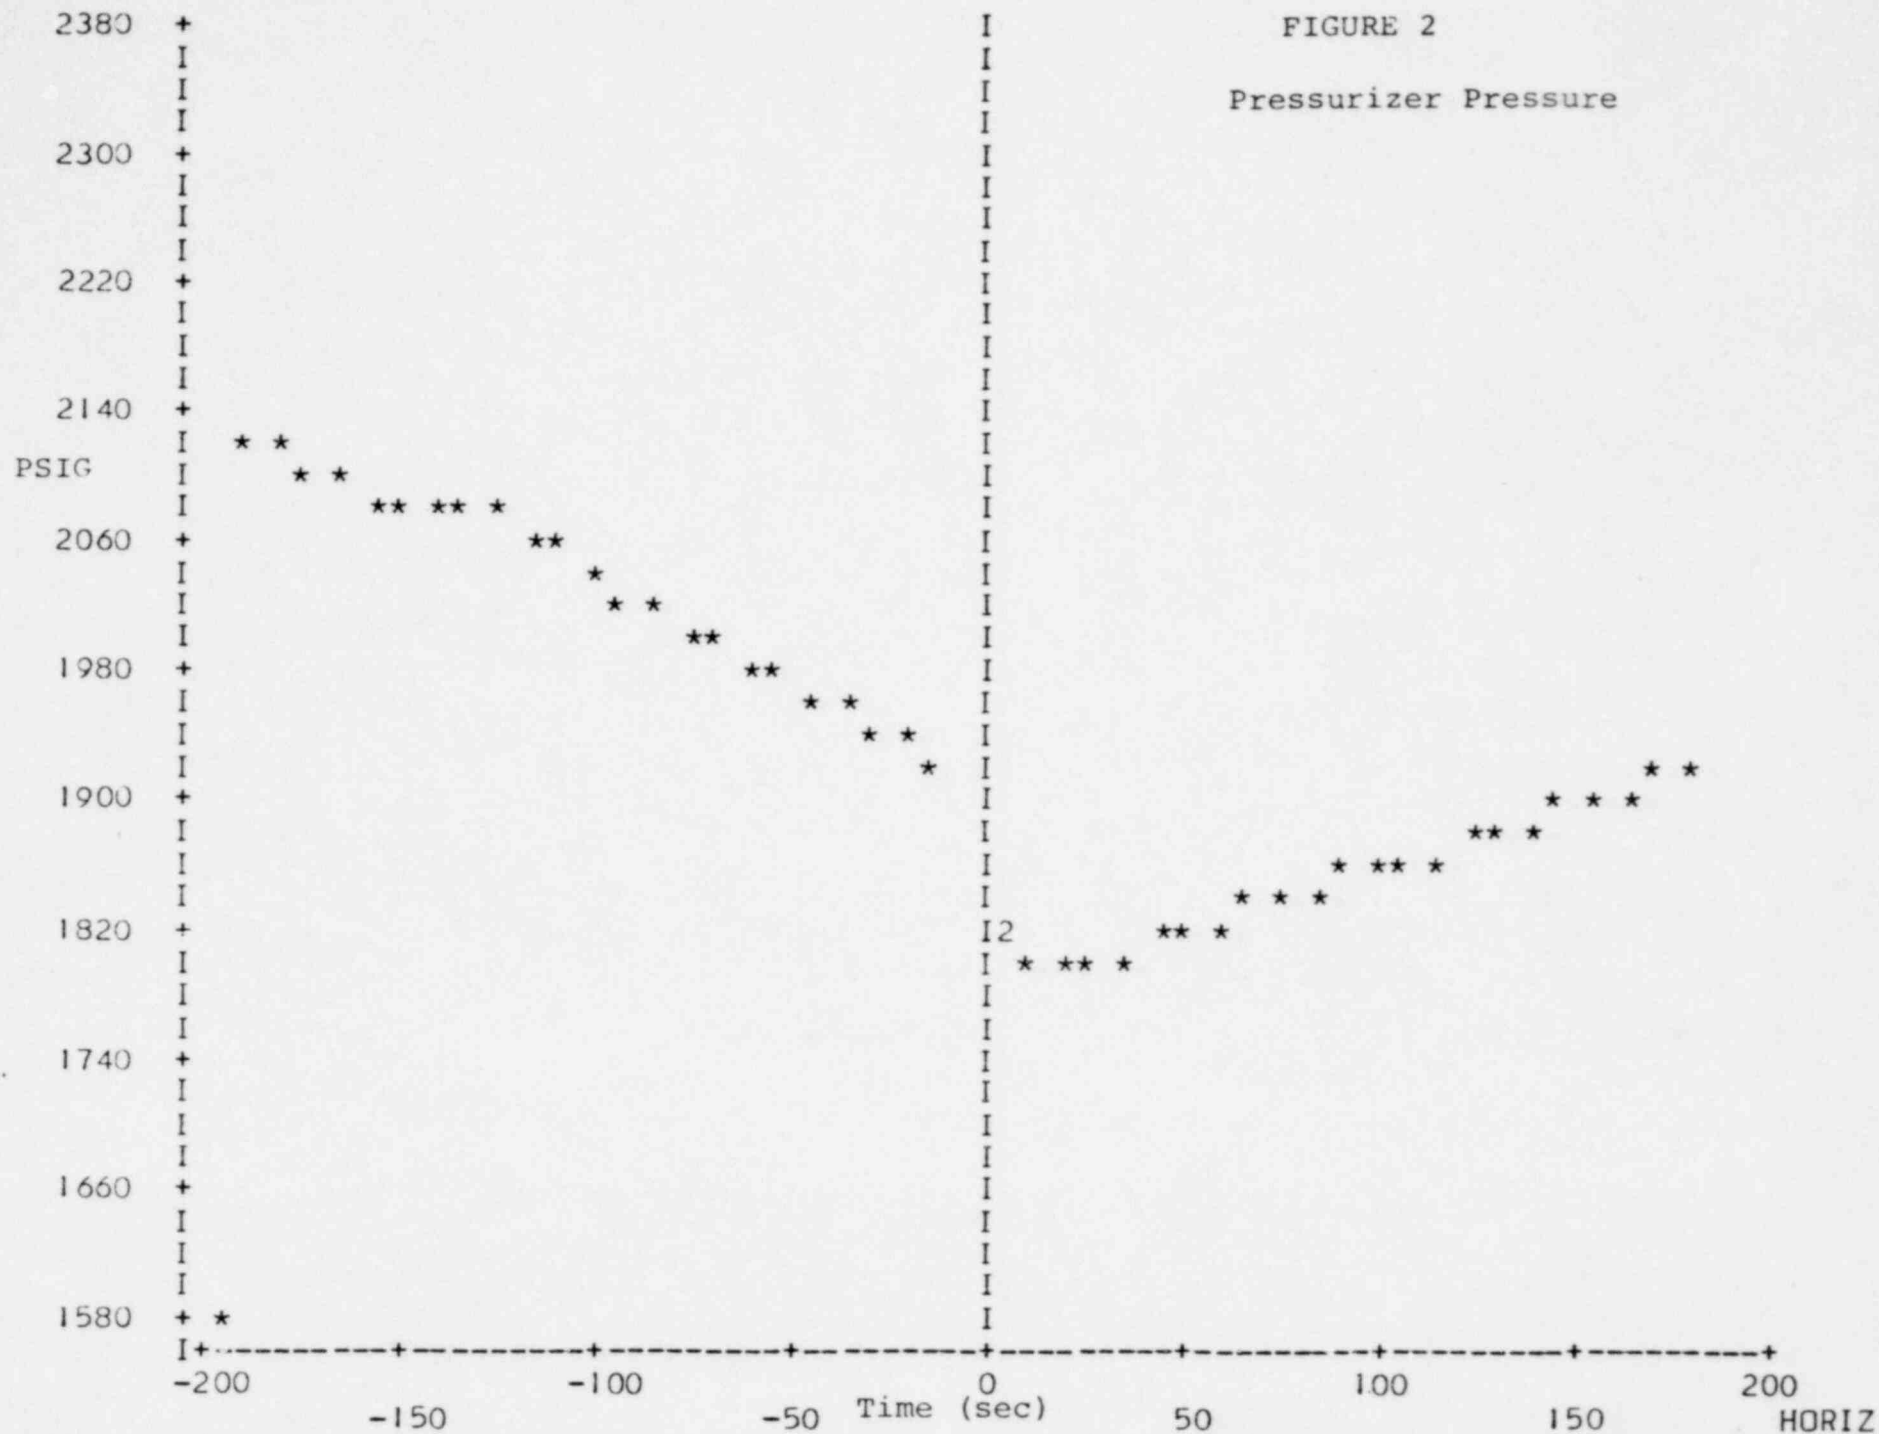
FIGURE 2
Pressurizer Pressure

Pressure during the most severe portion of the transient was dropping at a rate of about 100 psi/minute. Pressure recovery was rapid once the SI pumps started injecting.

From Figure 2, at 14h 24m 33s pressurizer pressure was increasing steadily indicating that RCS water inventory was increasing.

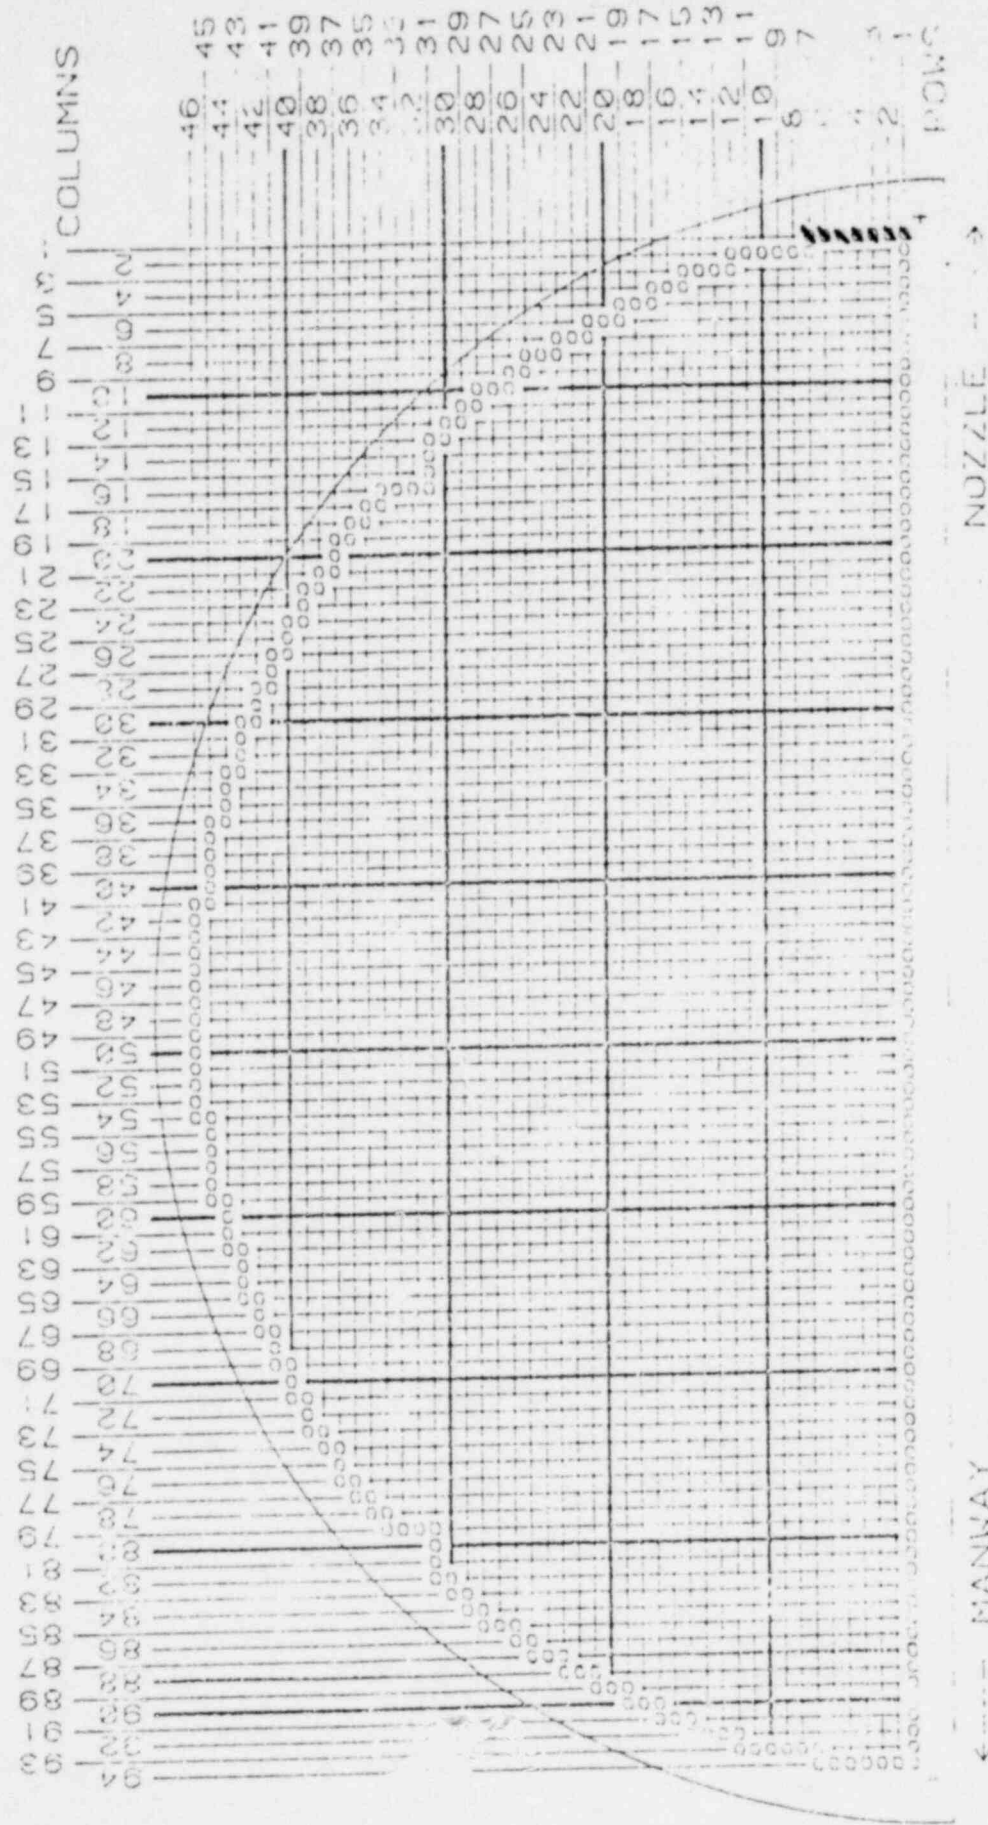
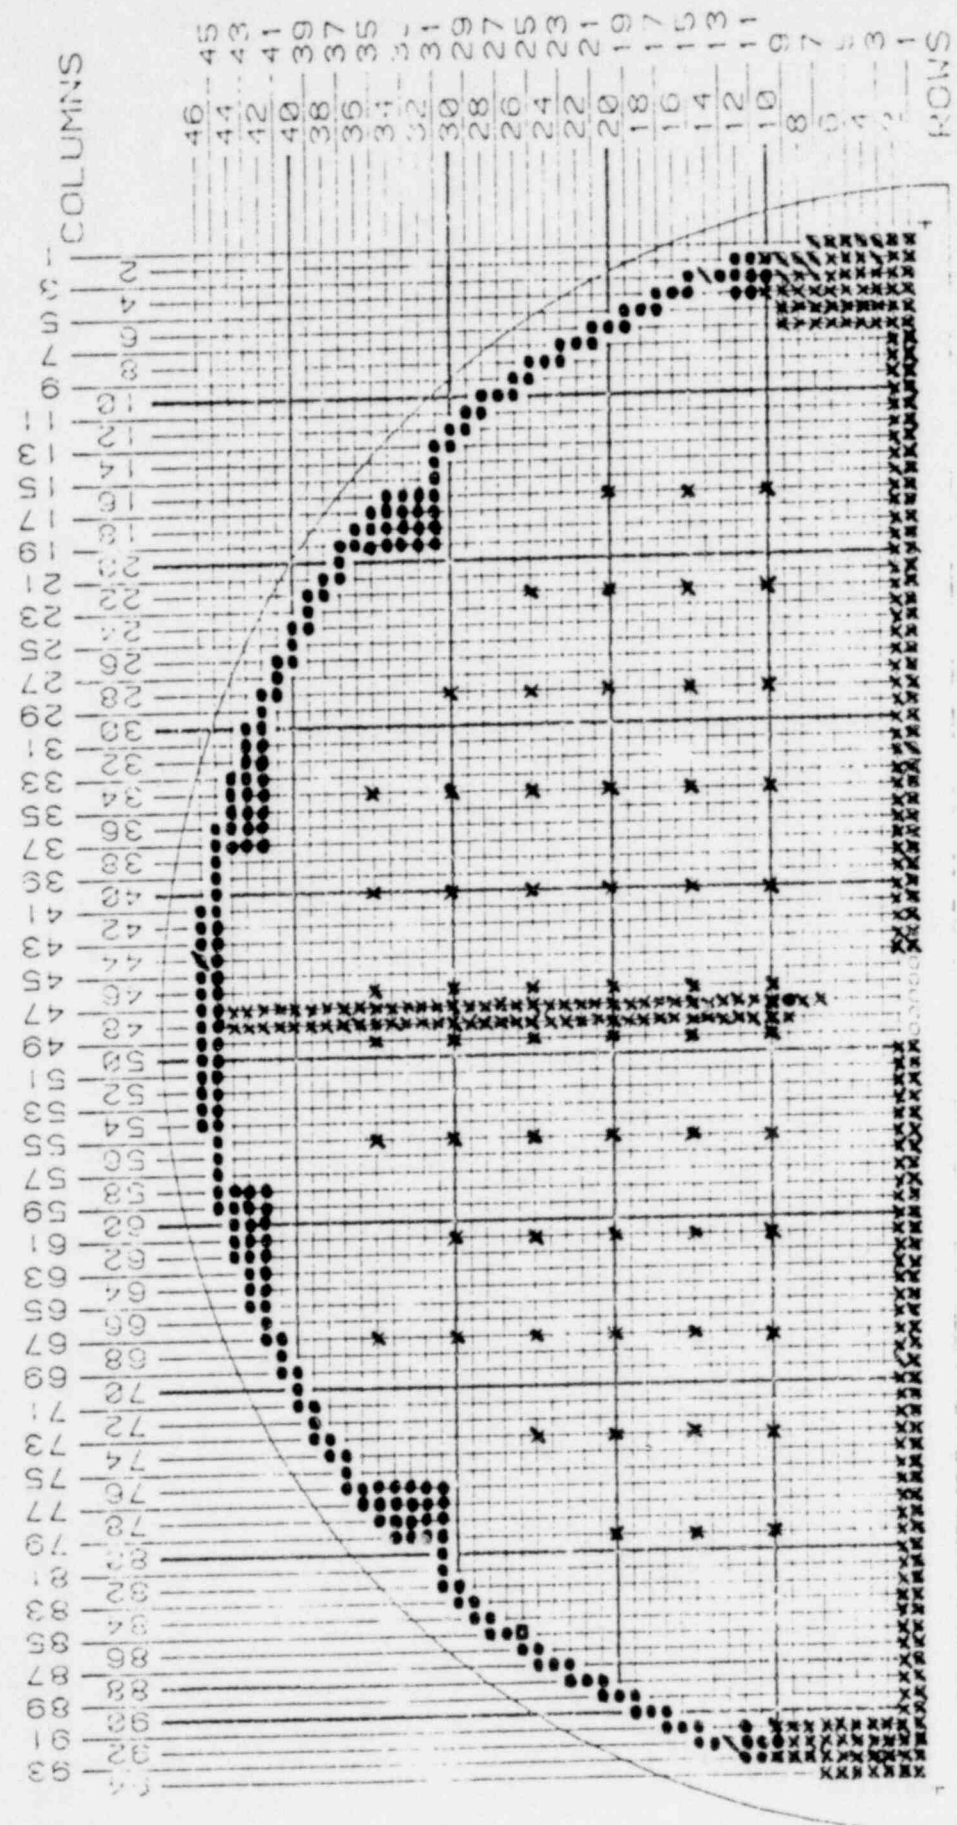
Since the leaking tube (Row 4, Column 1, Inlet side) was located in the outer periphery of the tube bundle and the break was just above the tube sheet within the flow lane, foreign object damage was suspected. Therefore, the eddy current inspection (shown in Figures 19 and 20 for 11 steam

generator and Figure 21 for 12 steam generator) was concentrated in the outer periphery tubes. The inspection program was conducted in accordance with Technical Specifications, Section 4.12. The results of the eddy current examinations revealed that the Row 3, Column 1 tube (adjacent to the failed tube) had indication of a 65% reduction in wall thickness. The Row 2, Column 1 tube (next tube) had a possible indication of <20% reduction in wall thickness. All of these indications were at approximately the same elevation.

A complete visual examination of the outer peripheral area of the tube bundles and the flow lanes for both steam generators revealed no other signs of foreign objects. In addition, the eddy current examinations conducted for both steam generators revealed no other tubes with wear or degradation.

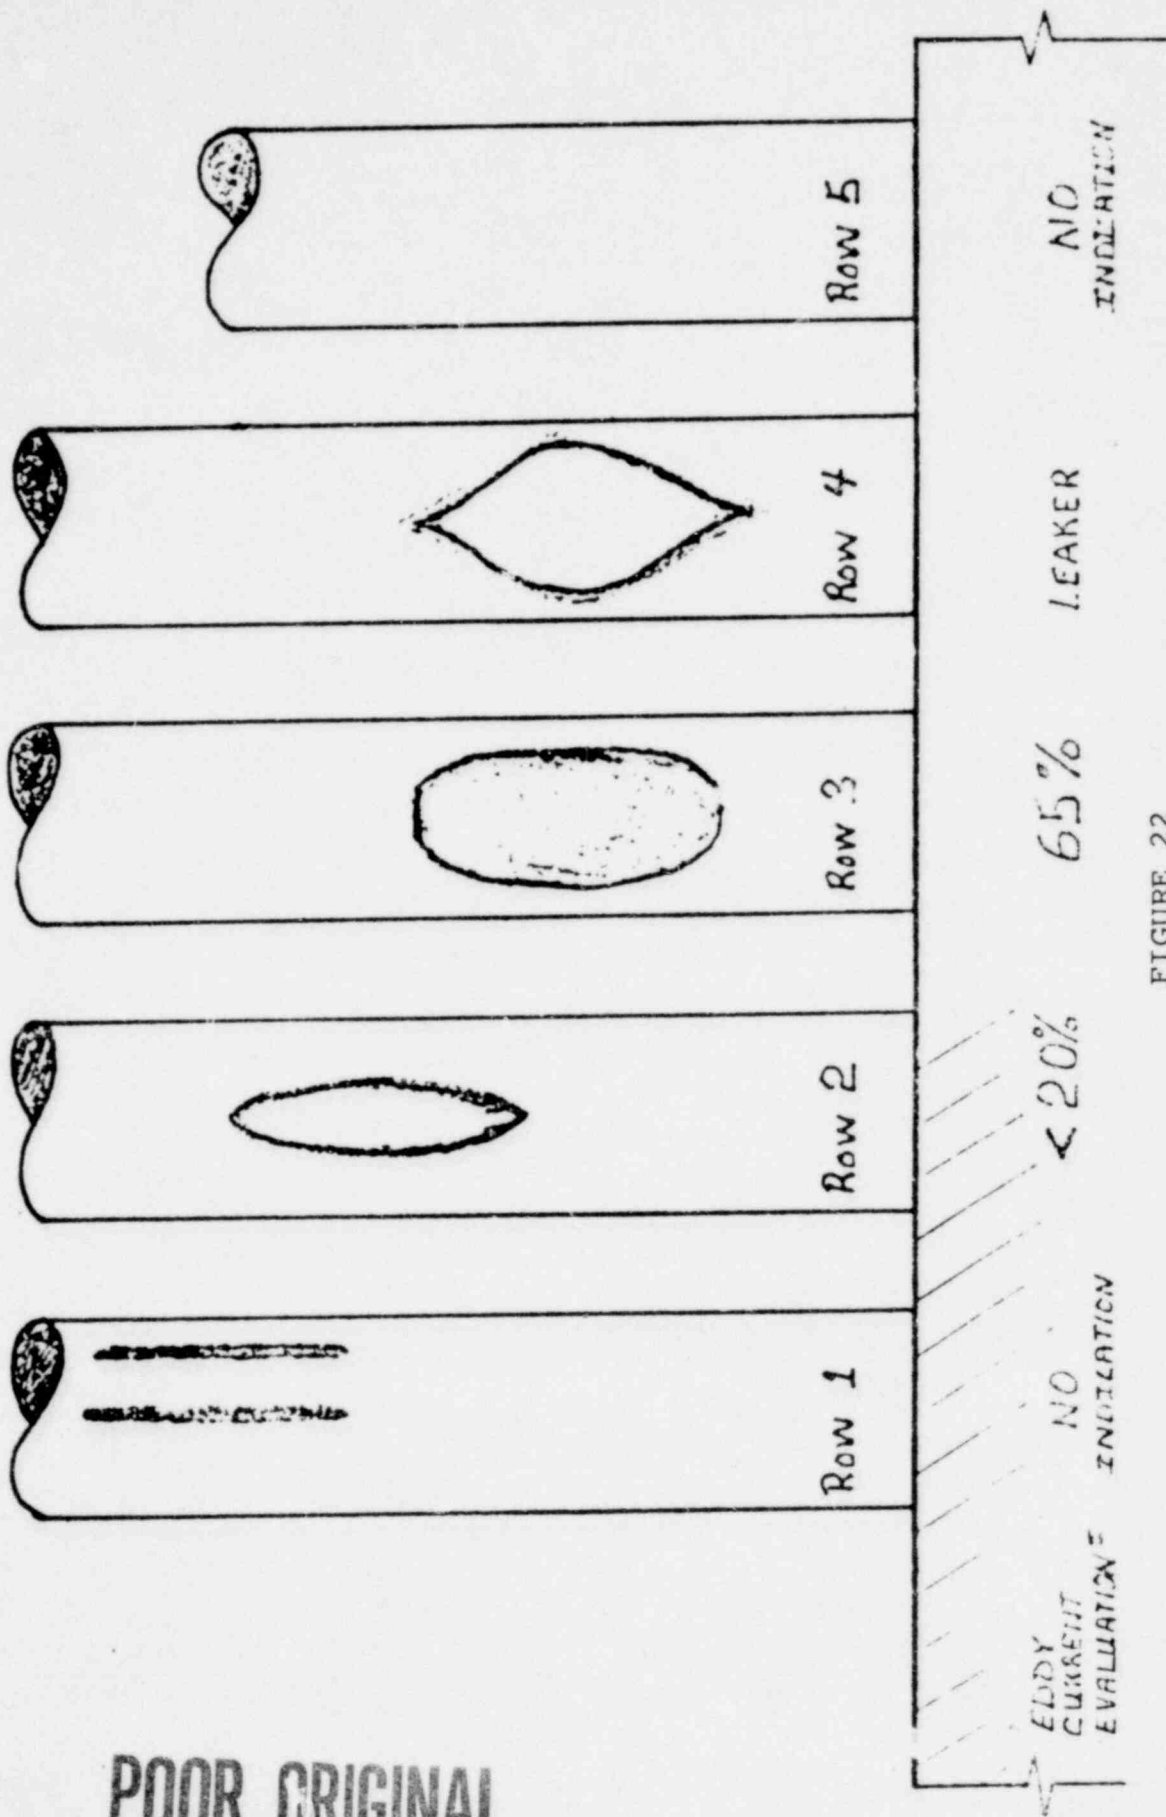
FIGURE 22
SKETCH OF LEAKING TUBE AND ADJACENT TUBES

With the aid of mirrors and fiber optics, a visual examination of the three degraded tubes verified the eddy current results and revealed that the break resembled a classical overpressure burst (running approximately 1 1/2" in the longitudinal direction of the tube with an opening width of approximately 1/2"). The other two tubes (Row 3, Column 1 and Row 2, Column 1) showed signs of wear. All wear marks were on the outer peripheral side of the tubes. These patterns were documented by photographs and are depicted in Figure 22.

During this time, a coil spring, later measured to be 8.5" long, 1.25" diameter, and 3/32 gauge was found to be lying on the tube sheet adjacent to the defective tubes. One end of the spring was lodged under the tube lane blocking device and the other end was free to move. Figure 23 is an overhead view showing the location of the spring, tube lane blocking device, and the peripheral tubes. Figure 24 is a side view, and Figure 25 is a front view. A definite wear pattern on the tube sheet indicated that the spring had moved during operation. Later, a second spring, identical to the first, was found on the cold leg side. It was located just opposite the first spring in a similar condition with one end lodged under the tube lane blocking device and the other end extending out onto the tube sheet. In addition, part of an aviation hose clamp was found next to this spring on the cold leg side. A close visual examination of the spring on the cold leg side, the tubes and the tube sheet surface revealed no signs of spring movement, tube damage or wear. This was confirmed by eddy current examination of all eight tubes in Column 1 in close proximity to the second spring.

It has been concluded that the tube break was the result of reduction of wall thickness by the wearing action of the spring against the tube.

The three courses of corrective actions identified were - (a) plug the two defective tubes and several adjacent tubes, (b) remove a section of the defective Row 4 tube and plug the two defective tubes, or (c) stabilize the defective Row 4 tube from the primary side and plug the two defective tubes. Discussions among NSP, Westinghouse, and NRC staff revealed that option (a) should be selected for several reasons -

In addition to the failed tube, and the tube with 65% wall reduction, the remaining four adjacent tubes to the failed tube were plugged. This action was taken to eliminate the remote possibility of the failed tube breaking further and damaging the adjacent tubes. A secondary side pressure test is being conducted to assure leak tightness of the plugs.

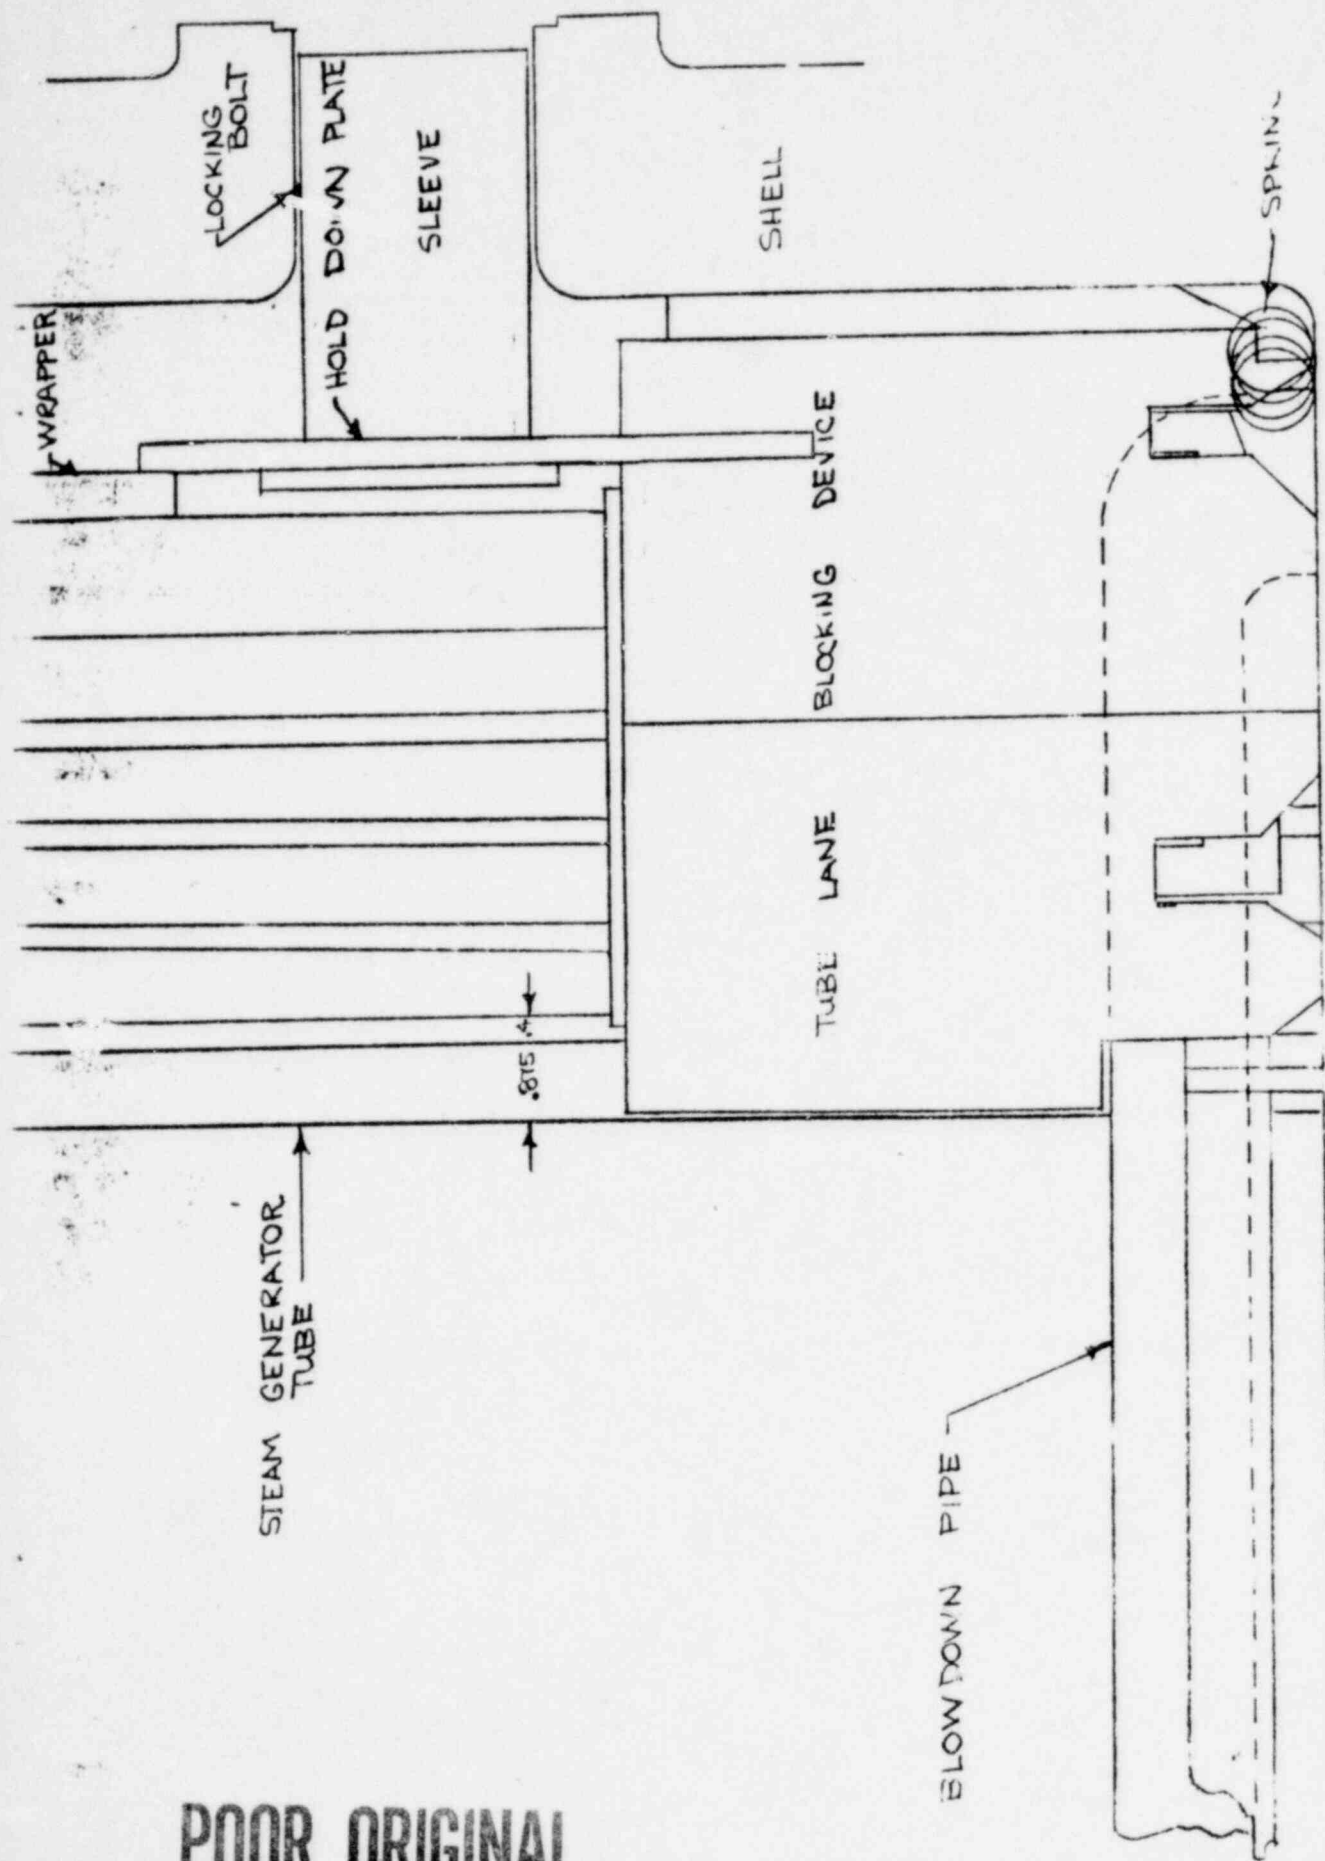
FIGURE 24

SIDE VIEW - FAILED TUBE AREA
