Public Service Company of Colorado

October 31, 1979
Fort St. Vrain
Unit No. 1
P-79252

REPORTABLE OCCURRENCE 79-42
ISSUE 0
Page 1 of 4

REPORT NO. 50-267/79-42/03-L-0

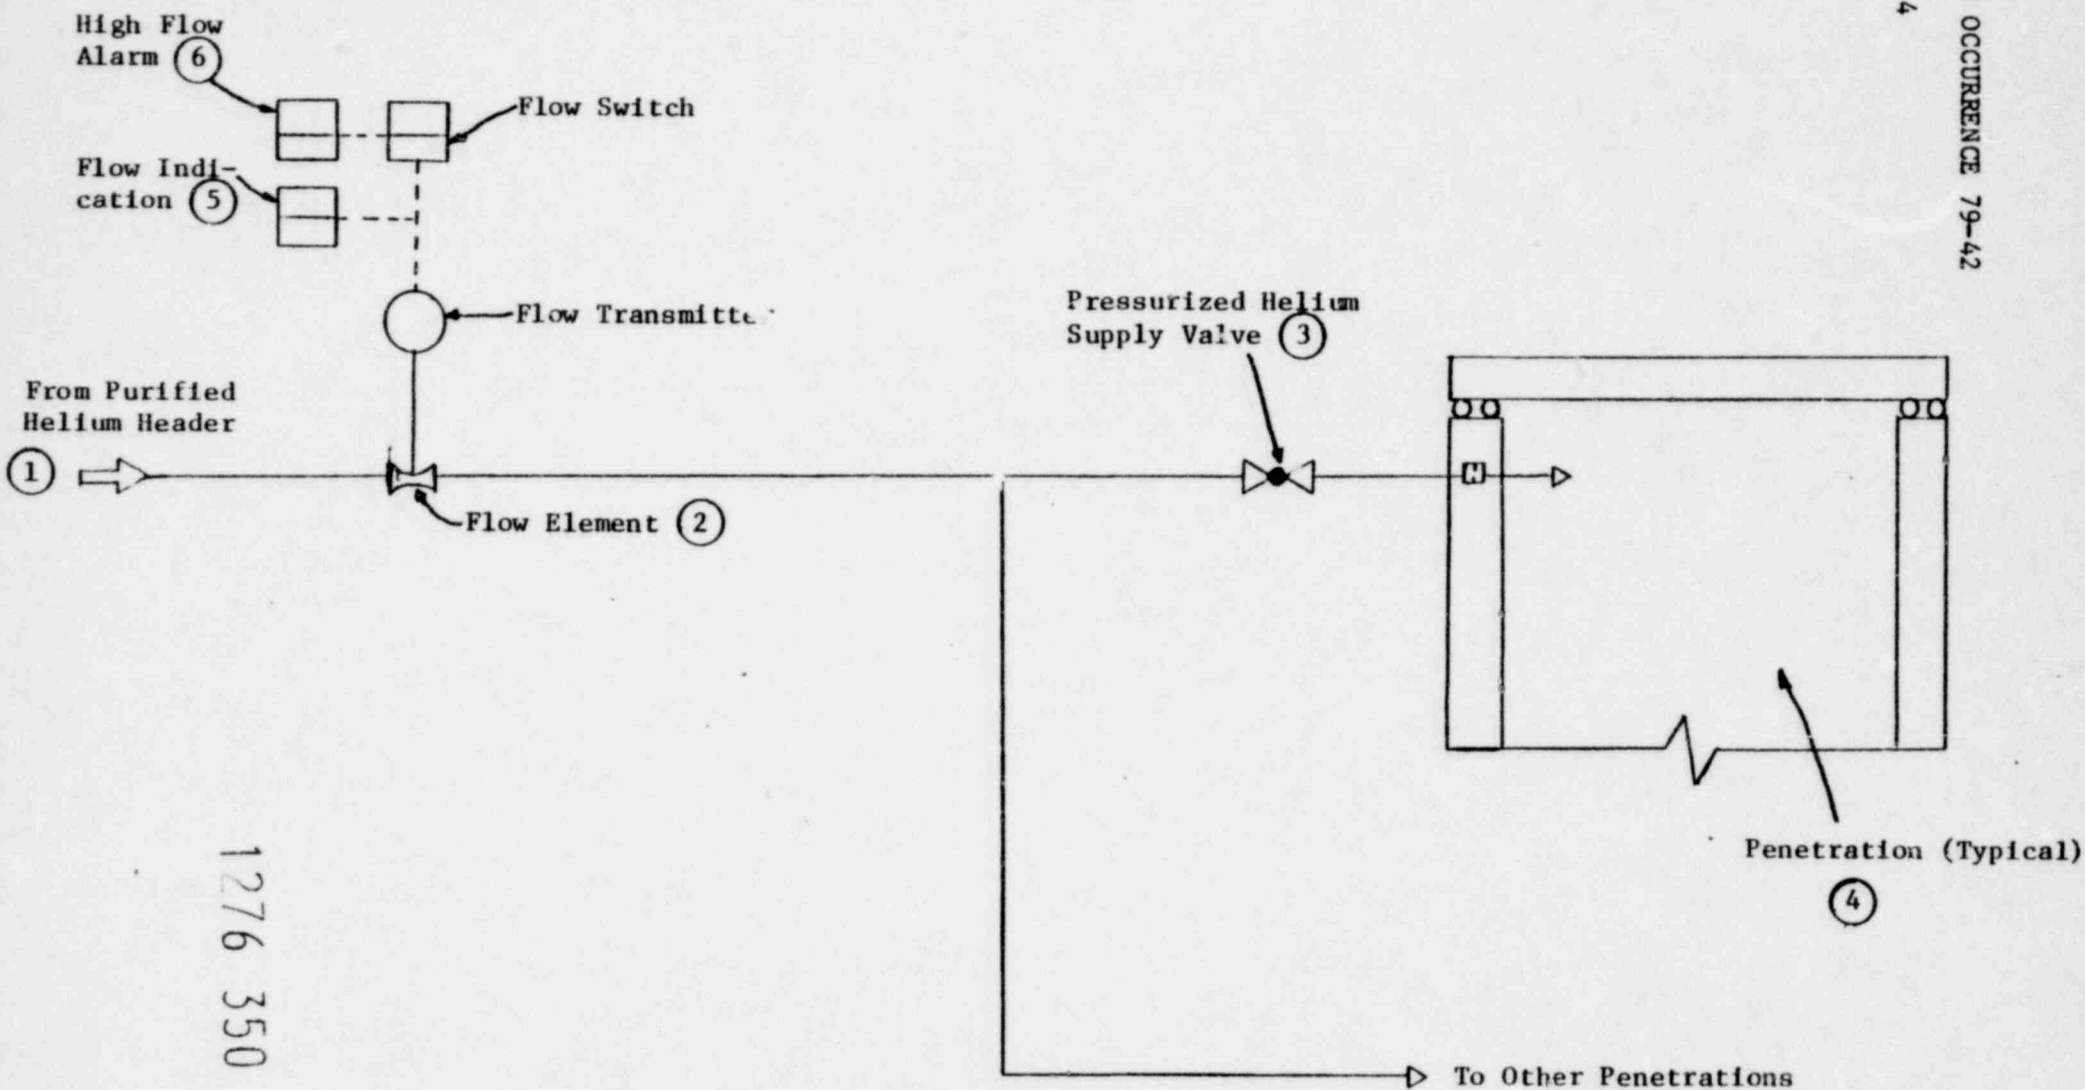
FIGURE 1

At approximately 1200 hours on October 2, 1979, with reactor power at approximately 24%, it was observed that three penetration interspace pressurization valves (one to each of the high temperature filter adsorbers and one to the top access penetration) were closed. This condition was first brought to the attention of plant personnel as the result of a Nuclear Regulatory Commission audit. Per approved plant operating procedures, these valves are called out to be in the open position to provide helium supply. Although a supply of purified helium via these valves is not specifically addressed in the Technical Specifications, the basis of LCO 4.2.9, PCRV Closure Leakage, states that the gas supply to the penetrations is monitored for flow so that an increase in closure leakage can be sensed and alarmed.

Refer to Figure 1 for typical flow path. Under normal operating conditions, gas is supplied to the penetrations via the purified helium header, (1), through a flow element, (2), and a pressurized helium supply valve, (3), to the penetration, (4). With the helium supply valve open as required, any increase in helium flow due to primary/secondary seal leakage would be sensed by the flow element, (2), thereby providing flow indication, (5), and a high flow alarm, (6). However, with the supply valve closed, flow indication and alarm capability associated with these three penetrations was not available. Other penetrations were not affected.

Upon notification that these valves had been found closed, they were reopened by operations personnel.

All personnel have been notified that valve positions are not to be altered without the express knowledge and permission of the Shift Supervisor. Personnel were also advised that any abnormal conditions observed are to be reported to the Shift Supervisor immediately.
