Joint Testimony

MICHEL P. ARMAND, ERNEST L. BIVANS AND WILFRED E. COE

Questions A1 and D of ALAB 537

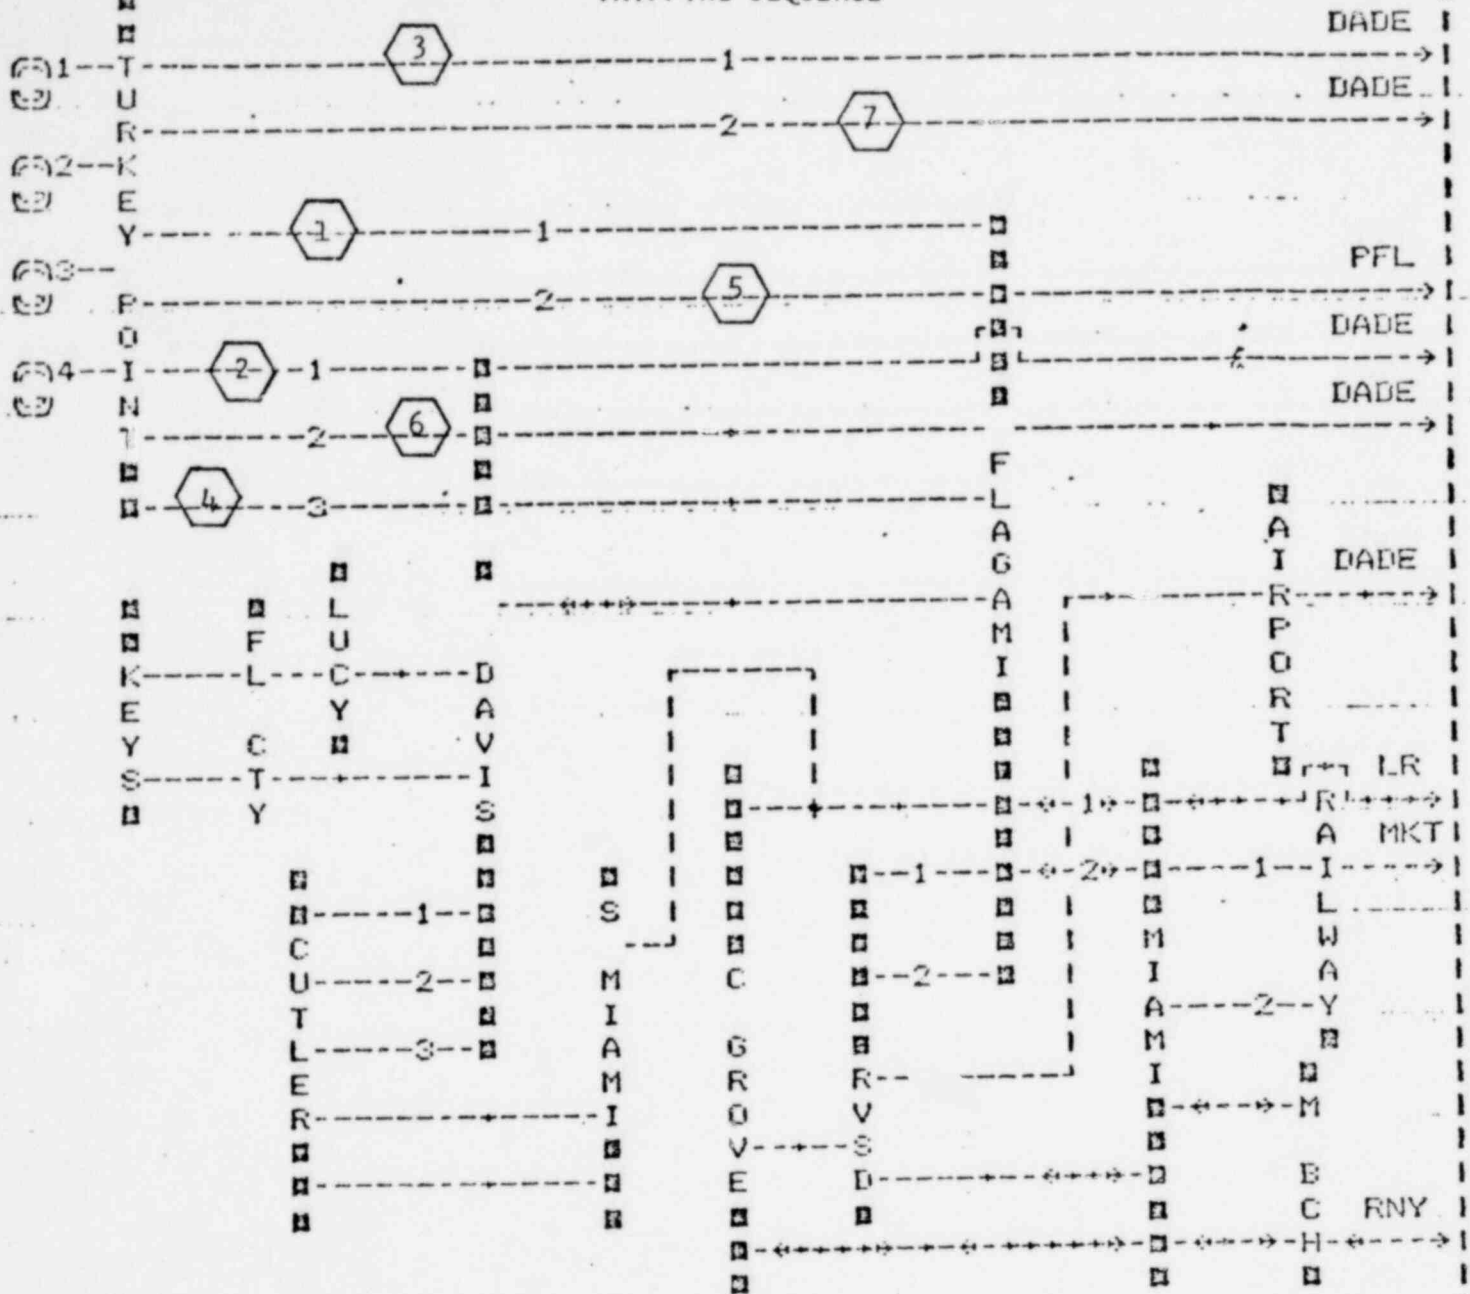
# TURKEY POINT TRANSMISSION LINE TRIPPING SEQUENCE

- 1) FLAGAMI-TP #1 Tripped 10:35 PM - Shattered Insulator String
- 2) DAVIS-TP #1 Tripped 10:41 PM - Contamination Left Out of Service for Washing
- 3) DADE-TP #1 Tripped 11:50 - Contamination
- 4) DAVIS-TP #3 Tripped 11:53 - Shattered Insulator String
- 5) FLAGAMI-TP #2 Exact Trip Time Unknown 11:53 - 11:57 Shattered Insulator String Found
- 6) DAVIS-TP #2 Exact Trip Time Unknown 11:53 - 11:57 Shattered Insulator String Found
- 7) DADE-TP #2 Exact Trip Time Unknown 11:53 - 11:57 Contamination

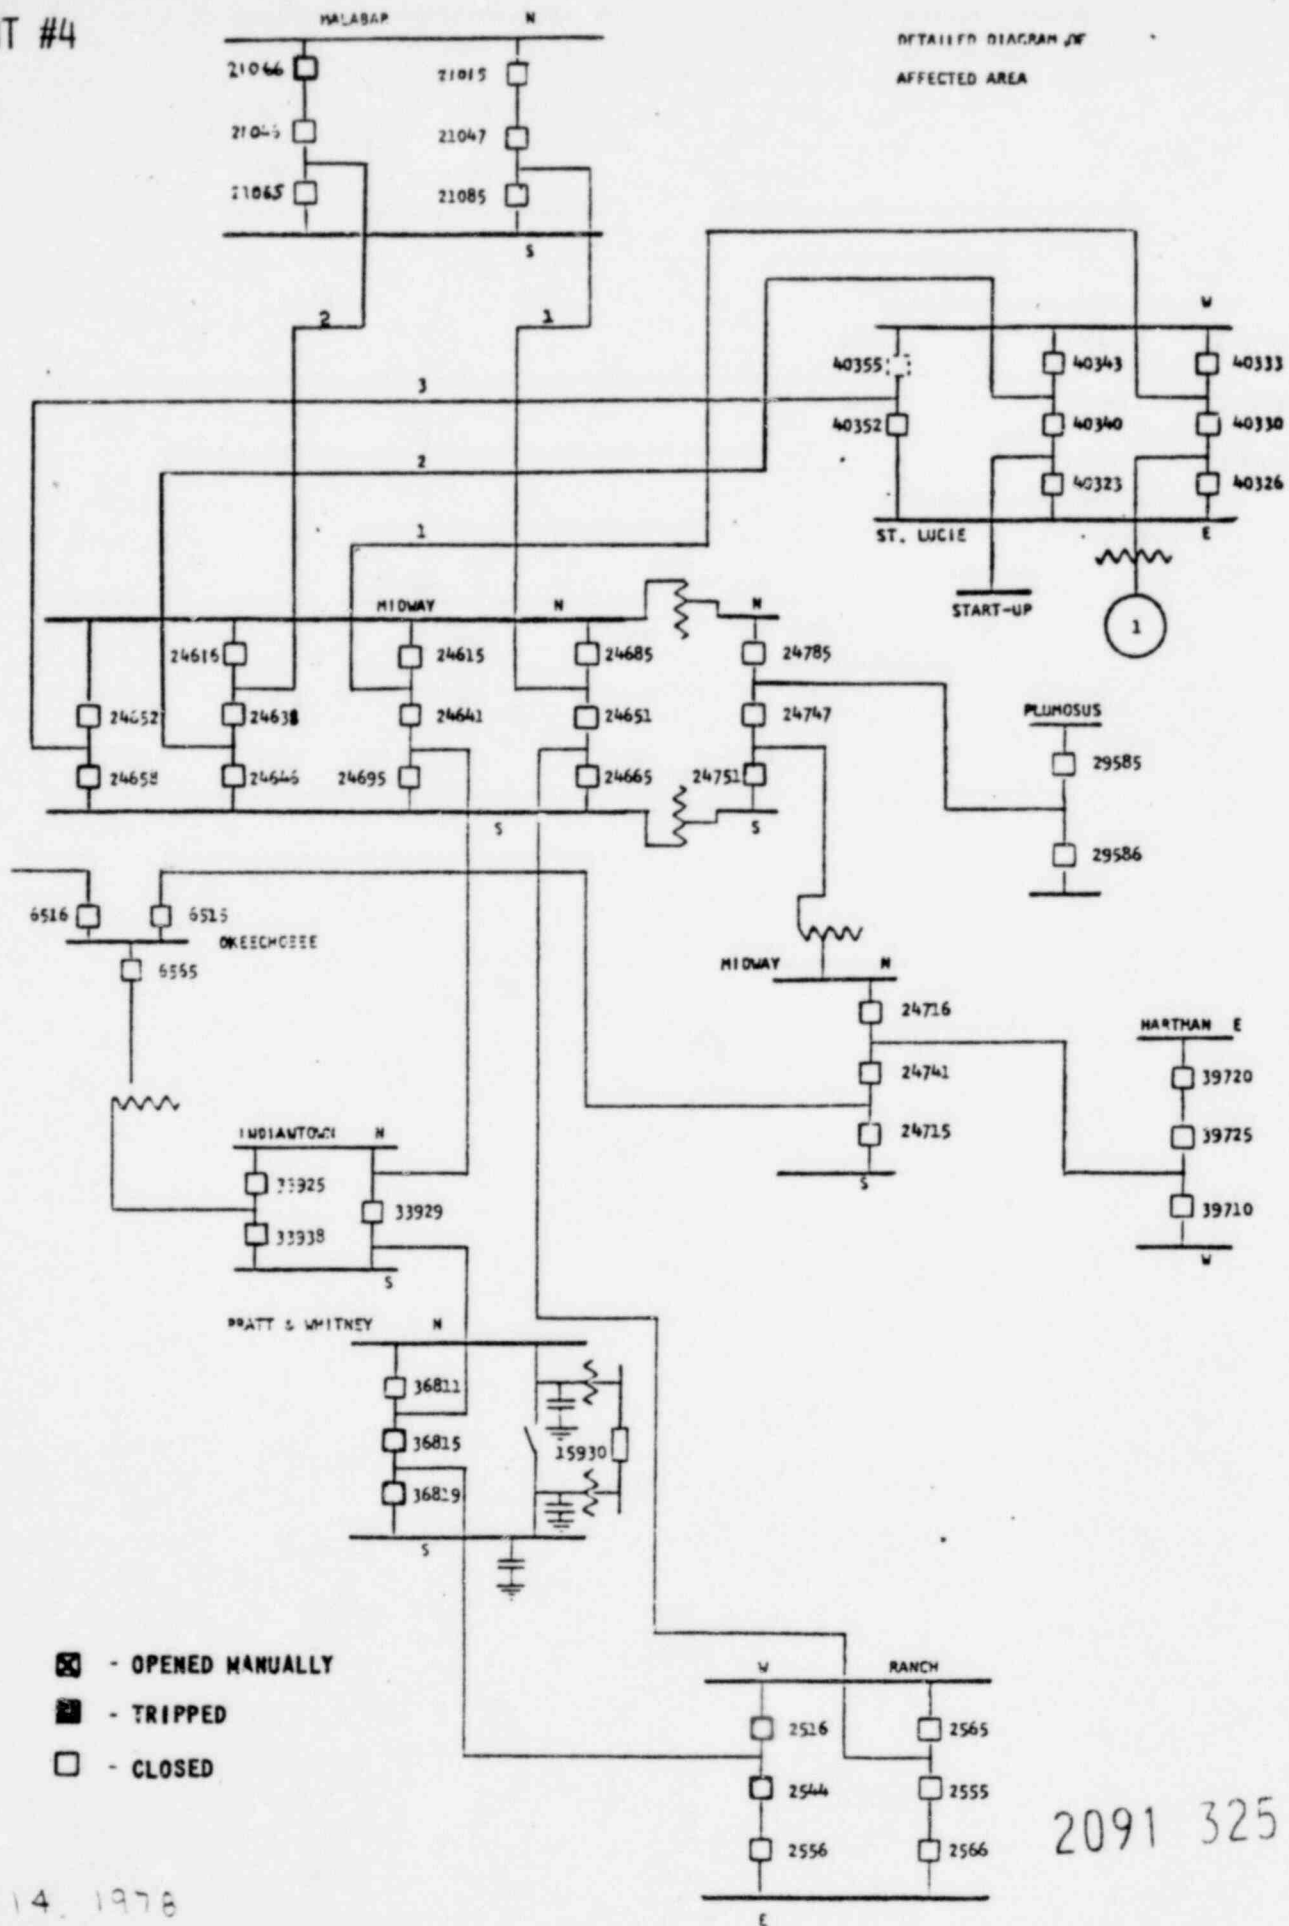
FIGURE 1

8/ Attachment #4 (Figures 1-4) illustrate these events. First, the Ranch to Pratt & Whitney 240 kV line was out of service for testing. Second, a

switching error at Pratt & Whitney substation resulted in the failure of a lightning arrester, which in turn produced a fault on the Midway-Ranch 240 kV line. Although the Ranch end relayed correctly, the third event, an improperly connected polarizing circuit at Midway, caused the Midway relays looking north to erroneously see the fault and kept the appropriate relay from tripping the Midway to Ranch 240 kV line. The result was to erroneously trip the two Midway-Malabar 240 kV lines, as well as the Midway-Plumosis 138 kV line. The two lines remaining at this time were rated at 69 kV. They then tripped, isolating the Midway substation from all sources of offsite power for eight minutes, sixteen and one-half seconds. Following this outage, the polarizing circuit was corrected and new procedures were established for testing this relay scheme.

MAY 14, 1978  
EXISTING CONDITIONS  
PRIOR TO SYSTEM DISTURBANCE

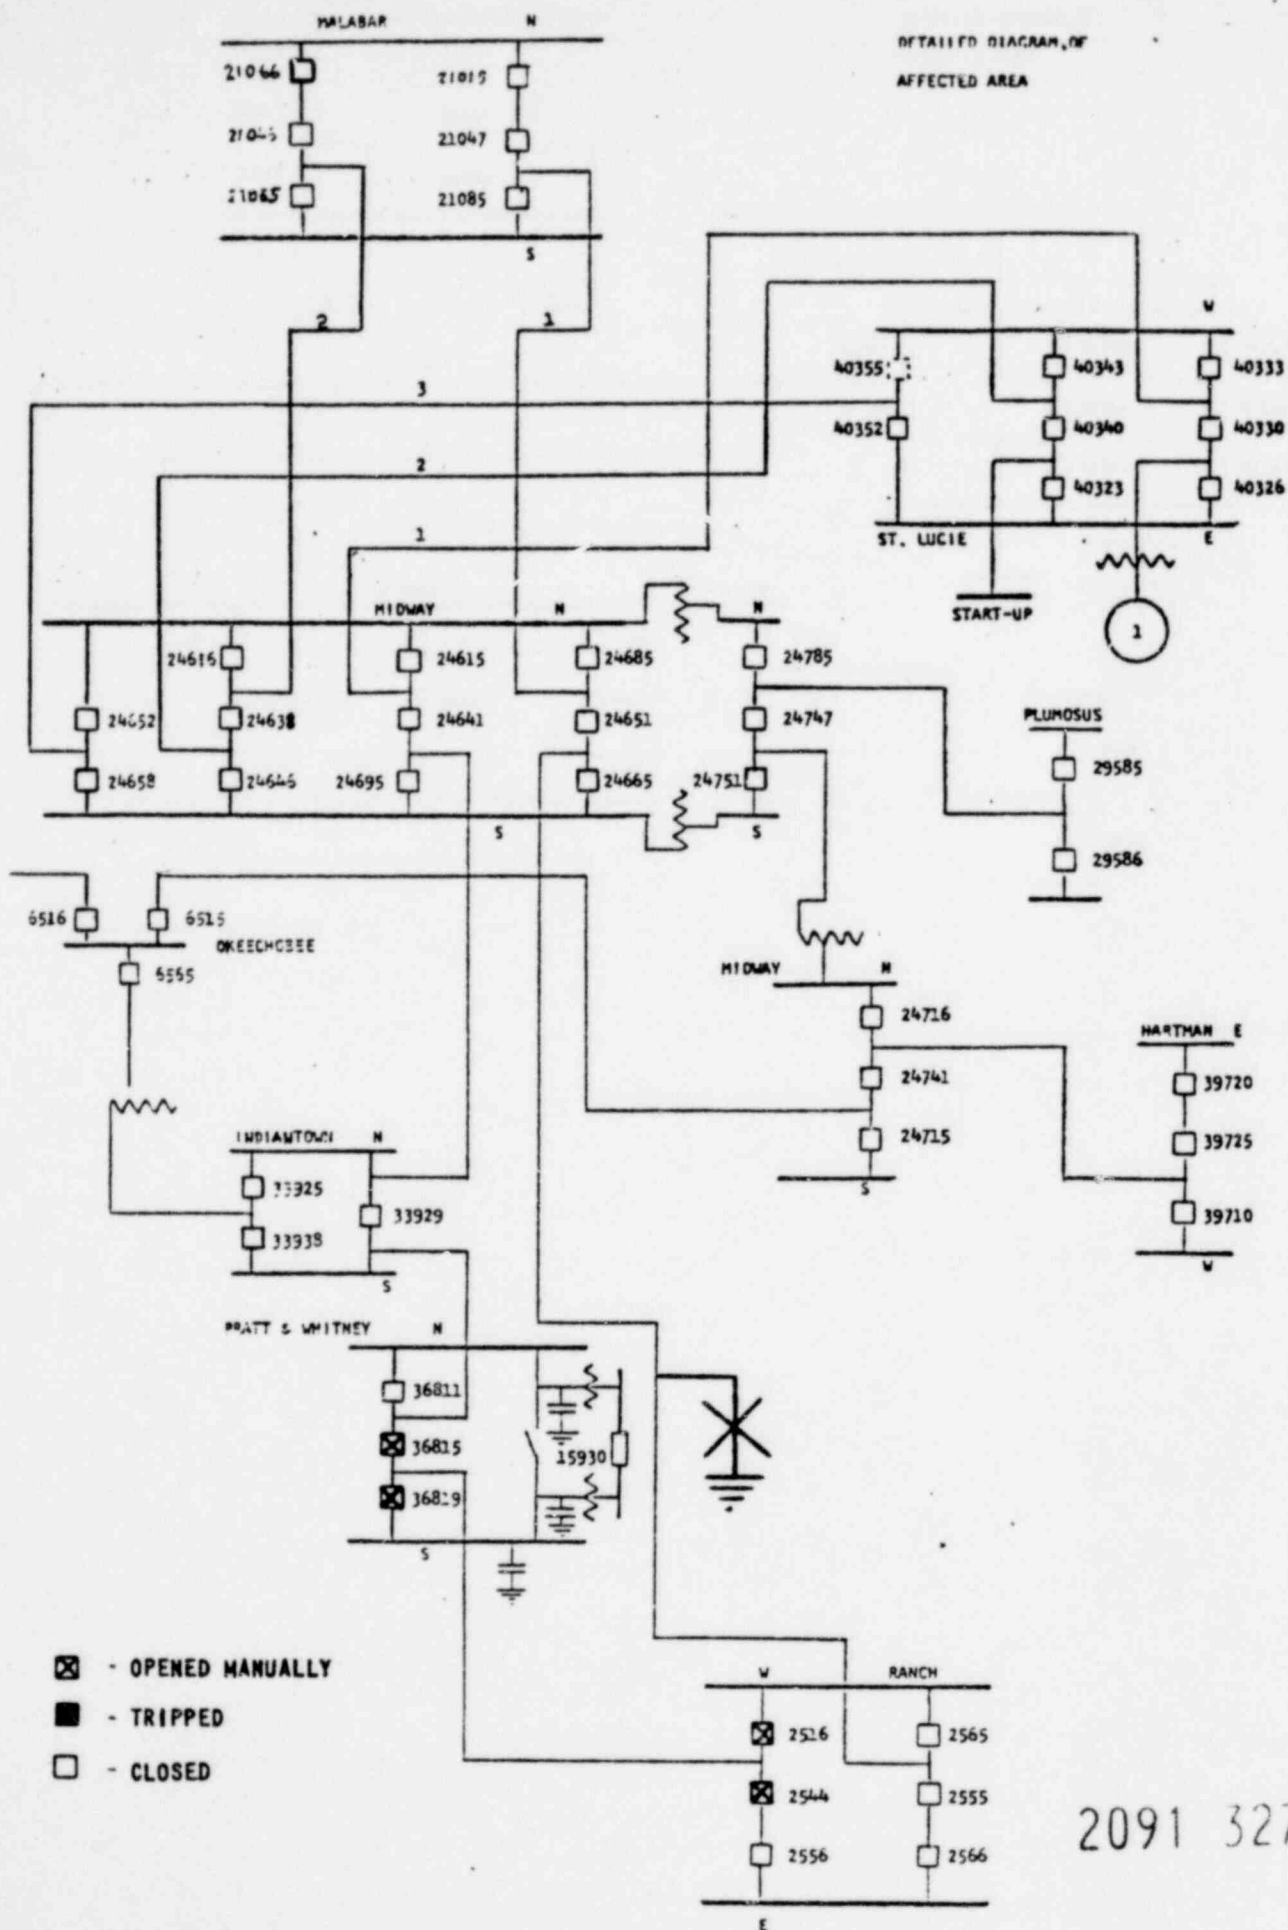
FIGURE 3

EVENT II

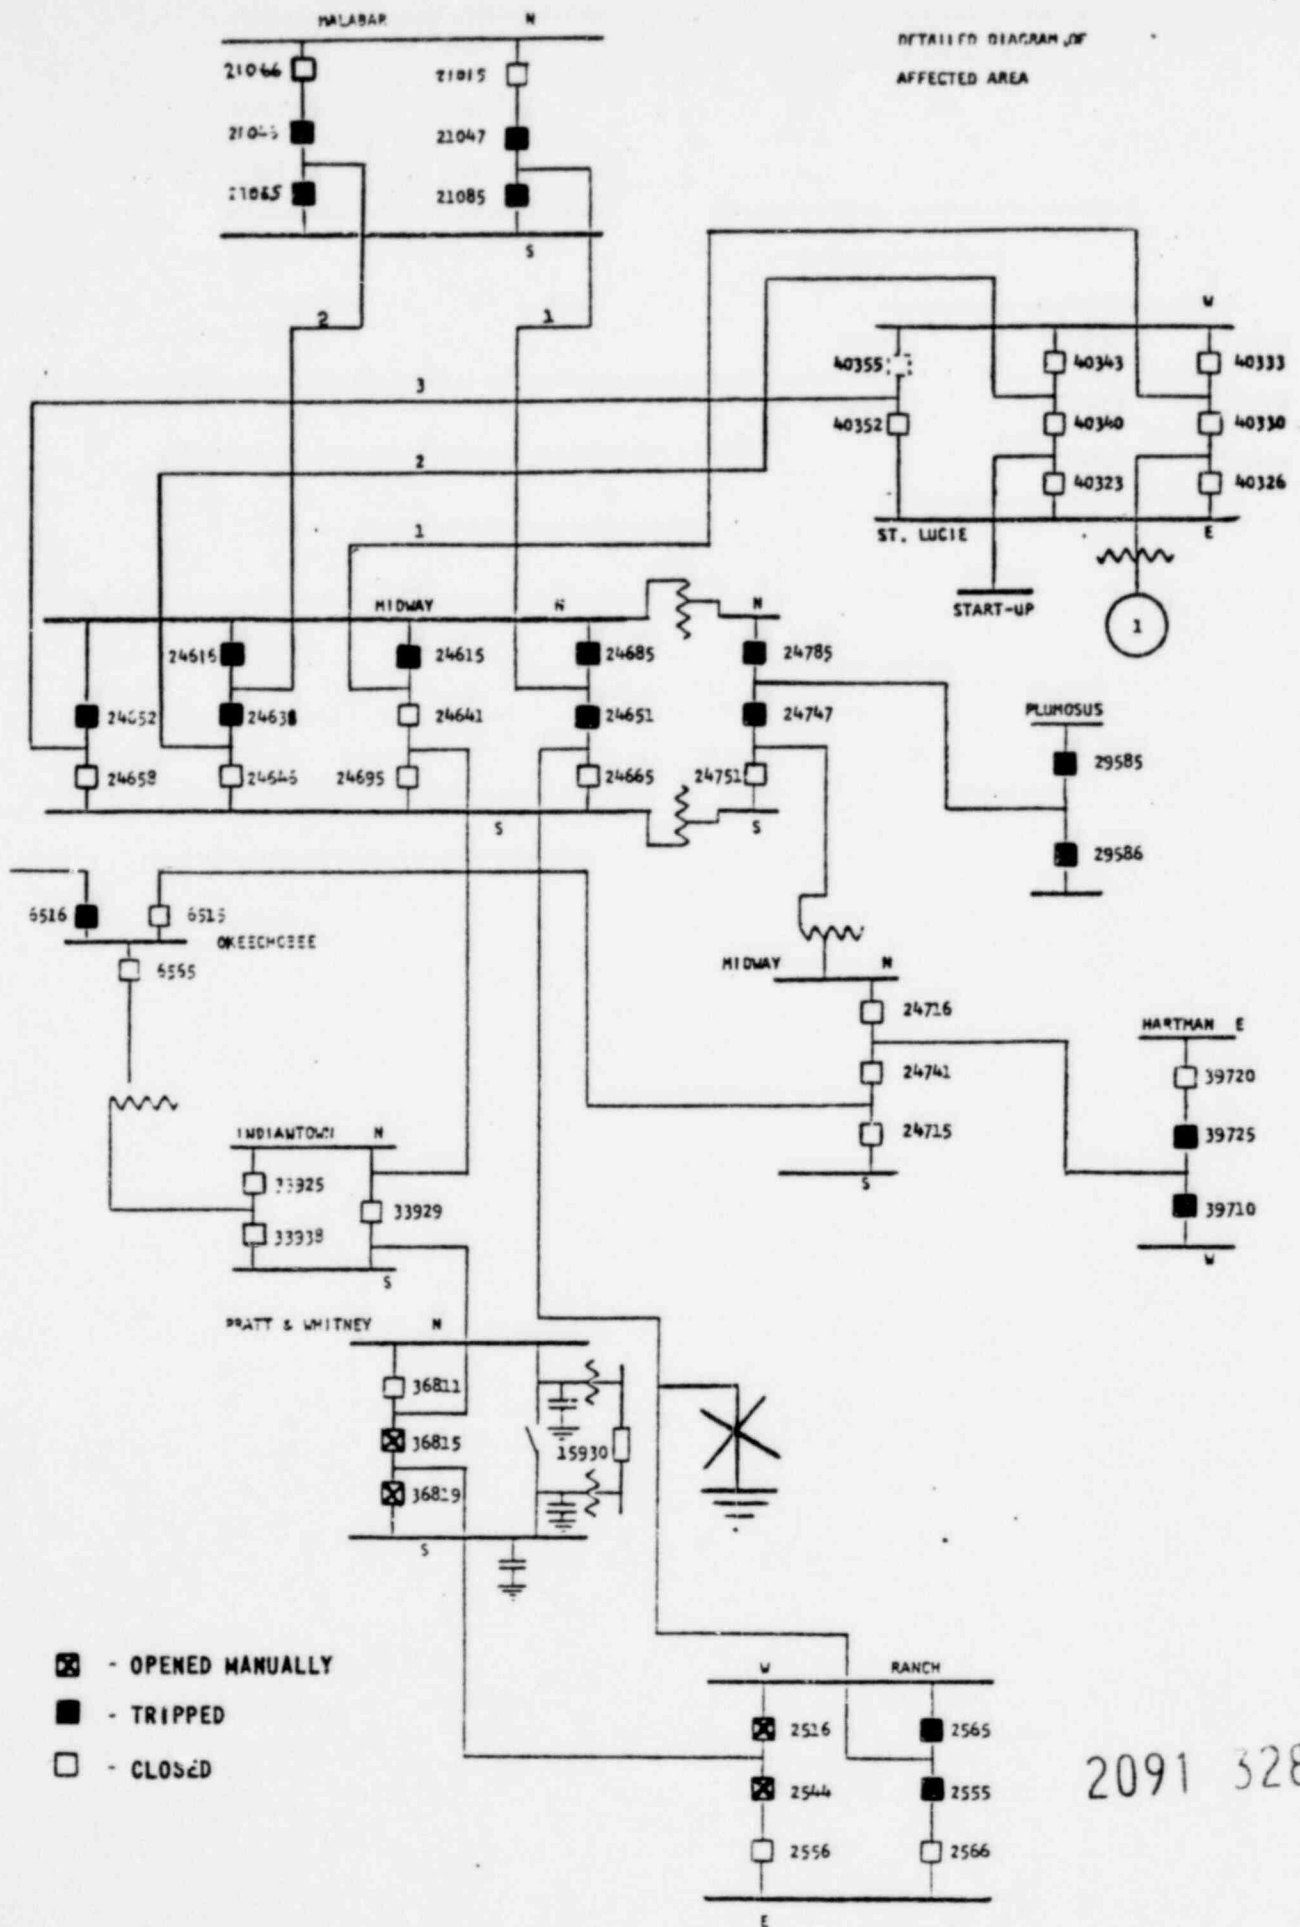
FIGURE 4

EVENT III

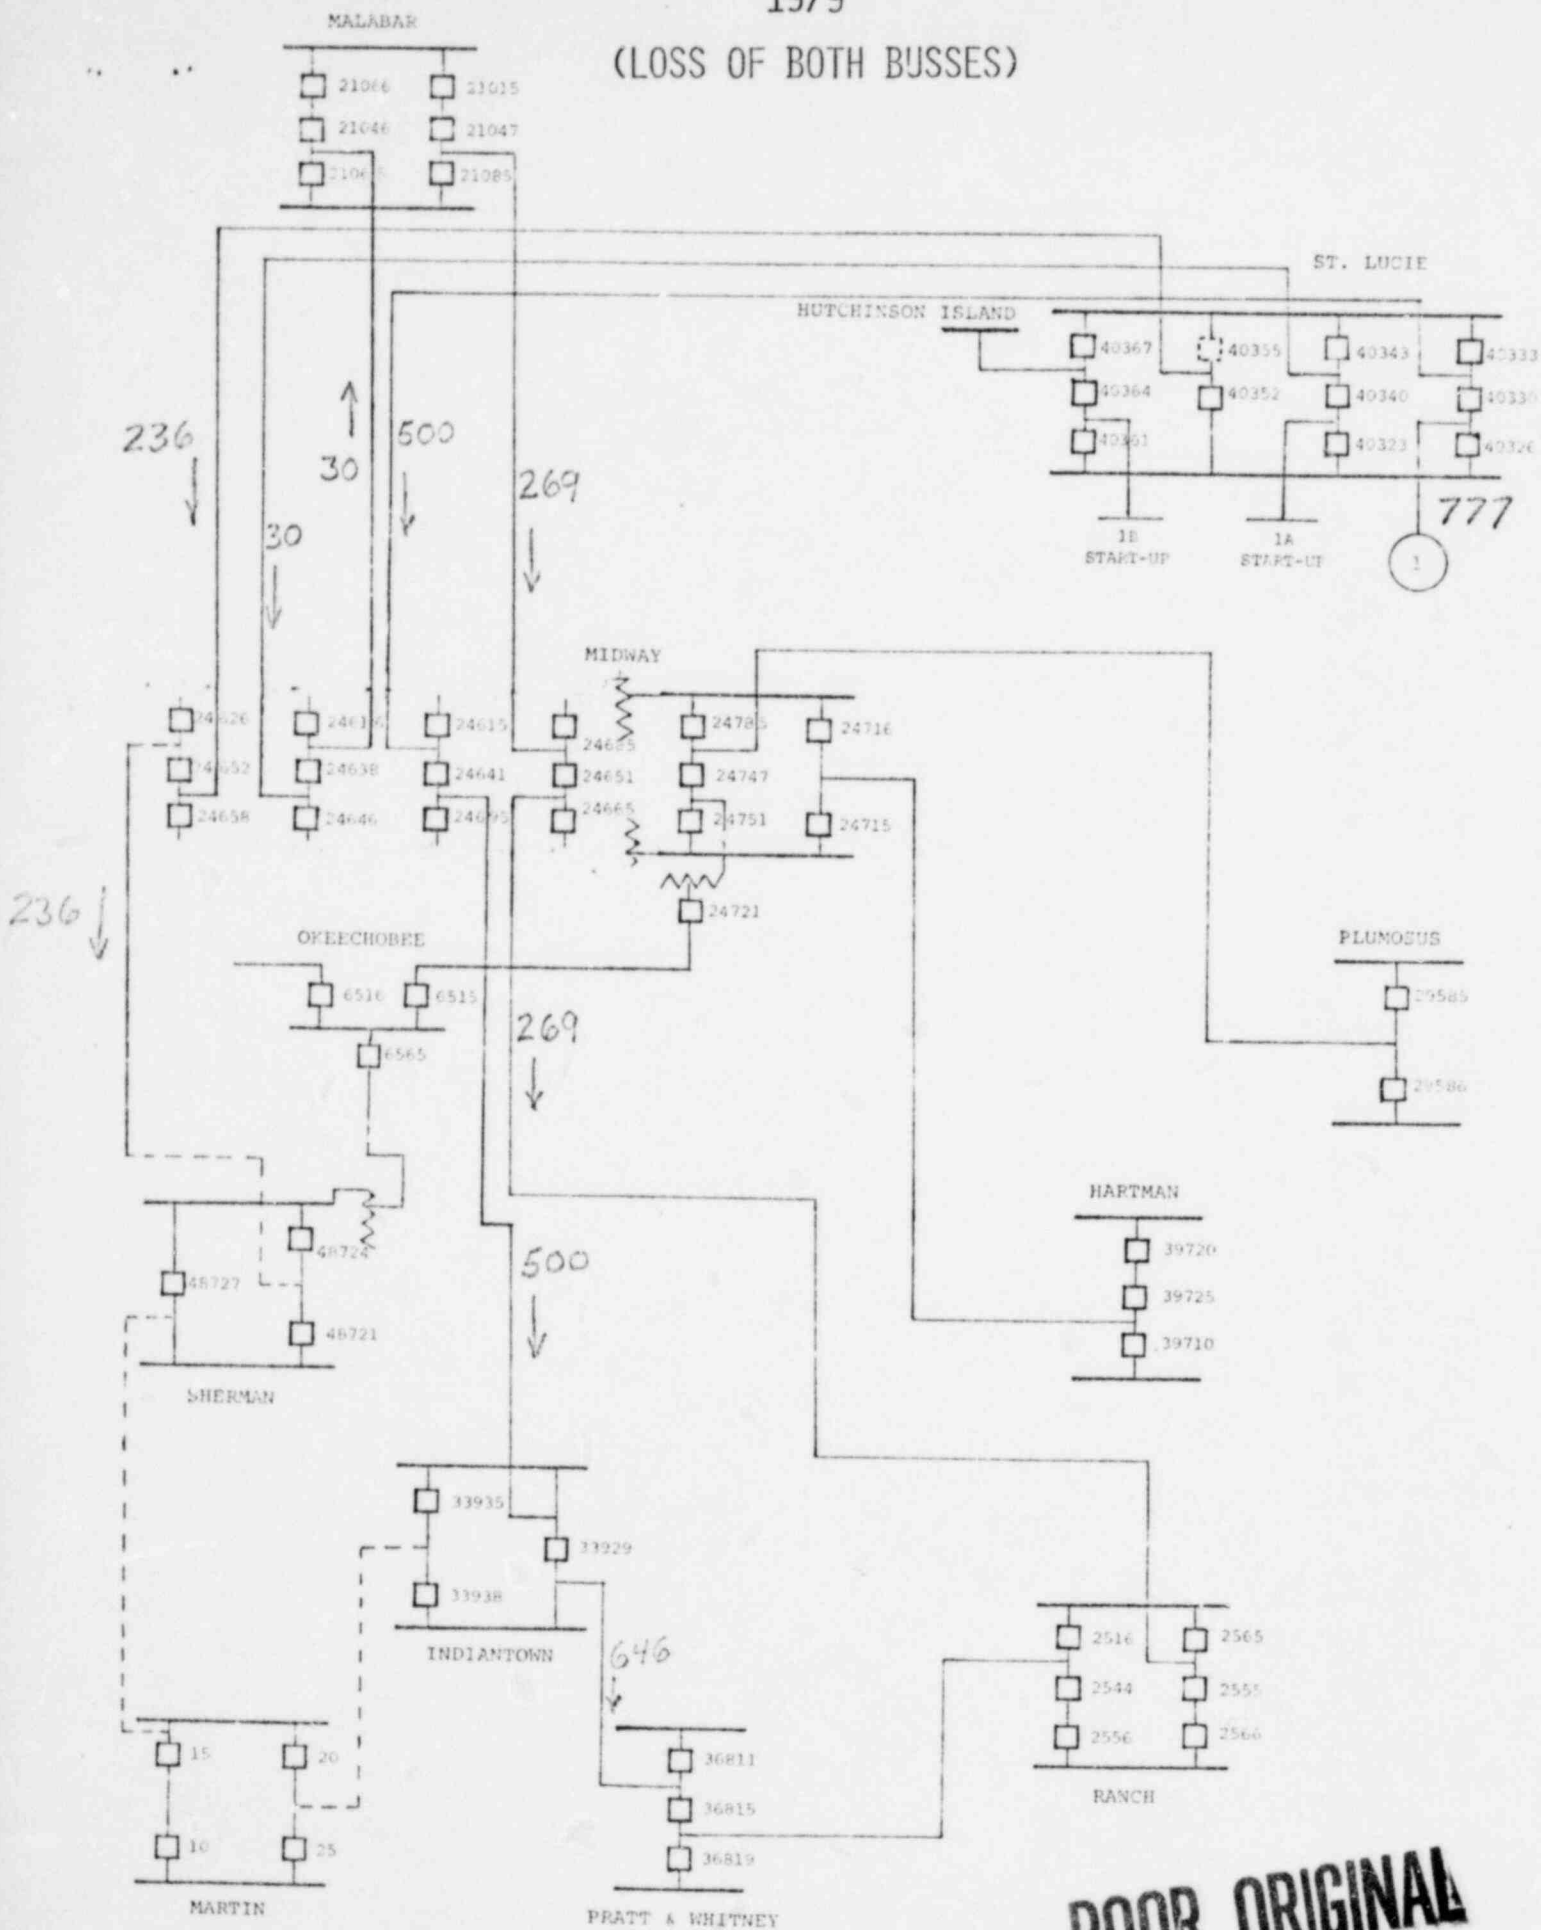
1 the impact of the simultaneous loss of both 240 kV busses at Midway.<sup>9/</sup> Power  
2 continues to flow into the station on all of the three lines from St. Lucie through  
3 the mid-breakers and then out to the Indiantown, Sherman and Malabar substations.  
4 With the loss of generation at St. Lucie, the reverse will be true and power  
5 will flow into St. Lucie over the three 240 kV lines.

(LOSS OF BOTH BUSES)
