TENNESSEE VALLEY AUTHORITY

August 14, 1979

PHIPPS BEND NUCLEAR PLANT  
Transverse Fault In Unit 2 Turbine Building  
Extension Of Fault Number 6

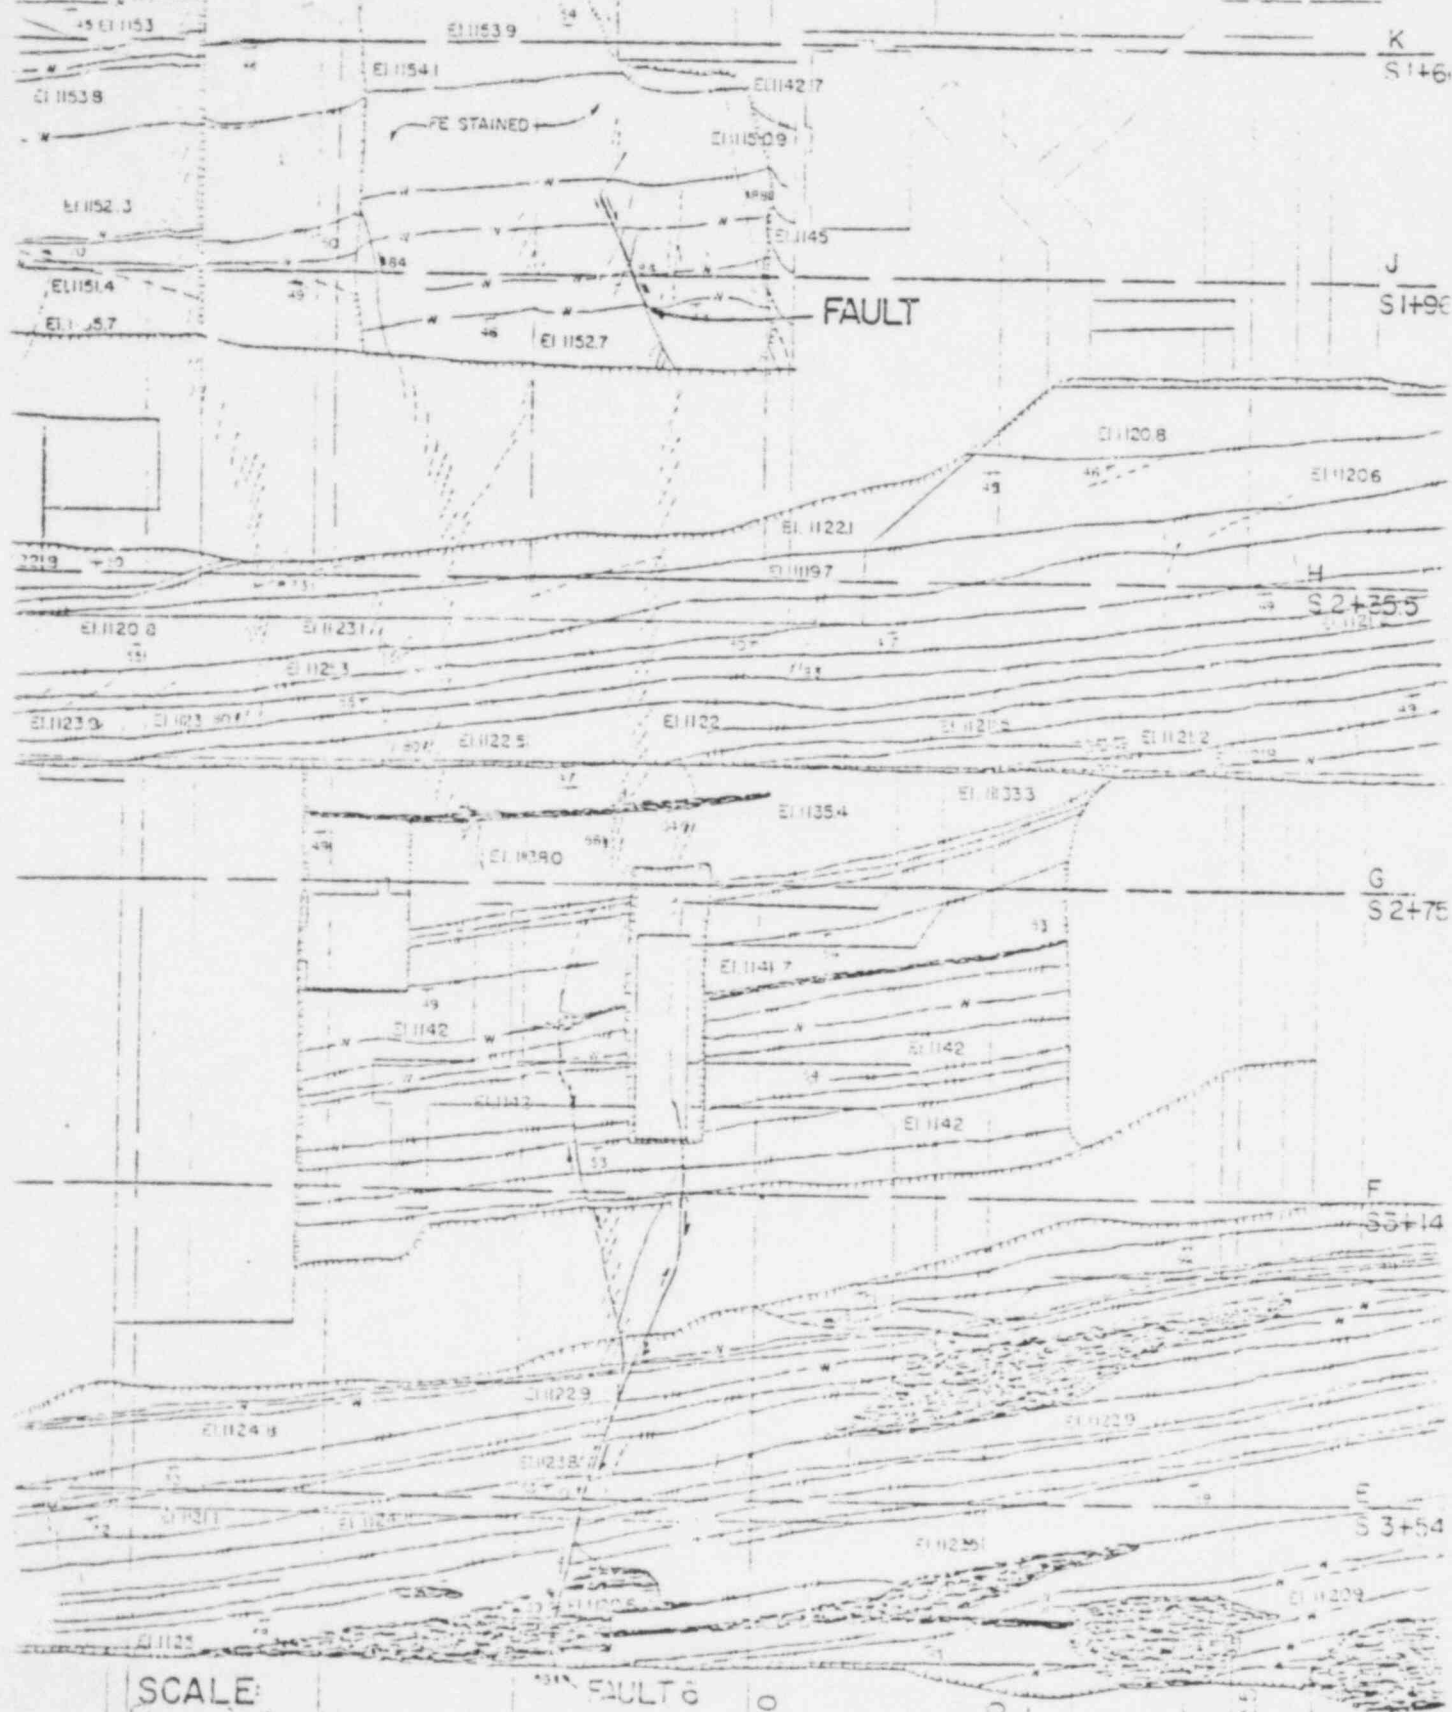
Top of rock cleaning in Unit 2 turbine building has exposed a transverse fault, located between T-3 and T-4 lines at J-line, in the northeast portion of the building (see attached map and photographs).

The fault is defined by a weathered zone, approximately 4 inches wide, which strikes N 54° W for a distance of 15 feet and dips 84° to the northeast. Bedding is offset an average of 4 inches at its intersection with the fault zone. The fault transitionally terminates into a near vertical joint which can be traced to the south to fault number 6 and to the north approximately 30 feet where the top of rock has not been cleaned.

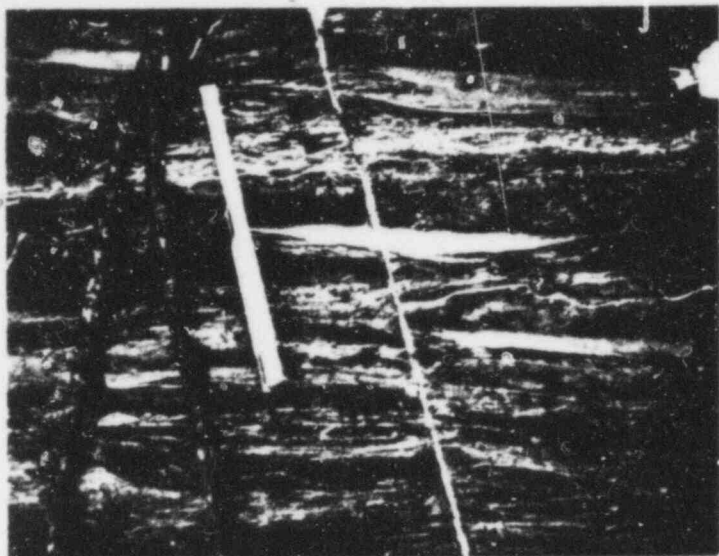
FAULT AT E3+25+JLINE

VIEW NORTH

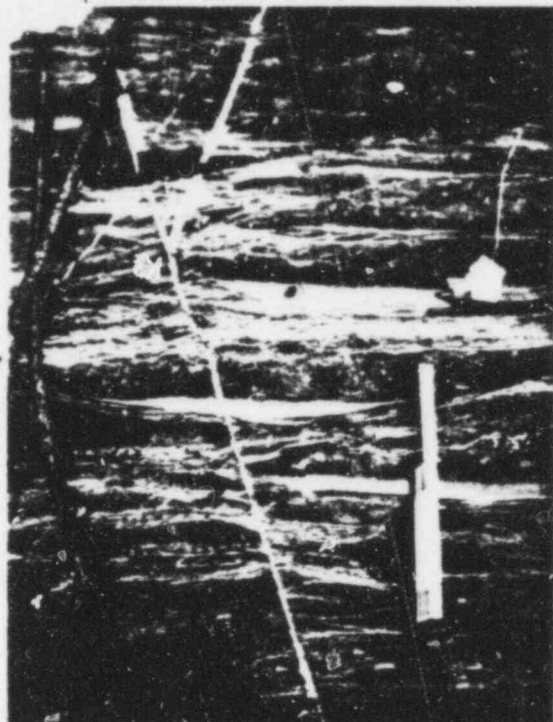
FAULT AT E3+25+JLINE

VIEW NORTH

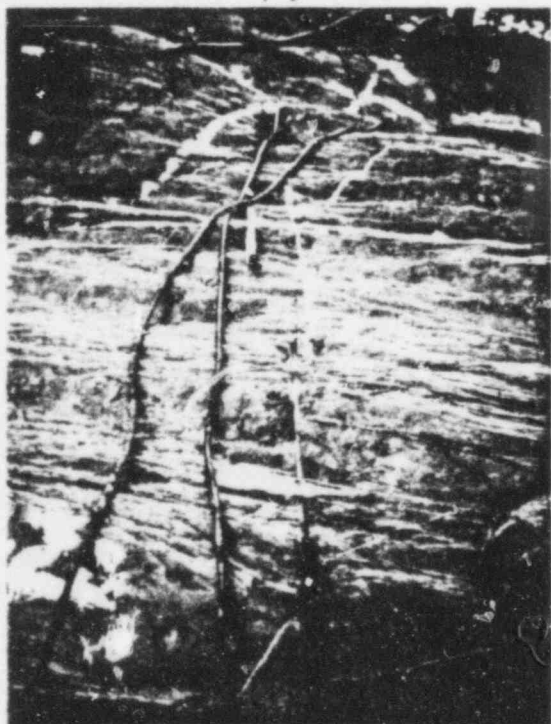
FAULT AT 3+25+ JLINE

VIEW NORTH

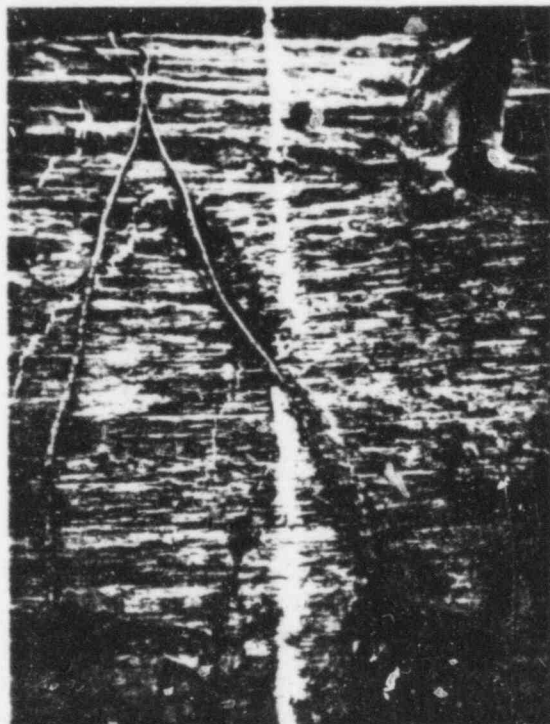
FAULT AT E3+25+JLINE

VIEW NORTH
