REPORTABLE OCCURRENCE 79-24

FORT ST. VRAIN NUCLEAR GENERATING STATION
PUBLIC SERVICE COMPANY OF COLORADO
P. O. BOX 361
PLATTEVILLE, COLORADO 80651

REPORT NO. 50-267/79-24/03-L-0

CORE AVERAGE OUTLET TEMPERATURE AND TOTAL PRIMARY COOLANT OXIDANTS

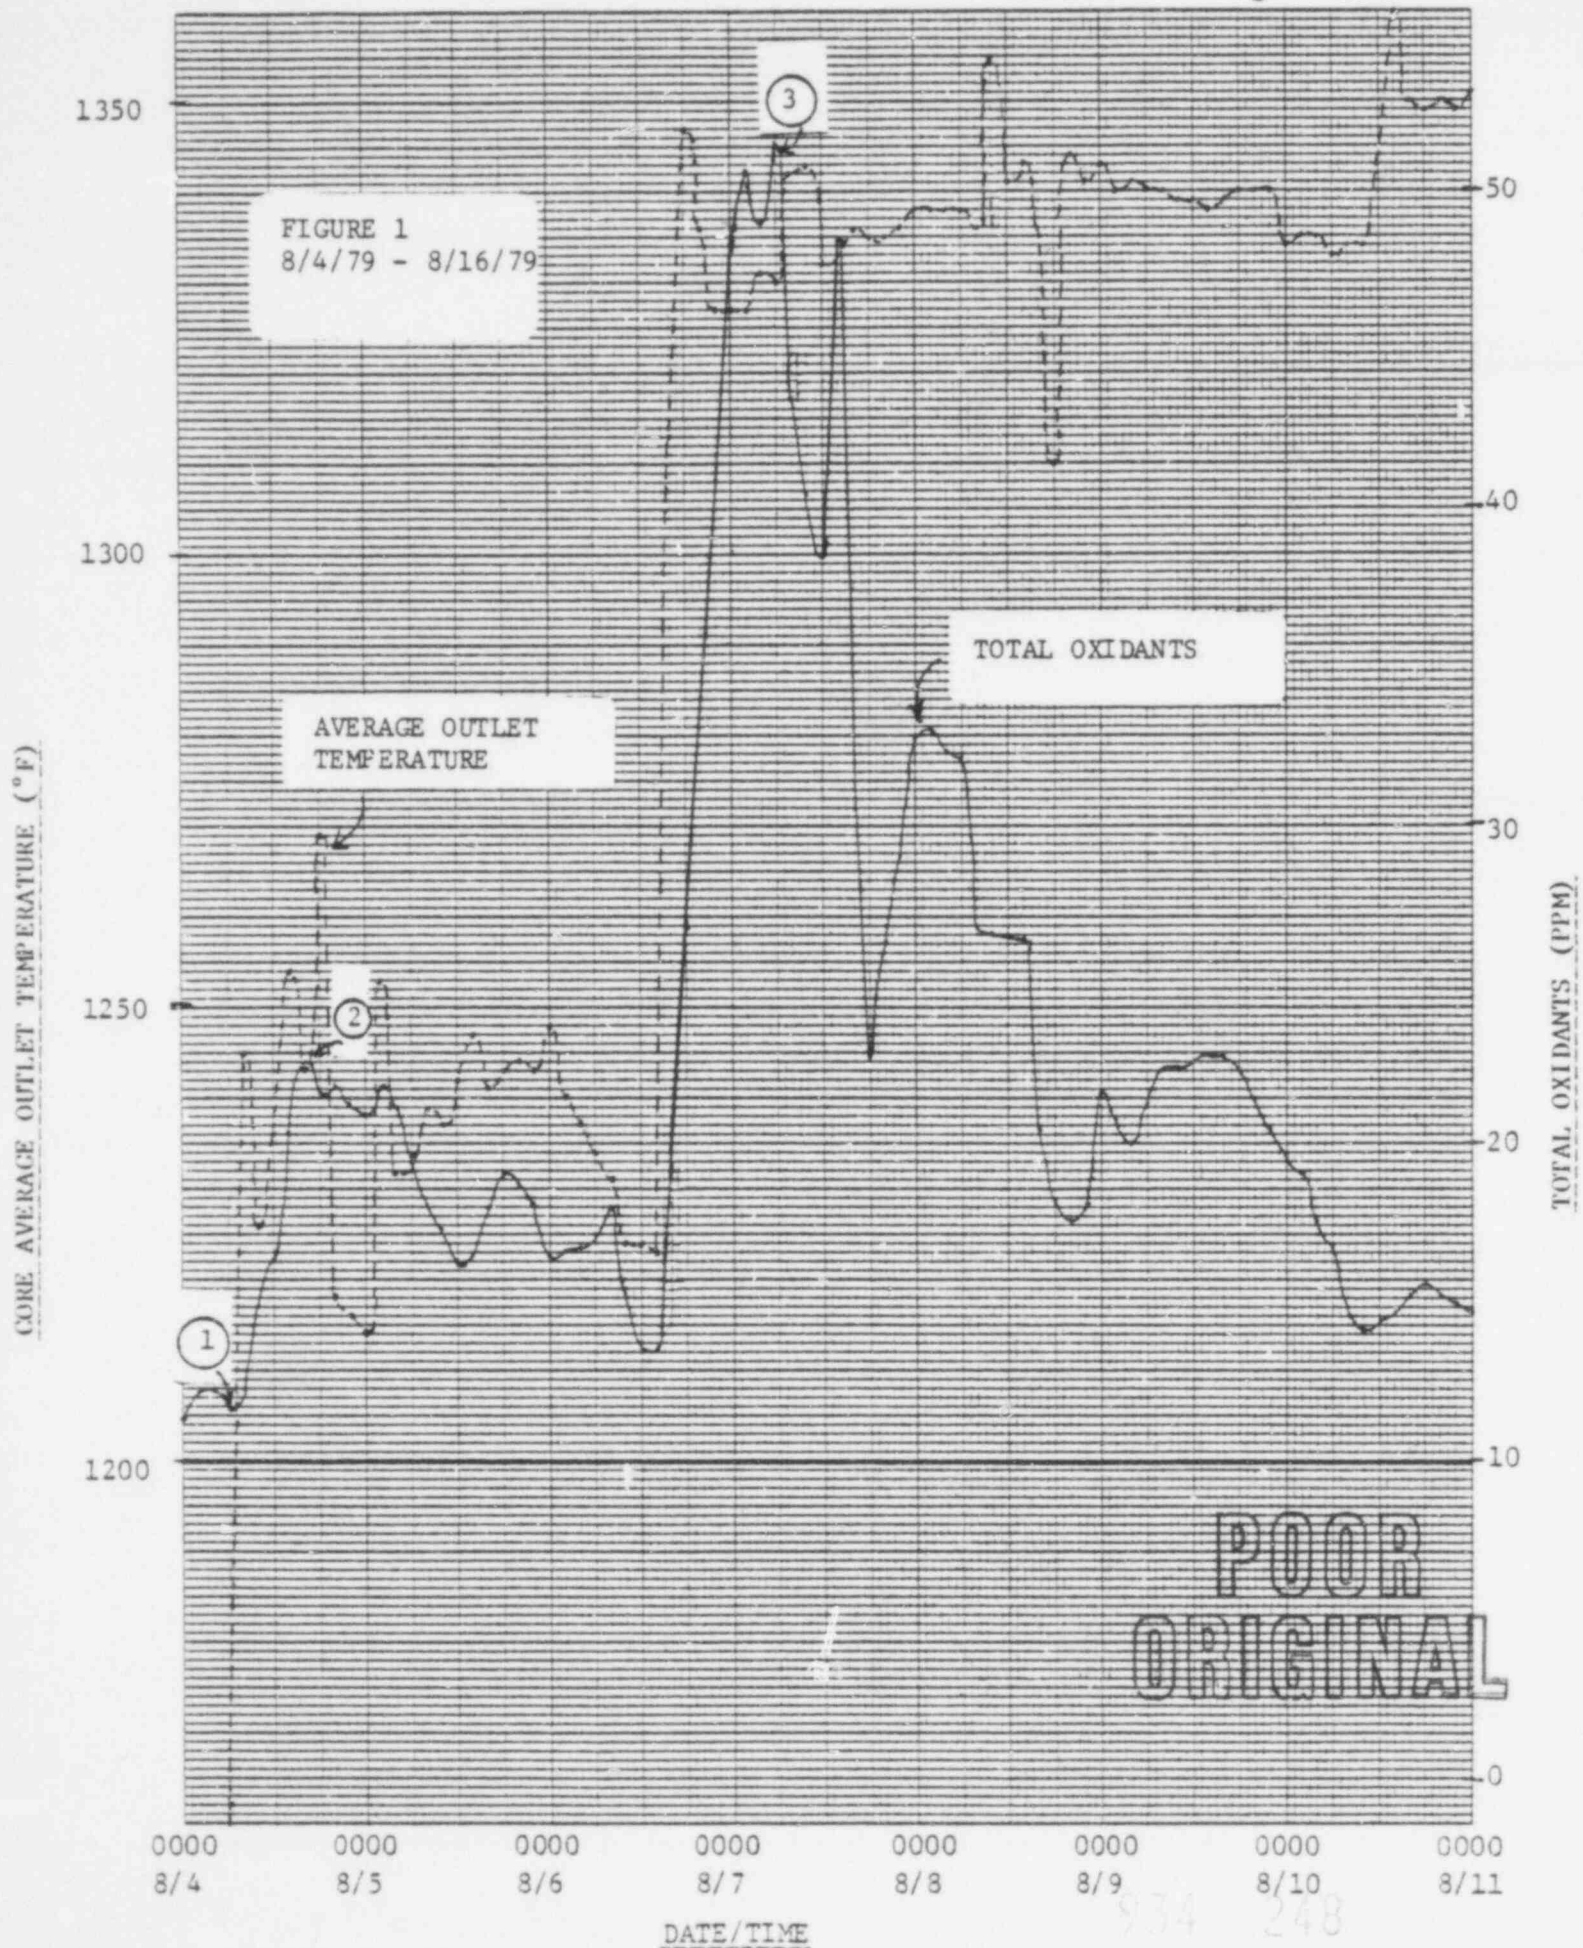
At about 0630 hours on August 4, 1979, with the reactor operating at approximately 45% power and total primary coolant oxidants at approximately 11.8 ppm, core average outlet temperature exceeded 1,200°F for the first time since the refueling shutdown (reference Figure 1, point (1)). Following an initial increase, (Figure 1, point (2)) oxidant levels appeared to be following a decreasing trend until approximately 1745 hours on August 6, 1979. Since as much moisture as possible had been removed at existing plant conditions, reactor power was increased to approximately 60% to facilitate additional "drying out" operations. At that time, it was observed that carbon monoxide indications were on the increase.

At 0230 hours on August 7, 1979, it was observed that primary coolant carbon dioxide levels were also increasing. At this point, it was determined that the "A" helium purification dryer had apparently broken through. Maximum oxidant concentration of 51.5 ppm was reached at approximately 0600 hours with average core outlet temperature of 1,300°F (reference Figure 1, point (3)).

Due to a circulator trip on August 11, 1979, temperatures were decreased to less than 1,200°F (reference Figure 1, point (4)). With the subsequent rise in power later that same day, temperatures were again increased to greater than 1,200°F, while oxidant levels continued their decreasing trend. At 1937 hours on August 11, 1979, the reactor scrammed, and temperatures again decreased to less than 1,200°F (reference Figure 1, Point (5)). Oxidant levels continued to decrease until a subsequent increase in temperature on August 13, 1979, resulted in LCO 4.2.10 limits again being exceeded at approximately 1500 hours on August 13, 1979 (reference Figure 1, point (6)).

At 0040 hours on August 16, 1979, a circulator trip occurred. Reactor power and temperature were decreased to allow recovery of the circulator (reference Figure 1, point (7)). Following this occurrence, no further degraded mode operation of LCO 4.2.10 occurred.

It is assumed that the continued level of oxidants in the primary coolant following regeneration of the purification train was a result of off-gassing due to a previous buffer helium dryer bypass which resulted in water ingress to the core.

As temperatures increase, the water reacts with the graphite in the core to form carbon monoxide and carbon dioxide. During the period covered by this report there were no significant changes in the moisture concentrations observed in the primary coolant, so the increased oxidant levels are attributed to the reaction between the water and graphite as a result of efforts to dry out the core following an extended refueling shutdown and the previously mentioned dryer bypass.

"B" purification train was placed in service in an attempt to keep the total primary coolant oxidant levels from increasing, and the "A" purification train which had broken through was regenerated.

Drying out operations were continued with consideration to the limits allowed per LCO 4.2.10. Decreases in temperature due to periodic circulator trips and reactor scrams precluded any necessity for planned temperature decreases.
