SUBJECT: Broken Reactor Vessel Anchor Bolt in Unit 1 Status Report

PROJECT: Consumers Power Company
Midland Plant Units 1 & 2
Bechtel Job 7220

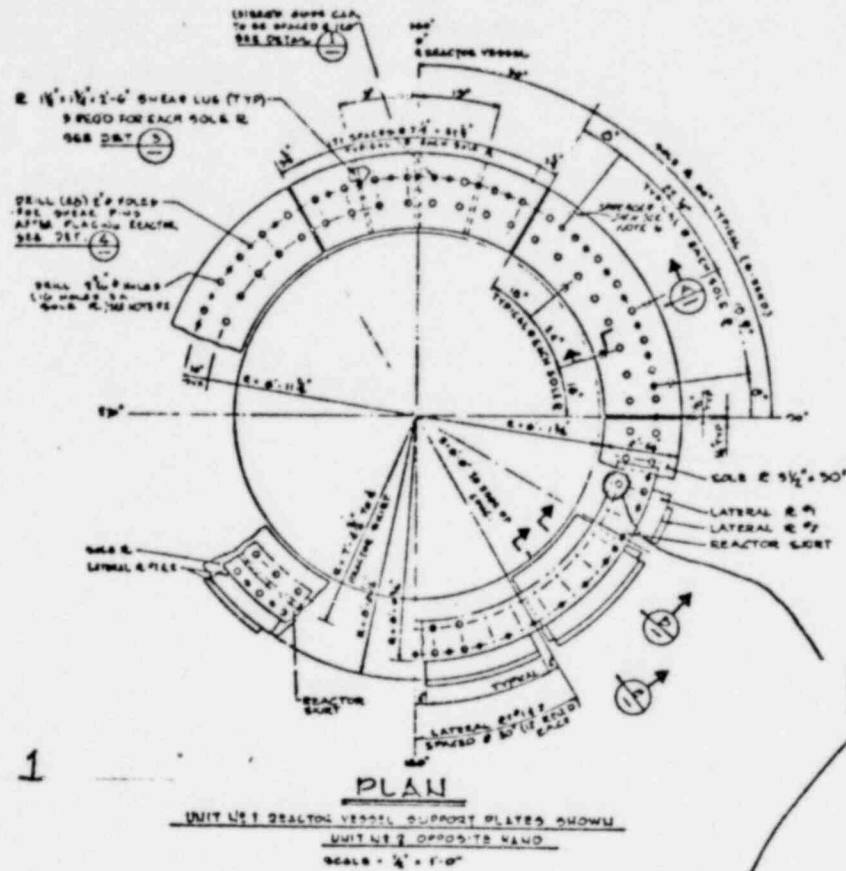
The anchor bolts are 7 feet 4 inches in length and 2-1/2 inches in diameter with 1-inch thick washers and heavy hex and jam nuts. There are 96 anchor bolts per reactor vessel with 48 on the inside of the reactor skirt and 48 on the outside (see Figure 1). The bolts are ASTM A 354 Grade BD, purchased under Bechtel Specification 7220-C-233(Q), Rev 3.

On July 26, 1979, anchor bolt 35 (the third stud clockwise from the X axis, on the inside with the "0" mark stamped on the anchor bolt; see Figure 1) in Unit 1 was tensioned to 75 ksi by B&W using the specified BIAC anchor bolt tensioner. On September 14, 1979, B&W personnel learned that this bolt and nut were missing when they attempted to install the jam nuts on the anchor bolts. On September 14, 1979, B&W issued NCR-1656 describing the situation. On the same day, Bechtel personnel initiated a search. The bolt was recovered on September 18, 1979. It was determined that the bolt broke 14 inches from the top end. The break occurred in the threaded portion approximately 1/2 inch from the last threads on the bolt, with separation occurring even with the bottom of the sole plate (see Figure 2). At the time of the break, the bolt apparently was ejected and may have caused several minute dimples on the surface of the reactor vessel itself (see Figure 3).

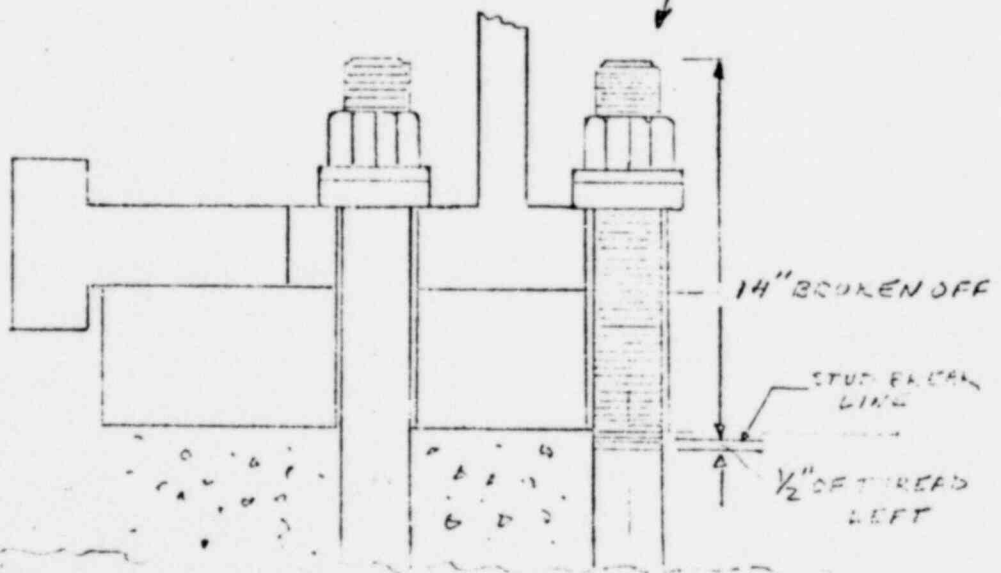
FIGURE 2

BOLT 35
