October 10, 1979
Fort St. Vrain
Unit No. 1
P-79230

REPORTABLE OCCURRENCE 79-36

FORT ST. VRAIN NUCLEAR GENERATING STATION
PUBLIC SERVICE COMPANY OF COLORADO
P. O. BOX 361
PLATTEVILLE, COLORADO 80651

REPORT NO. 50-267/79-36/03-L-0

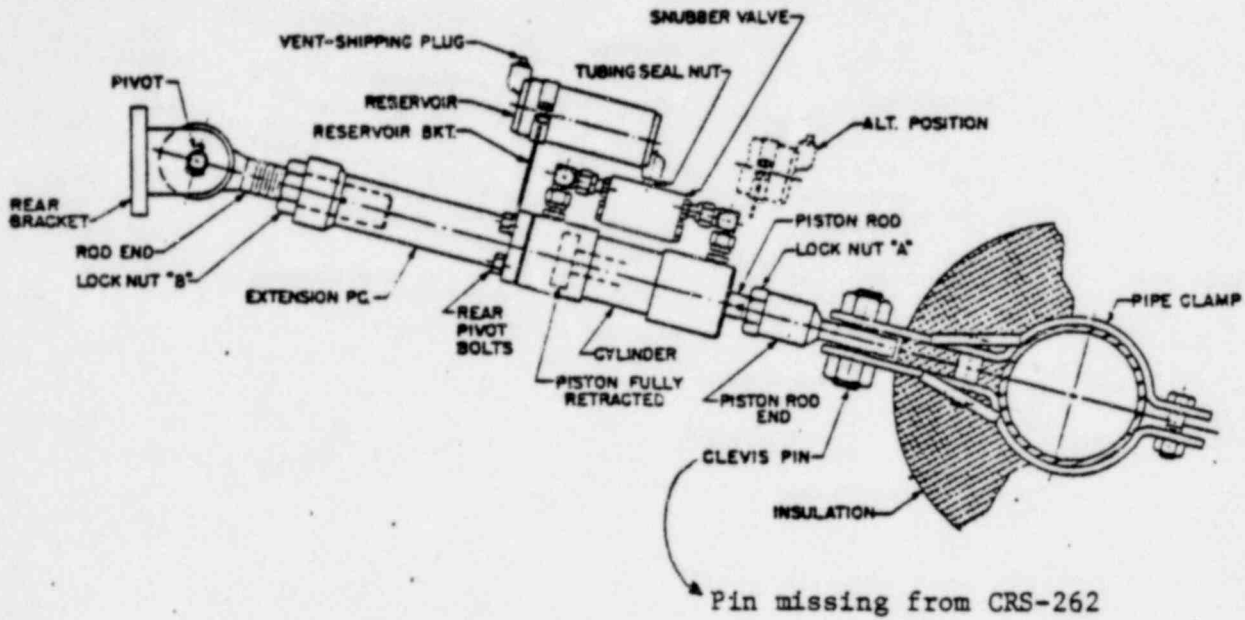
FIGURE 1

On September 10, 1979, with the reactor in a shutdown condition, engineering personnel observed that the pin at the piston rod eye of cold reheat snubber CRS-262 was missing. See details of Figure 1.

Because this pin was missing, the snubber was not properly attached to the pipe, and was therefore inoperable. This snubber had been verified operable per approved surveillance procedure during the refueling shutdown.

Prior to startup following the first refueling, this snubber was operable. There appears to be no cause for this missing pin traceable to plant operation.

A new pin was fabricated and installed and the snubber was returned to service. The present surveillance interval is 12 months \pm 25%. No change is required as a result of this occurrence.
