# NORTHEAST UTILITIES

November 5, 1979

Docket No. 50-336

Millstone Nuclear Power Station, Unit No. 2  
Feedwater System Piping

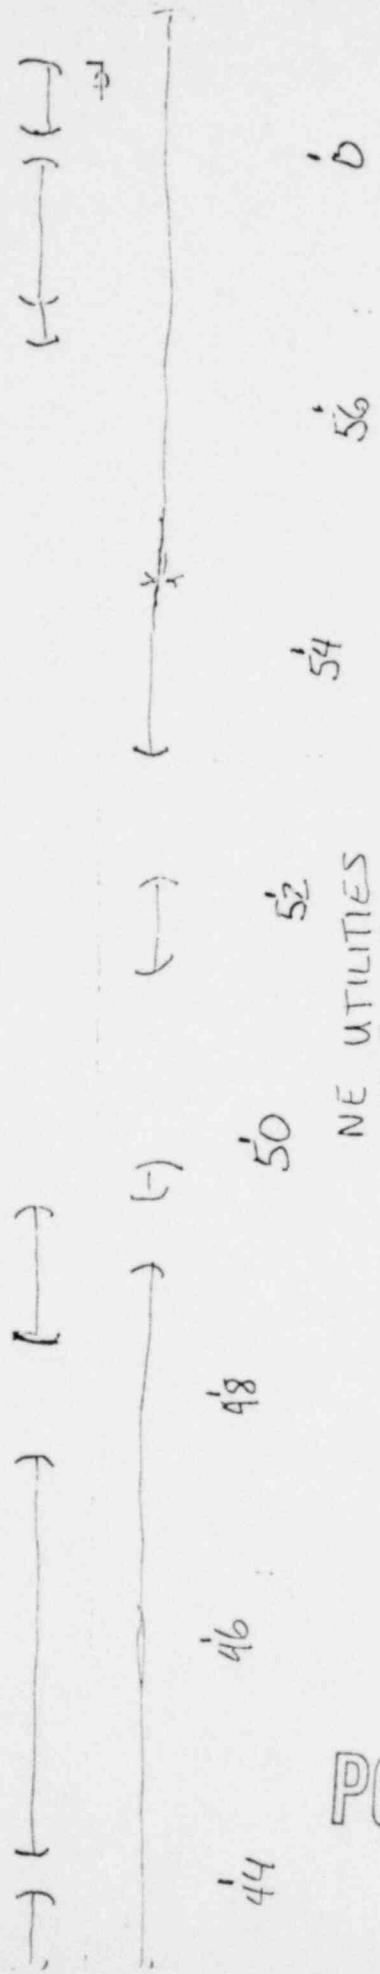
FIGURE 3

The RT results for two selected circumferential areas of Weld AC-G-1, comparing the data from the August, 1979 inspection to the data from the November, 1979 inspection, are provided in Figures 1 and 2. Similar data for three selected circumferential areas of Weld BC-G-1 are presented in Figures 3, 4, and 5. Based upon a comparison of the RT data of the two inspections, NNECO has con-

cluded that no measurable change in the size of the indications on either side of the safe-end to pipe welds has occurred.

NE UTILITIES  
ST. GEN. 2  
WELD BC-G-1  
PTM 11-3-79

NE UTILITIES  
ST. GEN. 2  
WELD BC-G-1  
PTM 8-11-79

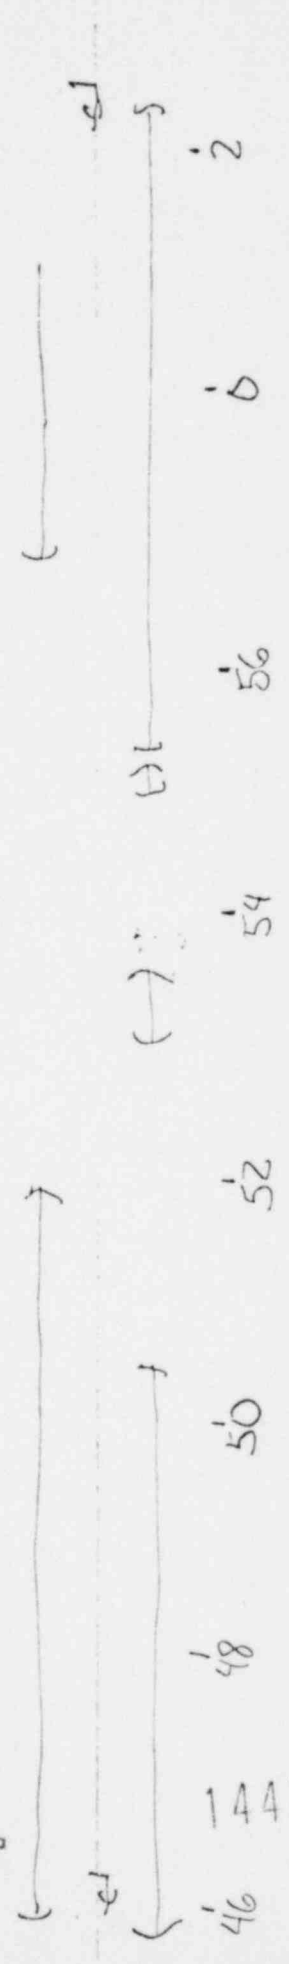
N.E. UTILITIES  
ST. Gen 2  
WELD BC-6-1  
PTM 11-3-79

N.E. UTILITIES  
ST. Gen. 2  
WELD BC-6-1  
PTM 8-11-79

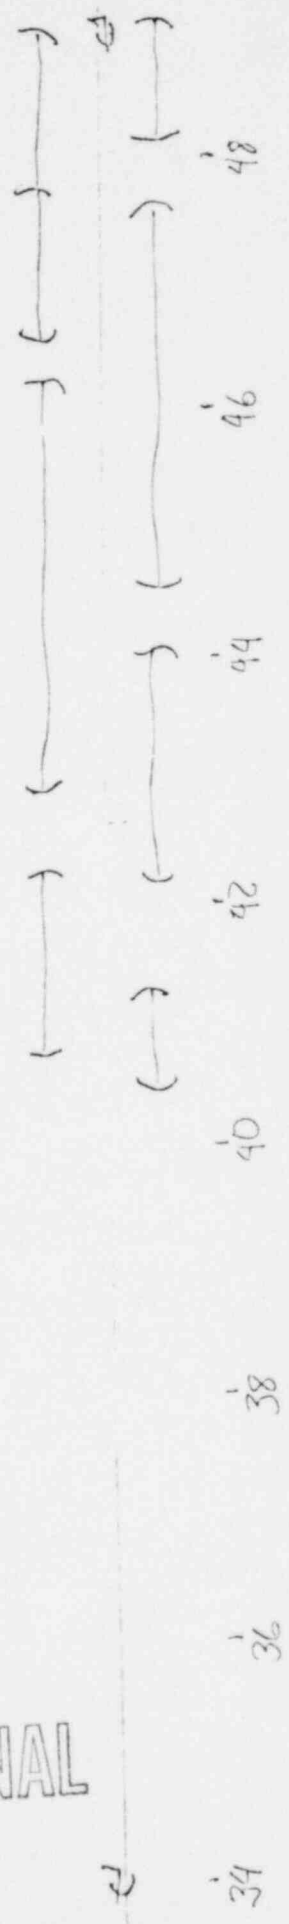
FIGURE (5)

N.E. UTILITIES  
ST. Gen. 2  
WELD BC-G-1  
PTM 11-2-79

N.E. UTILITIES  
ST. Gen. 2  
WELD BC-G-1  
PTM 8-11-79

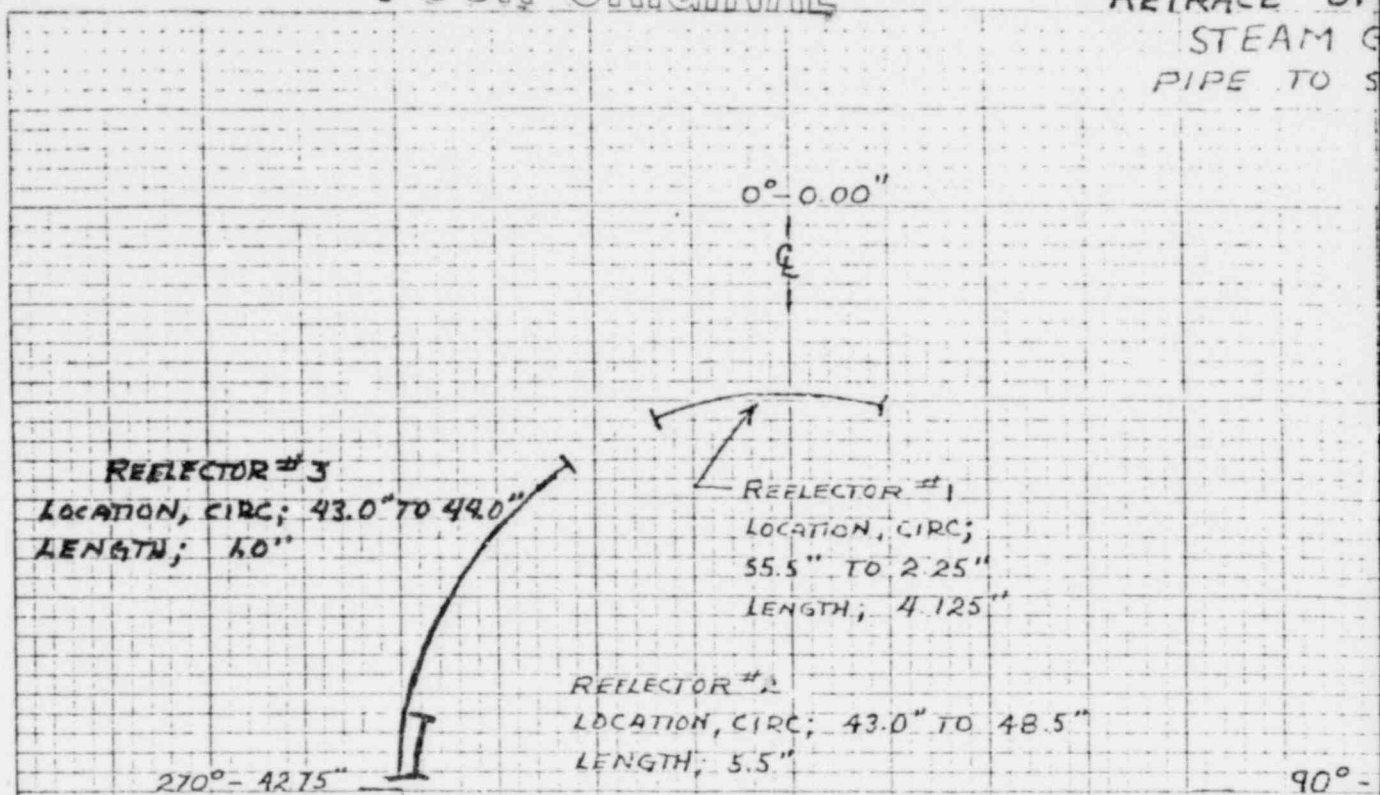
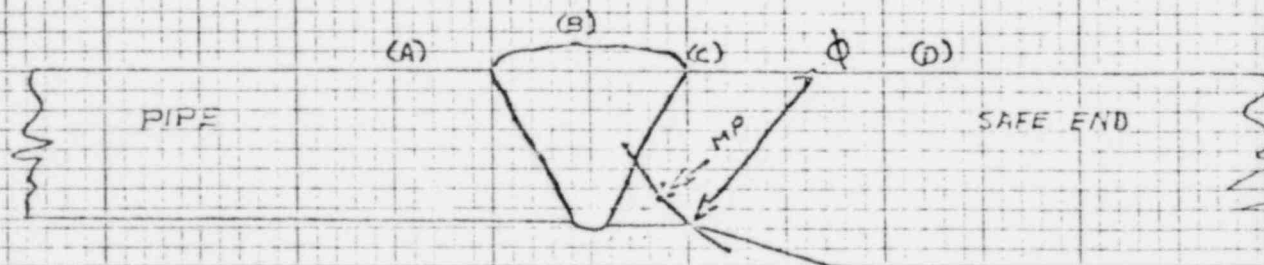
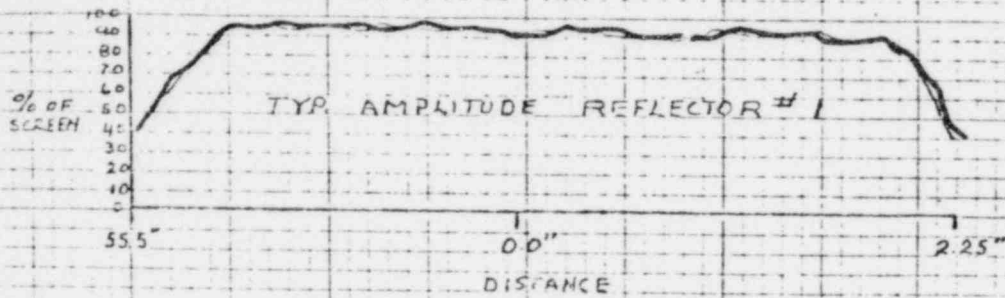
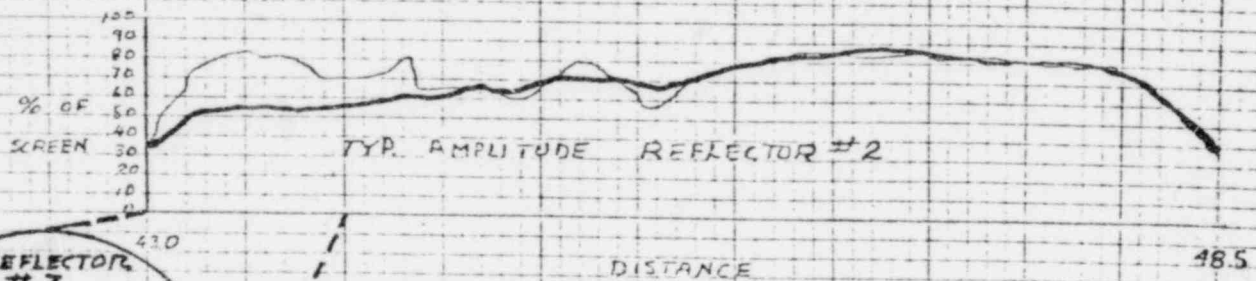
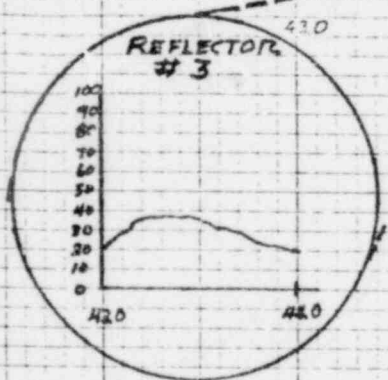
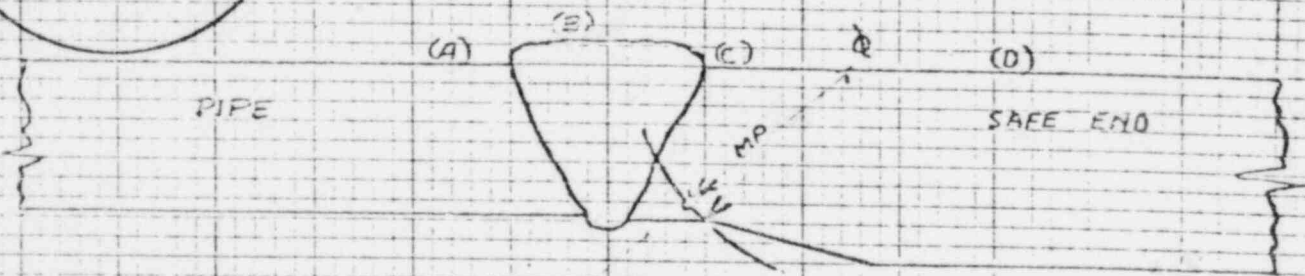
FIGURE 6

Subsequent to completion of the RT inspection, selected linear indications were ultrasonically examined. These UT results are presented in Figures 6 and 7. Based upon a comparison of the UT data from the August, 1979 and November, 1979 examinations, NNECC has concluded that no measurable change in the length of the originally mapped reflectors has occurred. Furthermore, comparison of the amplitude profiles confirms that no measurable increase in indication depth has occurred. However, in the nine o'clock position of the number two reflector on the safe-end side of Weld BC-G-1, the amplitude has decreased as a result of a one-inch long parallel indication shadowing the original reflector.

REFLECTOR #1 @ 0.0"

THICKNESS MEASURED

REFLECTOR #2 @ 46 1/2"

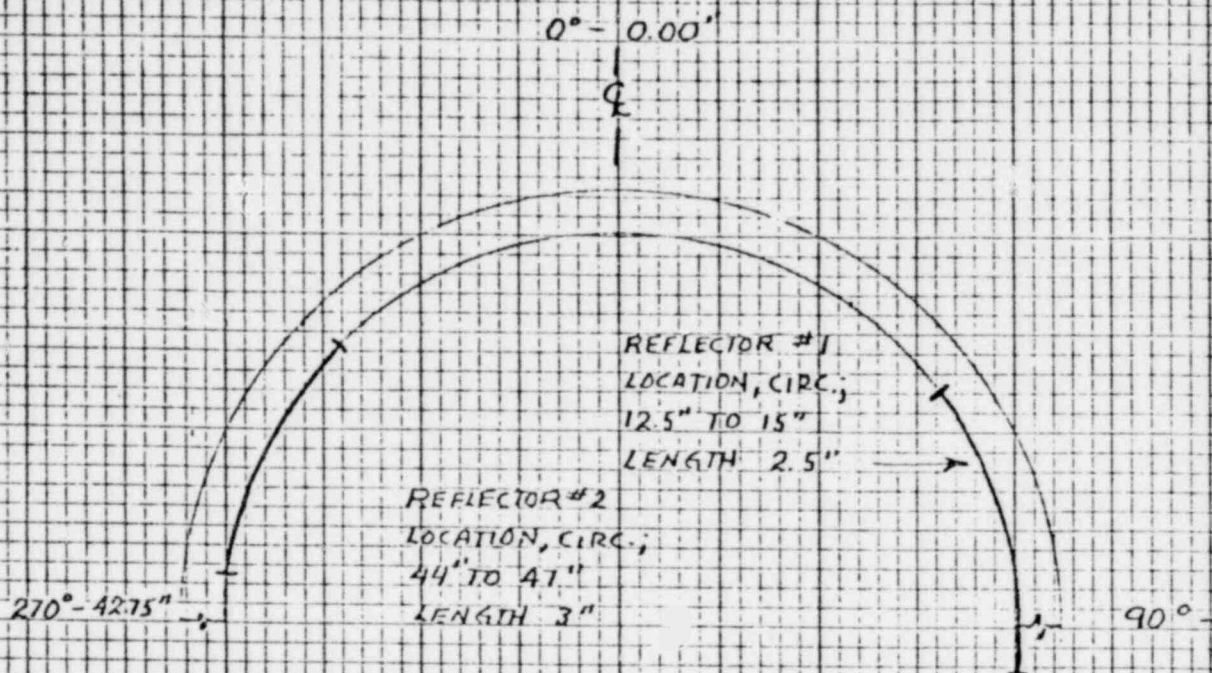
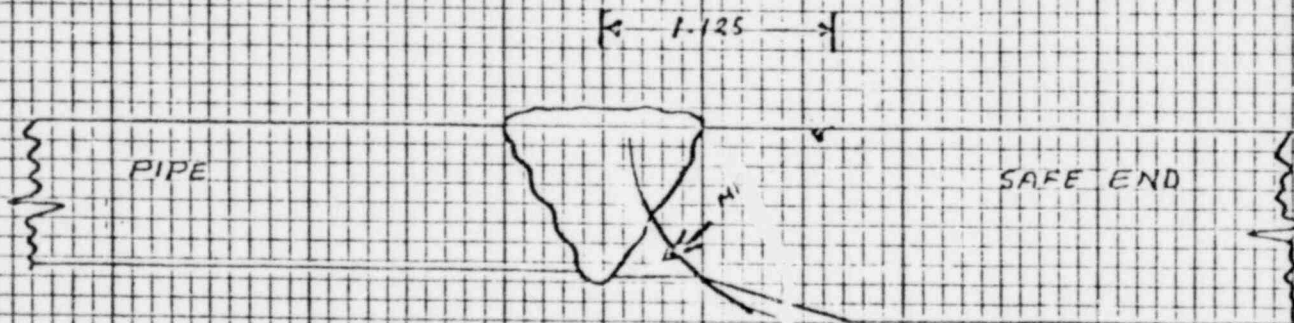
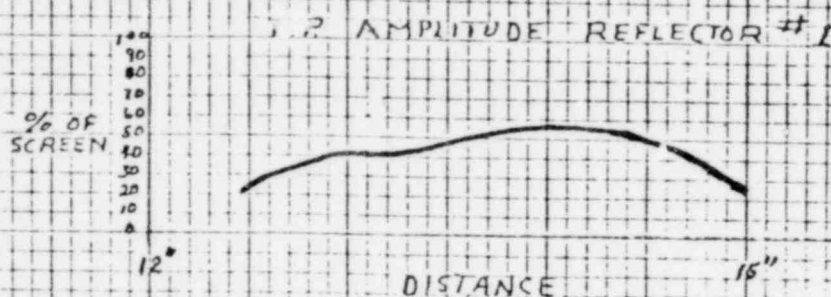
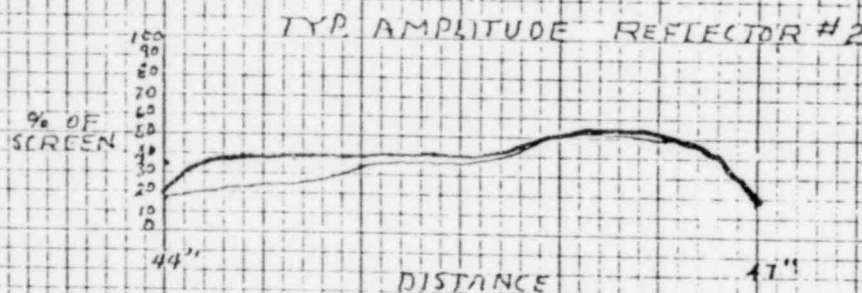
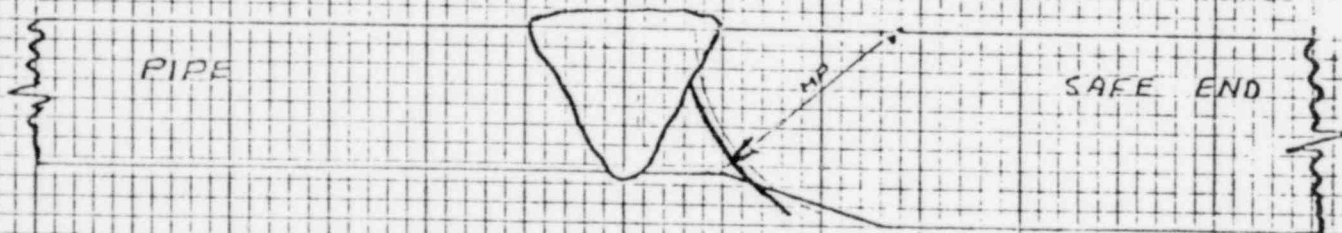
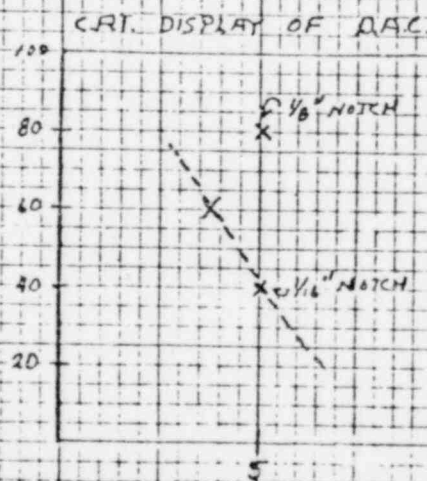
7

REFLECTOR #1 @ 14.5"

"NOTE" A APPROX. INCREASE OF 3 TO 4 dB WAS NOTED BETWEEN 44" TO 46"

REFLECTOR #2 @ 46"
