Re: McGuire Nuclear Station
Units 1 and 2
Docket Nos. 50-369 and 50-370
SD 369-370/79-06, Supplement 1

My letter of August 31, 1979, transmitted Significant Deficiency Report SD 369-370/79-06 which described a problem with the personnel air lock door seals. In the original report we committed to provide further details on the corrective actions taken. This information is contained herein.

McGUIRE AIR LOCK DOORS

SHOP INSPECTION PROCEDURE

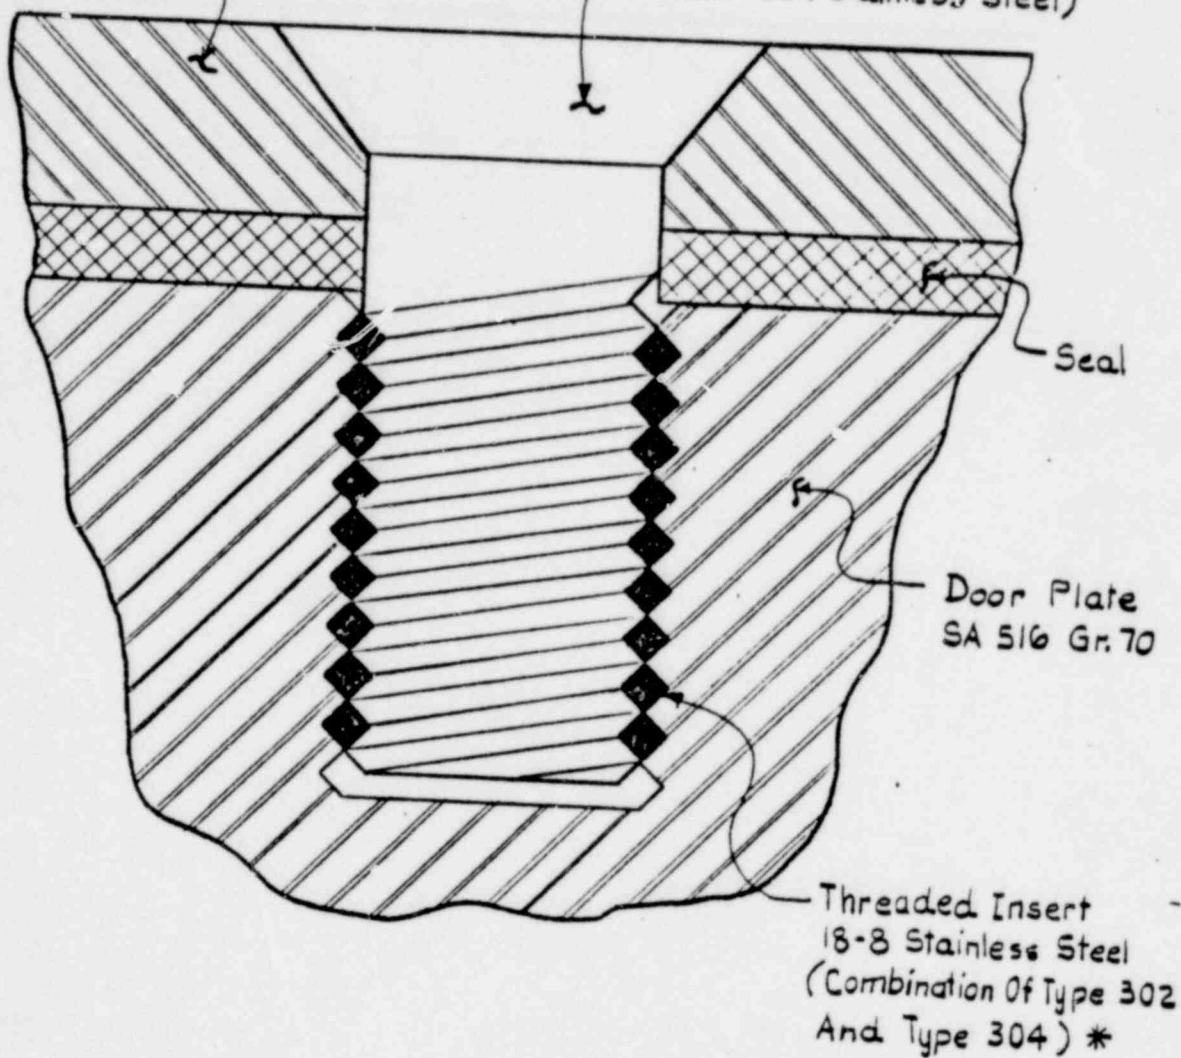
SKETCH 2:

Deficiencies related to thread condition and depth were repaired with threaded inserts. Attachment #3 shows a section of the threaded insert in place. These high strength inserts are installed after the holes have been re-tapped. The pullout resistance of the tapped hole is actually increased since the inserts allow greater shear area contact.

Clamp Bar
SA 516 Gr.70

$\frac{1}{2}$ " Φ Bolt - 13 UNC Thread
(SA-304 Stainless Steel)

* Cold Rolled Wire - Ultimate Tensile Strength 200-250 Ksi.

Threaded Insert Assembly
