Tennessee Valley Authority
Division of Engineering Design
Civil Engineering and Design Branch
Geologic Services

PHIPPS BEND NUCLEAR PLANT
GEOLOGIC FOUNDATION REPORT
DESCRIPTIONS OF FAULTS 1-10

August 1979

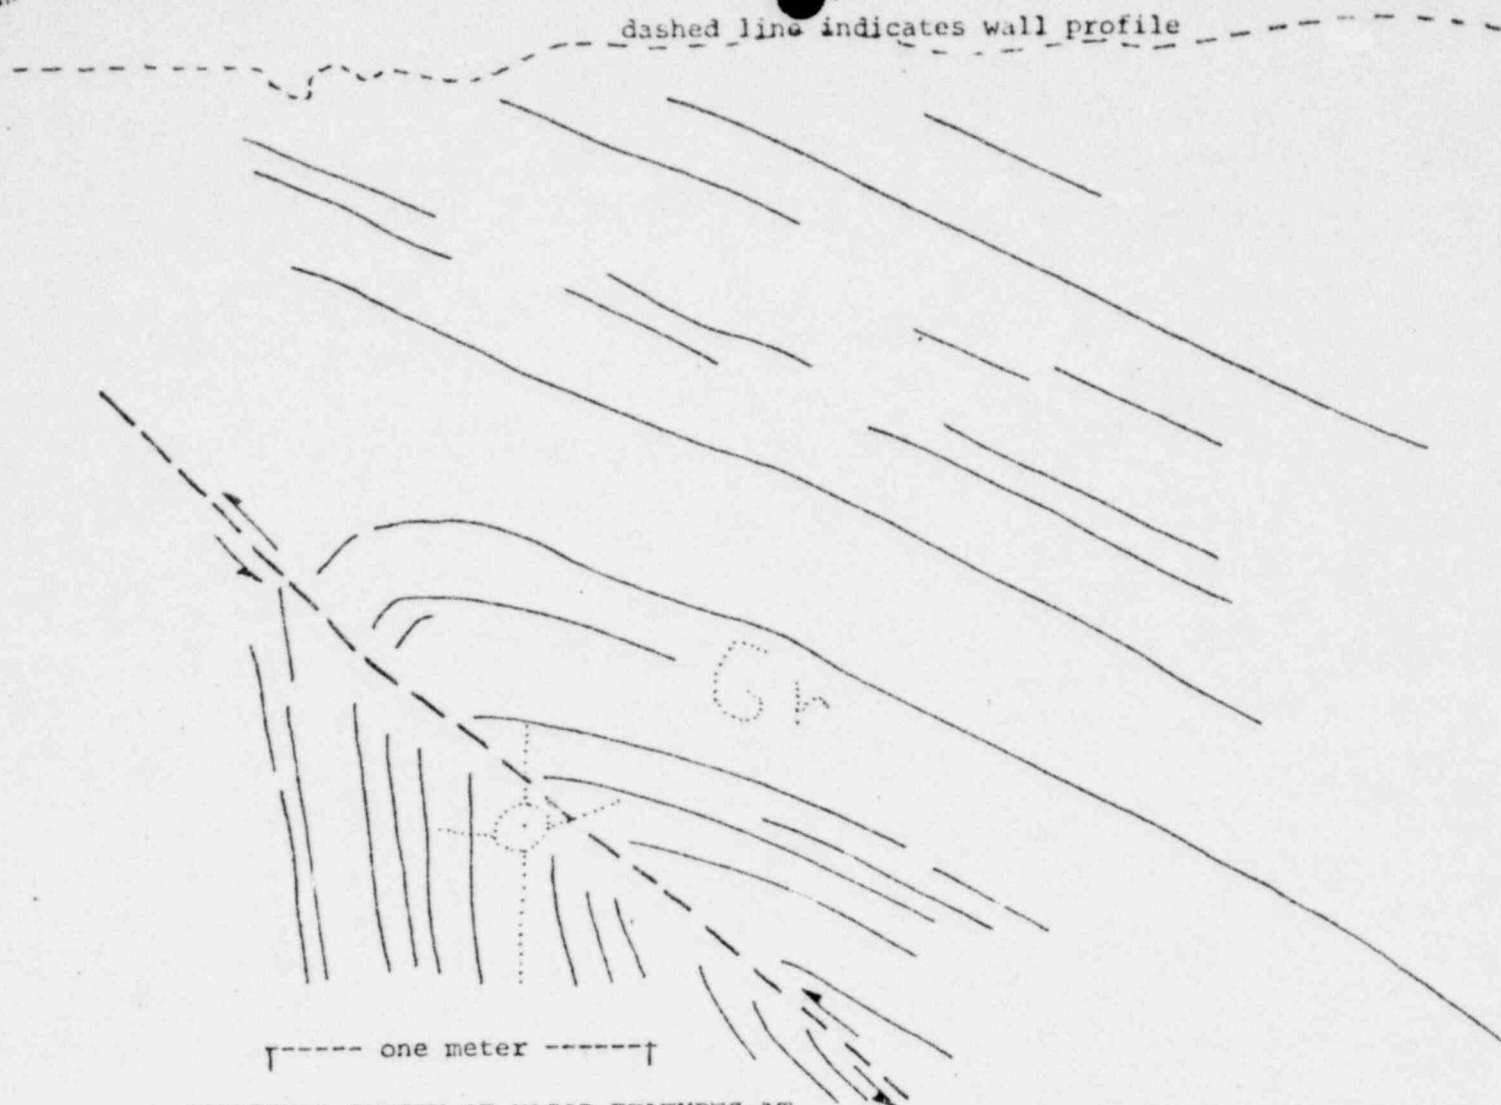
Site 1

The fault at this site (see structure sketch) is concordant with the orientation of the axial plane of the asymmetrical anticline which it cuts. Although the displacement is difficult to determine, beds on the north limb of the fold do not appear to have been moved more than a few centimeters. The fault is an example of axial plane "cleavage" developed on a mesoscopic scale. Thus, its origin is by shear stress which was produced during Paleozoic tectonism when overlying beds within the sequence were sliding upward toward the crest of the fold in a manner such as that illustrated in Figure 2. This relation of fault orientation to fold axial plane orientation is similar to that described by Swingle (1973) in calcareous siltstones of Knox County, Tennessee.

STRUCTURE SKETCH OF MAJOR FEATURES AT
 SITE 1. View toward northeast. Arrows indicate relative motion of fault.
 Dotted lines indicate painted markings of rocks. Most of beds shown are
 marked by slickensided calcite-filled layers.

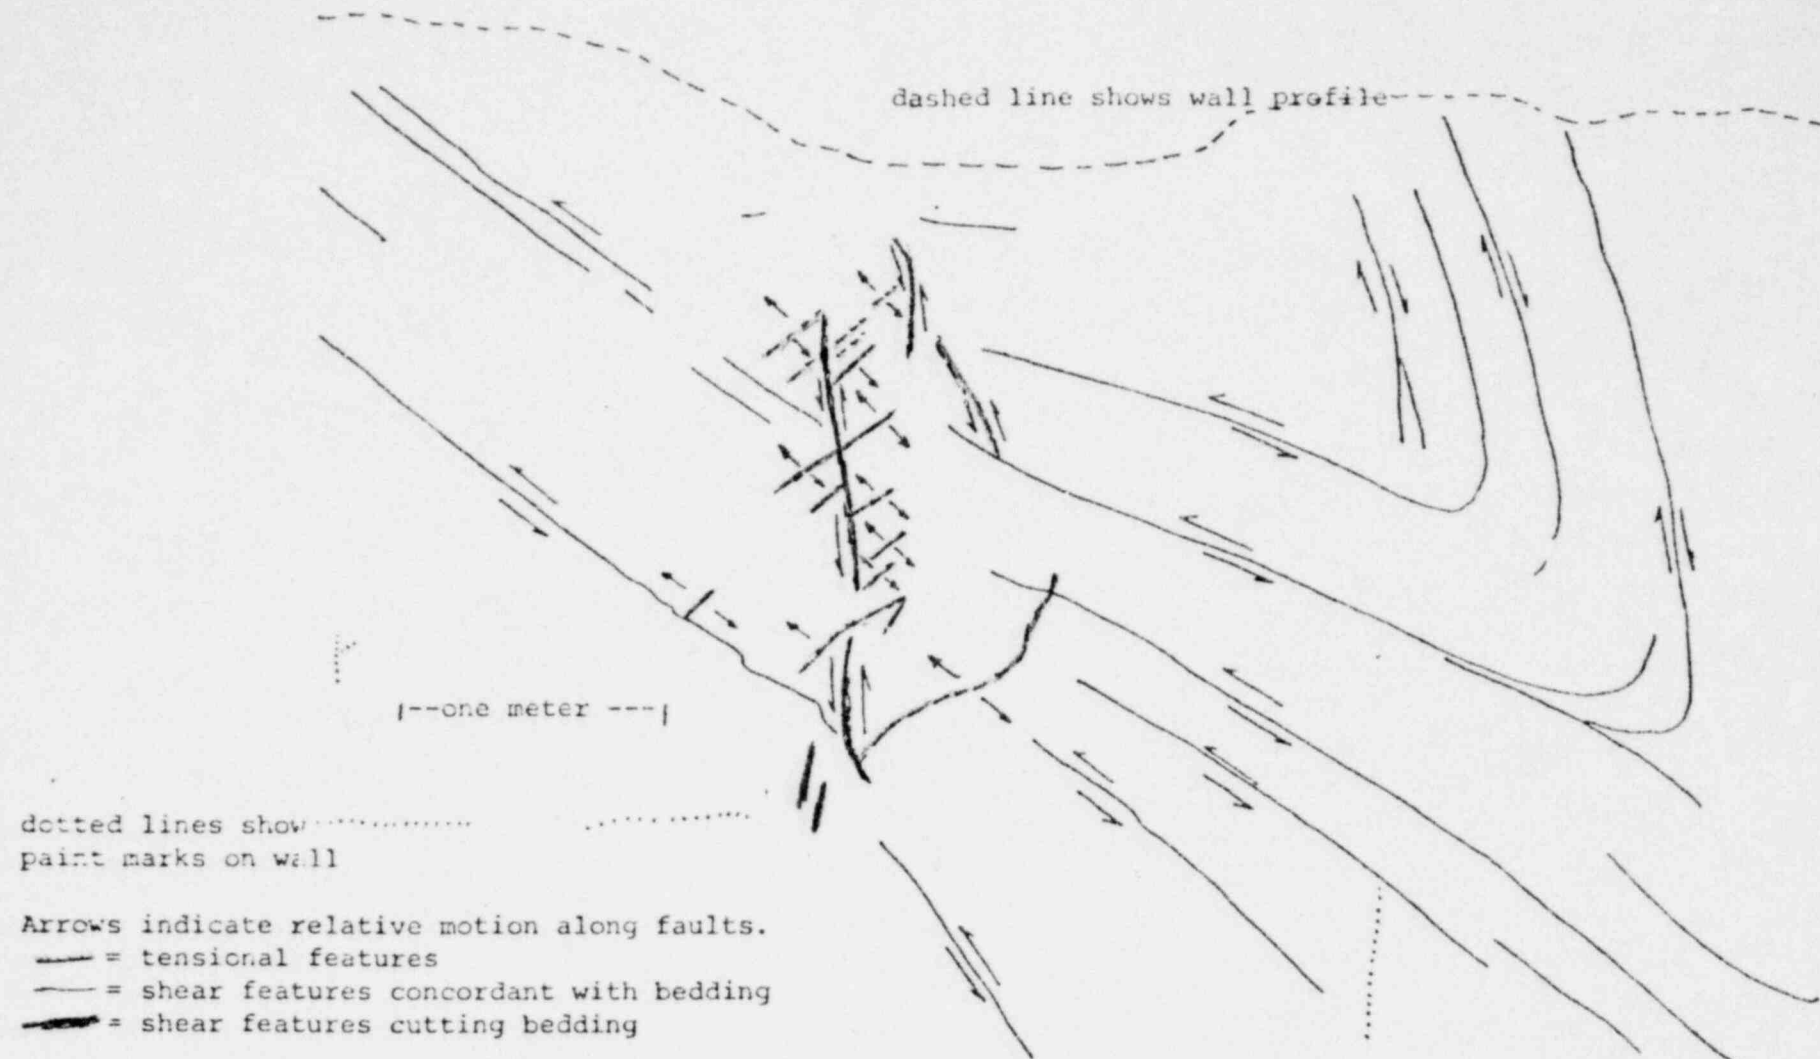
Site 2

This fault is located approximately 2 meters north of the axial plane of an asymmetrical syncline (north limb dip = 40° S.). Calcite-filled fractures and fault surfaces parallel to bedding were produced by shearing of beds during folding as each bed slid upward, with respect to the bed below it, toward the crest of the adjacent anticline. This is the same principle as shown in Figure 2. Thus, there was shear stress that produced fractures that are incipient small ramp faults such as those shown in Figure 5. As additional folding and slippage along bedding planes occurred, minor displacement of bedding resulted from the shearing motion shown by the disruption of calcite-filled bedding faults truncated by the near-vertical fault here. Calcite-filled fractures of lesser size and near normal-to bedding orientation

are of tensional origin. These small tension fractures were formed by the stretching of beds on the fold limb as thinning and thickening as illustrated in Figure 2 took place.

This somewhat indistinct fault extends for less than 20 feet to the east where it dies out on the excavated bedrock bench. Examination of the floor of the reactor site to the west reveals that the fault trace dies out within 15 feet of the excavation wall.

STRUCTURE SKETCH OF MAJOR FEATURES AT SITE 2.
View is toward the northeast

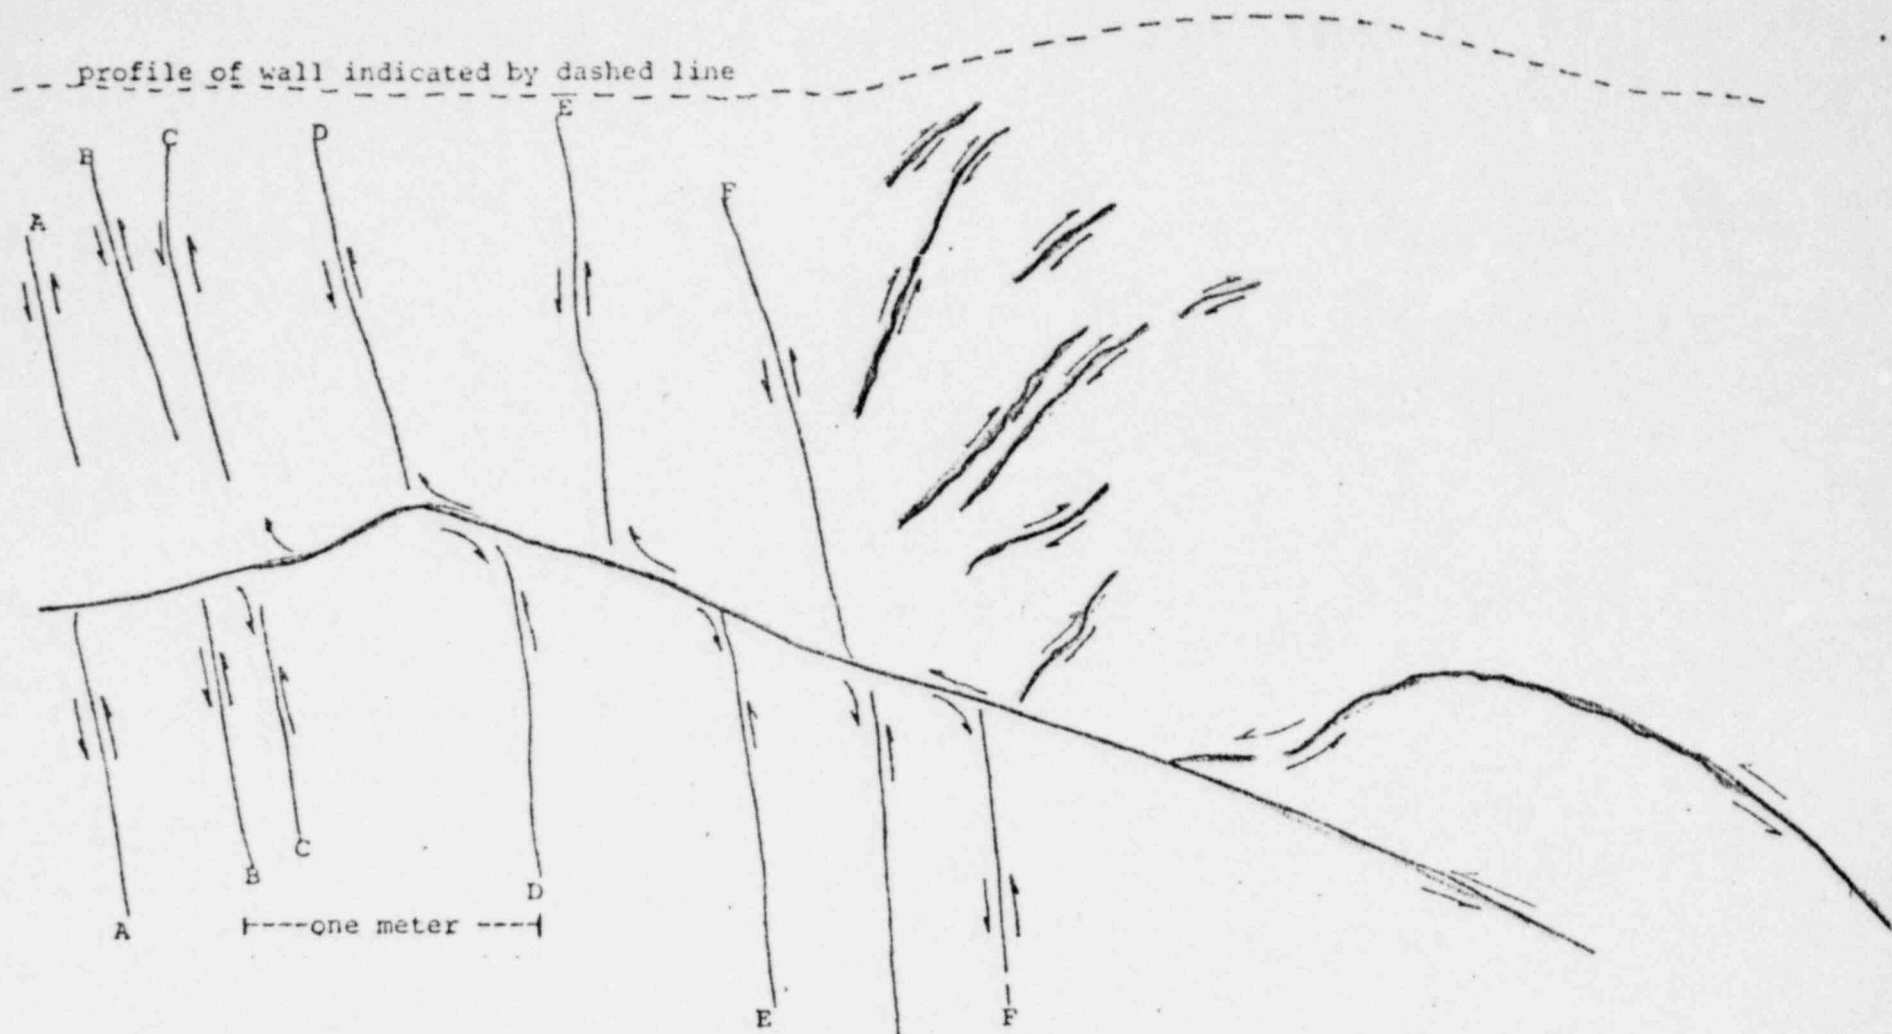
Site 3

The fault at this location is an excellent example of bedding plane faulting that locally breaks across bedding by ramping upwards through beds that are slightly more brittle (see Figure 5). As displacement of overriding beds took place as these beds moved higher toward the crest of the anticline, the space necessary to accomodate the volume change that accompanied the displacement was provided at sites where the fault broke across bedding. A series of these breaks occurred here and, as is shown in the structure sketch, enough space for accomodation of the beds was produced. Thus, a combination of shear faulting along bedding planes and shear and (or) tensional faulting normal to bedding intersect to provide an integrated network of displacement avenues and space.

STRUCTURE SKETCH SHOWING MAJOR FEATURES AT SITE 3. View toward the northeast.

Arrows indicate relative motion of faults.

Note how displacement along fault marked in red (—) decreases toward the north where its displacement is translated into bedding plane motion by ramping upward into bedding plane faults labelled A - F. Faults shown in green (—) are folded or tilted by drag effect associated with the anticline present here.
