DOCKET NOS. 50-266 AND 50-301
FURTHER RESPONSE TO IE BULLETIN 79-13
POINT BEACH NUCLEAR PLANT, UNITS 1 AND 2

METALLURGICAL EVALUATION OF FEEDWATER PIPE CRACKING

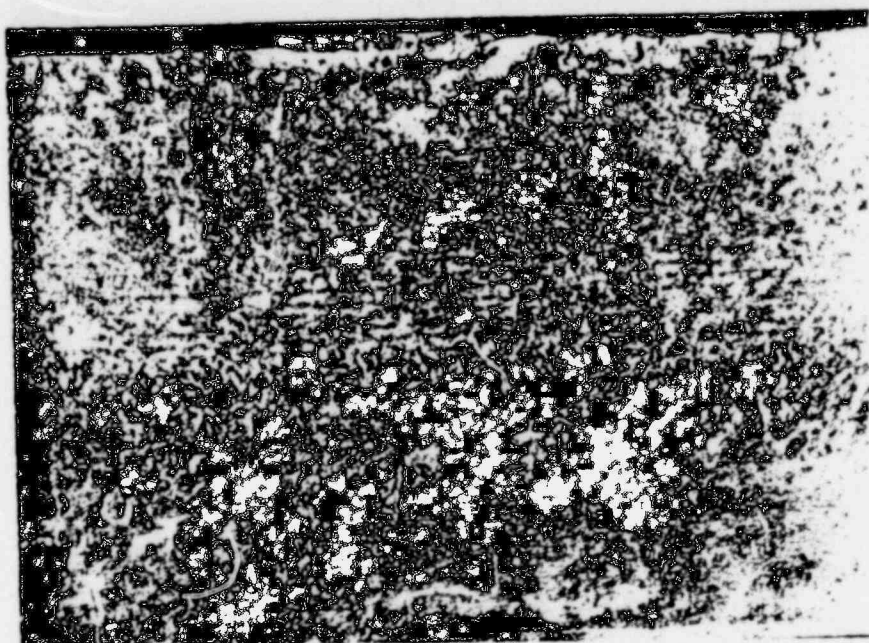
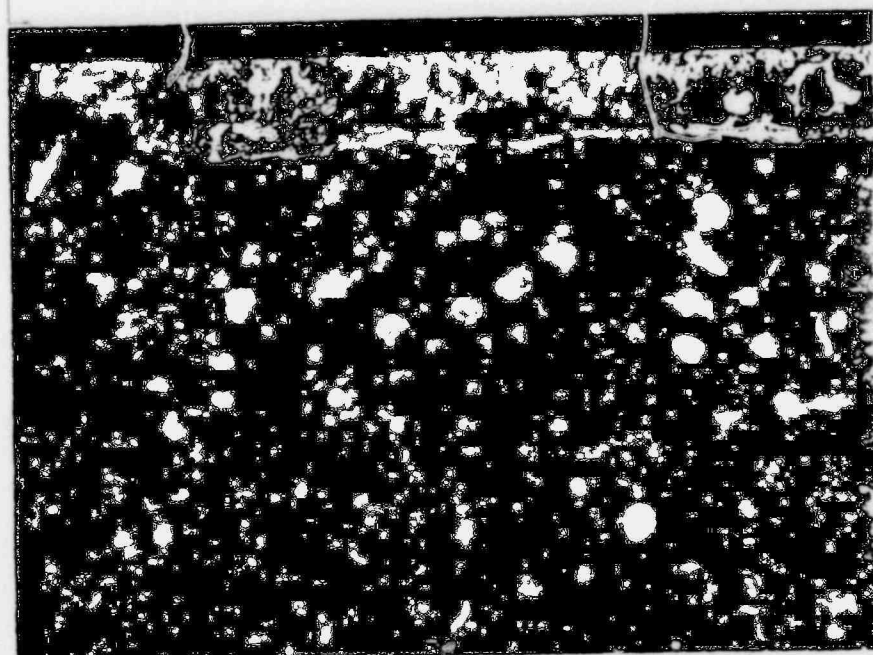
FIGURE 1. INTERNAL SURFACE OF REDUCER AT 18" COUNTER-BORE REGION.
Note the fusion-line crack in 1(b), 1(a), #19-20
segment, 1(b), #44-45 segment.

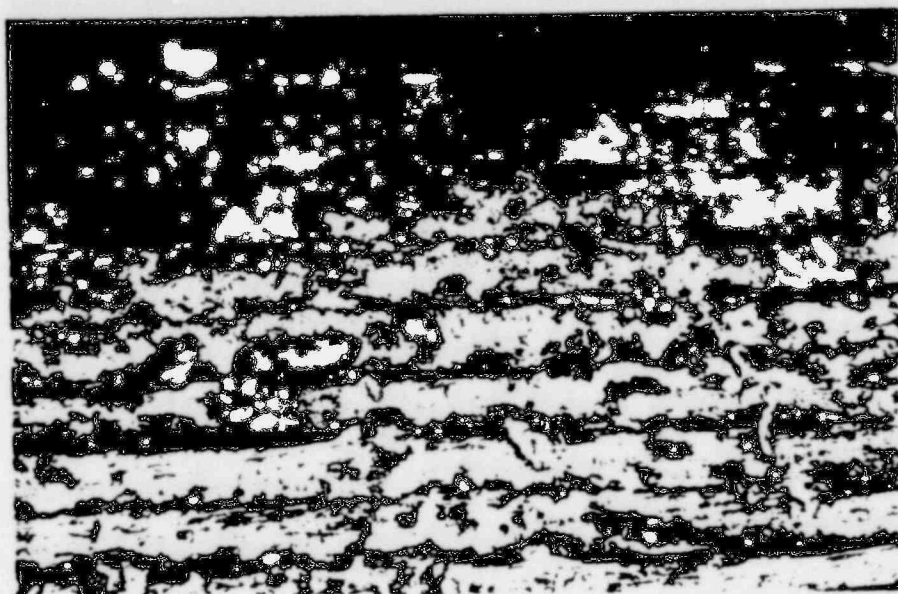
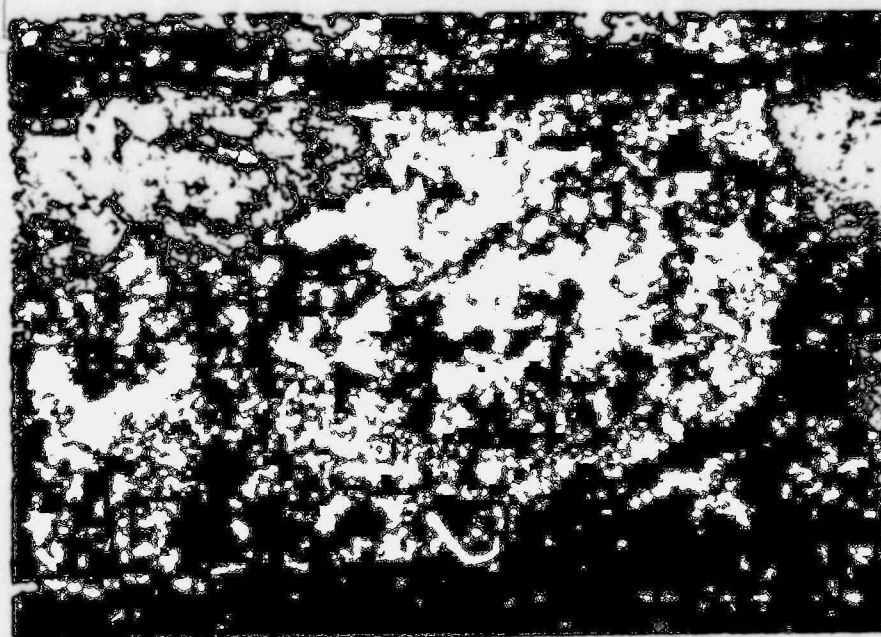
The oxide was electrolytically removed from selected segments to examine the underlying surface. On the 18-in. end copious cracking was observed at and near the counter-bore transition, that is, at the intersection of the flat counter-bore and bevelled counter-bore regions, Figure 2. Most cracks were situated at the root of machining grooves, at the root-pass fusion line or at the base of deep pits. No cracks in an axial orientation could be found in the base metal, although several small axial cracks were present on the weld bead, Figure 3(b). As will be seen below, no cracks were observed at the HAZ in metallographic sections. Macroscopic examination showed that grinding of the weld bead had virtually removed the machining marks in this area, Figure 3. Some small cracks were present in the HAZ, Figure 3(b), at pits or small grooves. Thus, the general absence of cracks in the HAZ is attributed to the elimination of stress-raisers, rather than to metallurgical structure or residual stress effects.

FIGURE 2. INTERNAL SURFACE OF 18" END OF REDUCER AFTER ELECTROLYTIC CLEANING. Note that cracking occurs at the root of machine marks near the counter-bore transition, (a), #15. Small axial cracks were occasionally present on the weld bead, (b), #43, in addition to fusion-line cracking.

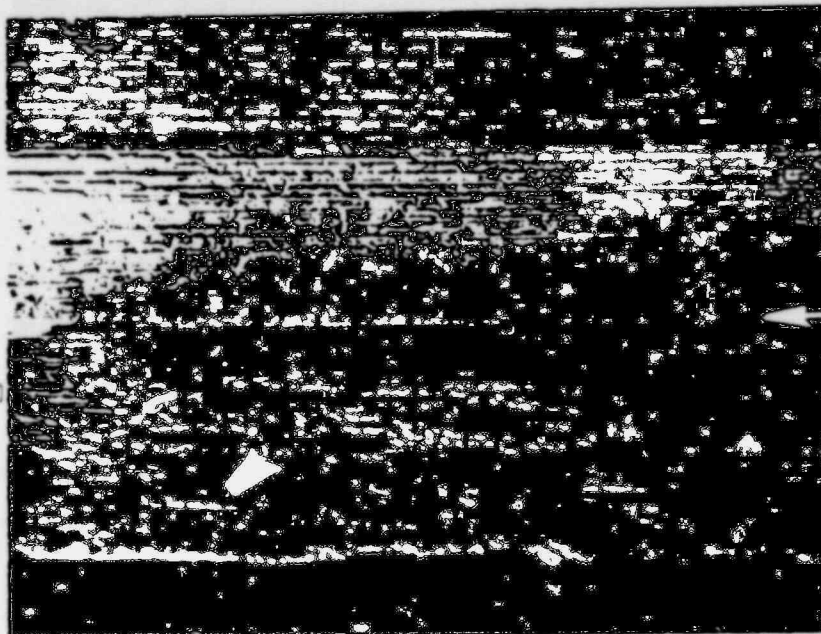
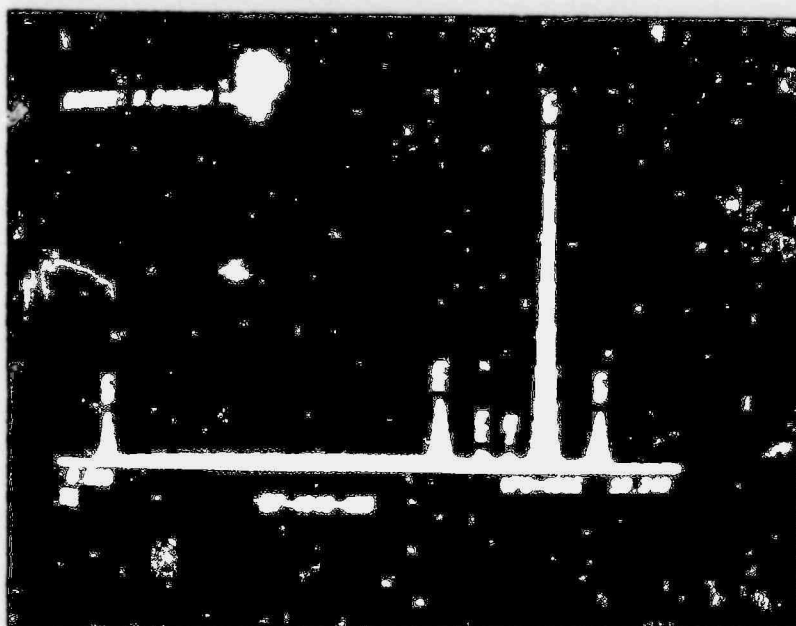
FIGURE 4. COUNTER-BORE TRANSITION (ARROWED) OF 16-IN. REDUCER END AT WHICH A COPPER DEPOSIT (b) WAS OBSERVED AFTER SOME CLEANING.

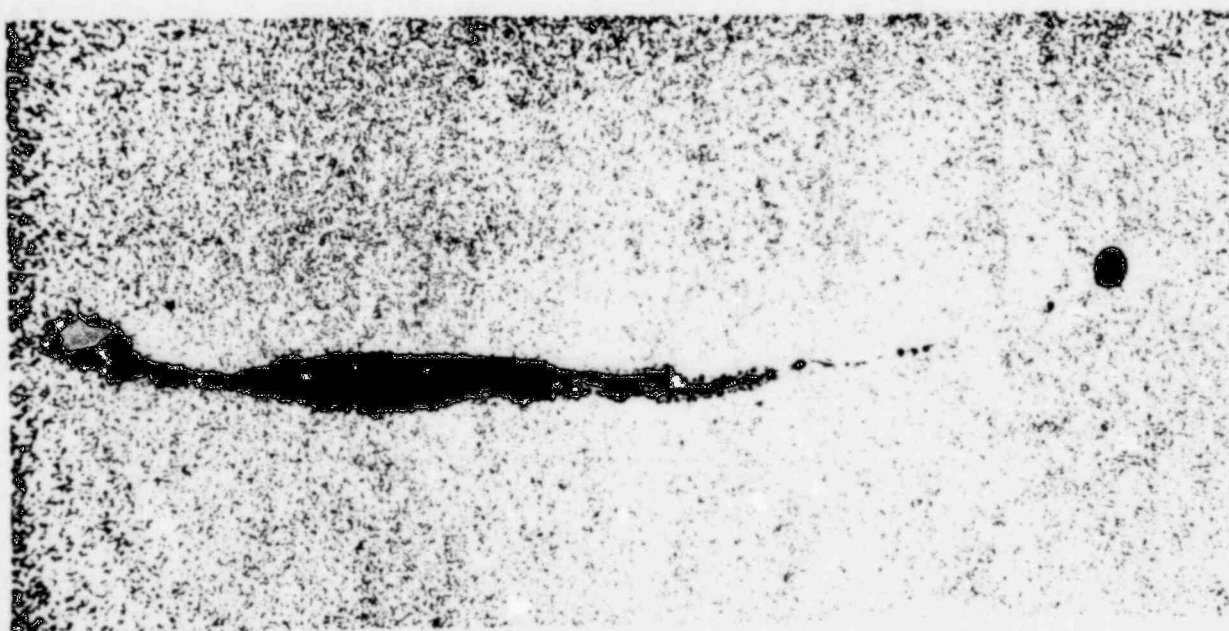
The structure of the reducer and welds was normal for mild steel piping, Figure 5. No metallurgical abnormalities such as islands of martensite, heavy banding or gross inclusions were observed. Sections at stations #11, #14, and #41 (80°, 100° and 295°) of the 16-in. end revealed a lack of fusion defect between the first and second passes, Figure 6.

In some sections this defect also contained oxide inclusions. This indicates that insufficient shielding of the first pass and insufficient heat input during the second pass were employed during deposit of the original reducer-to-pipe weld. Despite the size of these defects, there was no evidence that flaw growth had occurred.

FIGURE 6. WELD DEFECTS IN THE 17-IN. REDUCER TO PIPE WELD. The arrows in (a) indicate the extent of the lack of fusion defect. In some sections oxide or slag inclusions could be seen, (b).

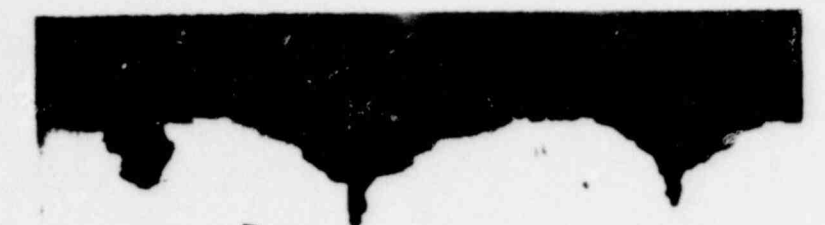
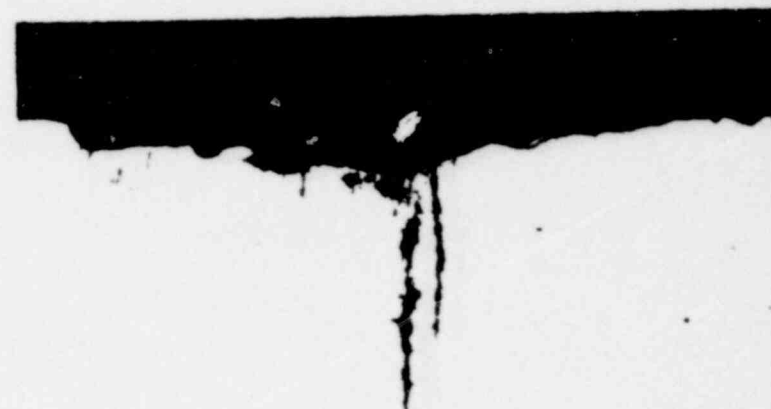
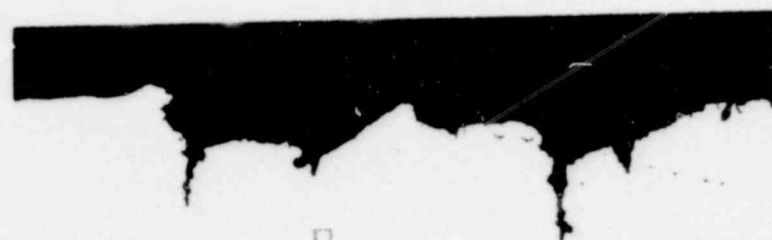
FIGURE 7. LONGITUDINAL SECTION OF 18" REDUCER AT, (a), AND, (b), STATION #19, (c), STATION #28.

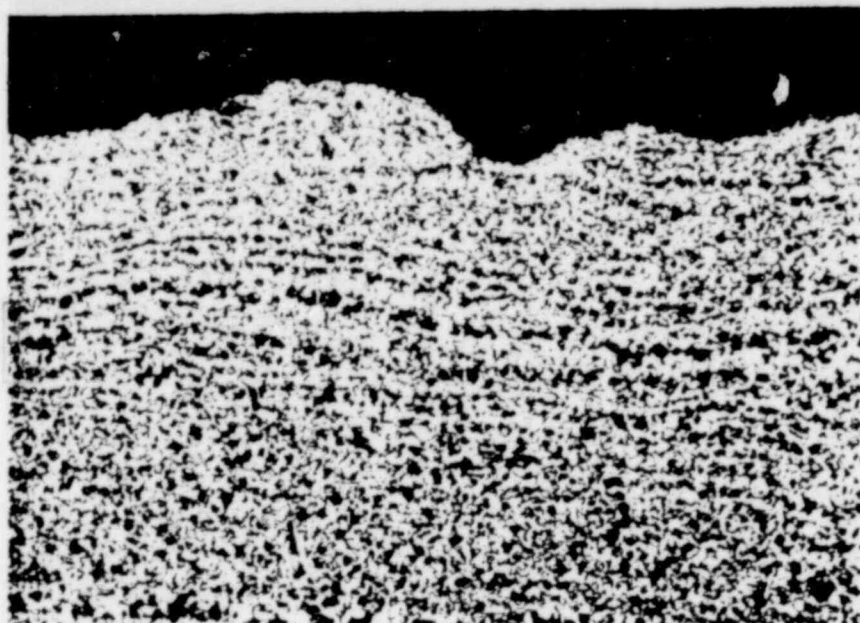
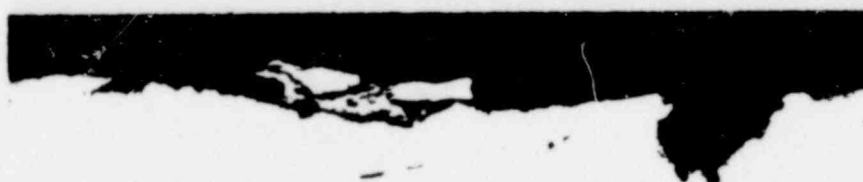
FIGURE 9. TRANSVERSE SECTION OF REDUCER I.D. AT STATION #17. Typical structure and surface finish, (a), and most severe attack observed, (b).

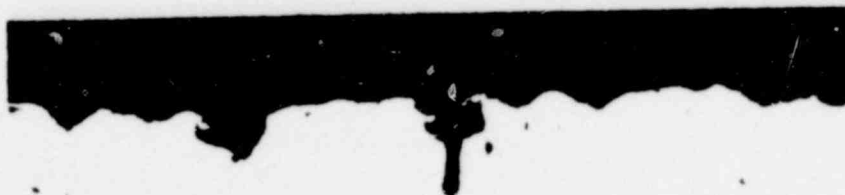
To characterize the small axial cracks on the root-pass weld bead, transverse serial sectioning was performed. Typical defects and the deepest defect found are shown in Figures 11(a) and 11(b), respectively. No cracks similar to those observed in the fusion line or counter-bore could be seen. It is worth noting that this section was electrolytically cleaned to remove the oxide prior to mounting. The same technique was also employed on sections from the 16-in. end of the reducer. As can be seen in Figure 12, this procedure did not remove the oxide from within tight cracks. Fractographic examination of specimens, which had been cleaved open and electrolytically cleaned, showed that no dissolution of the base metal had occurred. It can, therefore, be assumed that the defects observed in the weld bead were different from those in the base metal. It is most likely that the crack-like defects were formed during the welding and were subsequently corroded.

FIGURE 11. TRANSVERSE SECTIONS THROUGH THE WELD BEAD AT STATION #43, SHOWN IN FIGURE 2(b). No deep cracks, similar to those observed in the base metal, could be found.

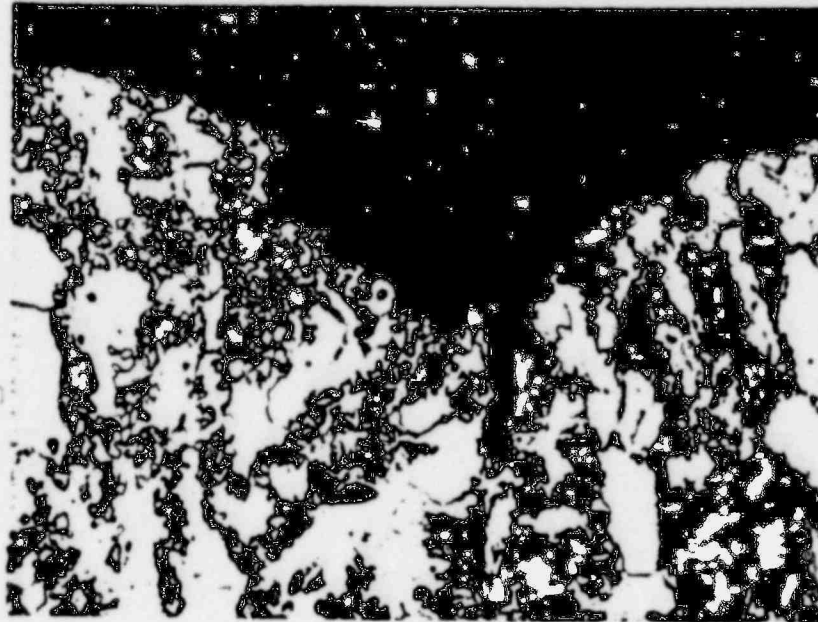
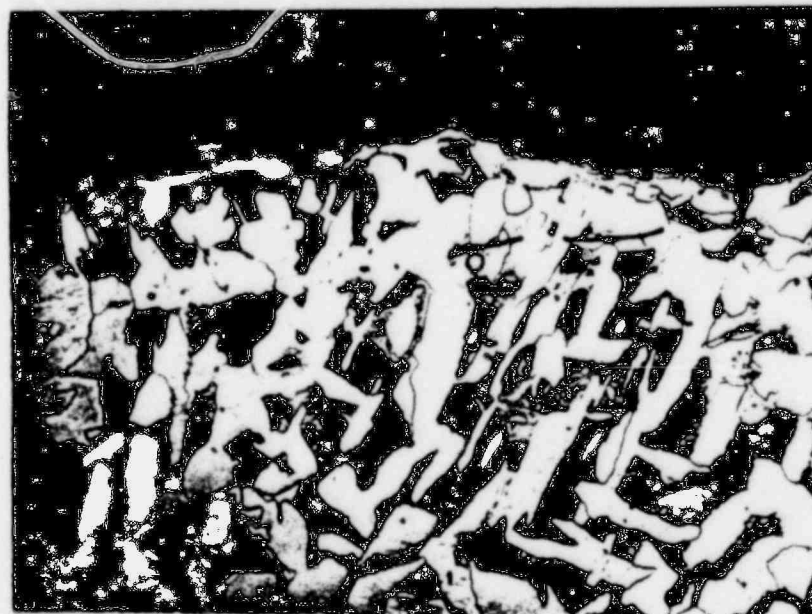
Two sections were taken from stations #14 and #41 of the 16-in. end where a careful magnetic particle test had indicated cracks at the weld fusion line on the reducer side of the weld. Cracks could be seen at both sides of the fusion line. These cracks were tight, oxide filled and branched, Figure 10(b). No cracks or oxide spikes were present in the counter-bore region. Sections were therefore taken at areas where visual examination showed cracks. Included for examination were the weld bead, transition zone and the step 2-7/32 in. from the weld. Micrographs showing typical cracks observed are shown in Figure 12.

FIGURE 12. CRACKS DETECTED AT THE COUNTERBORE REGION
AT THE 16-IN. REDUCER END.

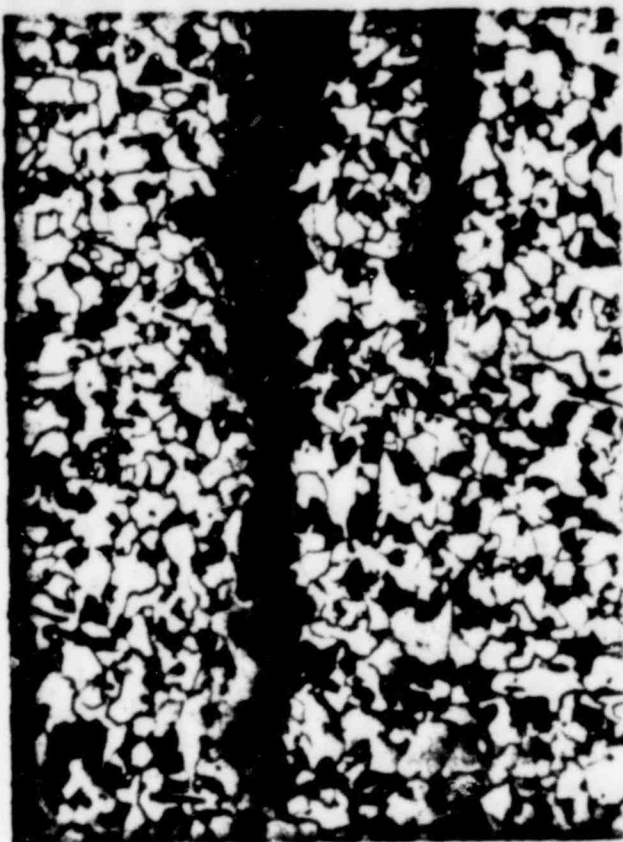
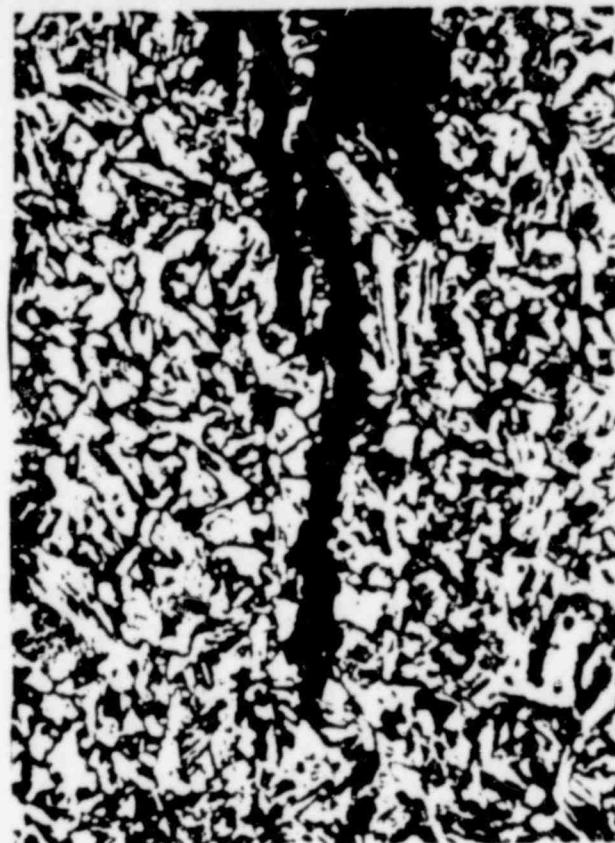
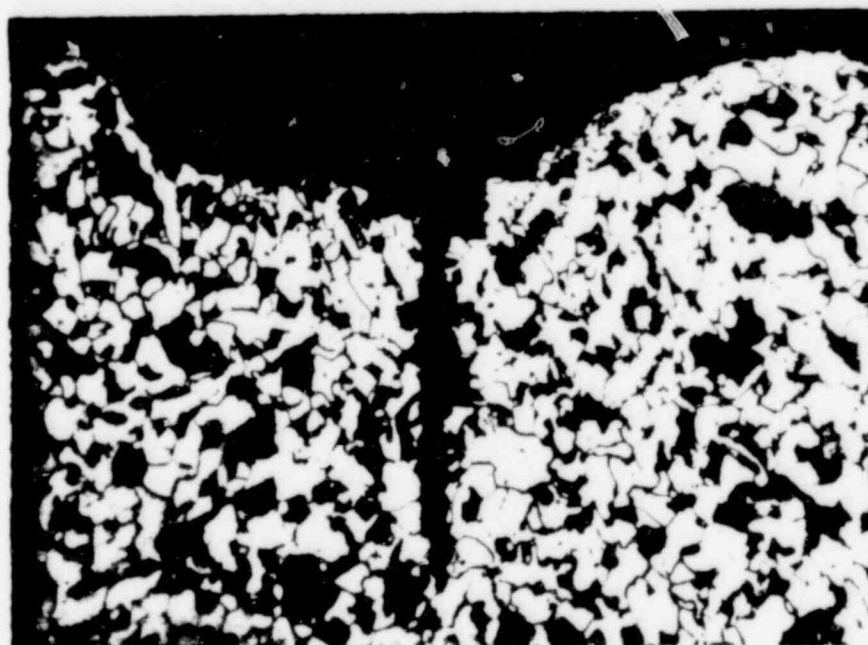
Detailed examination of crack tips showed that they are invariably blunt and oxide filled, Figures 7 through 13. On many cracks, oxide spikes propagated perpendicular to the crack for a considerable distance into the base metal, Figures 8 and 13. This behavior was not micro-structurally dependent, and must thus be attributed to changes in plant operating conditions which caused crack arrest for a prolonged period of time. In general, the oxide within the cracks was dense for a considerable distance from the crack-tip, Figure 13. In some cases, however, open fissures did extend in the oxide from the surface to the crack-tip, Figures 8 and 10. The Pillings-Bodsworth^{*} ratio for the oxidation of iron is always greater than 1, so that the oxide would tend to fill cracks even under the influence of a moderate mean stress. The cracks in which the oxide was fissured were deeper than others in the section. The possibility that stresses applied during reducer removal may have opened these cracks cannot be ignored. It is thus difficult to draw any conclusions based on this observation.

FIGURE 13. DETAILED VIEW OF TYPICAL CRACK TIPS, ETCHANT: NITAL. Sections taken at stations #19 [see Figure 5(b)], (a), and #34 of 18" reducer end and station #14, (b), of 16" reducer to pipe weld [see Figure 7(b)].

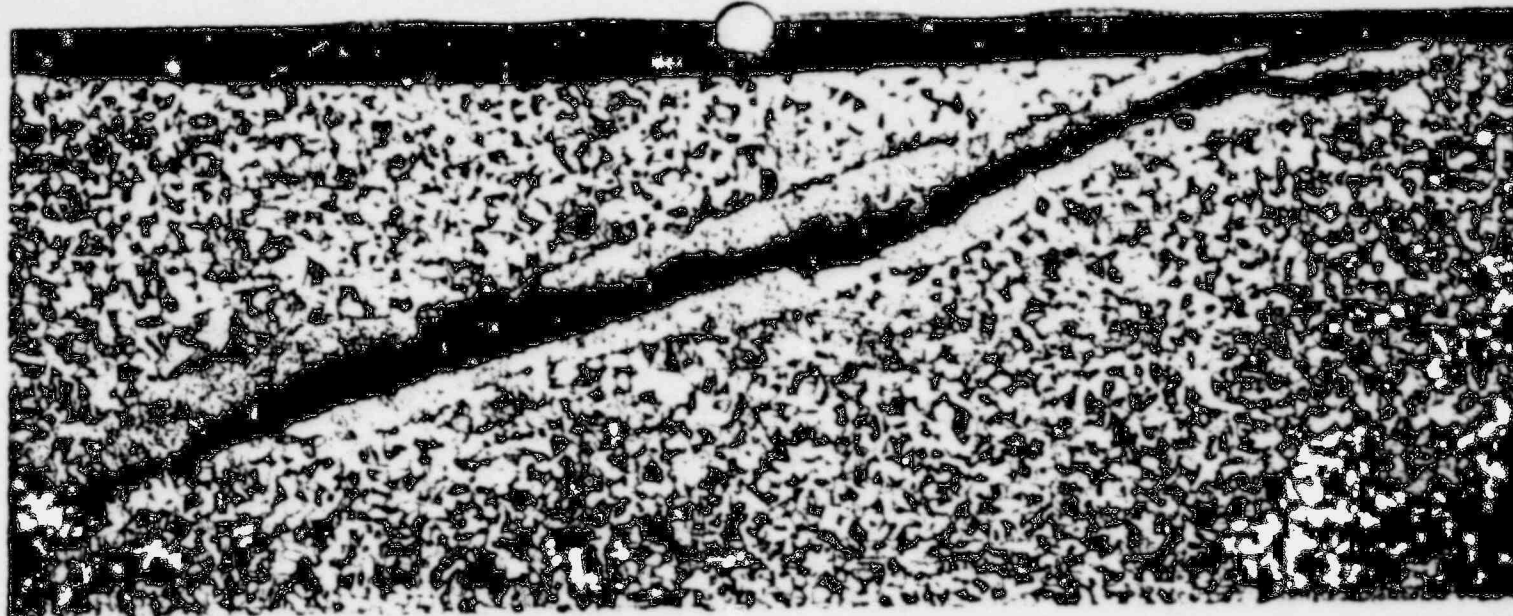
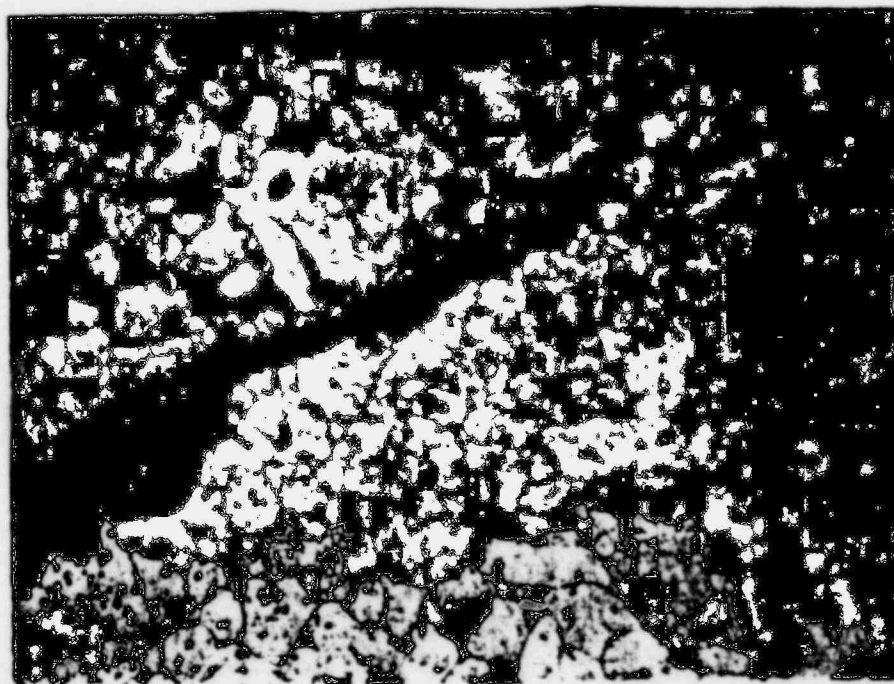
A transverse section through the sample received on July 18 is shown in Figure 14. The defect lies at a large angle to the pipe surface, as predicted from the UT examination performed by SwRI. The fissure was oxide filled and surrounded by a decarburized layer. Note that the pipe O.D. was not decarburized. No distinct interface existed between the decarburized and normal zone, Figure 14(b). Upon opening, the oxide was found to be powdery and nonadherent. These characteristics are typical of a rolled-in or forged-in lap. It is, therefore, concluded that this defect was present prior to welding and resulted from the pipe fabrication process.

FIGURE 14. TRANSVERSE SECTION THROUGH CRACK AT O.D. Note the decarburized zone surrounding the oxide filled crack, (a), and the absence of a distinct interface, (b), between this zone and the base metal.

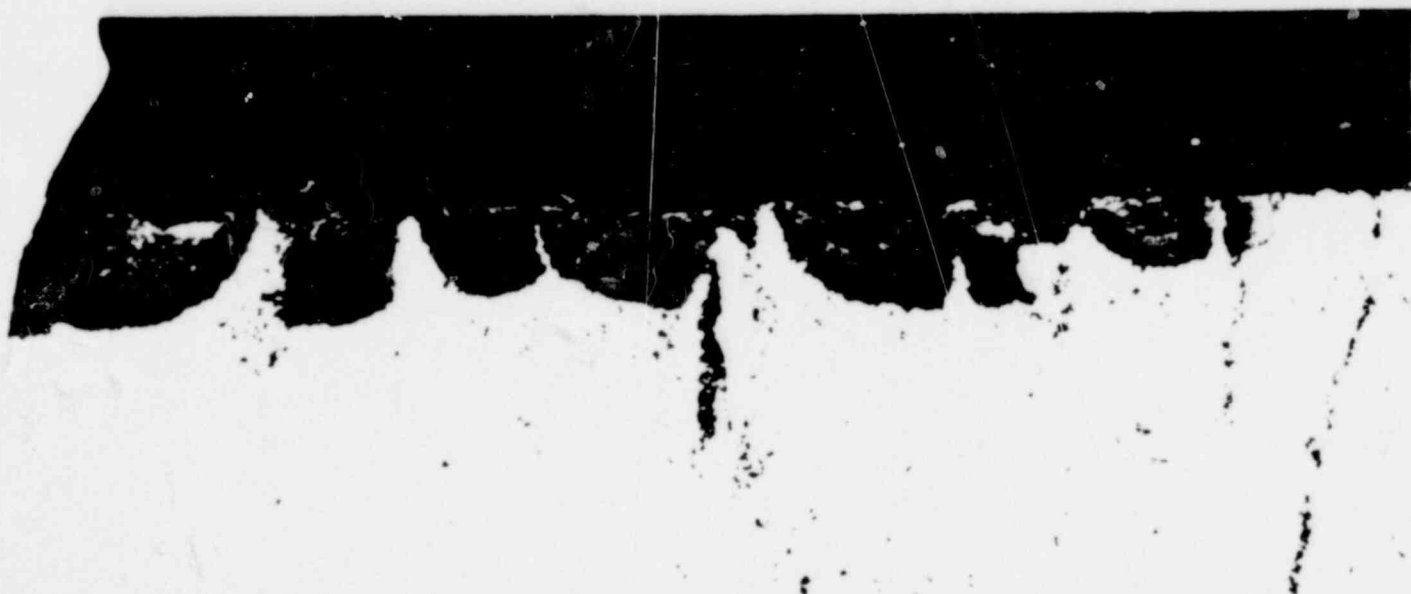
Specimens were taken adjacent to stations #15 and #43 of the 18-in. end for fractographic examination. Specimens were notched behind the counter-bore transition and broken open, Figure 15. Beach markings could be seen in several locations, Figure 15(c), indicative of periodic crack arrest. All cracks were heavily oxidized. Even at the transition to laboratory cleavage fracture no detail could be seen, Figure 16(b). In some areas, the fracture surface appeared to be intergranular, Figure 16(a), but electrolytic cleaning removed all such features. The cleaning procedure did not alter the appearance of the cleavage fracture. The intergranular facets are therefore attributed to the oxide morphology. After cleaning, the surface of in-service cracks was pitted in appearance, Figure 16(c), but did not show signs of fatigue striations.

FIGURE 15. SAMPLES FROM STATION #15, (a) AND #43, (b) and (c), READY FOR FRACTOGRAPHIC EXAMINATION.

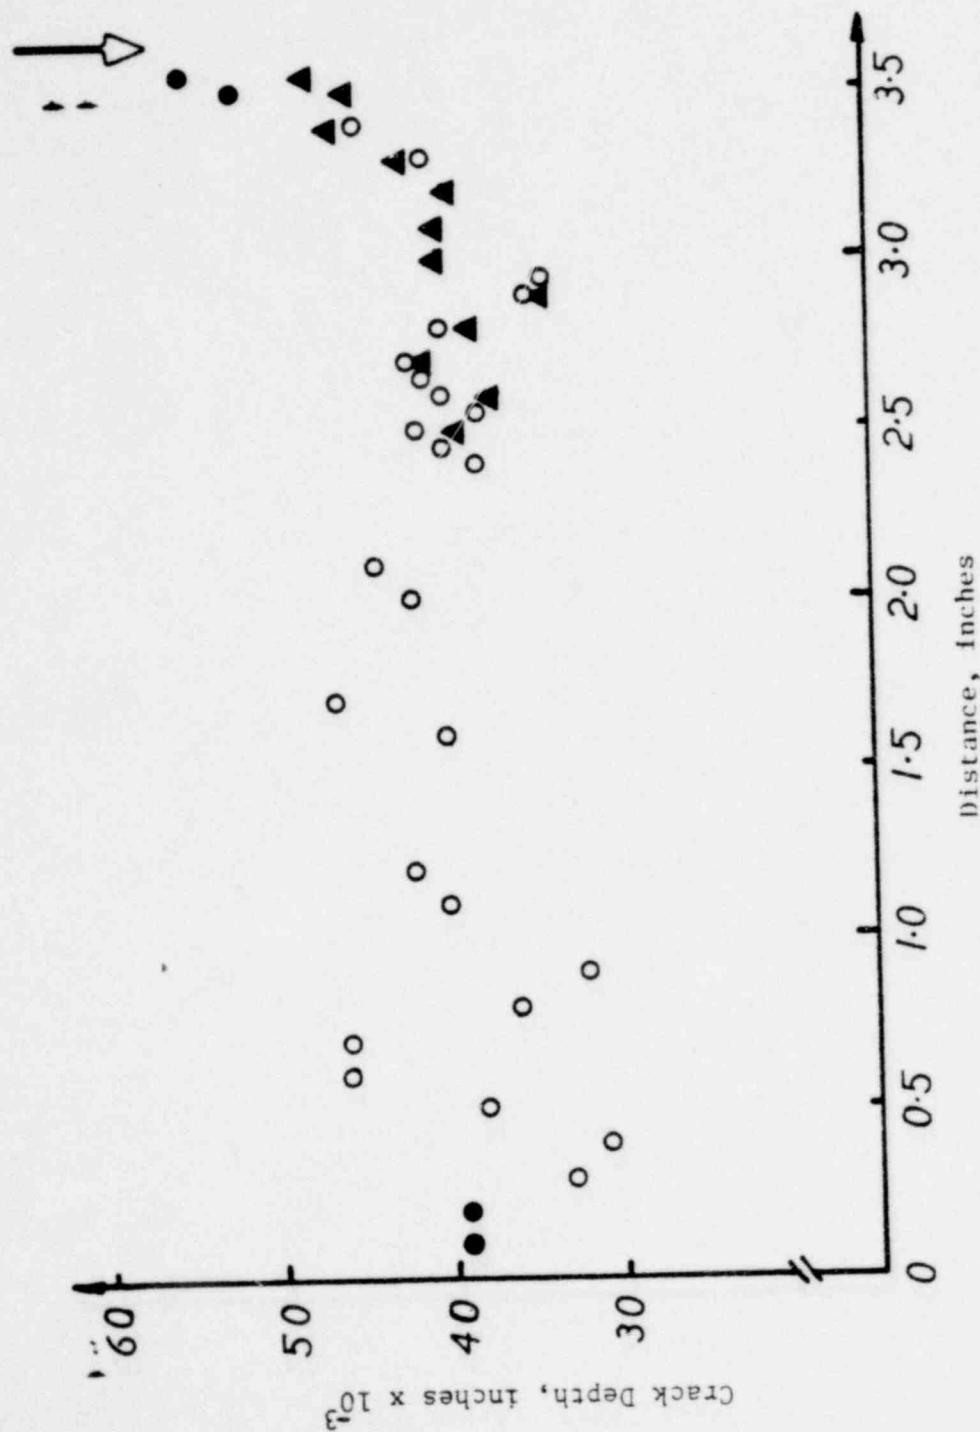
A large segment of the 18-in. reducer was subjected to crack sizing using the Satellite Pulse Technique developed at SwRI. The segment from station #11.5 to #15 was examined in detail and the crack depths plotted. Subsequently the segment from #14 - #15 was broken open and the crack depths plotted. The comparison of these data is given in Figure 18. From this data, it is apparent that the crack depth is less than 0.050 in. along the segment giving rise to the RT indications. It, therefore, seems unlikely that cracks significantly deeper than 0.050 in. exist elsewhere.

FIGURE 18. COMPARISON OF CRACK DEPTH MEASUREMENTS USING THE (NONDESTRUCTIVE) SATELLITE-PULSE TECHNIQUE, ○, AND (DESTRUCTIVE) DIRECT MEASUREMENT ▲. The solid circles are believed to have been influenced by edge effects. The edges of the sample were zero and 3.6 inches (marked by arrow).
