October 24, 1979

In the Matter of the Application of            )           Docket Nos. STN 50-553  
Tennessee Valley Authority                    )           STN 50-554

PHIPPS BEND NUCLEAR PLANT  
REVERSE AND TRANSVERSE FAULTS  
IN THE UNIT 1 ESW PUMPING STATION

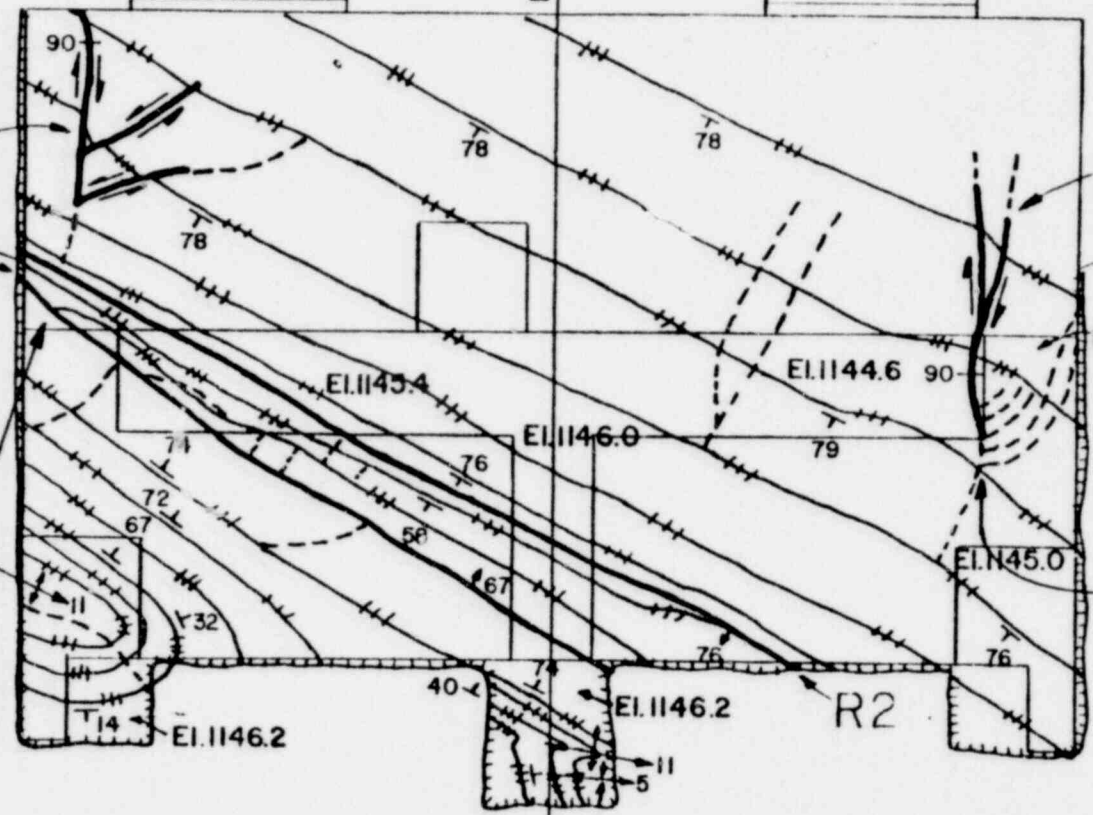
FAULT ZONE 15

Geologic mapping of foundation bedrock in the Unit 1 ESW pumping station has revealed two reverse faults in the southeast quadrant of the building, and two transverse faults located west of the reverse faults. They are grouped as fault zone 15 and designated R1, R2, T1, and T2 (see attached photos and drawing for locations).

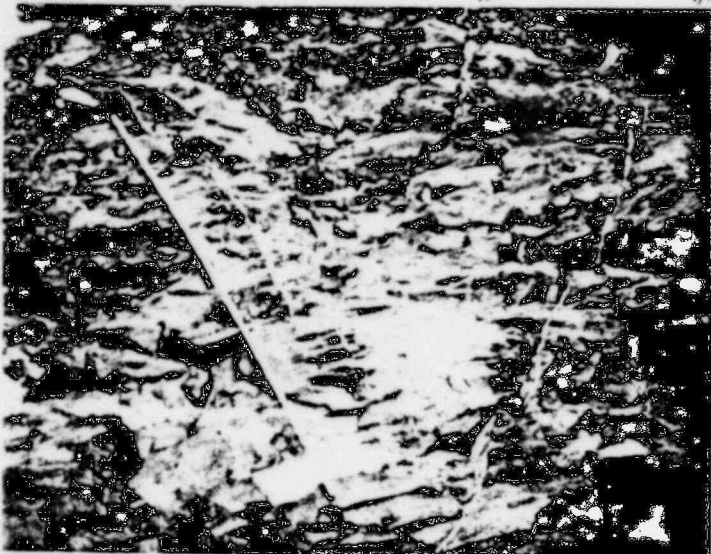
Transverse faults T1 and T2 are located west and northwest, respectively, of R1 and R2. T1 consists of three nearly vertical branches, one striking N.  $52^{\circ}$  W., and the other two striking N.  $10^{\circ}$  E. The fault traces are defined by calcite-healed fractures that offset bedding from 3 to 7 inches. T2 is 70 feet north of T1 and exhibits essentially the same characteristics.

PHOTO #1 - Fault zone #15 - T1  
View Northwest

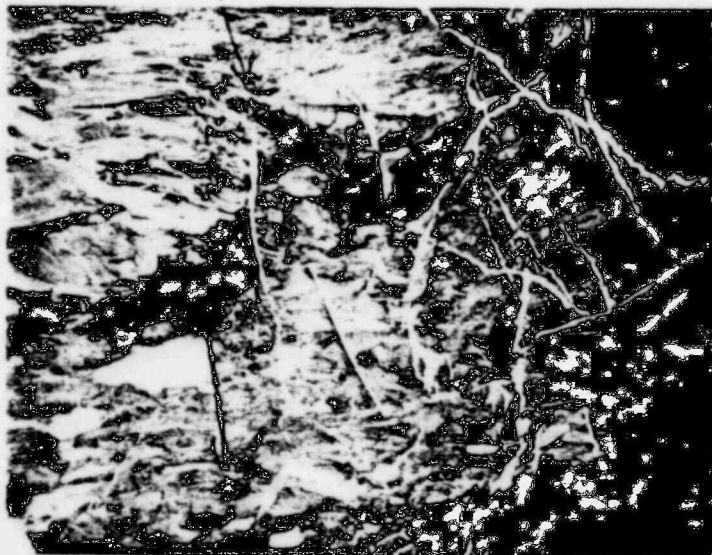
PHOTO #2 - Fault zone #15 - T2  
View Northwest

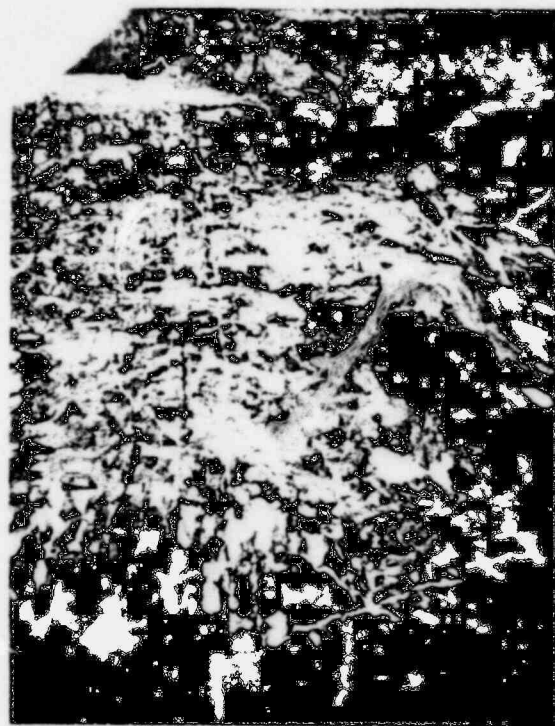
Faults R1 and R2 are reverse faults parallel to the axis of an anticline to the southeast. R1 dips  $67^{\circ}$  NW. and strikes N.  $50^{\circ}$  E. R2 dips  $76^{\circ}$  SE. and strikes N.  $50^{\circ}$  E. Both fault traces are defined by calcite-healed fractures that extend across the floor of the excavation from the south wall to the east wall of the building.

All four faults described were formed during the Paleozoic Era and are characteristic of tectonic forces that developed during the formation of the Saltville fault family. These faults, having been stable for 250 my, are not considered to be capable of producing ground offsets or generating earthquakes. Therefore, we do not classify them as capable faults, within the meaning of Appendix A to 10 CFR Part 100.

PHOTO #3 - Fault zone #15 - R1 & R2  
View Northeast
