BEDROCK DEFORMATION IN THE COOLING WATER TUNNELS

**Perry Nuclear Power Plant
Units 1 & 2**

GAI REPORT NO. 2063
Prepared for Cleveland Electric Illuminating Co.

BEDROCK DEFORMATION IN THE
COOLING WATER TUNNELS
PERRY NUCLEAR POWER PLANT
NORTH PERRY, OHIO

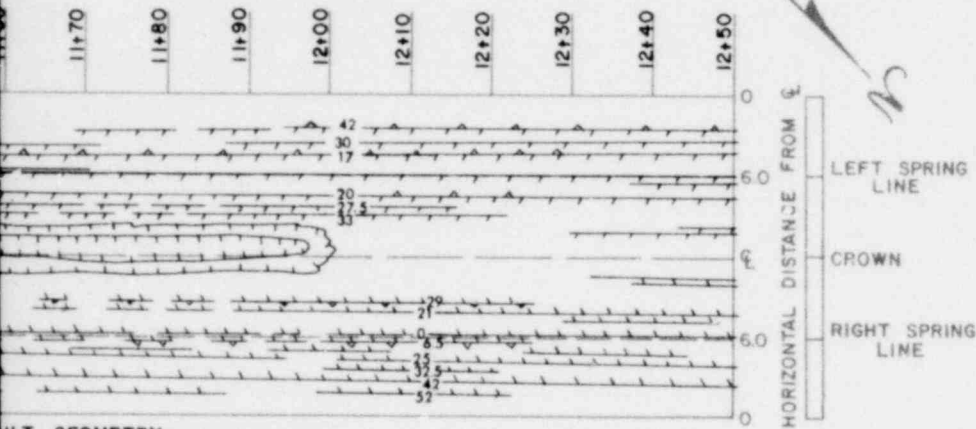
ULT GEOMETRY

displacement - 22"
vertical displacement - 12"
N 47° E
prox. 17°
broken rock (1/2" - 18")

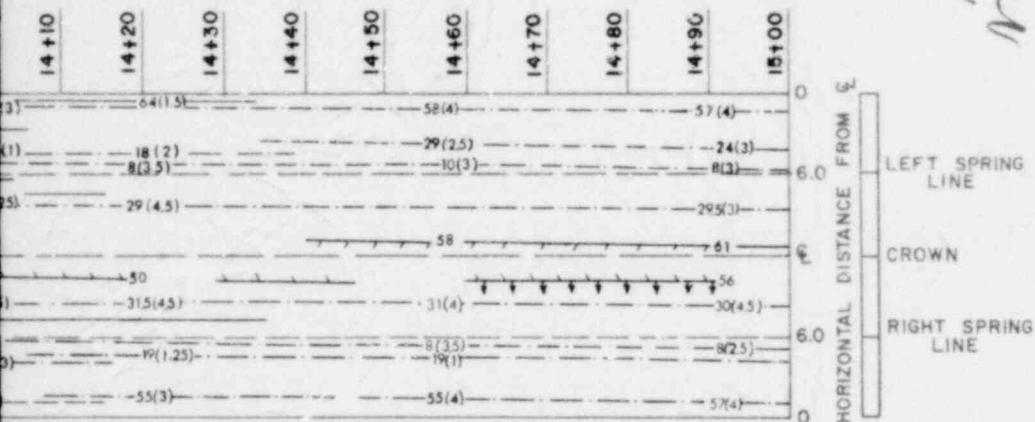
FAULT GEOMETRY
 parent displacement-12" to 25" d.) Dip approx. 16.5°
 dual vertical displacement-8-1/2" to 11-1/2" e.) Width of broken rock (1/2" to 24")
 like - N66°E

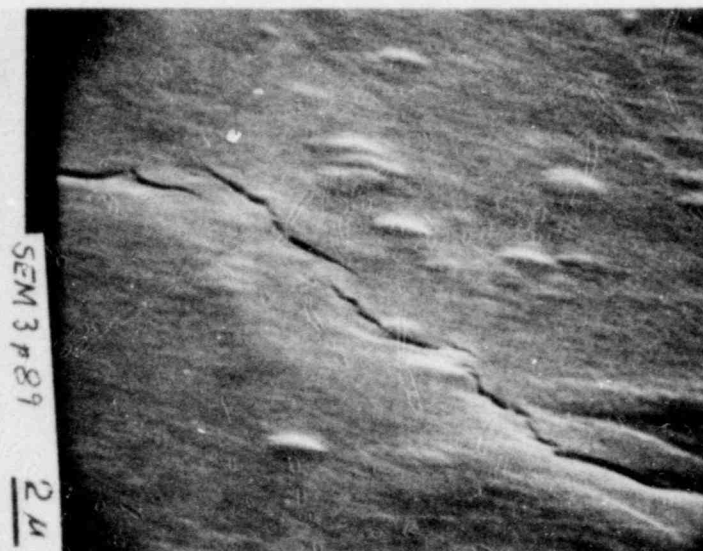
Figure 10 Desiccation cracks observed in a sample of chlorite. These cracks were observed in the SEM during formation.

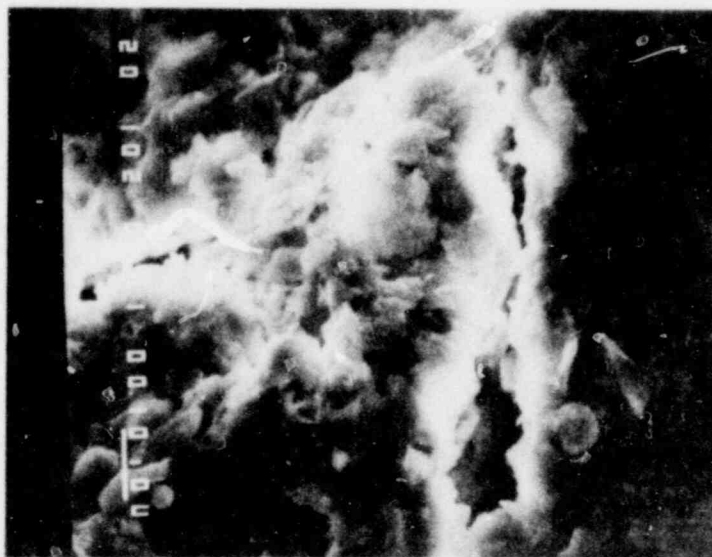
Figure 13 Microcrack in Perry sample. This variant for the microcracks in the Perry samples is relatively short and contains new mineral growths that span completely the microfracture. Note that many crystals can be seen projecting into the crack from the walls (13b).

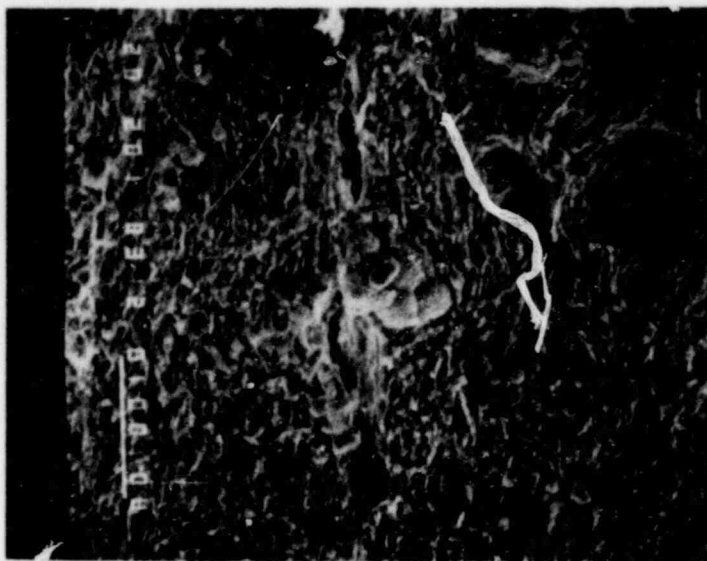
Figure 15 Slickensides in the Perry samples. The slickenslides appear to have been formed by pyrite grains that are stronger than the shale. In 15b, and 15c individual grains of pyrite can be readily observed.

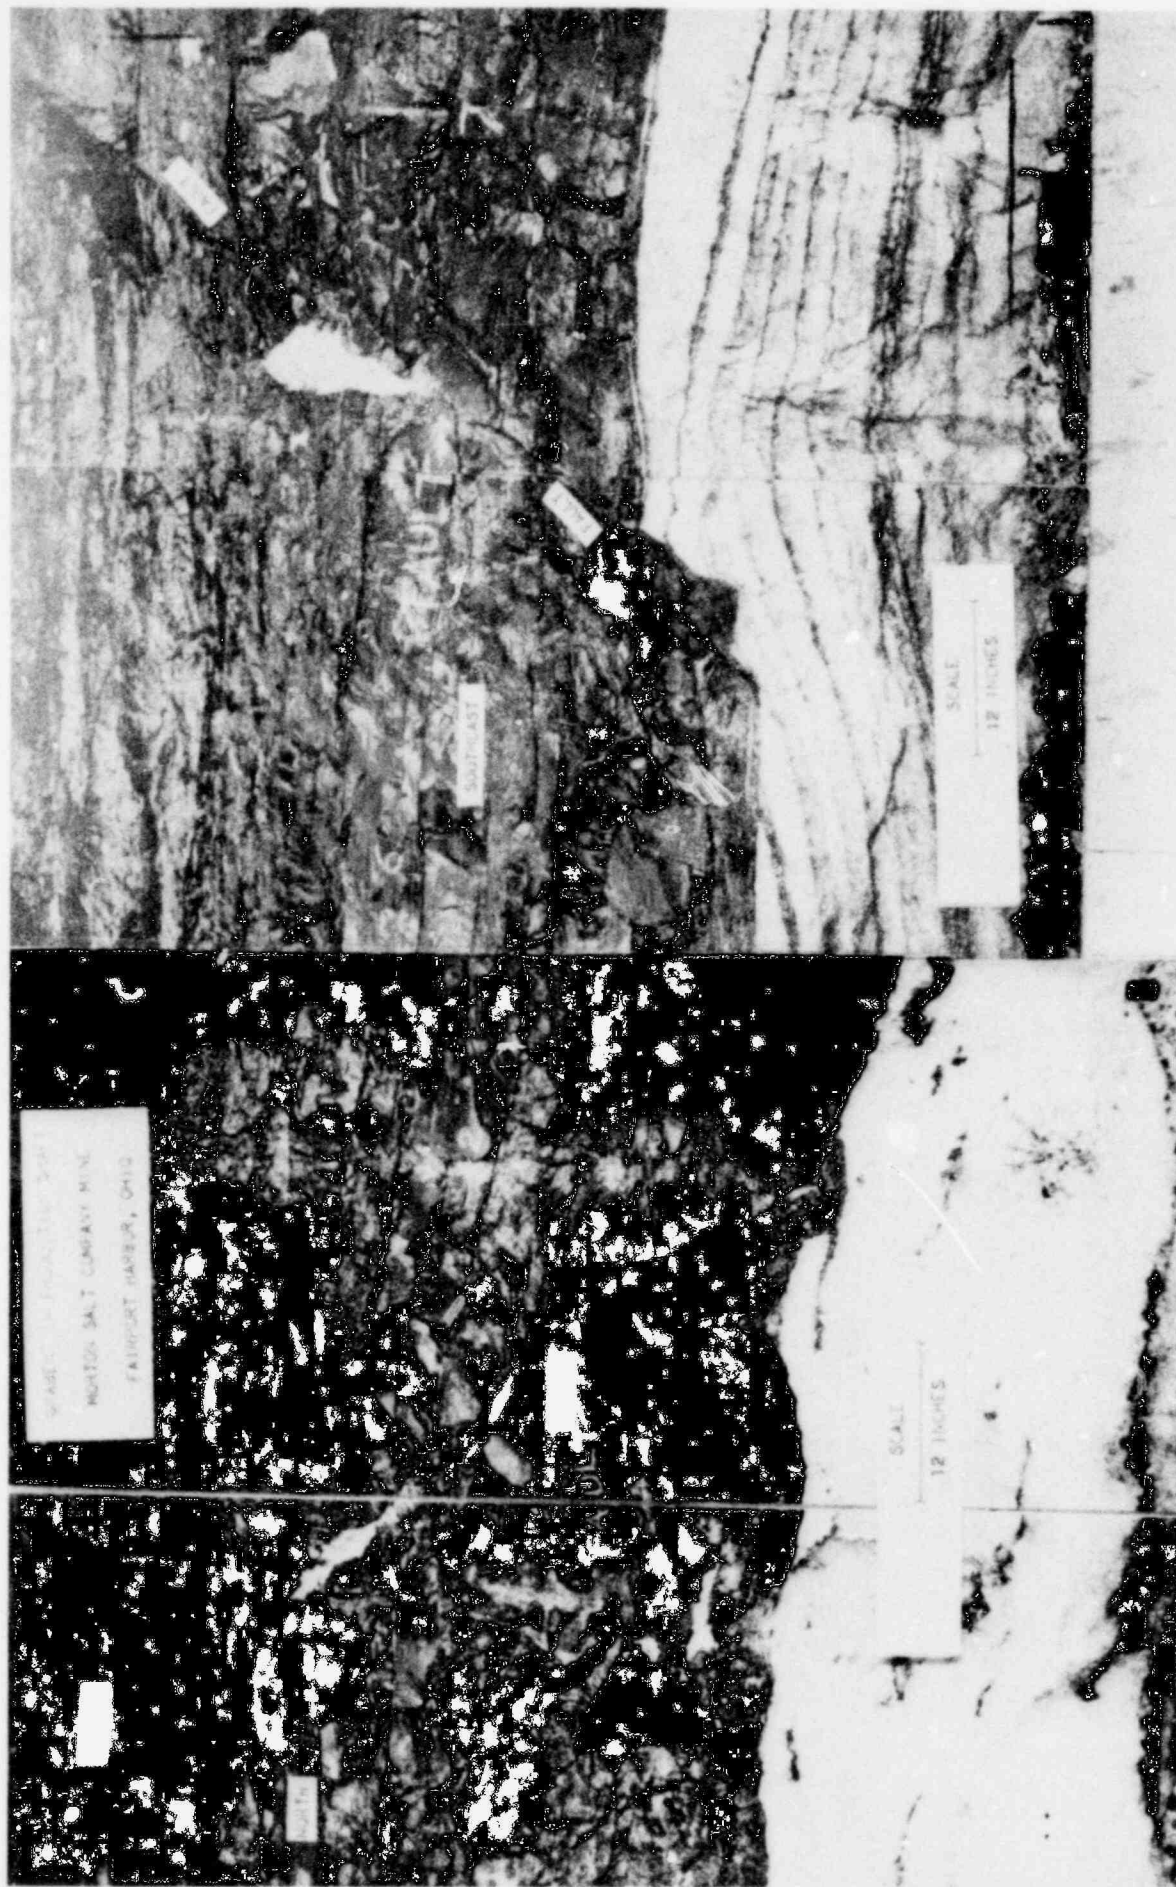
FIGURE 12
 "GRABEN" IN PRODUCTION SHAFT
 MORTON SALT COMPANY MINE
 FAIRPORT HARBOR, OHIO
