FINAL REPORT
SERVICE WATER INTAKE STRUCTURE
SETTLEMENT EFFECTS AND RELATED WORK

VIRGIL C. SUMMER NUCLEAR STATION

OCTOBER 1979

PREPARED FOR:
SOUTH CAROLINA ELECTRIC & GAS CO.
COLUMBIA, SOUTH CAROLINA

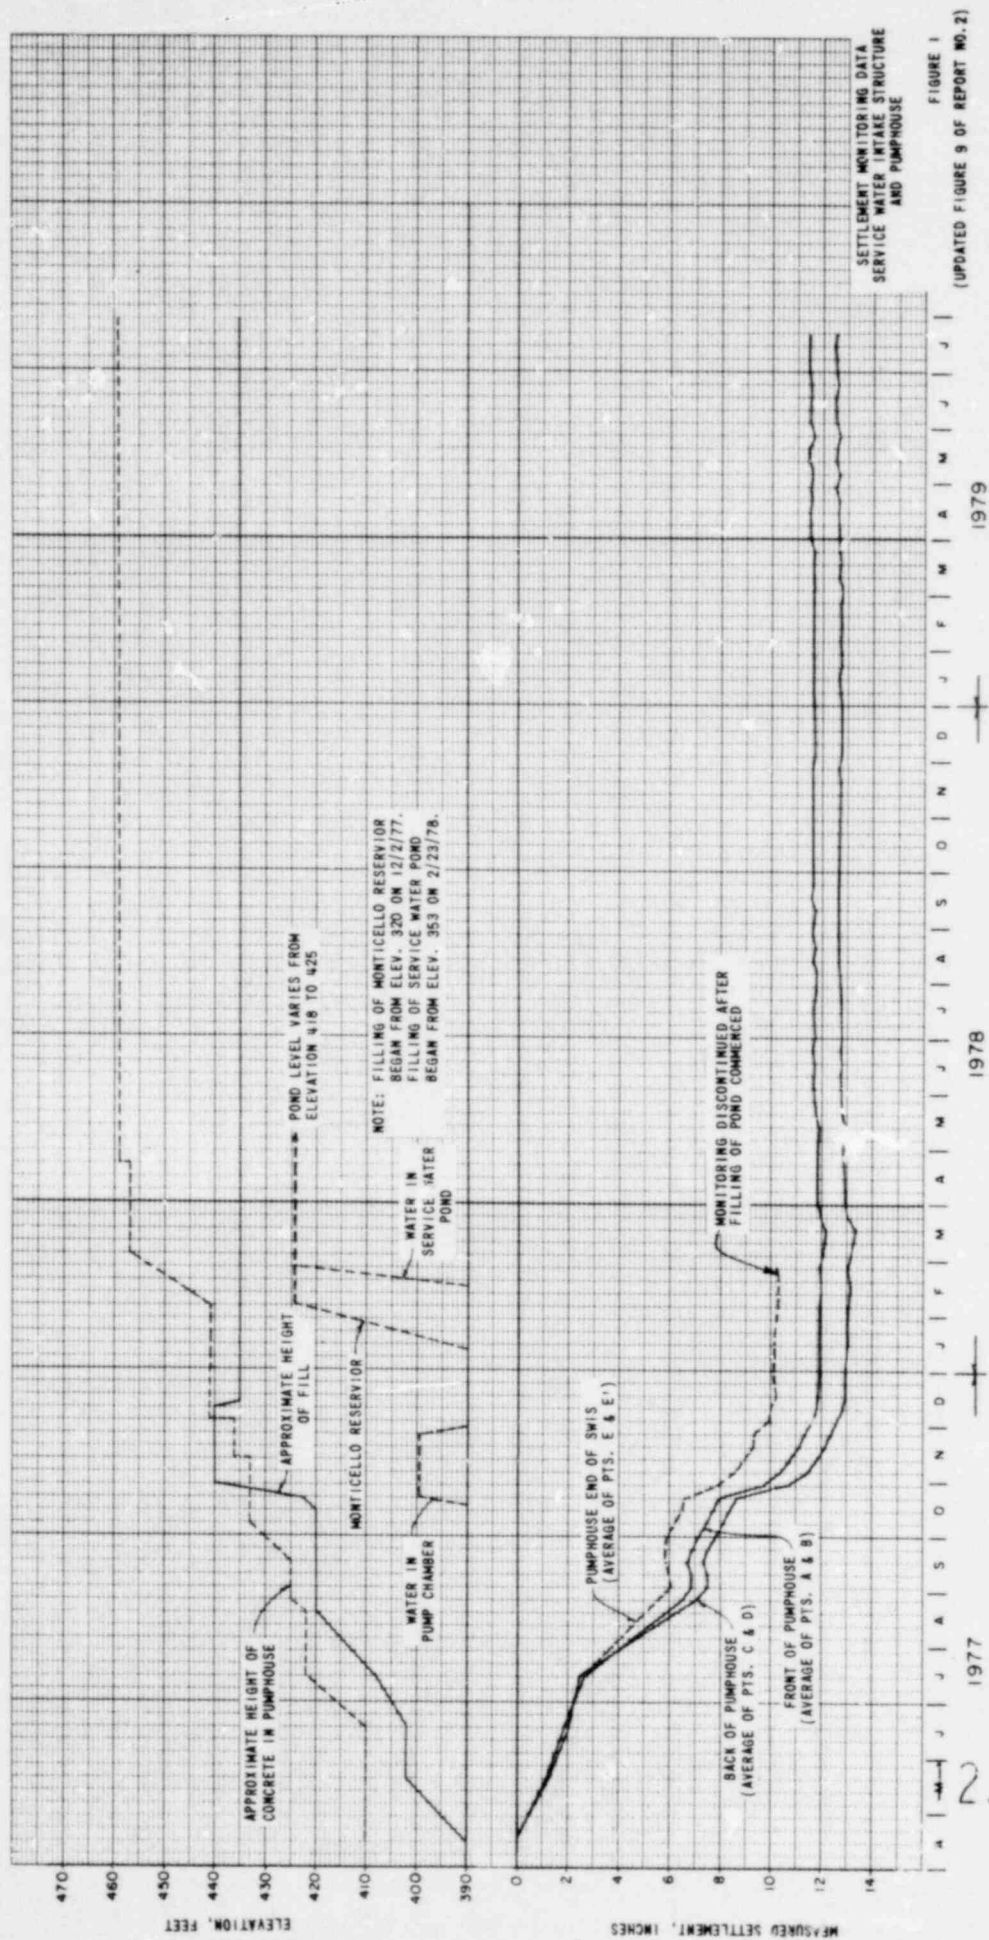
As shown in Figure 1, the Pumphouse settled an average of 12.5 inches and the Pumphouse end of the Intake Structure settled about 10 inches before the grouting of the cracks in the Intake Structure and the subsequent filling of the Service Water Pond. The settlement resulted due to the weight of 80 feet of West Embankment fill placed on the underlying saprolitic soils.

As described in Report No. 2, the Service Water Pumphouse experienced an average of 0.19 inch of settlement during the filling of the Service Water Pond in February and March 1978. After the filling was completed, the Pumphouse began to rebound, experiencing an average upward movement of 0.68 inch through July 18, 1979, resulting in a net upward movement of 0.49 inch. The Pumphouse monitoring data is provided in Table 1, (Updated Table 3 of Report No. 2) and is shown in Figure 1 (Updated Figure 9 of Report No. 2) and Figure 2.

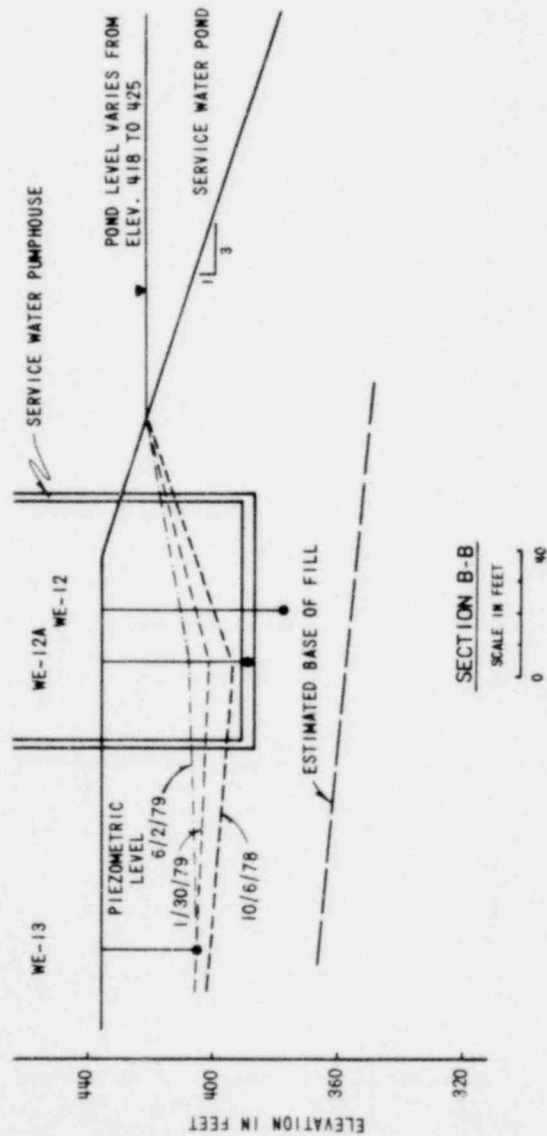
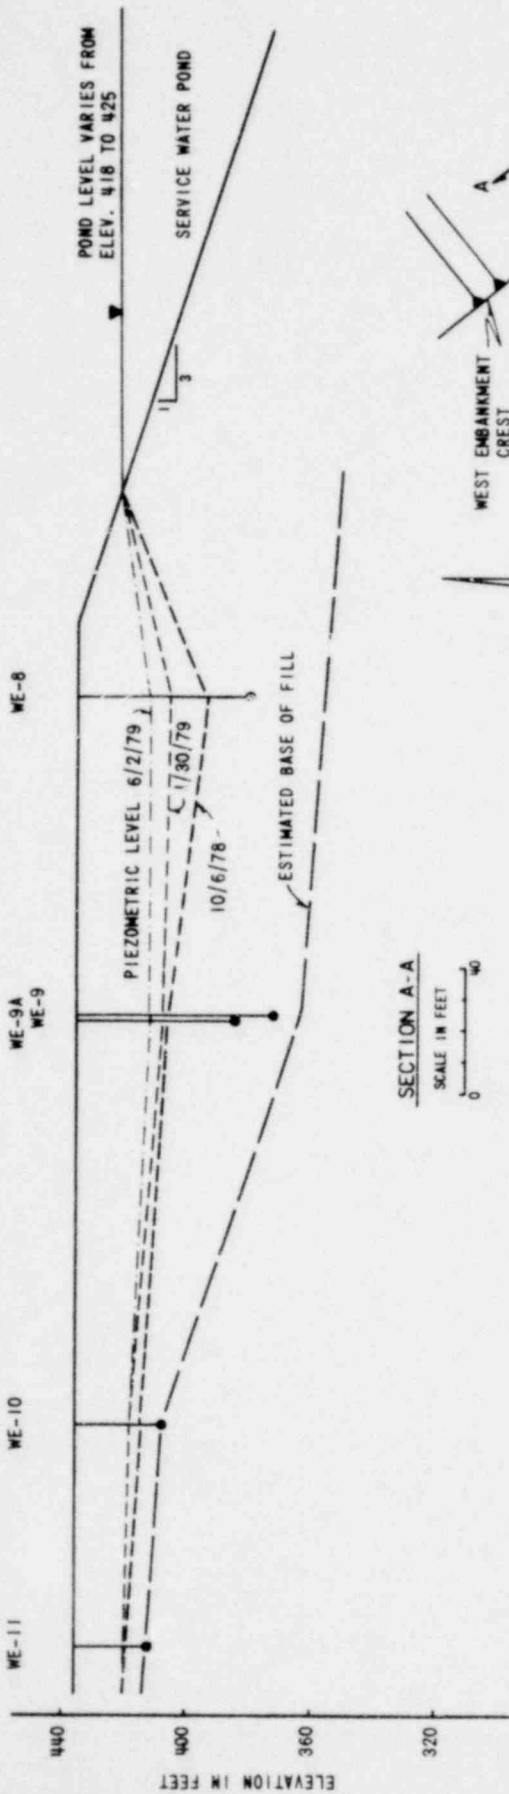
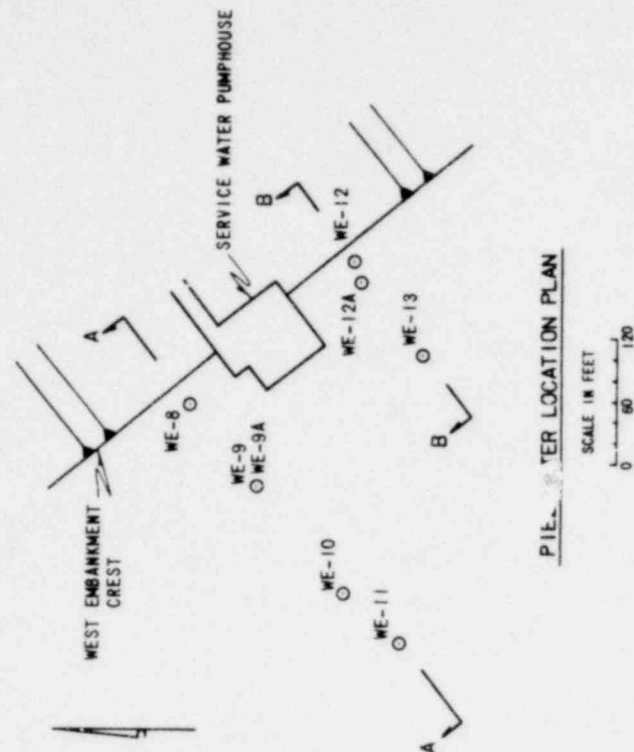
FIGURE 4

Eight well-point piezometers were installed in the West Embankment in August 1978, to monitor groundwater levels. The piezometers are located as shown on Figure 4. The piezometer readings are tabulated in Table 3 and are shown on Figures 4 and 5. The data indicate a gradual rise in groundwater level towards the level of the Service Water Pond and Monticello Reservoir. Initially, the data showed the groundwater level increasing in elevation with greater distance from the Service Water Pond, indicating that the fill is probably being saturated by a gradual rising of the groundwater from within the natural ground beneath the West Embankment fill in response to the filling of Monticello Reservoir and the Service Water Pond. This is also indicated at the two locations where piezometers are installed at two levels. In both of these cases, the lower level piezometer shows a higher piezometric level, indicating an upward gradient in

the groundwater flow. The more recent data also shows high groundwater levels near the Pond, indicating that saturation of the West Embankment directly from the Pond has also progressed to a noticeable degree.

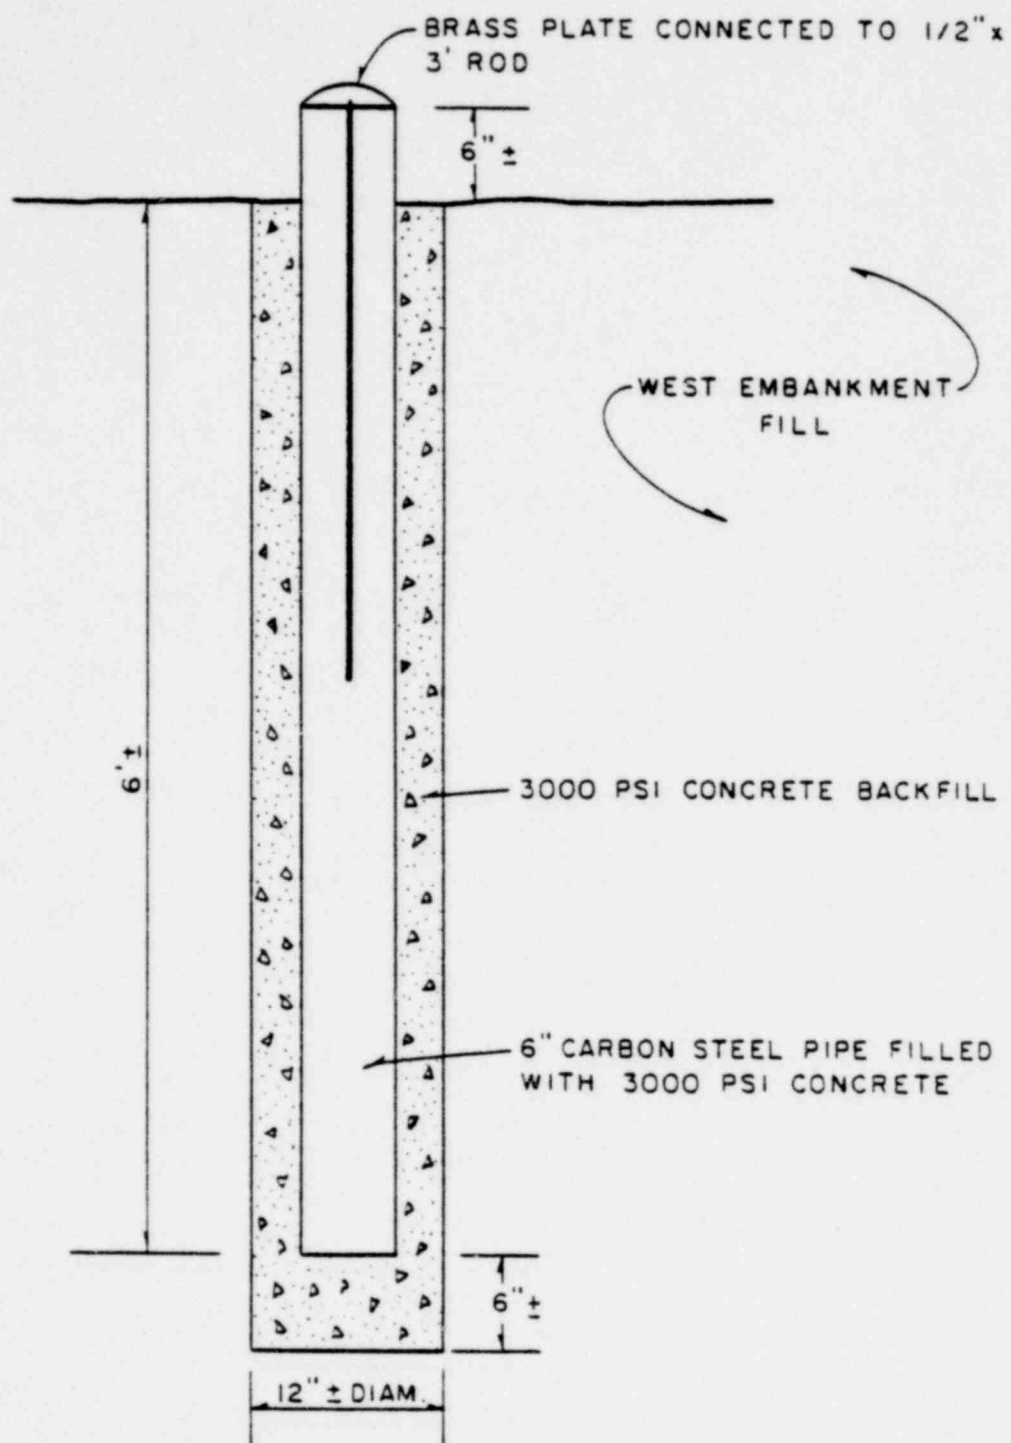
FIGURE 6

Seven crest settlement monuments were installed in the West Embankment in September 1978. Each monument is located adjacent to a piezometer with the same identification number. The piezometer locations are shown on Figure 4. The monuments consist of six-inch diameter concrete-filled steel pipe, embedded approximately six feet below the surface of the West Embankment fill in a 12-inch diameter concrete-filled hole, as shown in Figure 6. A brass plate is attached to the top of each monument with a three-foot long rod embedded in the concrete within the pipe.

Data obtained from the monuments are presented in Table 4. The data indicate that the embankment surface generally experienced up to 0.08 inch of settlement during the first six weeks after installation of the monuments. During this time, the Pumphouse was essentially stationary. It is possible that during this period the monuments were settling slightly due to "seating," or that continuing compression of the upper portion of the fill above the groundwater level was greater than the simultaneous expansion of the soil below the groundwater level because of buoyancy effects. After that time the monuments generally show upward movement, with the net rebound through July 1979, ranging from 0.05 to 0.67 inch. During this time, the Pumphouse experienced about 0.15 inch of rebound.

Monument WE-8 indicated a settlement of 0.43 inch during the first five months of monitoring, followed by 0.25 inch of rebound during the next four months. The initial settlement is atypical and was probably because of poor seating of the monument during installation. It is believed that the monument is now seated and is correctly reflecting the rebound which is occurring.

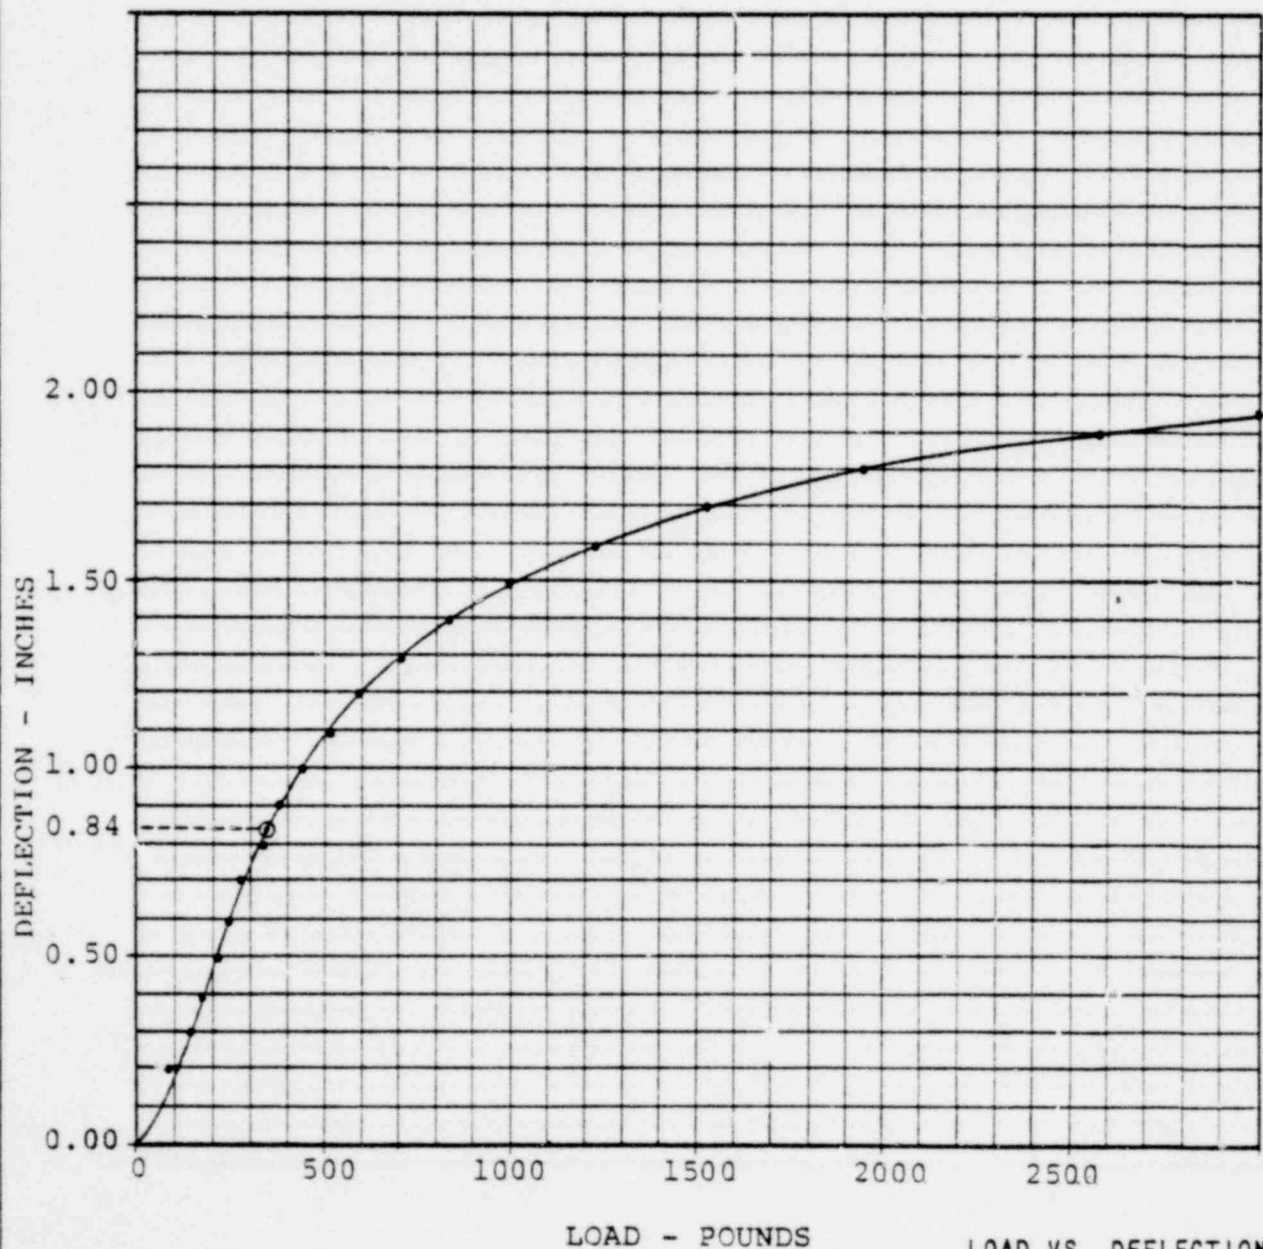
FIGURE 7

Compressibility tests were conducted on the Servicised Closed Cell Plastic foam to determine the flexibility of the joint foam after its compression from duct settlement. Tests were conducted on samples having the same thickness as that placed around the duct bank in the wall openings. These tests showed that the spring modulus of the compressed filler was 0.19×10^5 lb/cu ft, which is much softer than the modulus of subgrade reaction of west embankment soil surrounding the duct banks (lower bound value of 1.5×10^5 lb/cu ft).

It was concluded from these tests that an additional one inch of relative downward movement of the duct banks would be necessary

before substantial stiffening of the foam filler would approach the soil stiffness. Since the filler stiffness is less than the soil stiffness, no concentrated reaction on the duct banks occurs at the Pumphouse wall entry. No further significant relative settlement of the duct banks in the future is anticipated. It is concluded that the original duct banks design assumptions will remain valid and the duct banks will remain well within their ultimate strength capacity when subjected to the design surcharge loads for the embankment.

⊙ 0.841 inches recorded maximum accumulative "squeeze up" as of June 1979

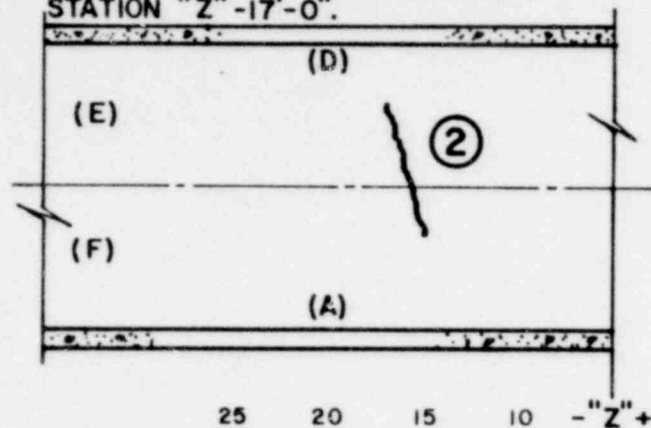
A HAIRLINE CRACK THAT STARTS AT
STATION "Z"-15'-0", 5'-0" UP FROM (A)
AND ENDS 3'-0" DOWN FROM (D) AT
STATION "Z"-17'-0".

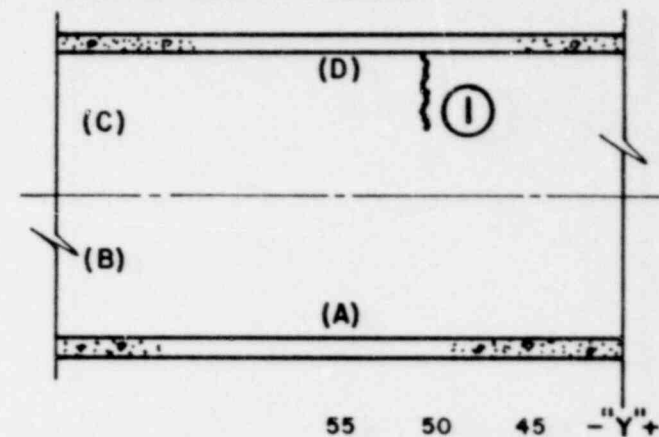
A HAIRLINE CRACK THAT STARTS AT THE
CORNER C-D & RUNS VERTICAL DOWN
4'-0" AT STA. "Y"-50'-0".

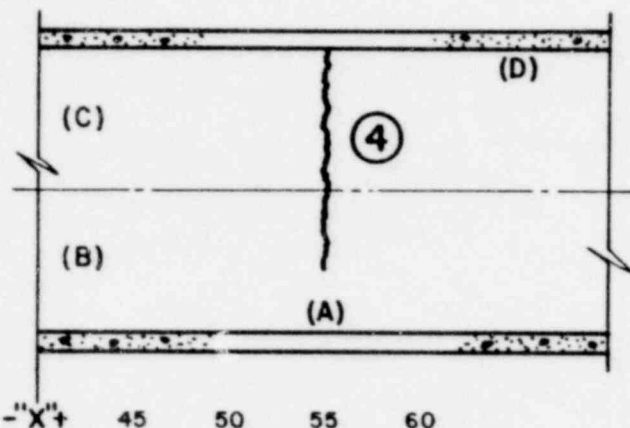
A HAIRLINE CRACK THAT STARTS AT THE
CORNER C-D AT STA. "X"+55'-0" AND
ENDS 3'-6" ABOVE (A) AT STA. "X"
+55'-0".

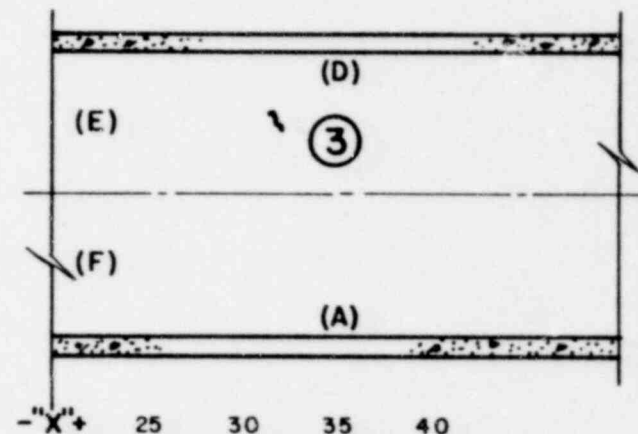
A HAIRLINE CRACK THAT STARTS 4'-0"
DOWN FROM (D) AT STA. "X"+32'-0" AND
ENDS 3'-6" FROM (D) AT STA. "X"
+31'-8".
