Millstone Nuclear Power Station, Unit No. 2
Feedwater System Piping

MILLSTONE NUCLEAR POWER STATION, UNIT NO. 2

RESPONSES TO
ADDITIONAL INFORMATION REQUIRED
TO ASCERTAIN ACTIONS NECESSARY
REGARDING THE FEEDWATER SYSTEM PIPING

ASSESSMENT OF GROWTH OF FEEDWATER LINE FLAWS

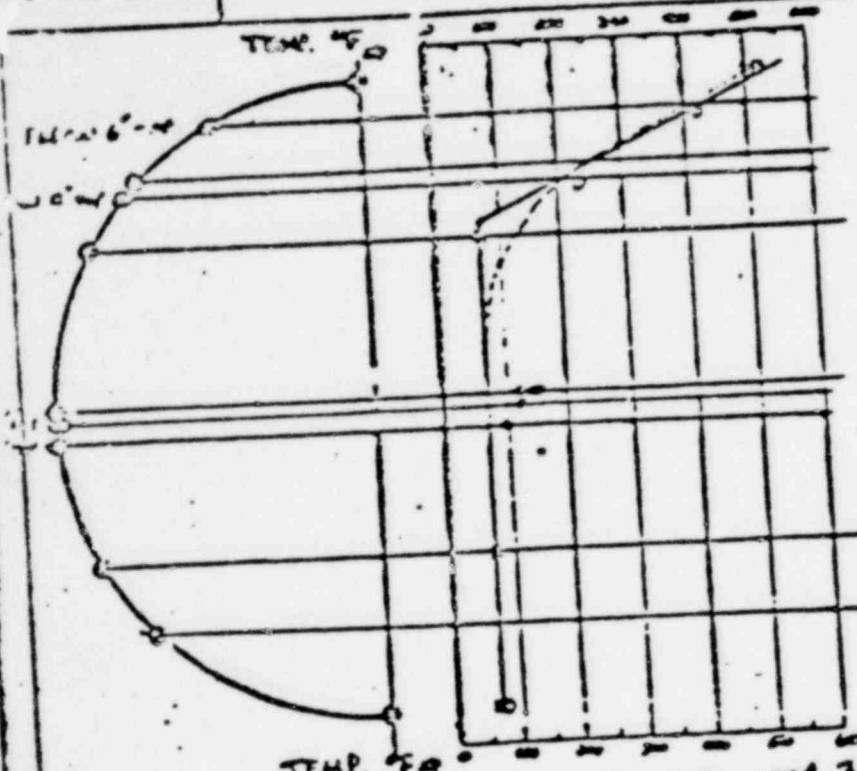
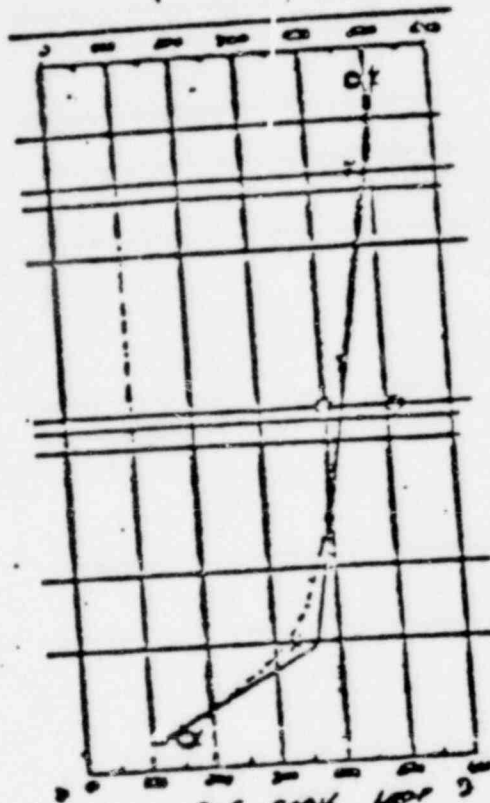
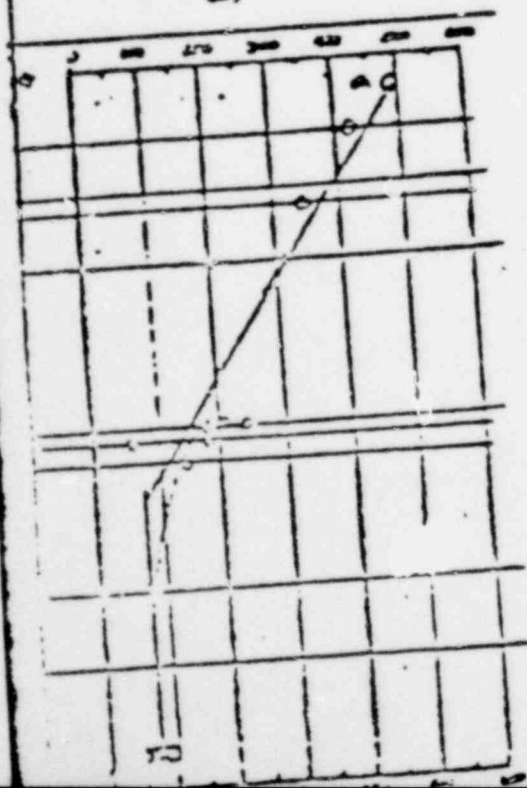
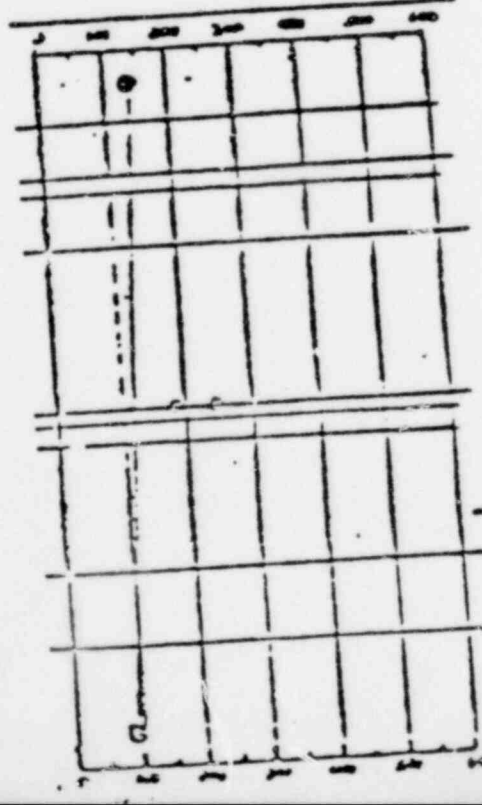
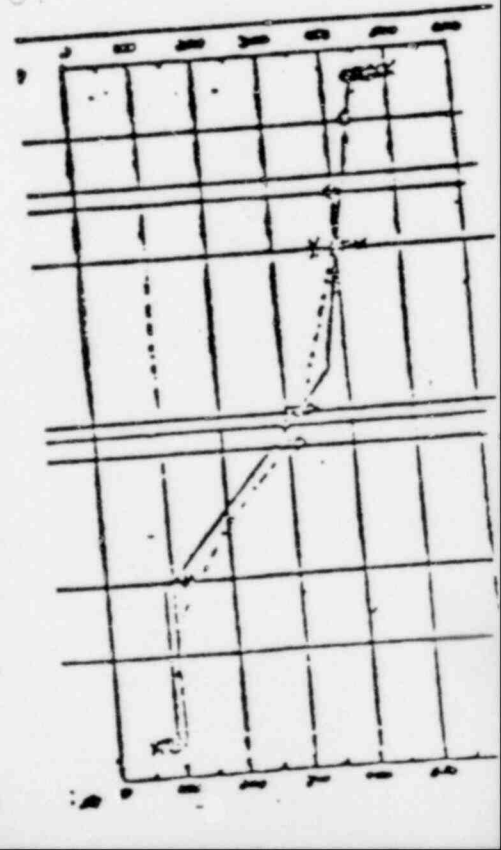
FIGURE 1.

A three dimensional finite element stress analysis has been completed for each of the five temperature profiles in Figure 1, and transient studies have shown that the five profiles represent limiting conditions compared with the stress results obtained for any transient step in between the profiles.

STEADY STATE TEMPERATURE DISTRIBUTIONS

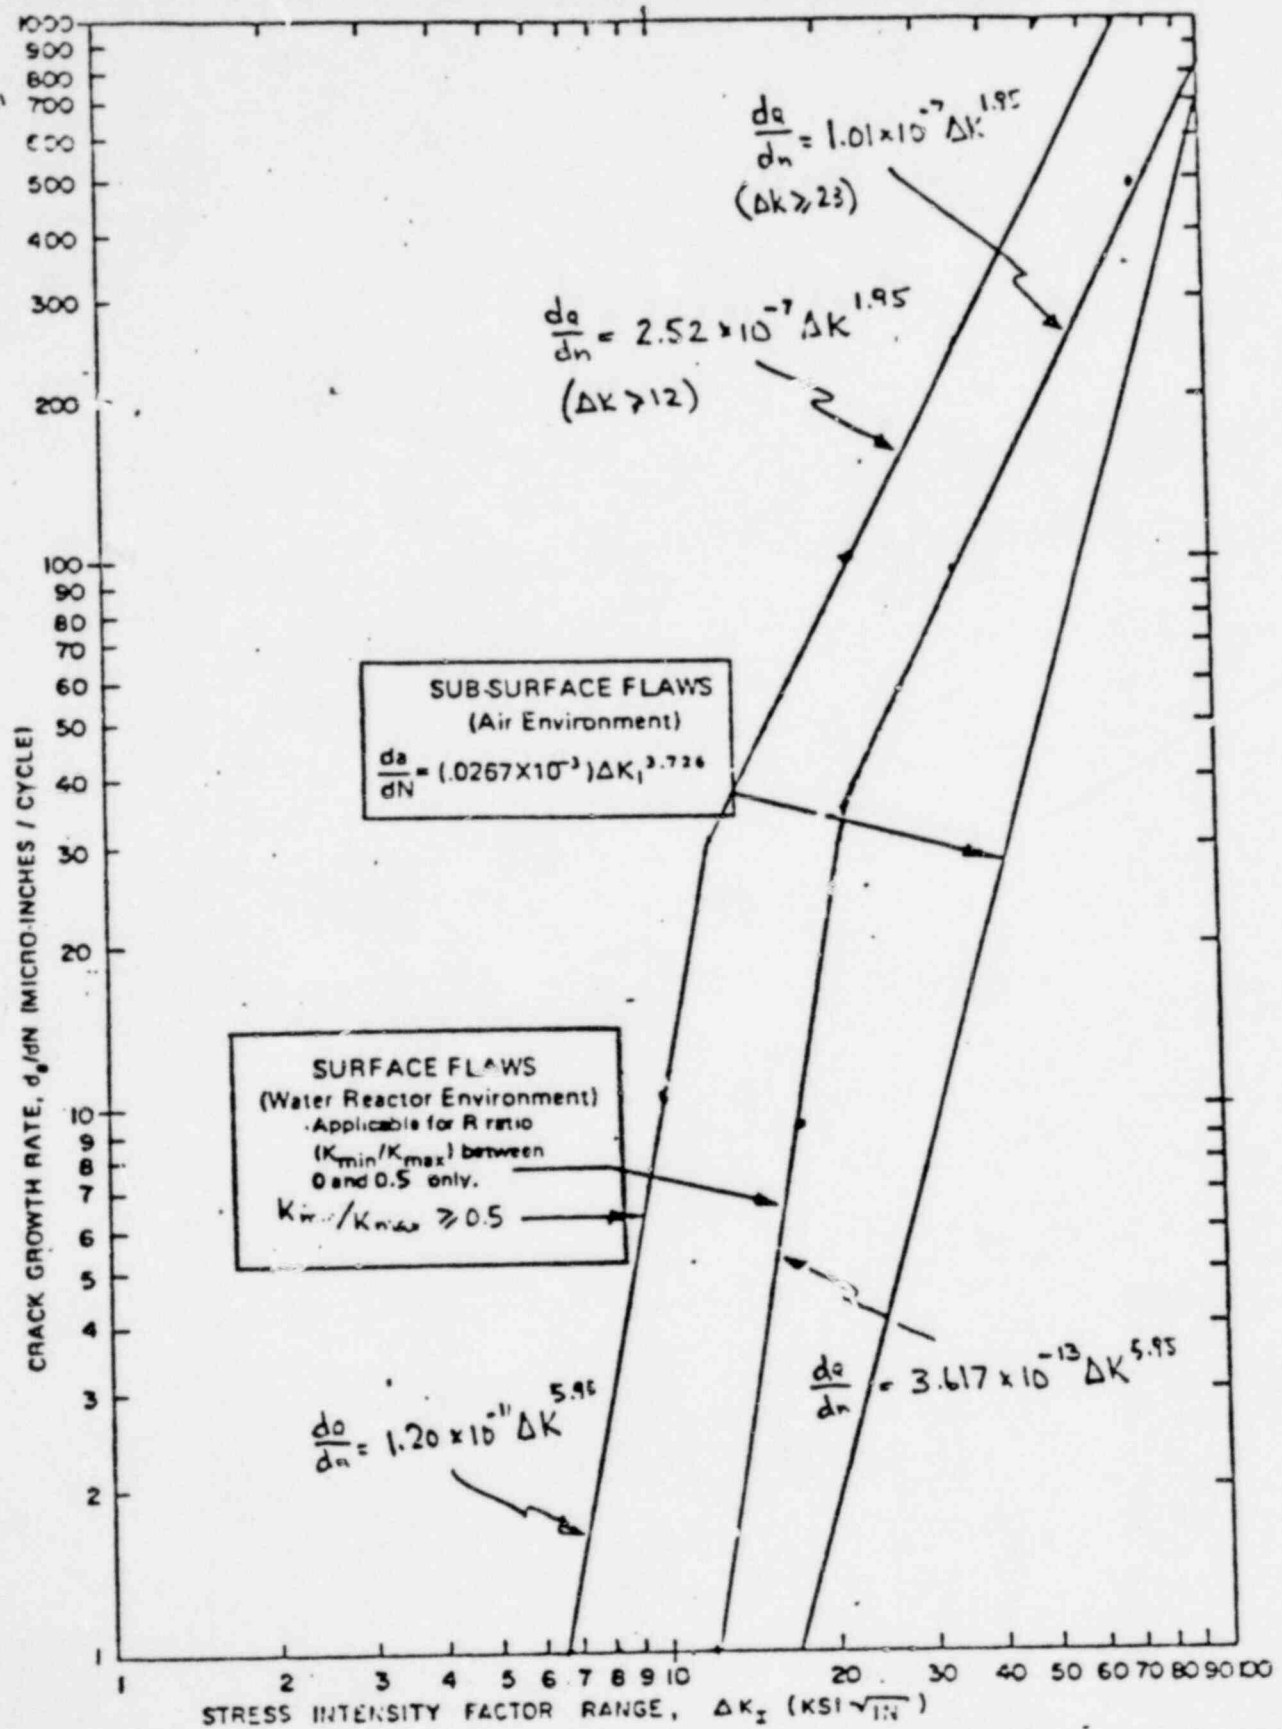
FIGURE 2 FATIGUE CRACK GROWTH DATA FOR SA-509, CLASS 2 AND CLASS 3 AND SA-533, GRADE B, CLASS 1 STEELS

A fatigue crack growth law which accounts for mean stress or R ratio ($\sigma_{min.} / \sigma_{max.}$) as well as the presence of the water environment was used. The law is shown in Figure 3.

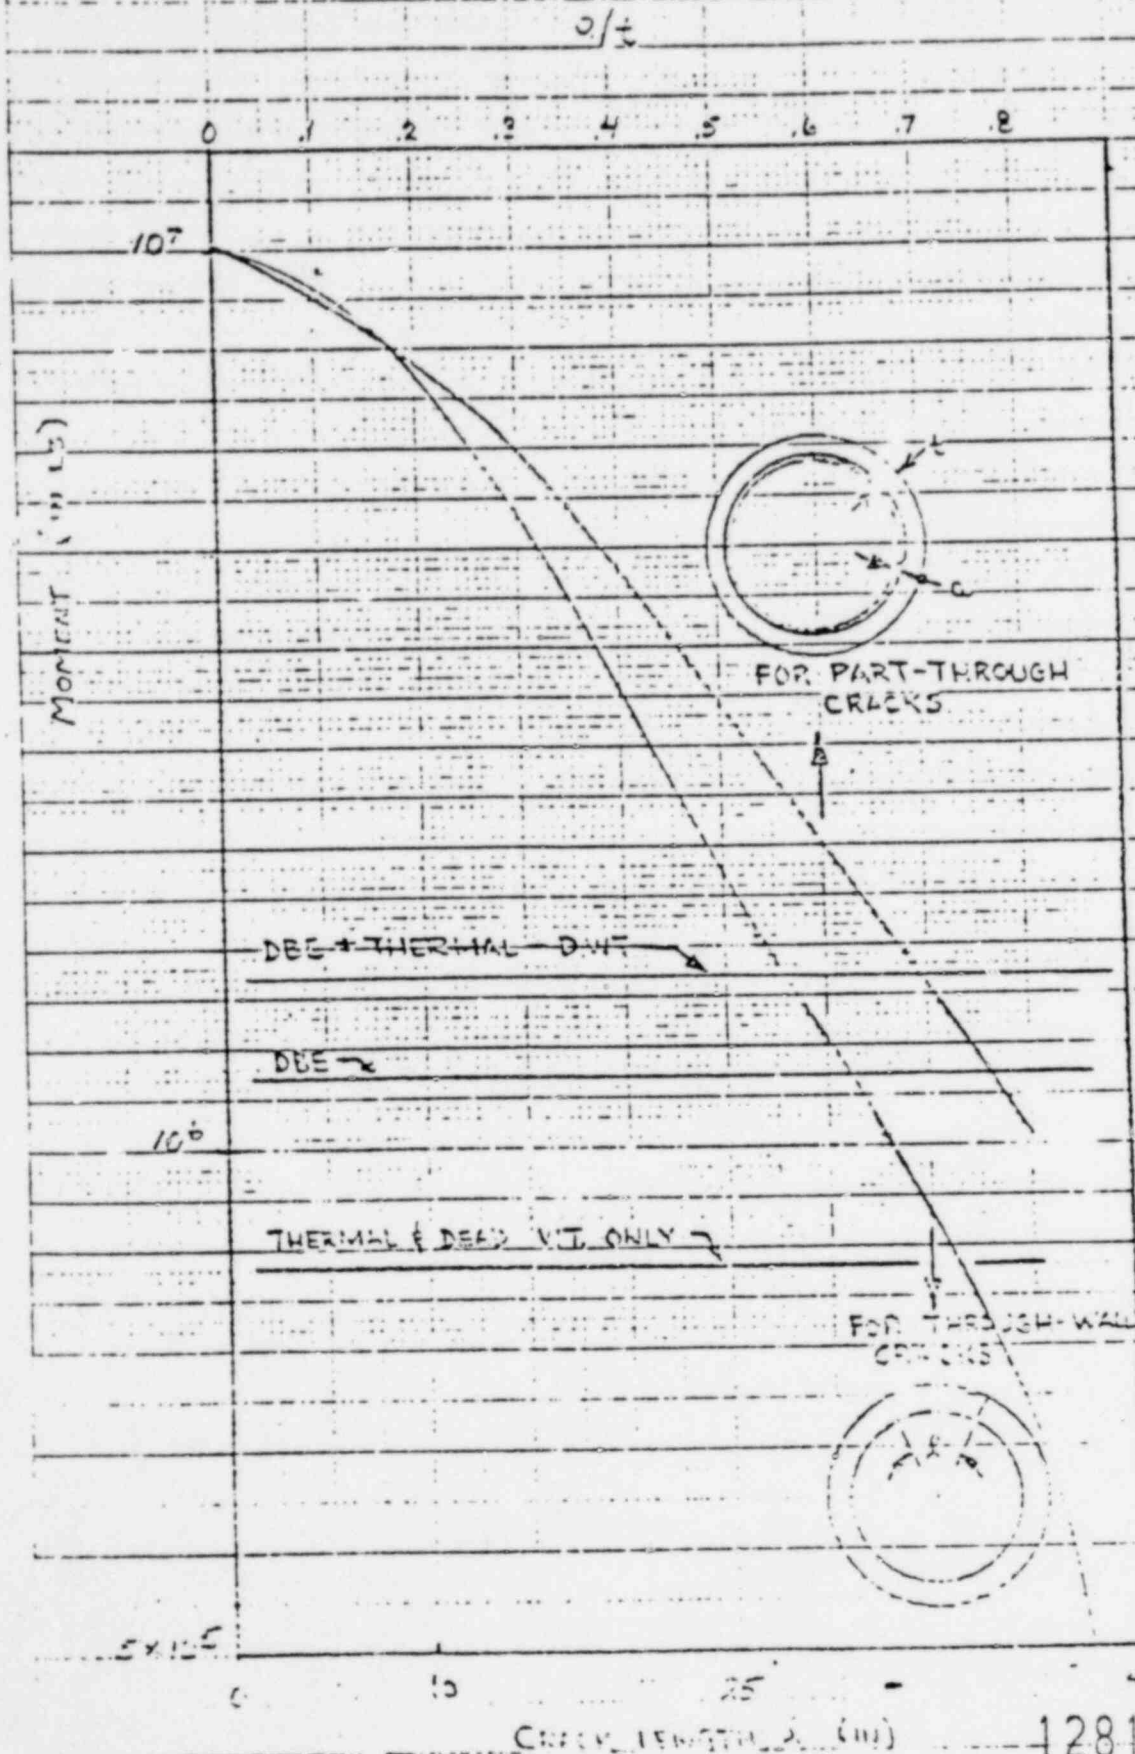
FIG. FAILURE PREDICTIONS - 18" ID PIPE 0.75" WALL

Results of the crack growth analysis are shown in Table 6, for each of the locations considered. These results show that the observe flaws will not grow significantly during the next years service. The final flaw size for the worst location is a factor of 5 smaller than the critical flaw size for the pipe, as shown in Figure 4.
