BFRO-50- 259 / 7829 R1 Technical Specification Involved 5.6

Identification and Description of Occurrence:

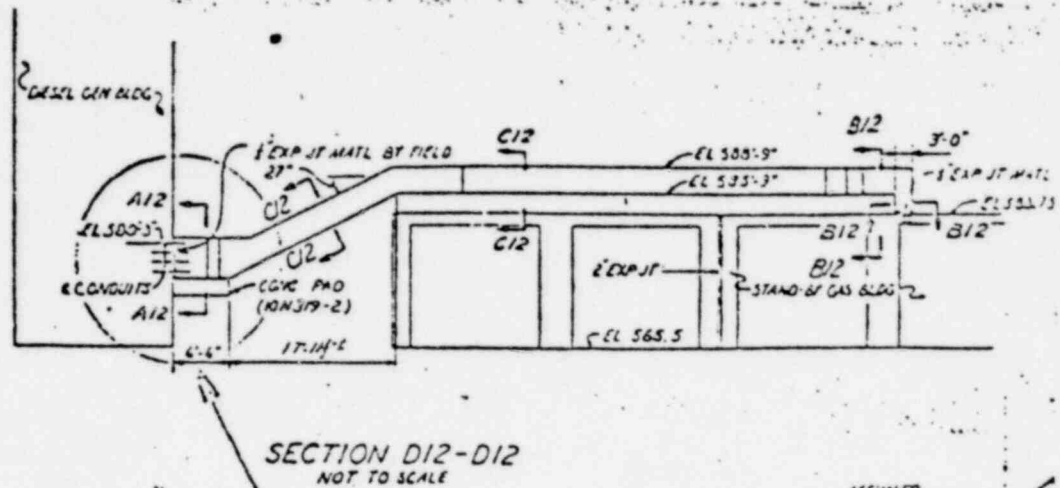
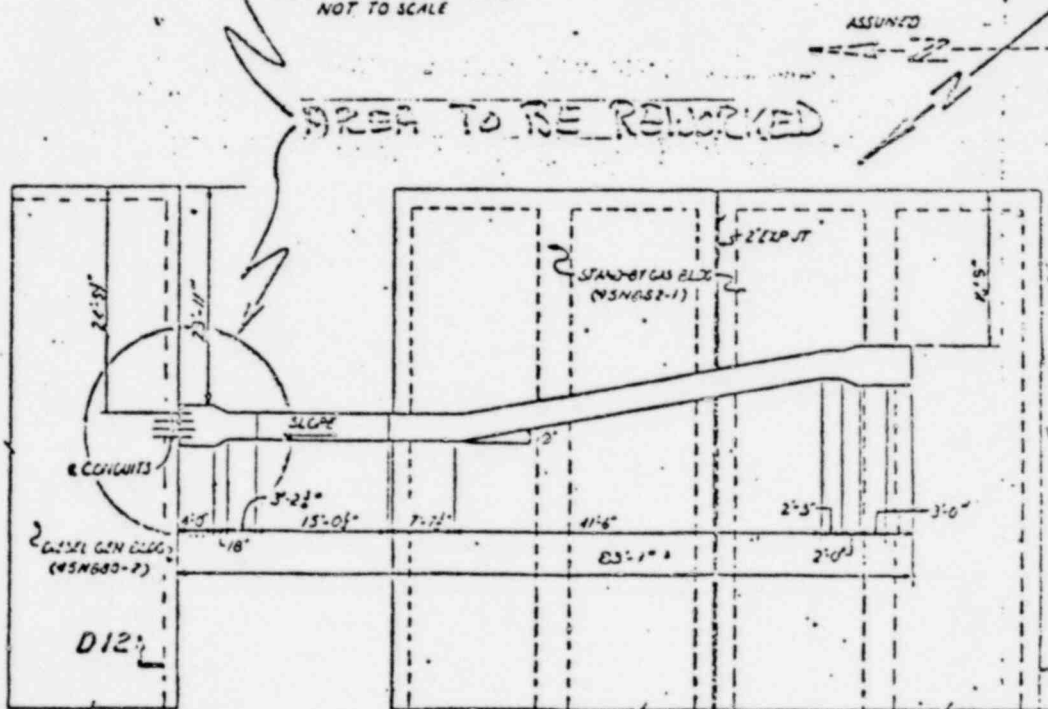
The conduit raceway between the diesel generator building and the standby gas treatment building appeared to be settled about 2 inches at the expansion joint between the end of the raceway and the diesel generator building (see Attachment). No damage to the cables in the raceway is evident.

The cause of the occurrence was settlement of the conduit raceway foundation into the earth backfill underneath.

Design of the raceway requires an expansion joint between the raceway and diesel generator building. Therefore, support at this end is dependent upon backfill underneath which allowed the raceway to settle.

Corrective Action: Overburden was excavated and the raceway realigned to its original design position and resupported to meet seismic category I requirements. Inspections of raceway and cables revealed no damage. Position of the raceway will be periodically monitored for the next two years.
